Death in the line of duty...

A summary of a NIOSH fire fighter fatality investigation

December 16, 2005

Career Fire Captain Dies When Trapped by Partial Roof Collapse in a Vacant House Fire - Texas

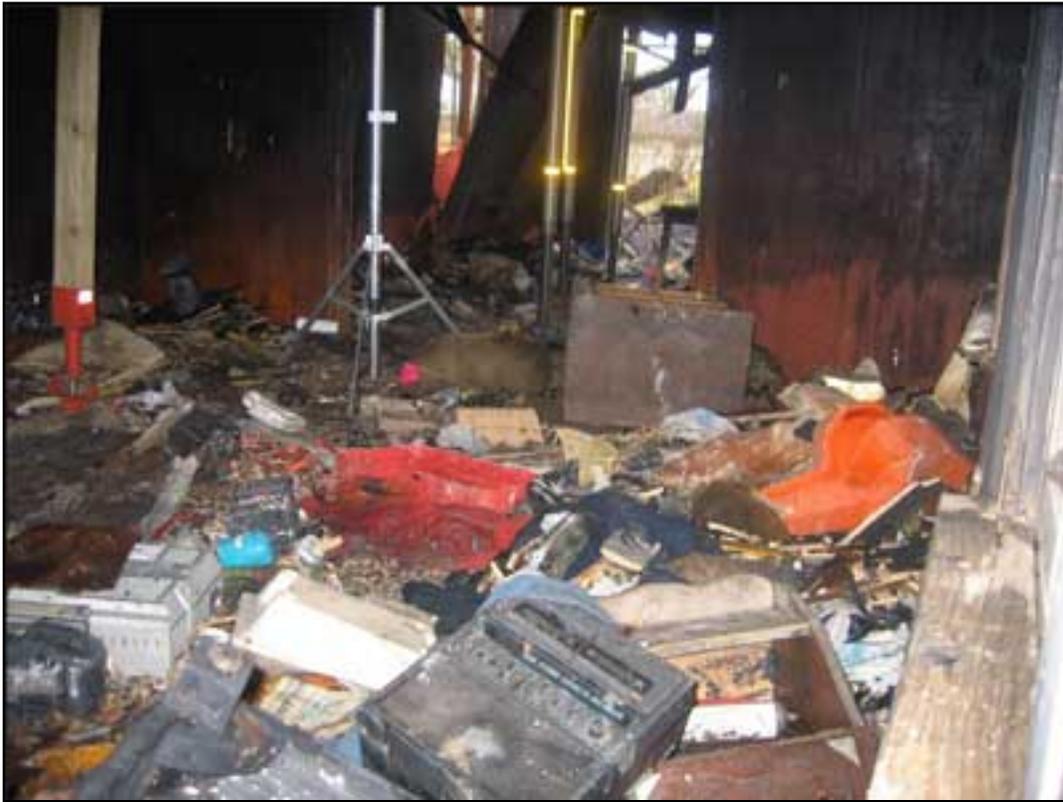
In this incident, the structure had been abandoned since the time of the owner's death in 2004. The structure was known to be used by vagrants for illicit activities. The structure had also been ransacked resulting in broken furniture, household goods, debris, and litter cluttering the floors.

Photo 1. Note cluttered condition of floor in living room.

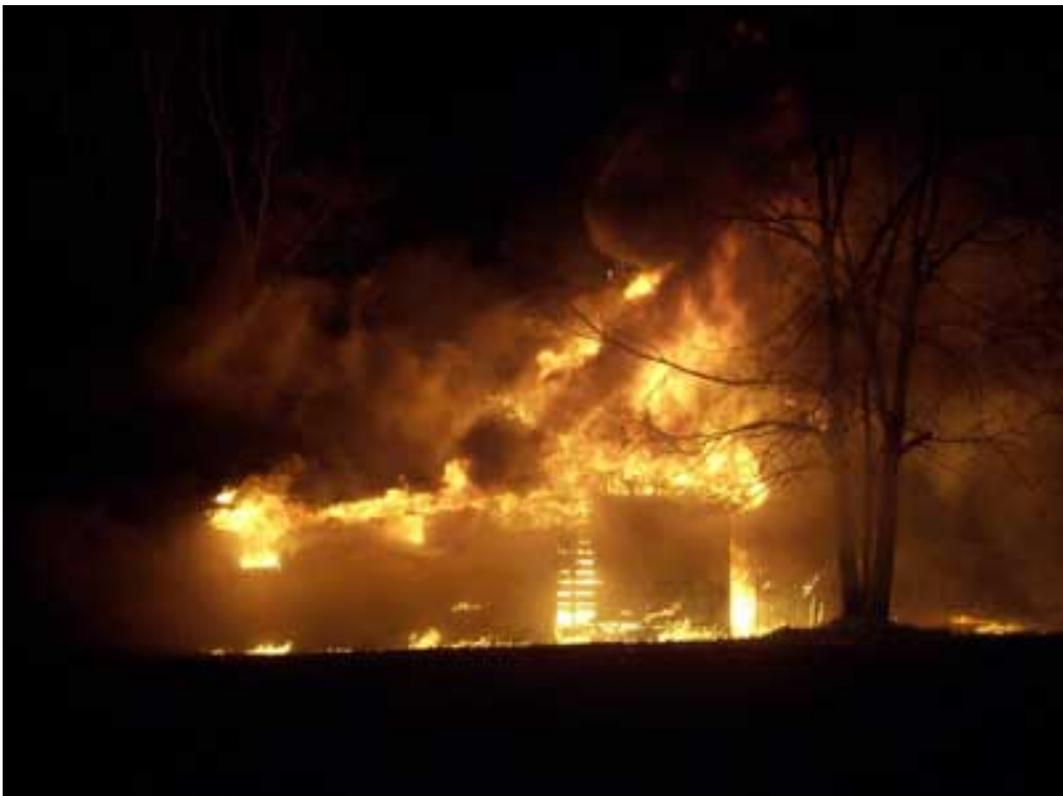
The DC46 and the Captain of L46 walked around to the C / D corner of the structure to observe conditions (see [Figure 1](#)). DC46 told the L46 Captain that roof ventilation was not possible. DC46 directed L46 to do interior search. The L46 Captain told his crew to take the front door off of its hinges because the door was partially obstructing access into the house. The L46 Captain entered by himself. After removing the door and setting it to the right of the entranceway, the L46 crew (2 fire fighters) entered the structure and started a left-hand search through the living room and front bedroom, keeping in contact with the interior walls. The Captain and the L46 crew members never met inside the structure. L46 was equipped with a thermal imaging camera (TIC) but it was not used during the initial search operations. *NOTE: Several fire fighters reported to NIOSH investigators that flames were venting through the roof at the rear of the structure when they arrived on-scene. Some reported that flames could be seen well above the roof line (see [Photo 2](#) taken shortly after crews began arriving on-scene).*

**Photo 2. Taken just prior to, or near the time, of the collapse.
See Photo 3 for the same view after fire extinguishment.**

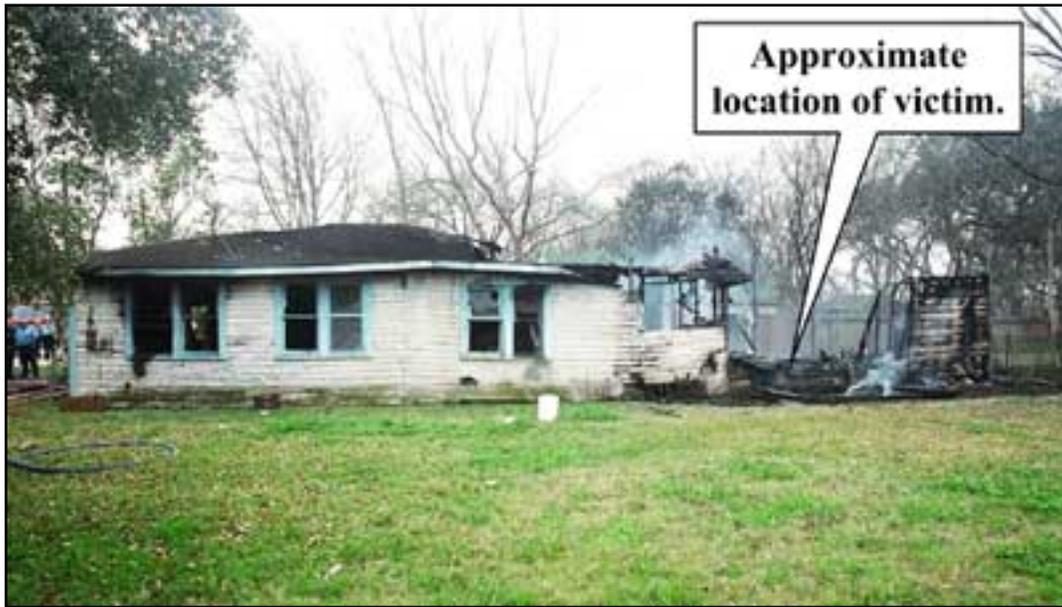
The roof collapse occurred over the den addition at the rear of the structure (see [Photo 3, 4](#) and [Figure 1](#)). The E46 crew was operating in the kitchen area and had just located the fire and begun to direct water onto the flames. The E46 captain (the victim) had just taken the nozzle from the nozzleman to direct water toward the rear of the house. The two E46 fire fighters were just reaching to pull more slack when they were knocked down by the force of the collapse. The L46 Captain who was in the dining room behind the two E46 fire fighters reported hearing a rumbling sound just prior to the collapse. The L46 Captain immediately began yelling for everyone to get out. The L46 Captain radioed that fire fighters were trapped, and requested help. Then, while trying to adjust his radio, he dropped it and was not able to retrieve it (see [Figure 1](#)). The nozzleman from E46 was disoriented by the collapse but began moving toward the front of the house. At some point, he noticed flashing lights from the apparatus parked on the street and dove headfirst out a living room window on the D-side. The other E46 fire fighter was able to follow the hoseline to the front door. Just prior to the roof collapse, the E55 crew had advanced the second 1¾-inch hoseline to the kitchen near where E46 was operating. They could hear the L46 Captain talking nearby. The E55 crew also were knocked down by the force of the collapse, but were able to follow their hose line toward the front of the house and were assisted to the outside.

Photo 3. Note roof collapse area at rear of house.
Photo courtesy of fire department.

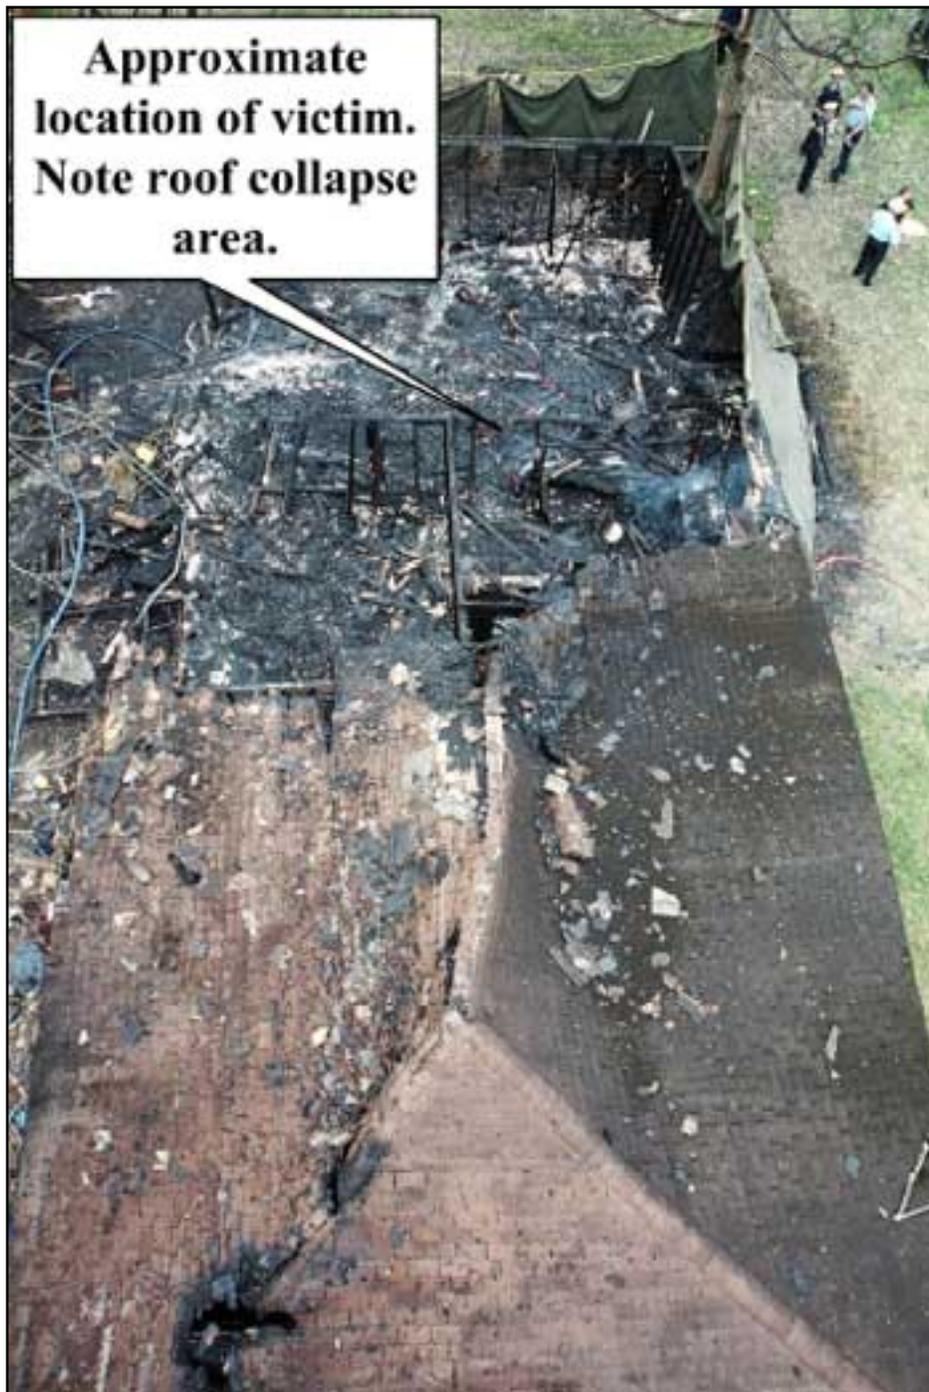
Photo 4. Aerial view of collapse zone.
Photo courtesy of fire department.

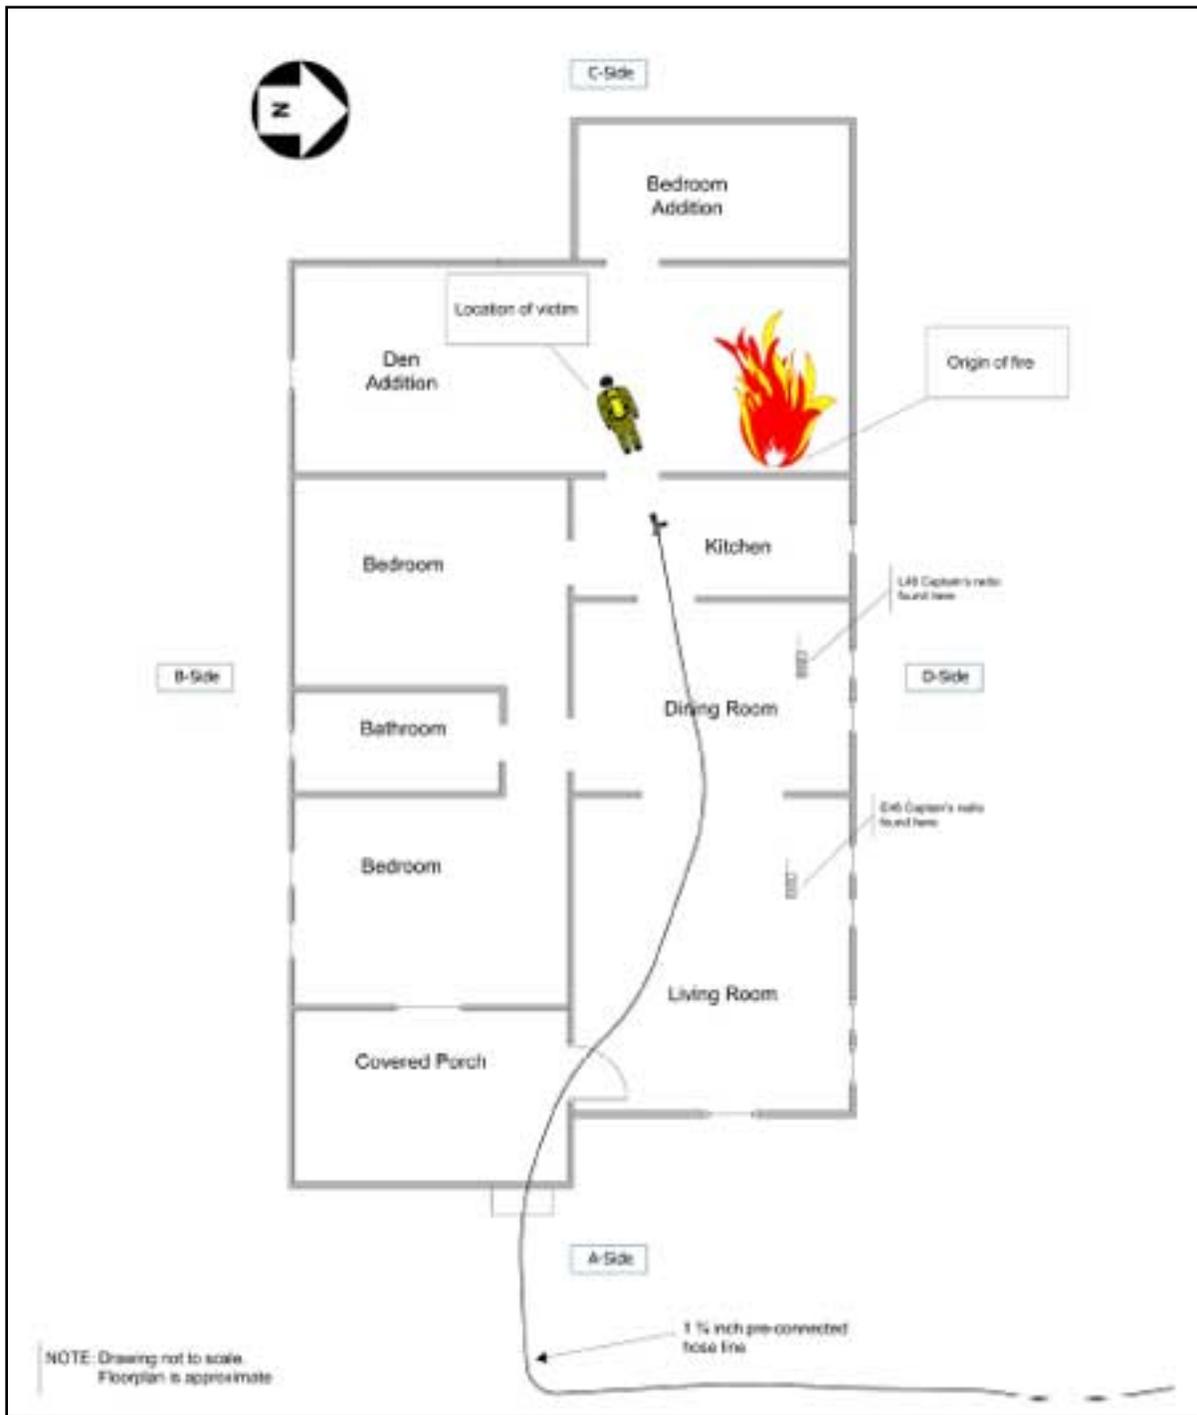
Figure 1. Layout of structure.

At approximately 0629, the E25 crew located the victim face-down under approximately 2 – 3 feet of debris and rubble from the collapsed roof. The victim was found facing the rear of the structure (see [Figure 1](#)). The victim's SCBA cylinder was the only thing showing above the debris. The victim's PASS device was not in alarm mode (no audible alarm and no flashing lights were detected) when the rescuers found the victim. The victim was pronounced dead on the scene by medical examiners. The victim's turnout gear and SCBA were severely damaged by heat and/or flame exposure at the time the victim was located. The SCBA was too badly damaged to be tested by NIOSH for proper performance.
