Schomberg Plaza Fire New York City (Harlem)

Schomberg Plaza Fire New York City (Harlem) (March 22, 1987)

By: Philip Schaenman

This is Report 004 of the Major Fires Investigation Project conducted by TriData Corporation under contract EMW-86-C-2277 to the United States Fire Administration, Federal Emergency Management Agency.

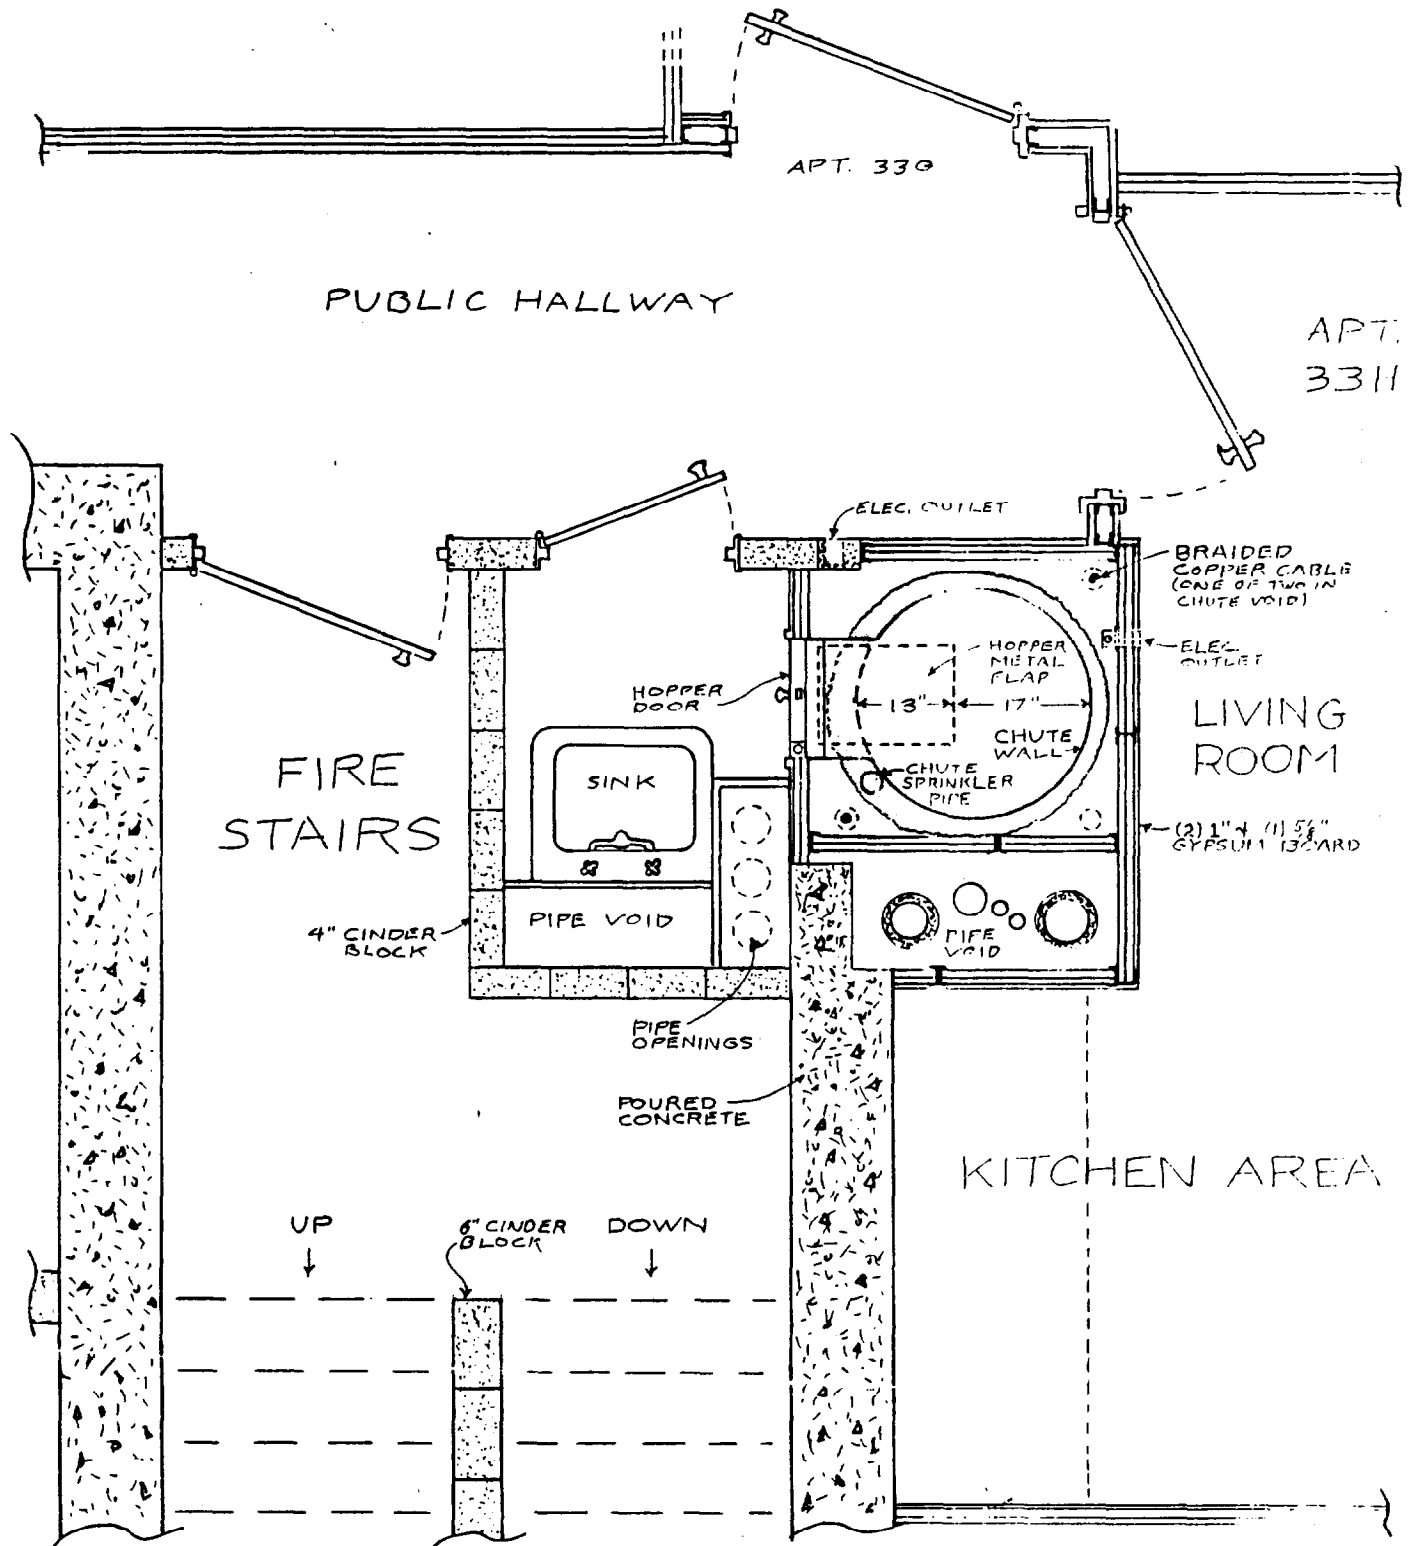
1295 5TH AVE MAN. 33RD FLOOR COMPACTOR CHUTE AREA*

horizontally into the adjoining pipe chase void via a one and one-eighths inch (1 1/8") opening at the bottom of the partition wall between the shaft enclosure and the pipe chase void. This opening was created as a result of the two inch (2") sheetrock wall resting on top of various pipe brackets and chute anchors rather than being secured to the concrete floor. (See attached diagram). In addition, it was found that the chute penetrated each floor through a concrete opening of a slightly larger diameter thereby creating a space between the outside of the chute and the concrete opening which varied from floor to floor. These openings allowed for vertical heat transfer from floor to floor within the shaft.

Examination found additional openings in the sheetrock construction of the walls which divided the compactor chute enclosure and the pipe chase void from the kitchen and livingrooms of the "H" bank apartments. These openings allowed heat transfer from the chute enclosure and the pipe chase void into the "H" bank apartments. Further, the above mentioned metal pipe brackets extended from the pipe chase void into and under the kitchen broom closet, making contact with the combustible components of the broom closet.

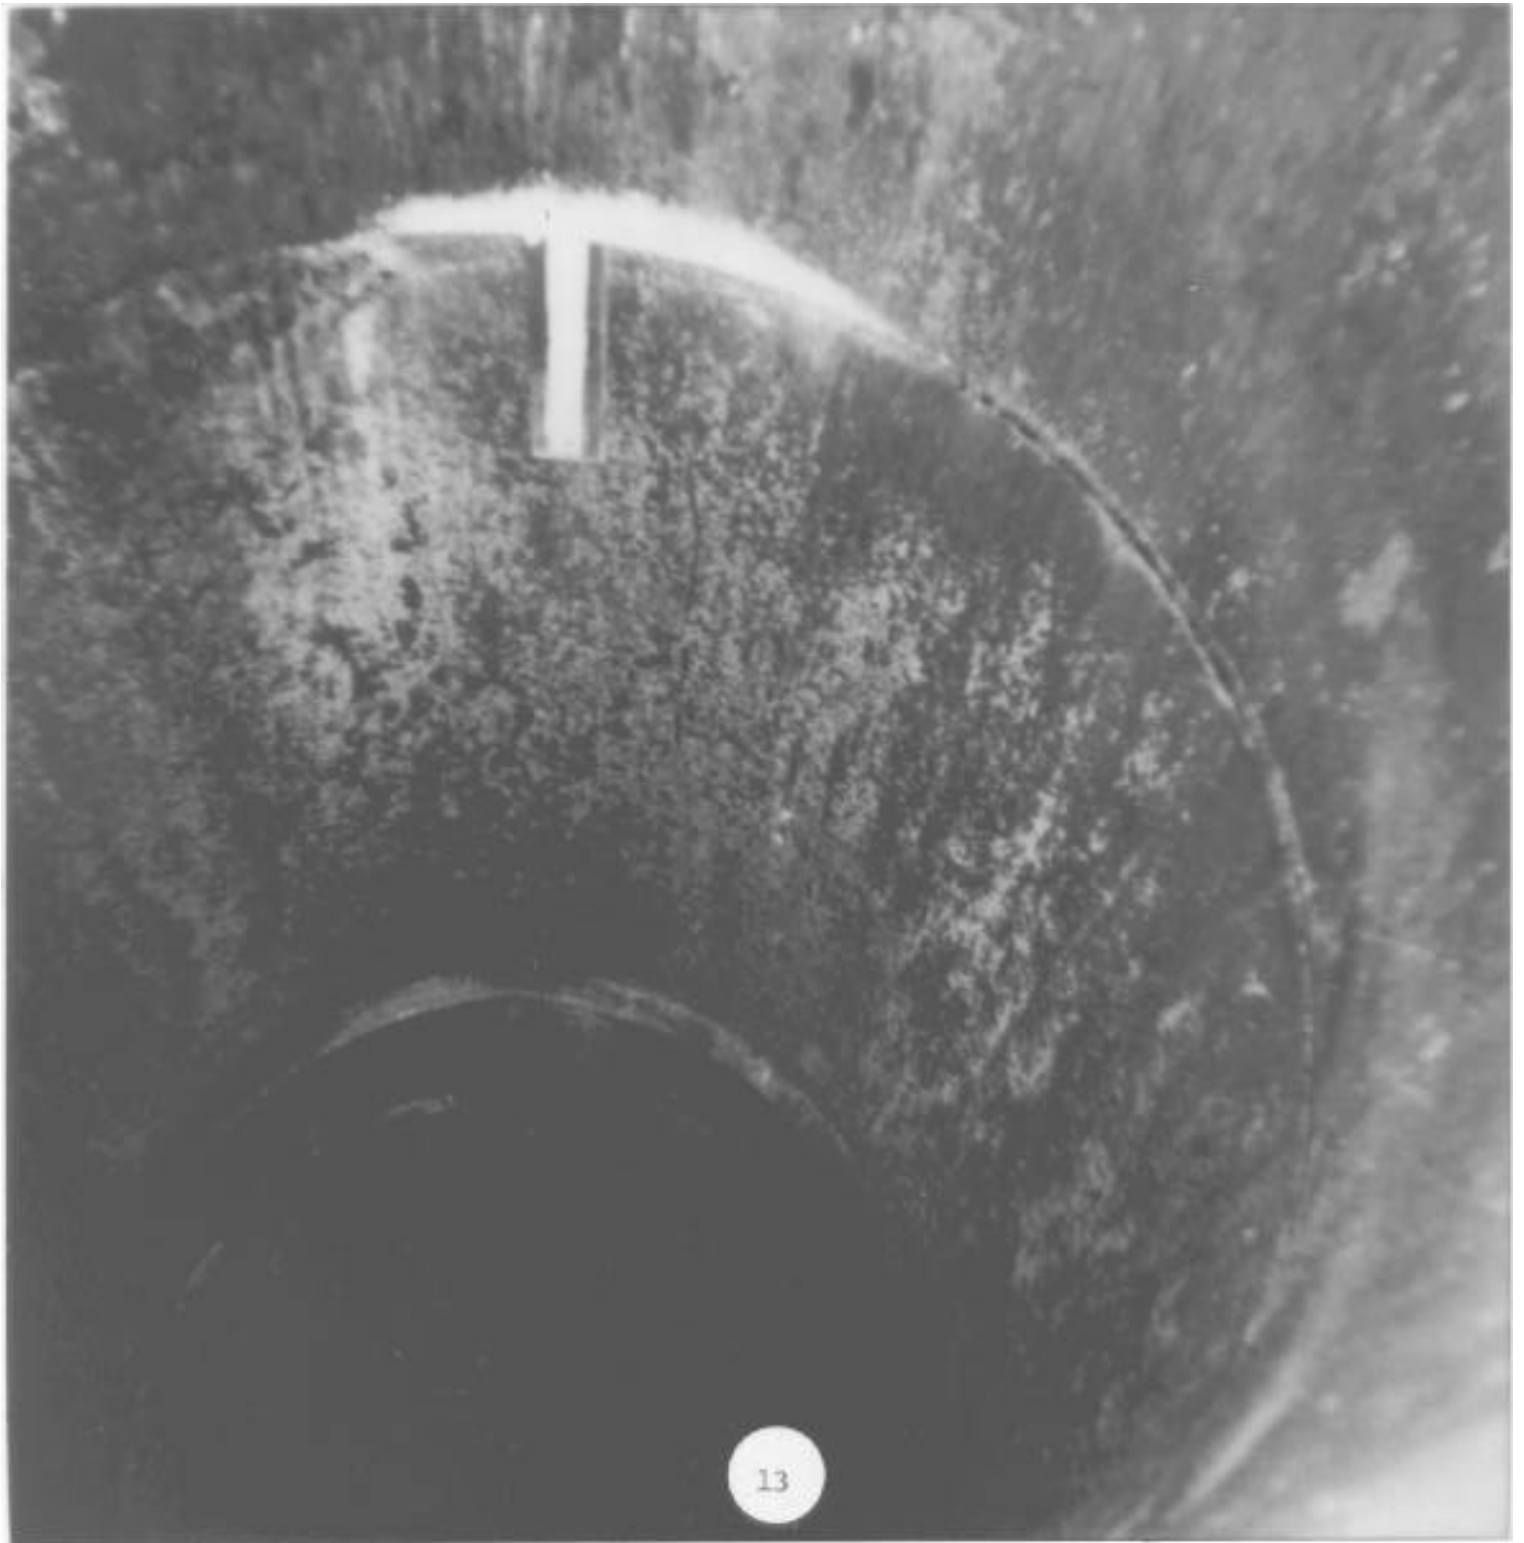
12

12. Void between chute and structure floor allowing for passage of heat from floor to floor.
13. Interior of chute with opening at seam.
14. Clogged sprinkler head.

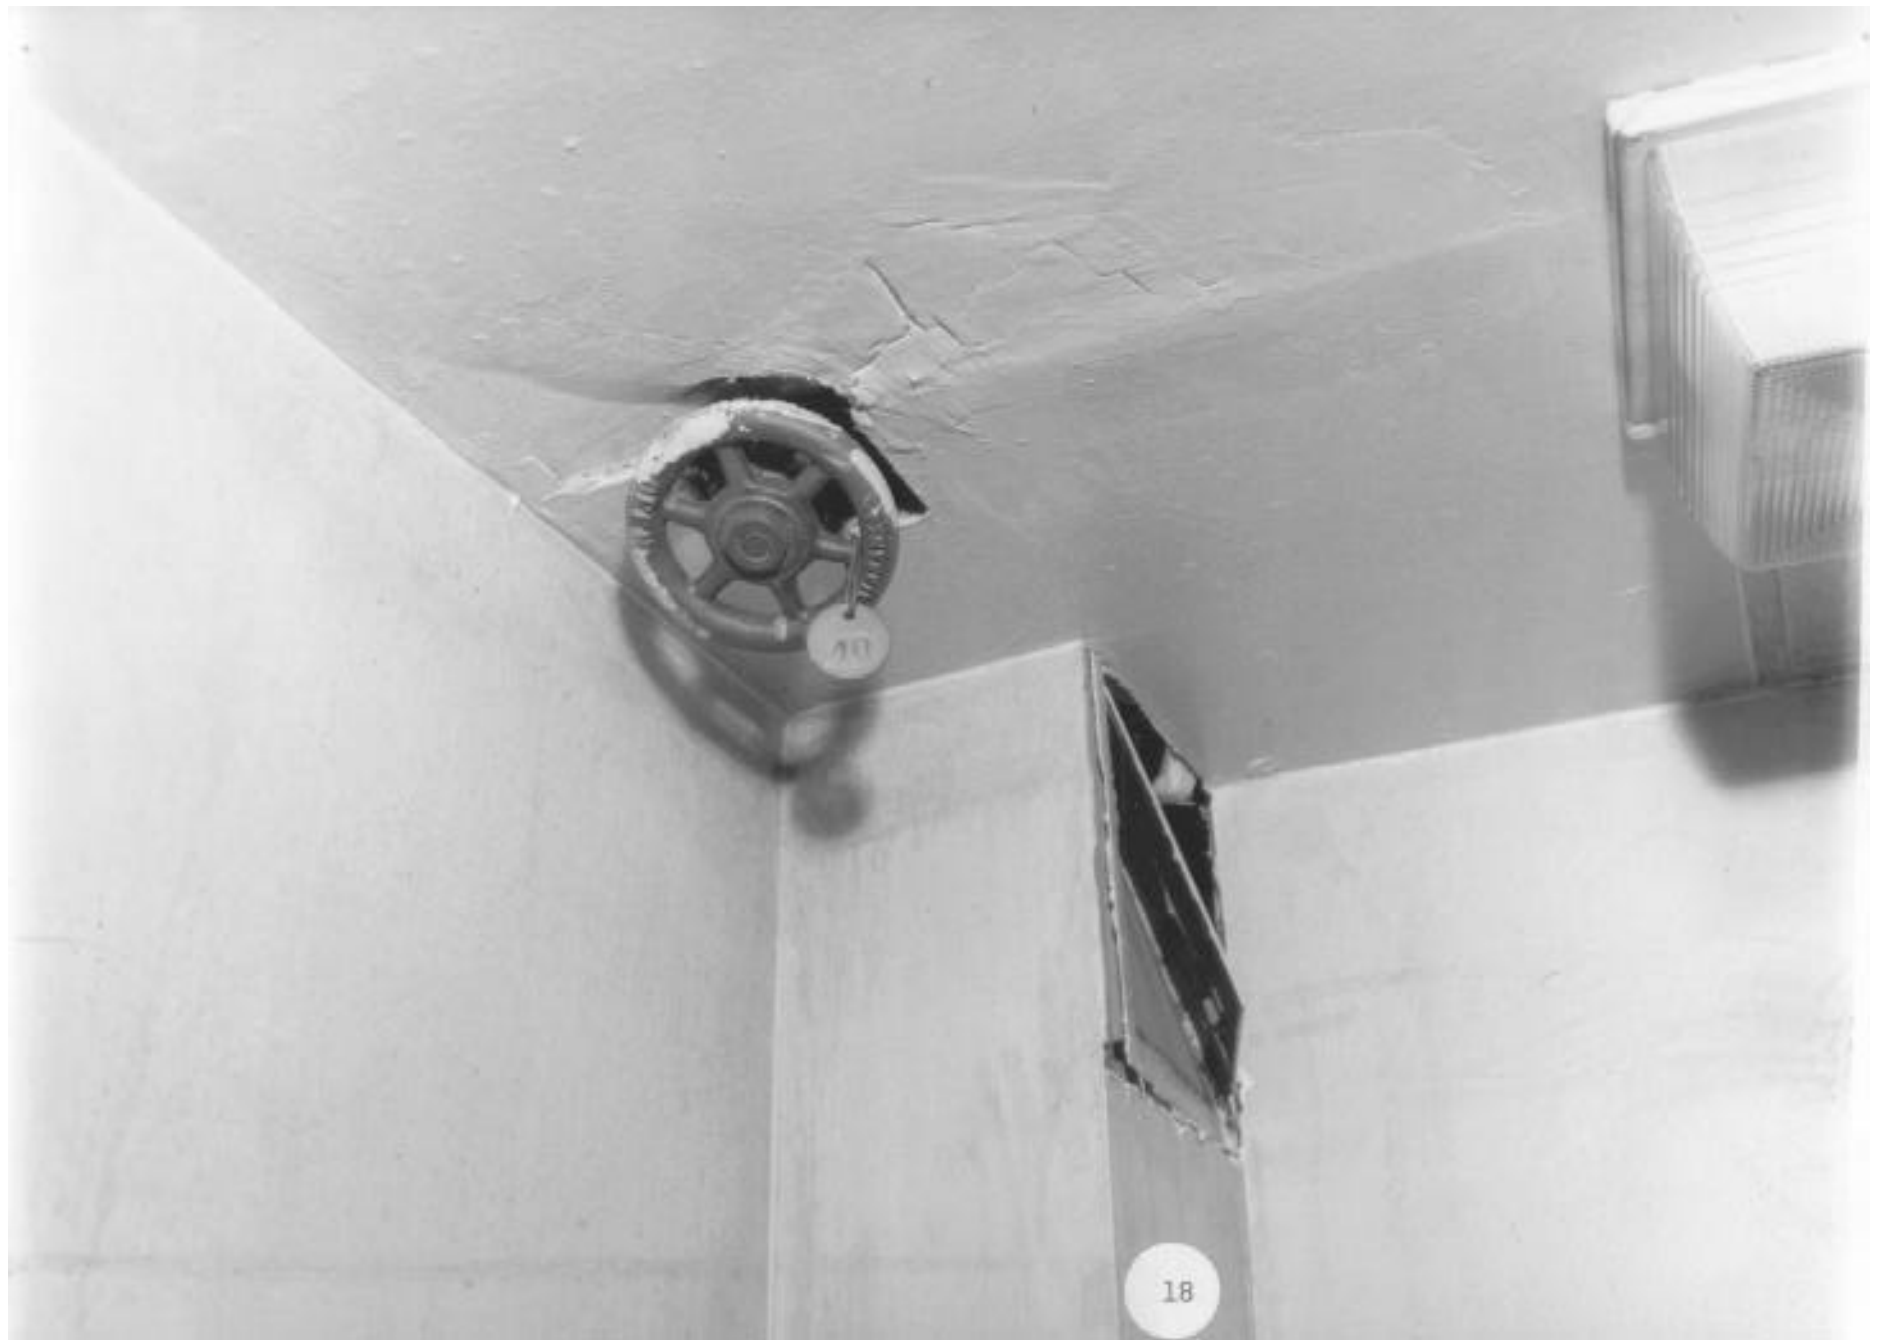
17

15. Horizontal piping with solidified silt and rust.
16. Evidence voucher. (Sample)
17. Sprinkler shut off valve in dayroom, 1st floor.
18. Sprinkler shut off valve in closet (compactor) on 35th floor at ceiling.
