## **\$10 Million Marina Fire Bohemia Bay, Maryland**

# **\$10 Million Marina Fire Bohemia Bay, Maryland (January 6, 1989)**

**This is Report 026 of the Major Fires Investigation Project conducted  
by TriData Corporation under contract EMW-88-C-2649 to the United  
States Fire Administration, Federal Emergency Management Agency.**

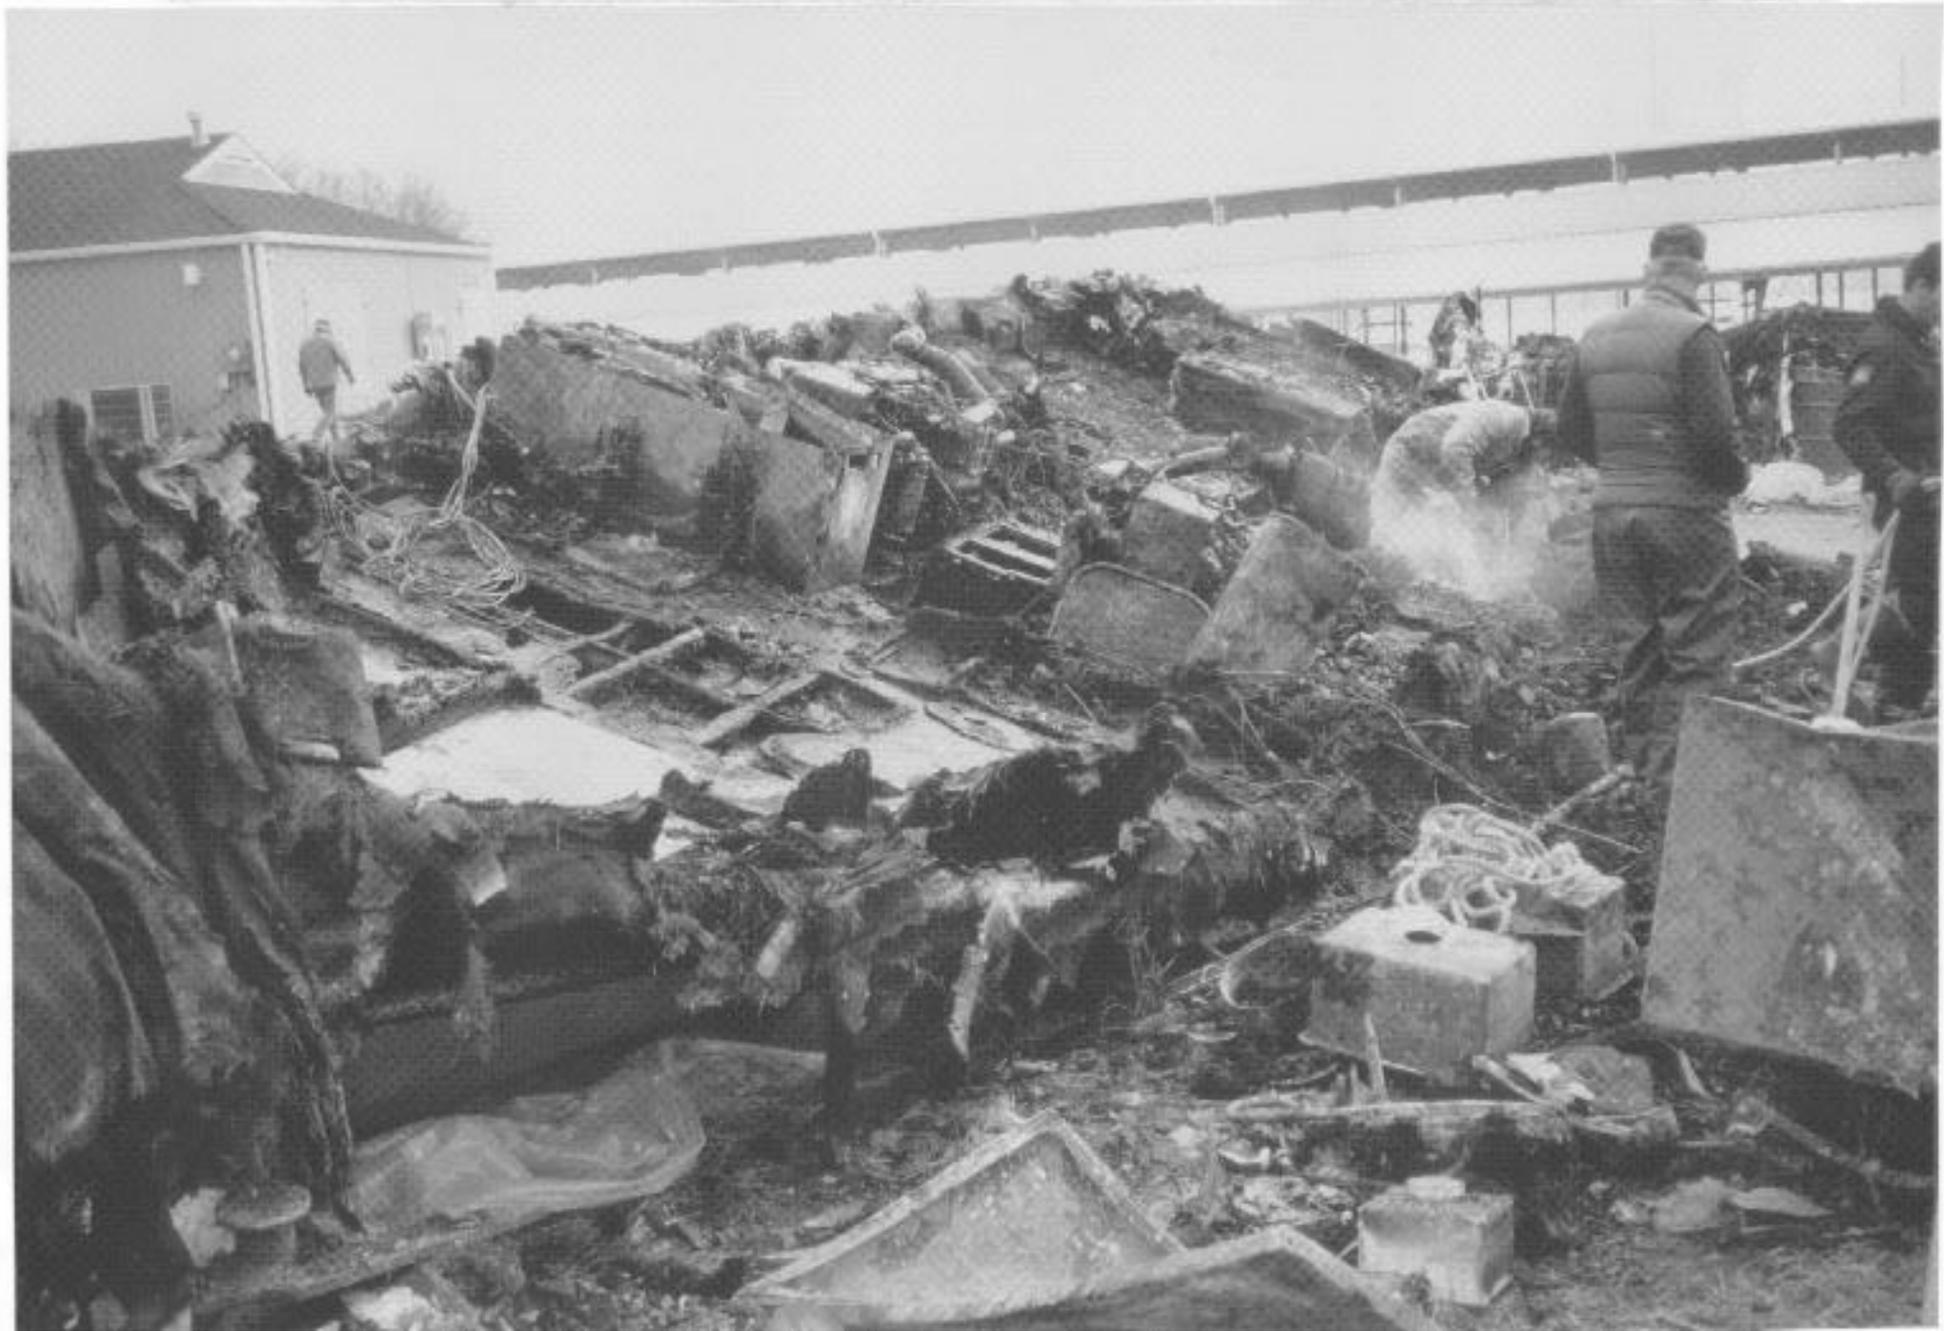
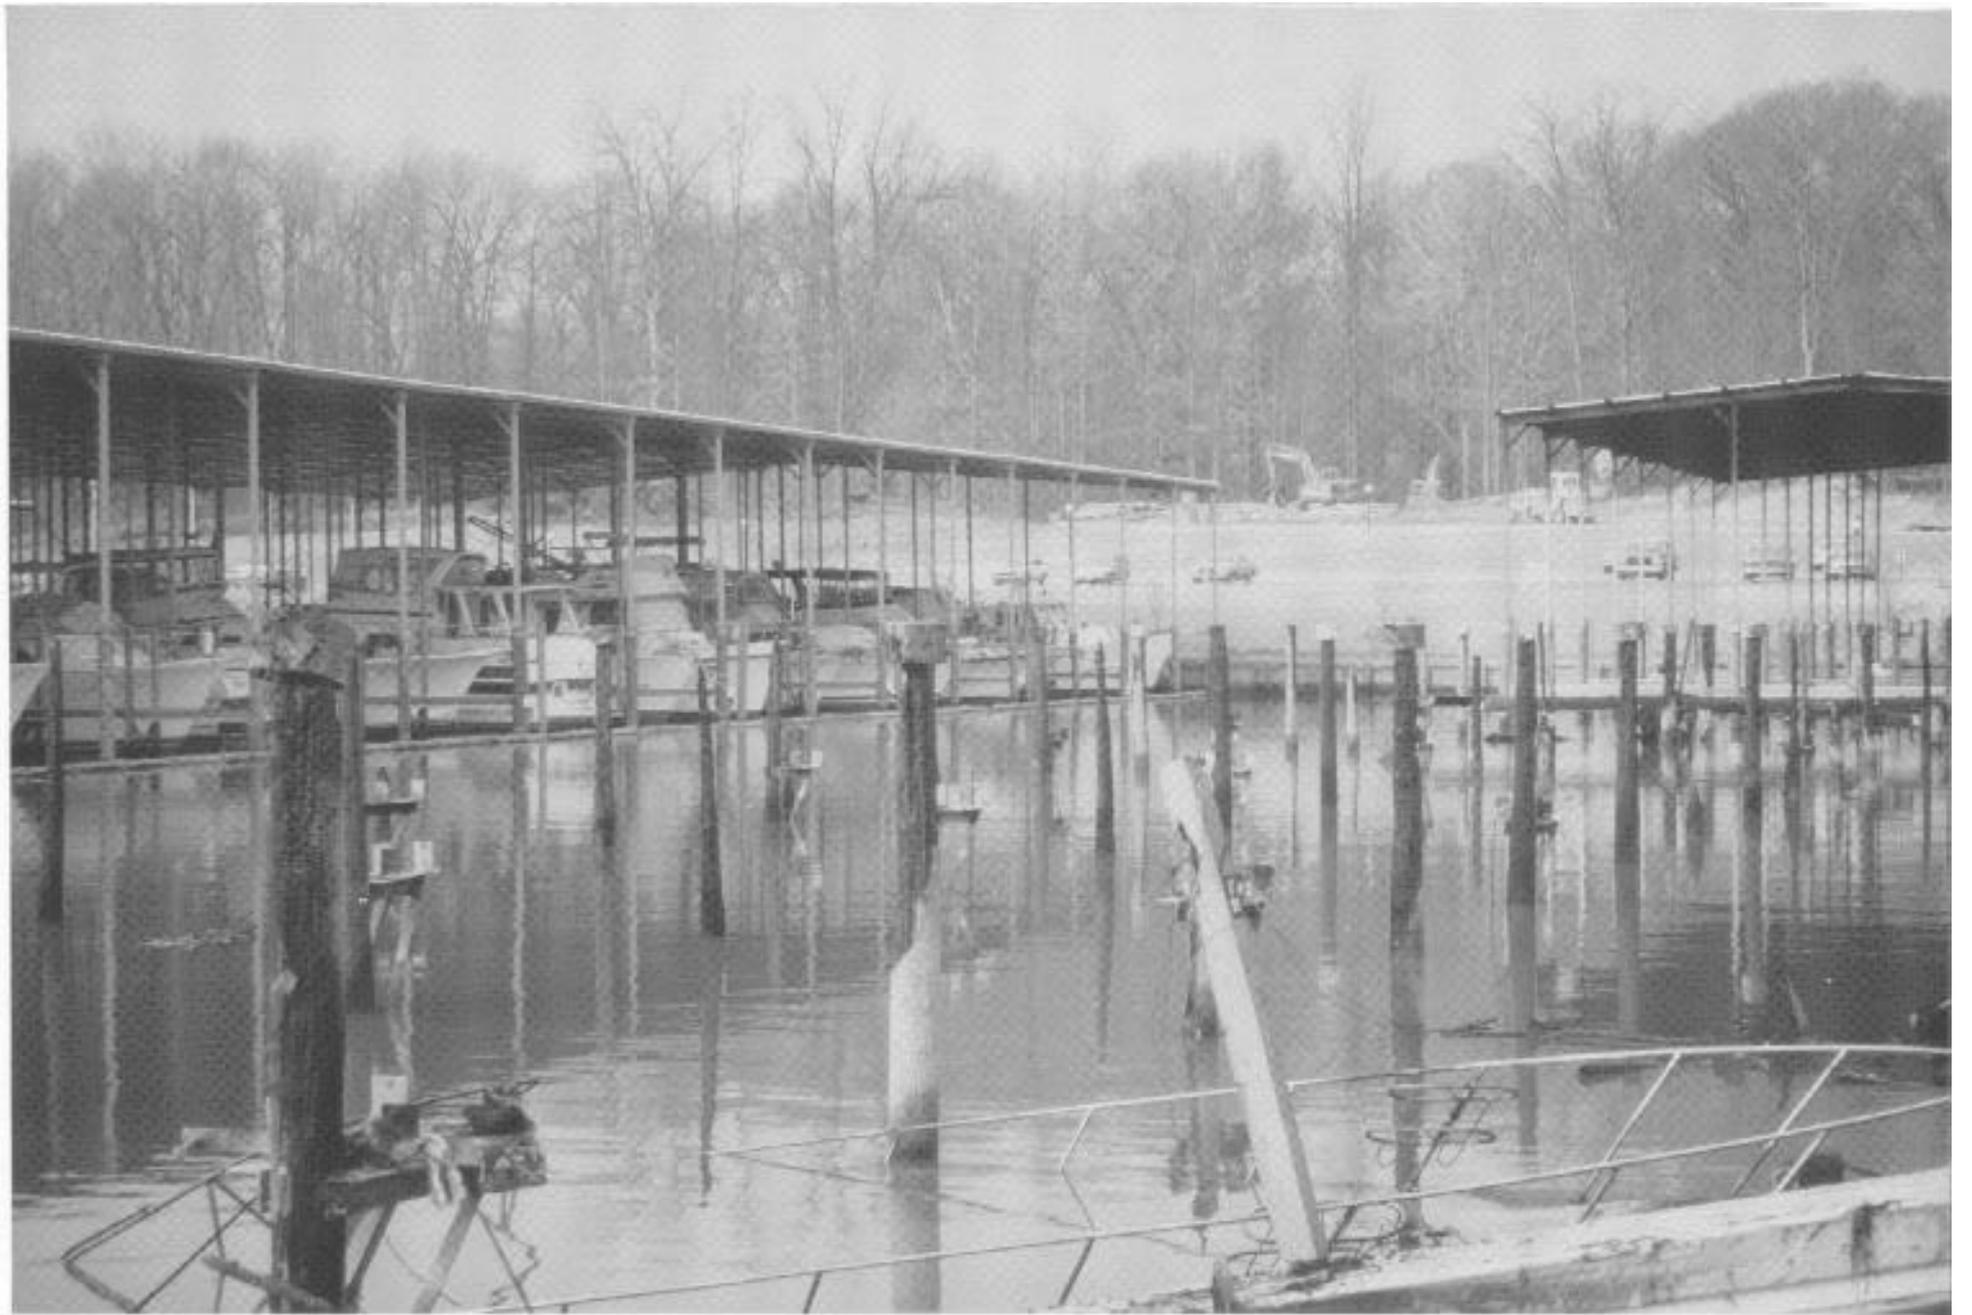
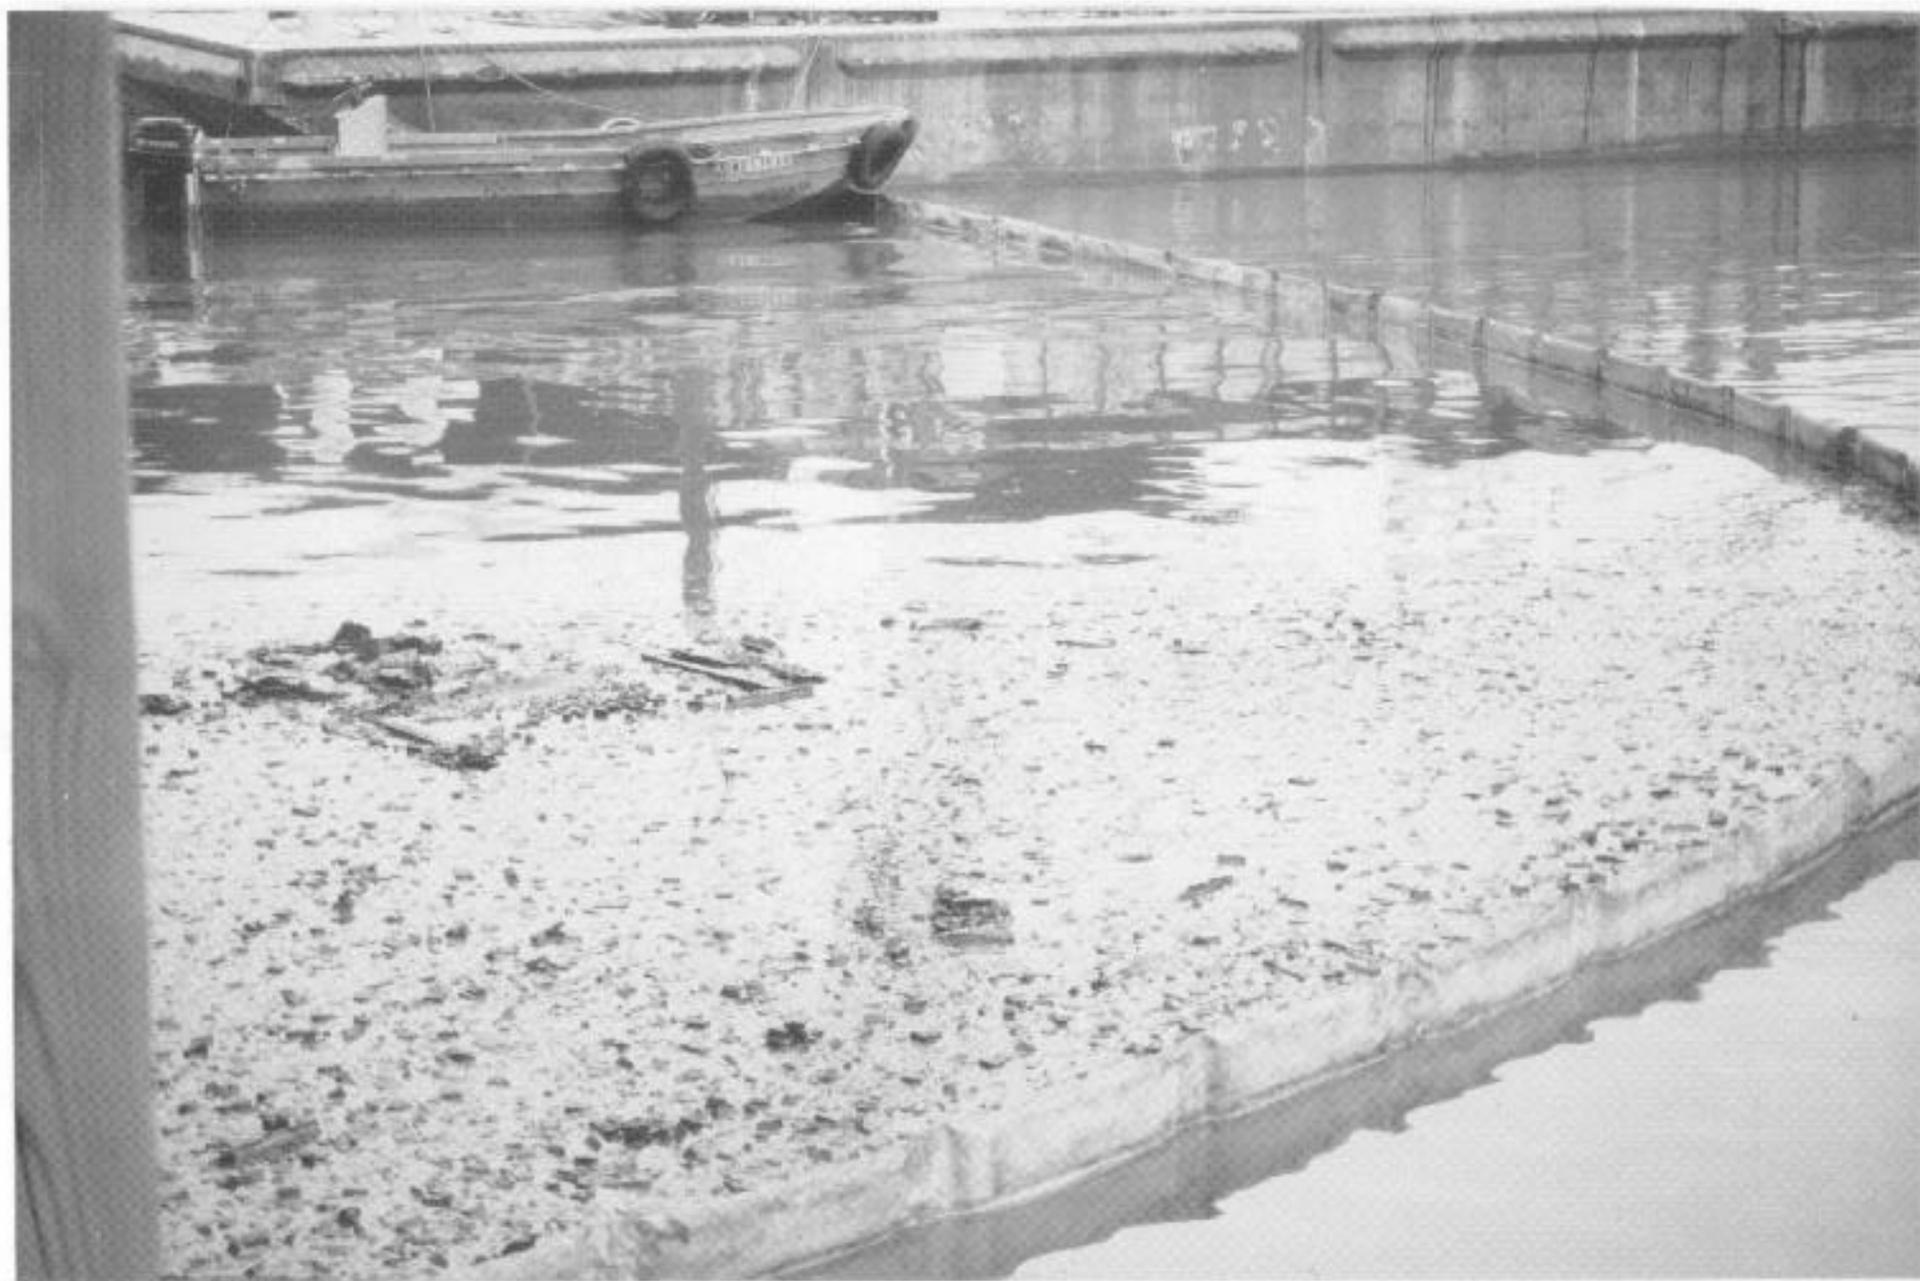
* 4	Burned piers of 'F' dock.
5	South end of 'F' dock showing sunken vessels.
6	Sunken vessel being raised amidst burned piers - south end of 'F' dock.
7	Looking south between 'E' and 'F' docks.
8	Remains of north portion - 'F' dock roof structure.
9	North portion - covered slip areas. Note sloping terrain.
10	Heavy equipment required for conducting investigation and salvage work.
11	Carport section of remaining roof structure 'F' dock.
12	Remaining carport section of 'F' dock - note restricted access.
13	Remains of wooden pier - 'F' dock area.
14	Remains of vessel after being raised.
15	Remains of 'F' dock finger pier and sunken vessel.
16	Looking south at center pier of 'E' dock.
17	Damaged pier at 'E' dock, slip 21.

* 18	Equipment used for containment ponds.

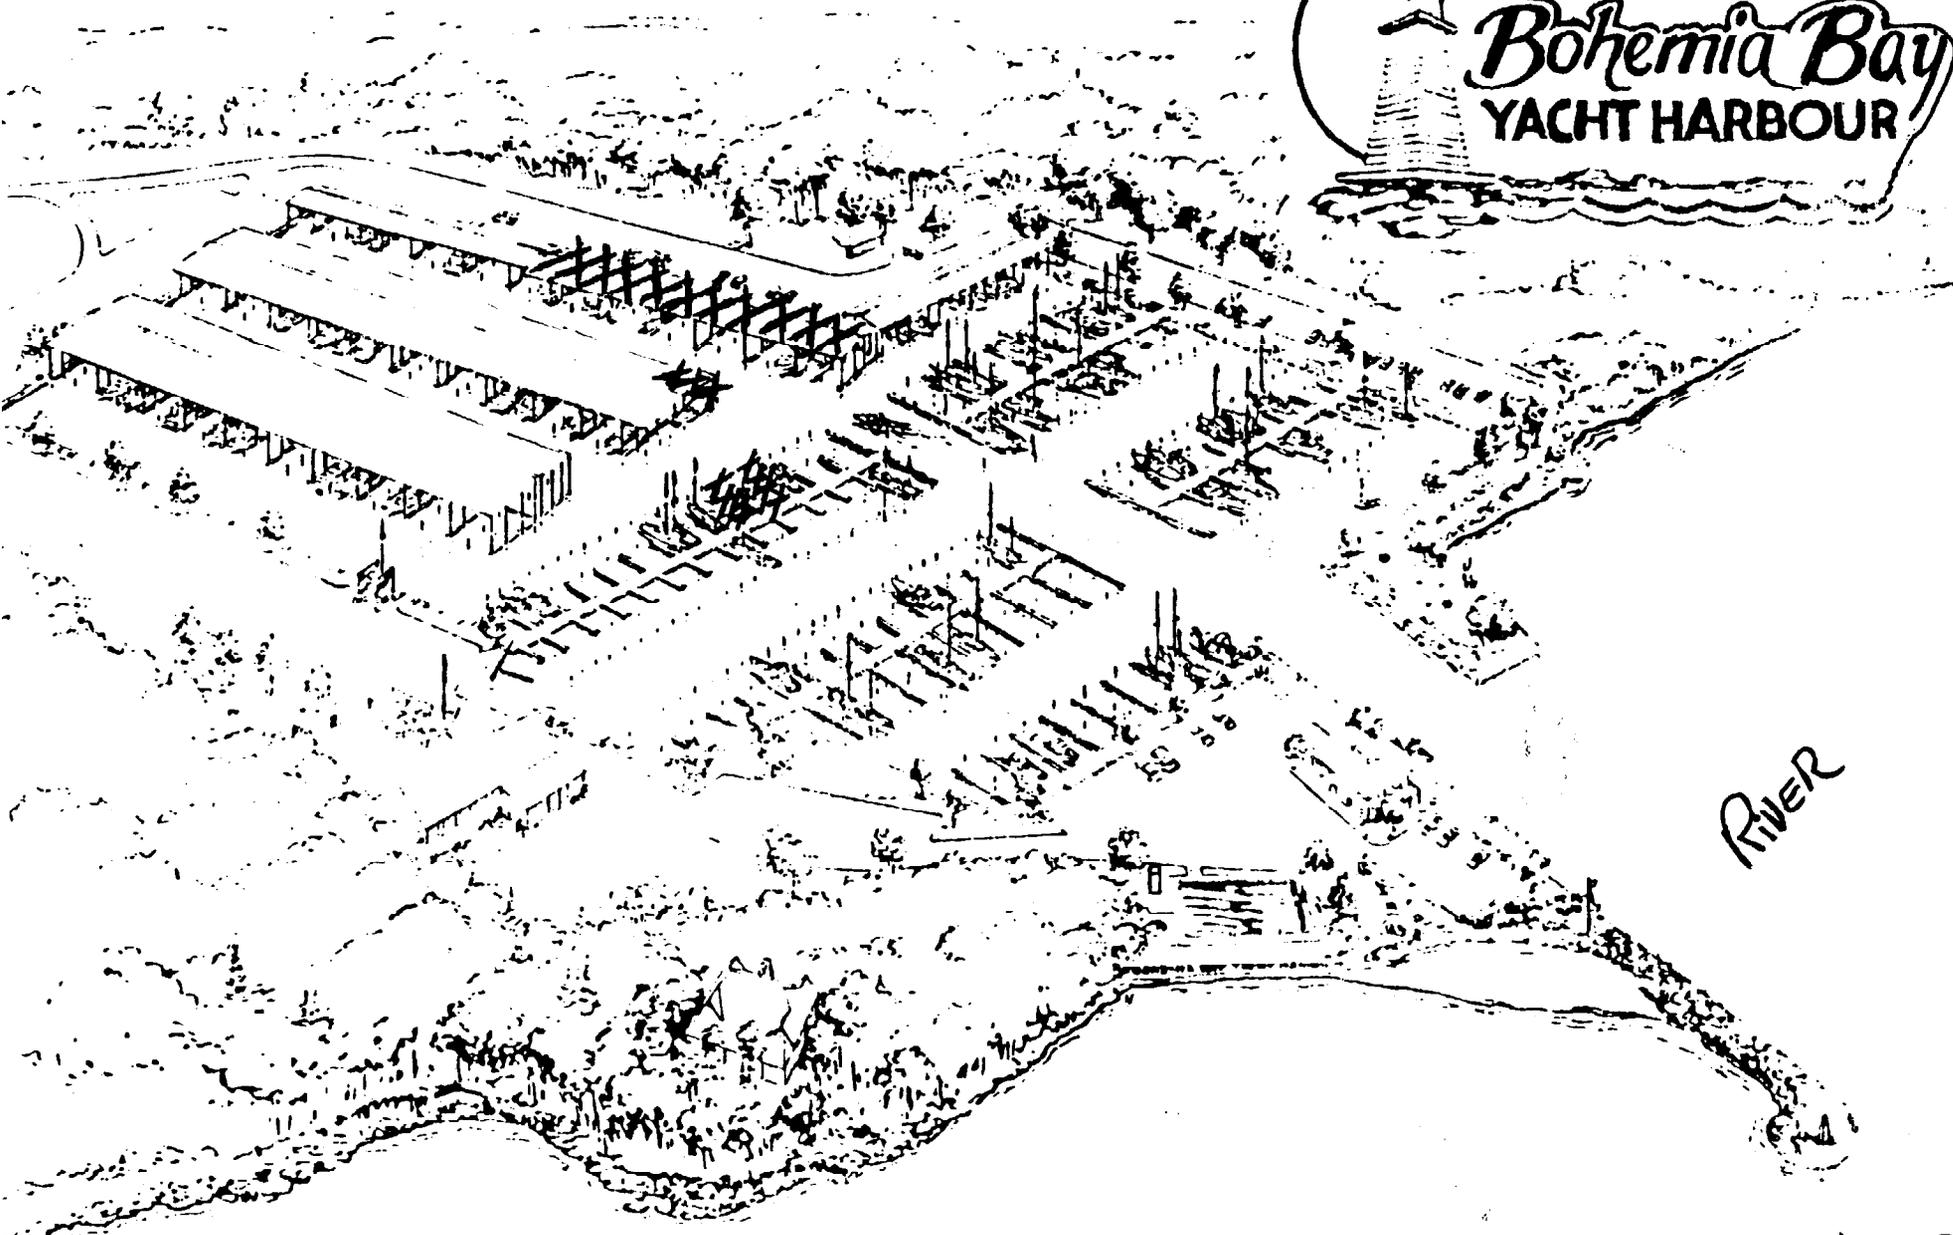
EXTENT OF FIRE DAMAGE TO BUILDINGS & DOCKS

Approximately two-thirds of the metal structure of 'F' dock (250 feet) had to be removed before any investigative or salvage operations could begin. Even though the structure itself did not burn, the foundation was weakened and could no longer be used because of supporting piers burning.

Most of the finger piers, pilings, and walkways between slips 9 and 23 on 'F' dock were destroyed. Sixteen vessels were sunk. One vessel located at 'F' dock received heavy damage and two at 'C' dock received substantial damage as a result of fuel burning on the water. Approximately 100 boats received light damage from soot and burning embers. Their cleaning proved much more difficult and expensive than first thought.
