Sprinklers Control Arson Fires in Rack-Storage Warehouse Mt. Prospect, Illinois

Sprinklers Control Arson Fires in Rack-Storage Warehouse Mt. Prospect, Illinois (October 16, 1988)

Investigated by: April Berkol

**This is Report 030 of the Major Fires Investigation Project conducted
by TriData Corporation under contract EMW-88-C-2649 to the United
States Fire Administration, Federal Emergency Management Agency.**

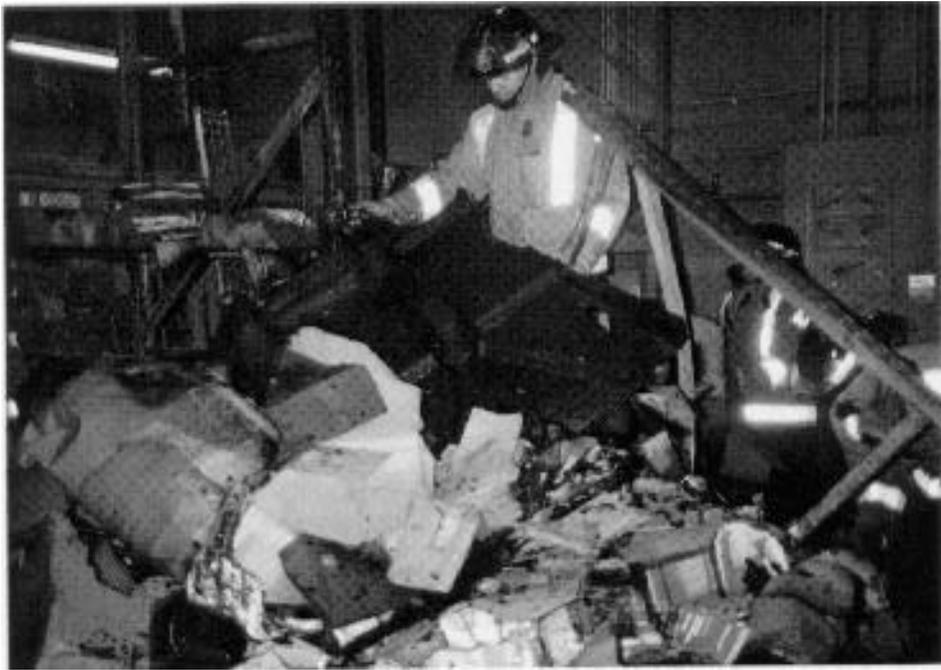
- *2. Looking due southwest from the second aisle. The main sprinkler riser is visible just above the firefighter's right hand.
3. Shows damage to goods stored.

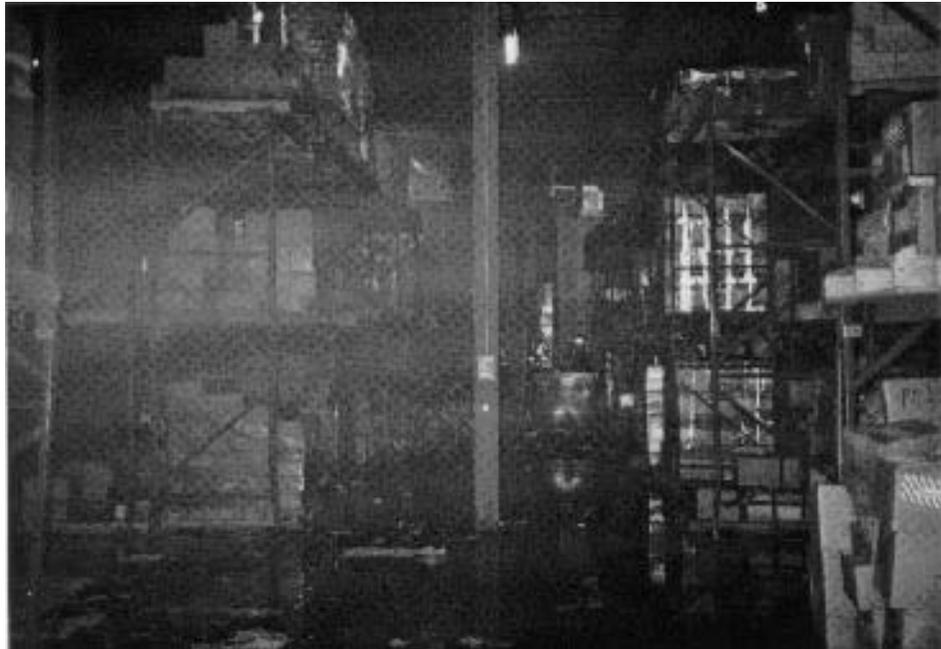
4. Shows break room with burglarized change machine.
- *5. Looking up aisle three, damage to rear of racks is evident at far end.
6. Main entrance to building.

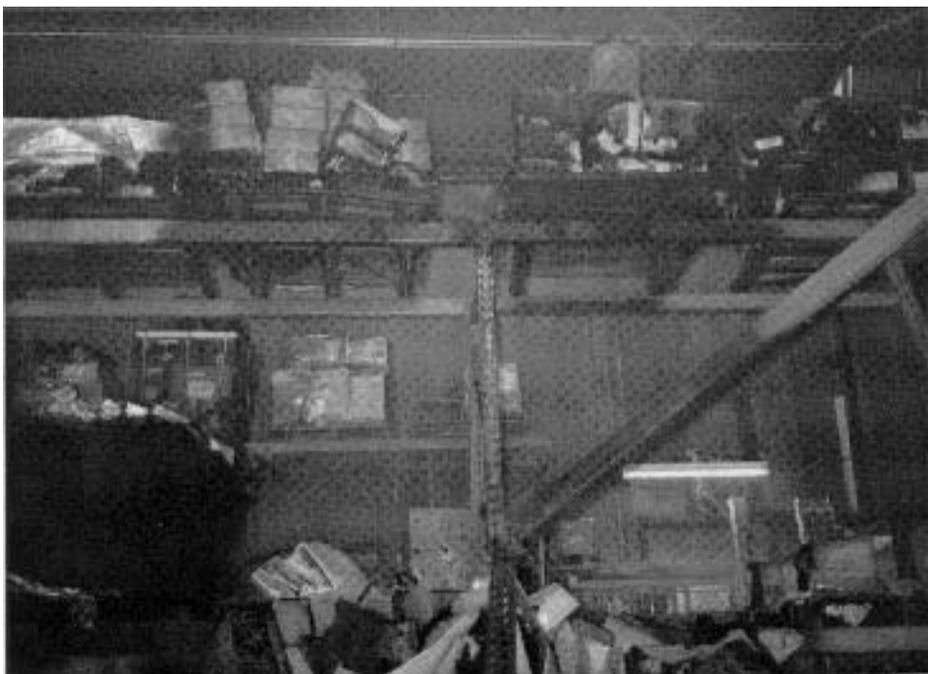
- *7. Typical damage to goods on upper level of racks.
8. Looking due south at door leading to warehouse section. Shows extent of water penetration due to fire.

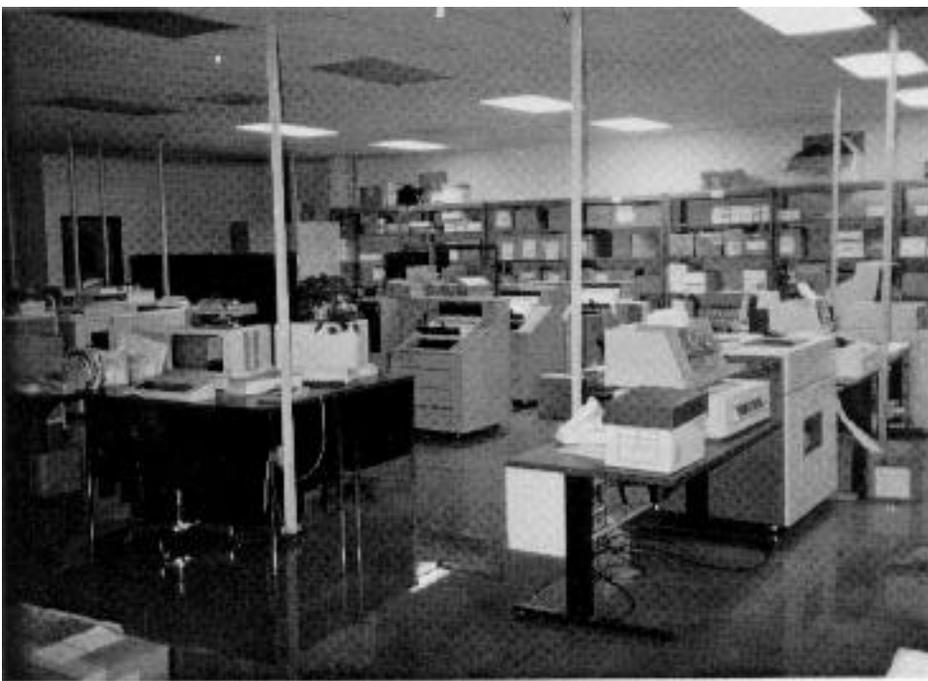
- *9. Data processing room, showing water accumulation on floor.
10. Data processing room. Shows extent of water penetration. No damage to equipment.
- 11-14. From aisle two showing fire damage to first double rack and single rack at southwest end of warehouse.

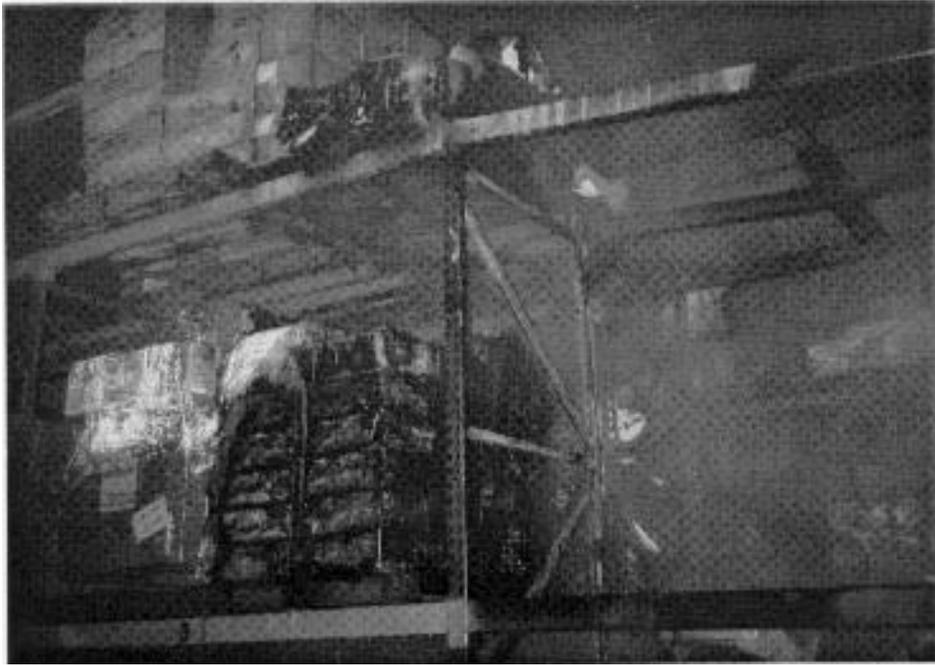
17. From aisle two showing fire damage to storage racks.
- *18. Typical fire damage to goods on rack in aisle two.
19. From aisle two, showing fire damage to storage racks.

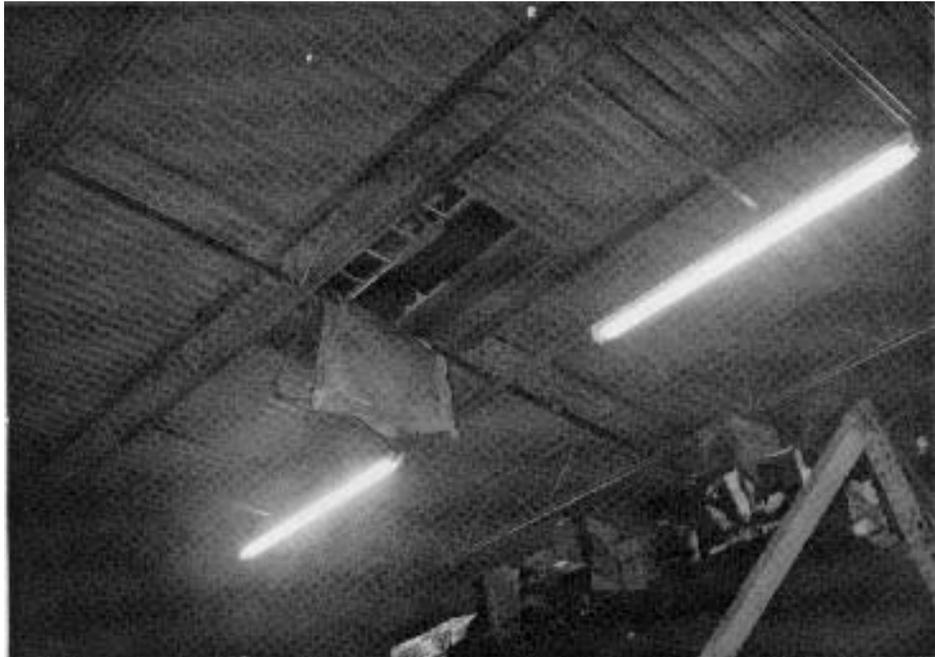
Although the building did not suffer any structural damage, a skylight located above the fire area failed prior to extinguishment. This failure is thought to have occurred soon after the time the first responding units arrived on the scene. This is based on the fact that no outward signs of

fire were observed upon arrival, but once the Fire Department completed its walk around the building, smoke was simultaneously observed from the loading dock area and the roof at the southwestern end of the structure.

- *20. Failed skylight above aisle one. Note sprinkler piping.

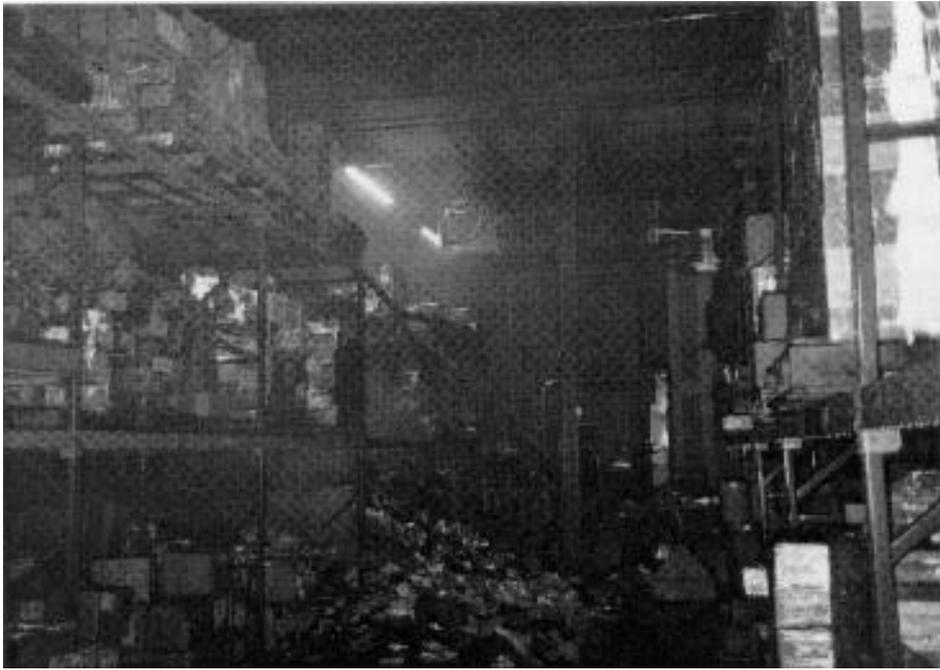
*28. Overall view of fire area showing damage to racks.

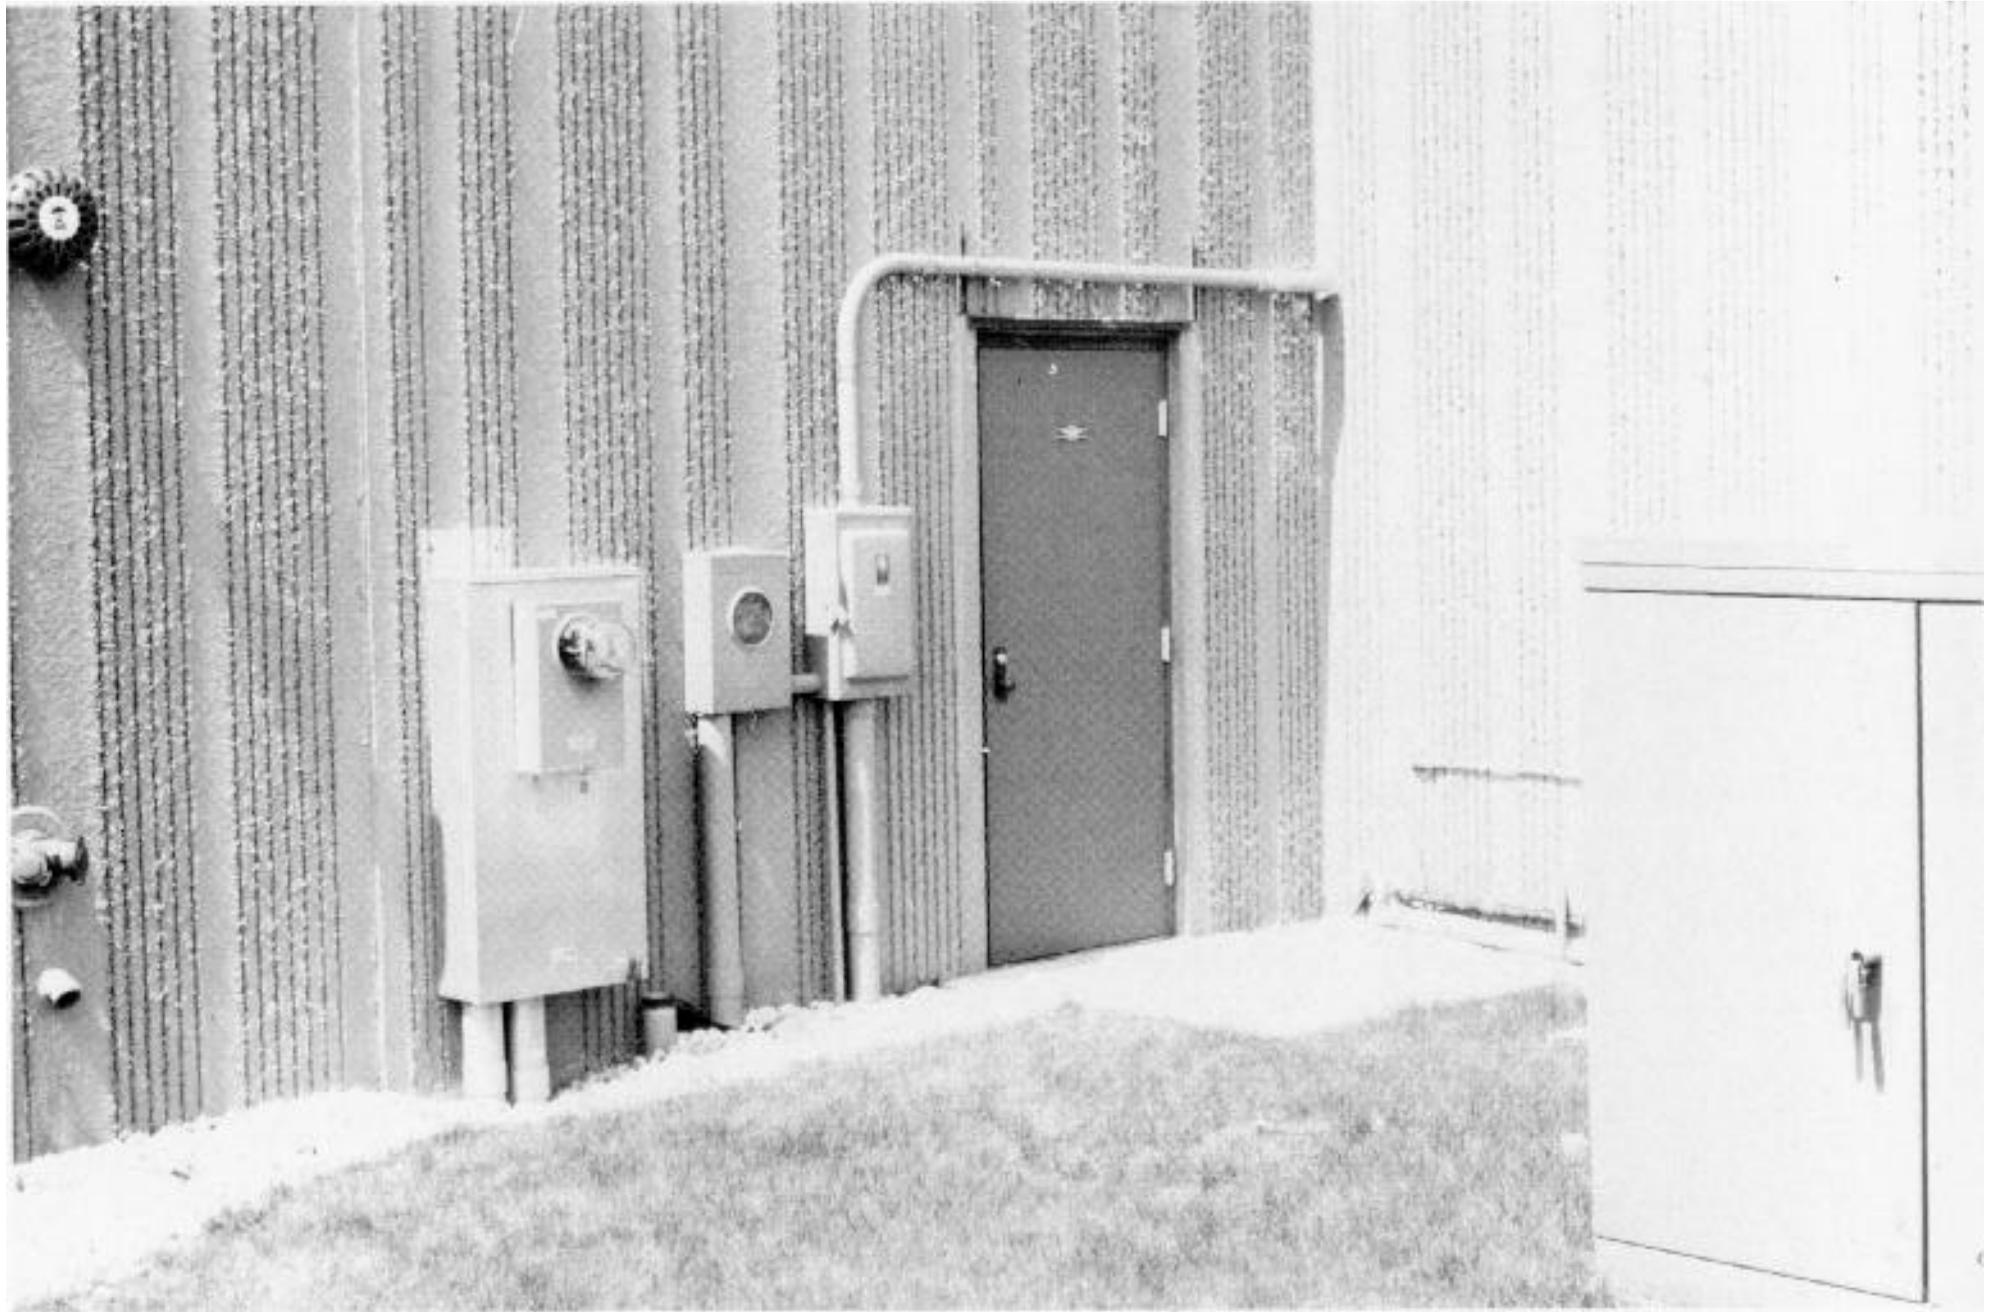
*39. Northeast view of exterior of warehouse section showing Fire Department connection and door used to gain entry on west side of building.

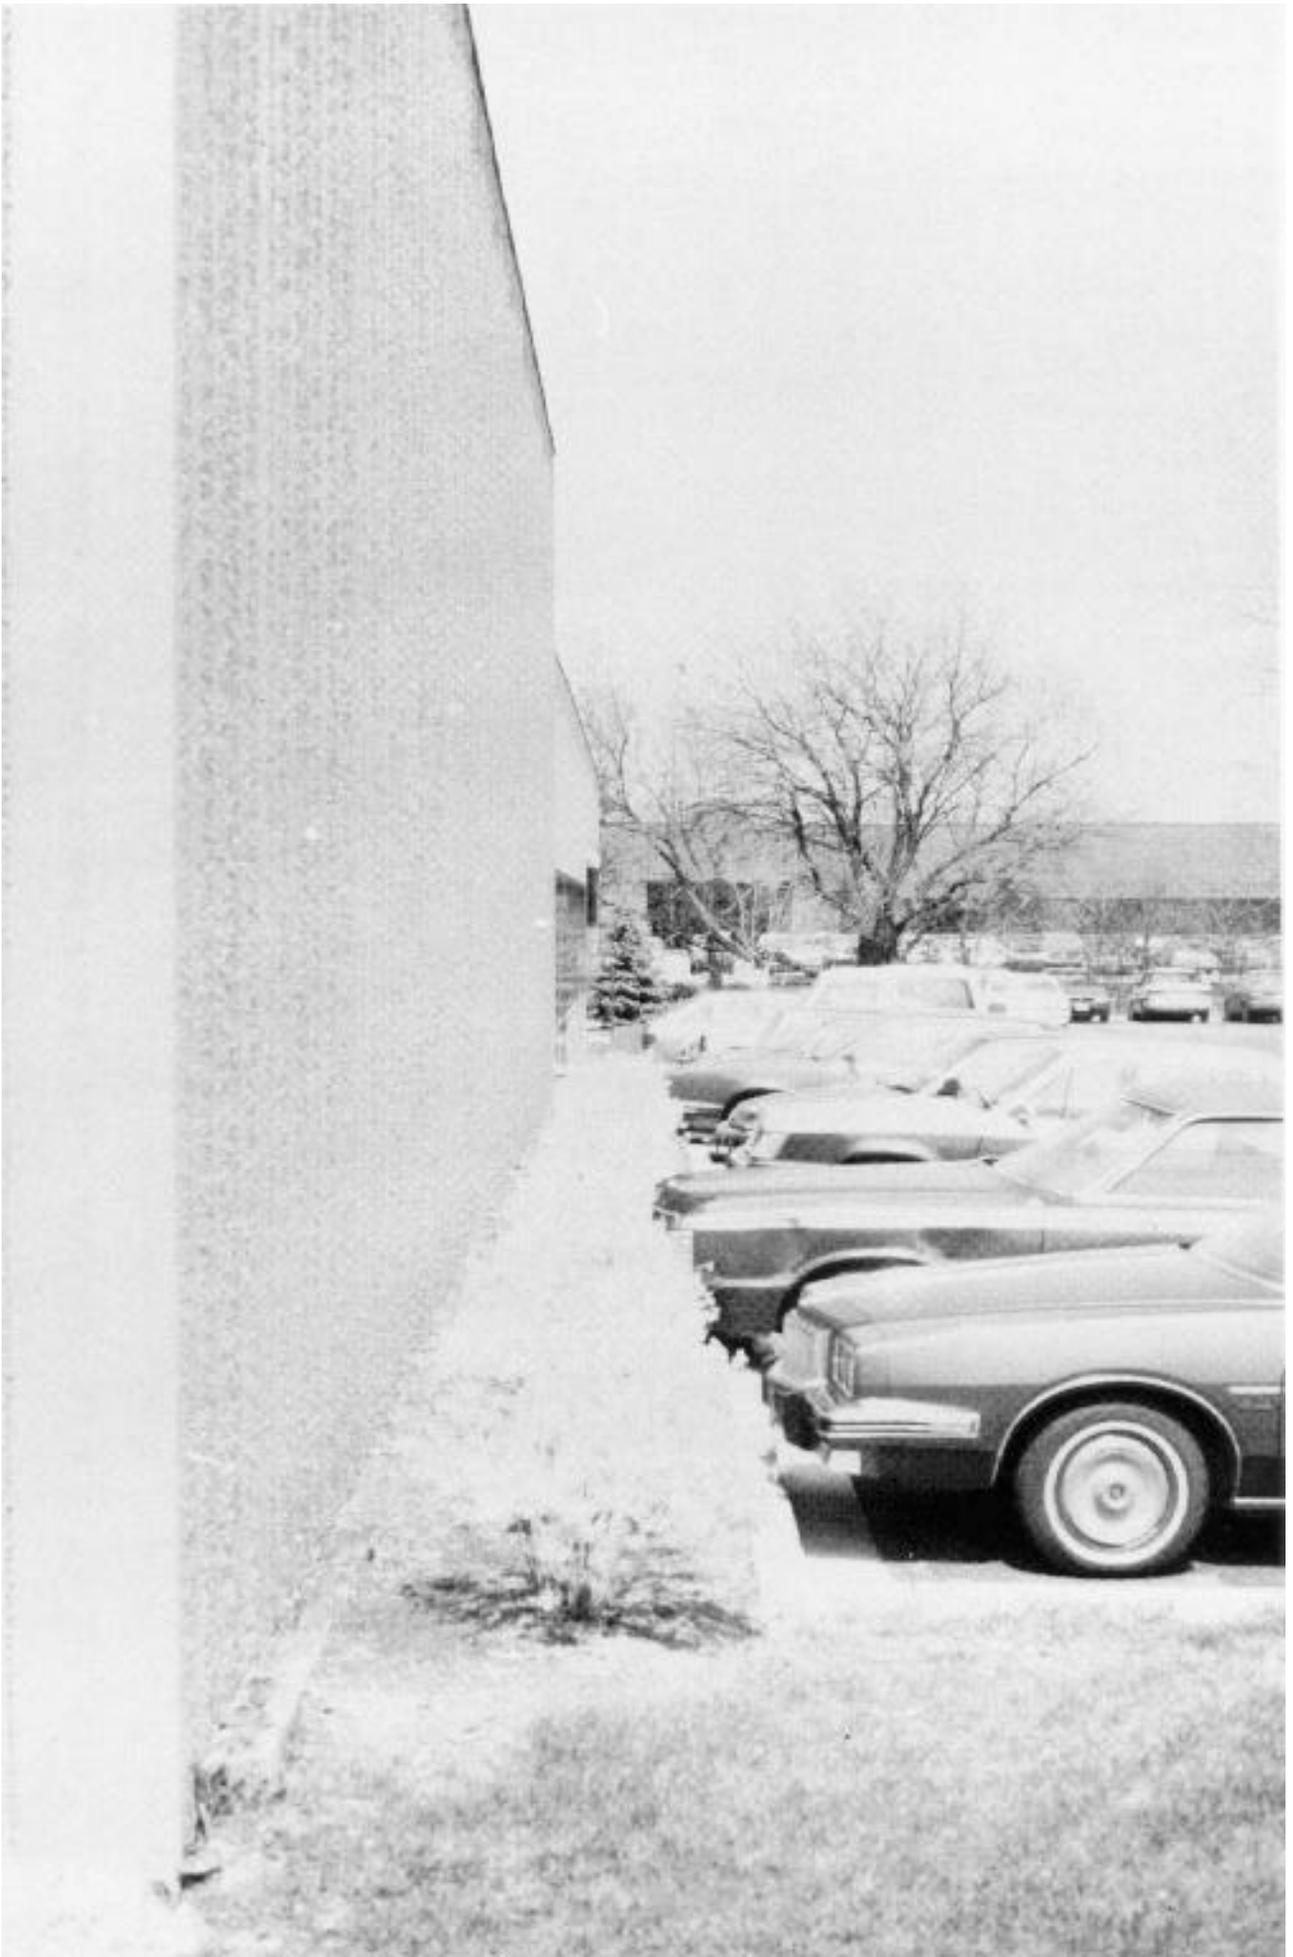
*41. Looking north along southwestern corner of building. The main entrance is visible at far end of building.
