Shenandoah Retirement Home Fire Roanoke County, Virginia

Shenandoah Retirement Home Fire Roanoke County, Virginia (December 14, 1989)

Investigated by: Randolph E. Kirby

This is Report 038 of the Major Fires Investigation Project conducted by TriData Corporation under contract EMW-88-C-2649 to the United States Fire Administration, Federal Emergency Management Agency.

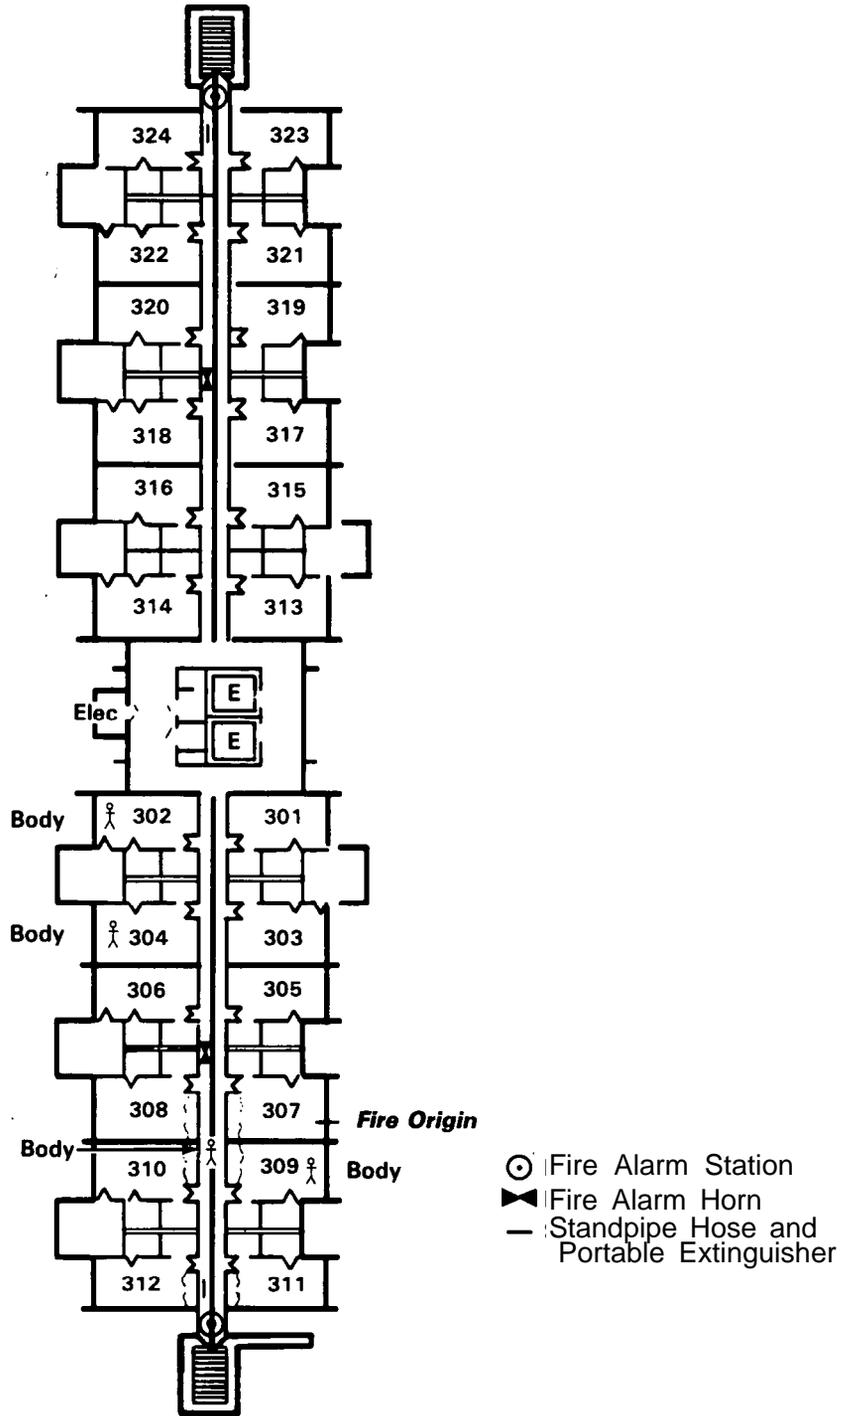
Appendix A

Four elderly residents from the third floor died as a result of smoke inhalation -- three women and one man, ranging in age from 79 to 87 years. The body of the resident of Apartment 307, (area of origin), who was confined to a wheelchair, was found in the hall a few feet south of his apartment door. One female victim of apartment 309 was found in her unit on the floor next to her bed. The third victim (female) was found in Apartment 302. The fourth victim, (female), was found in Apartment 304, between the rear of the television and the window. This person was actually having a telephone conversation with the fire dispatcher while fire operations were taking place in the building. She was provided with instructions by the dispatcher regarding covering her nose and putting towels under the apartment door. Meanwhile, the dispatcher was advising firefighters on the scene of the woman's situation and her location. Because of heavy smoke conditions and locked doors, rescuers were unable to locate her in time to save her (see Appendix A).

Shenandoah Retirement Home
Third-Floor Plan and Location of Fatalities

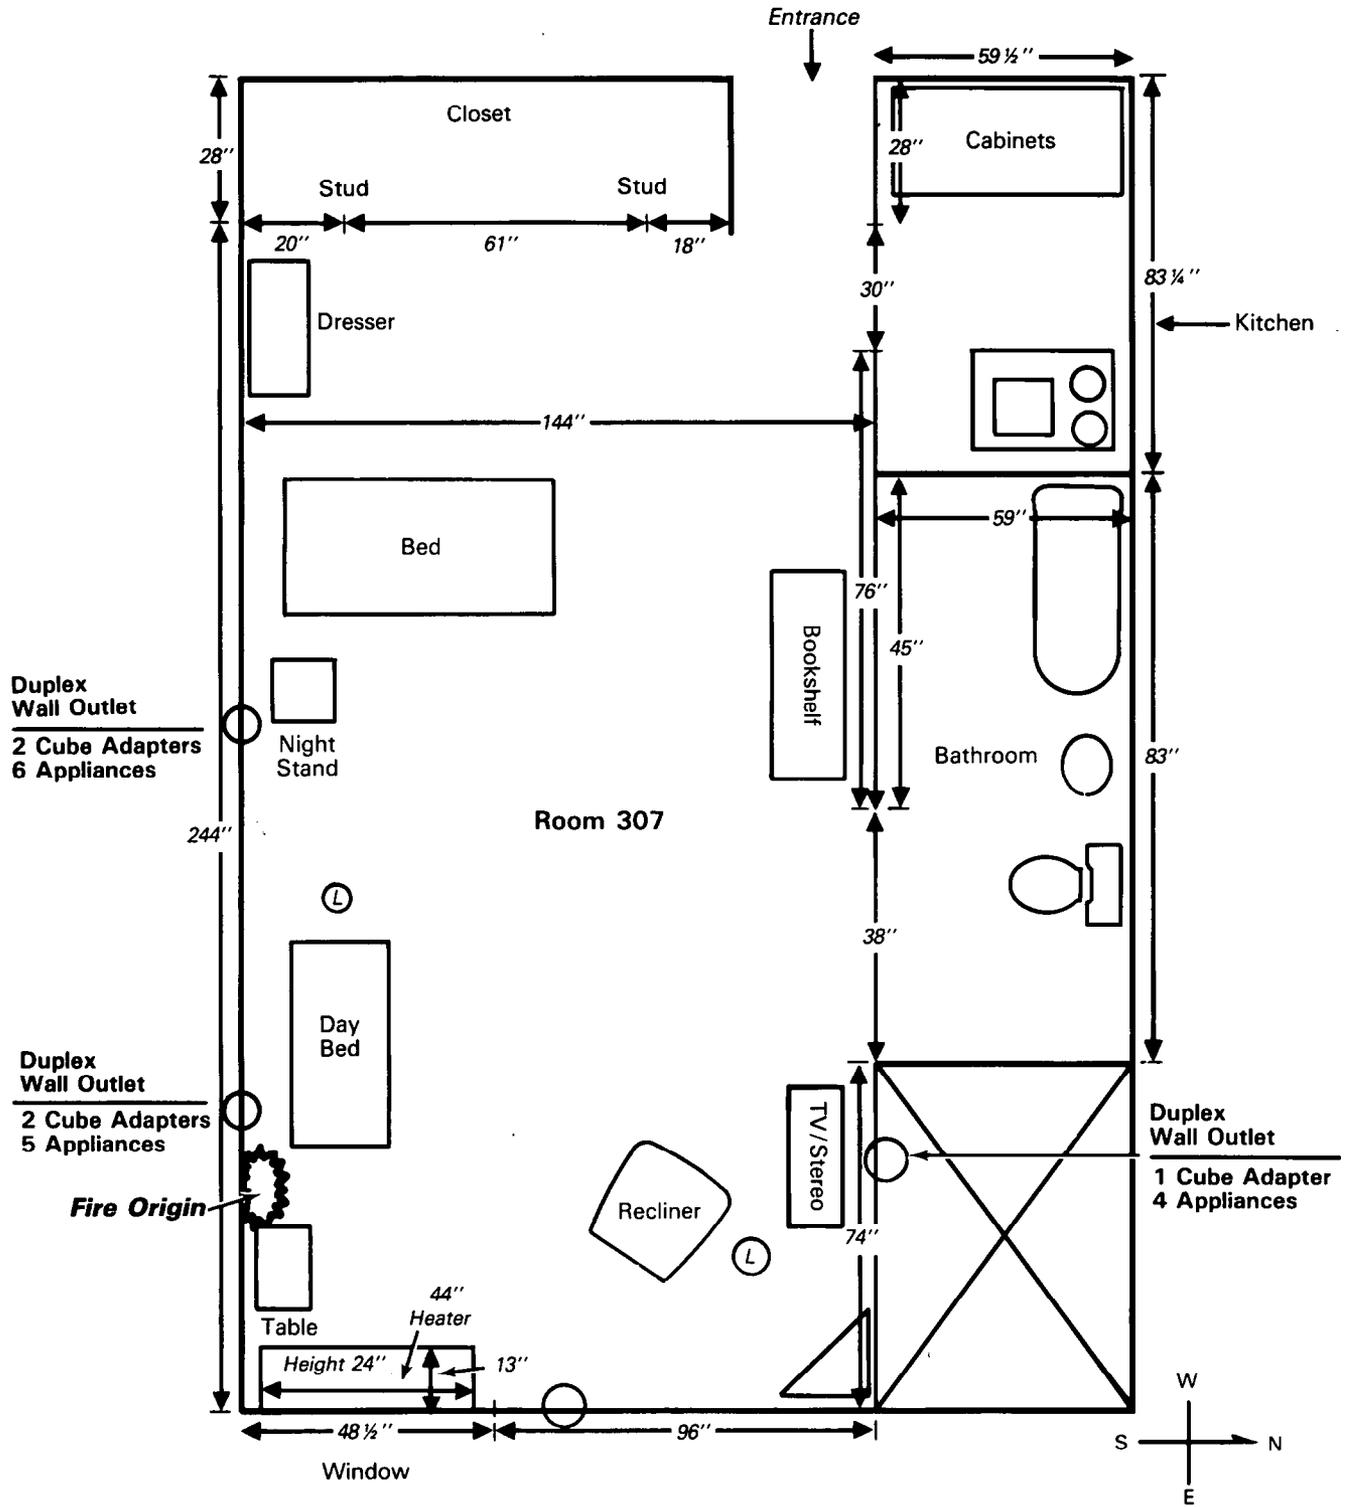
Appendix B

The fire originated in apartment 307 and is believed to be the result of an electrical overload which caused ignition of wood paneling; This particular one-room unit had 17 appliances of various types connected to the electrical receptacles provided for the unit (see Appendix B).

Room of Fire Origin

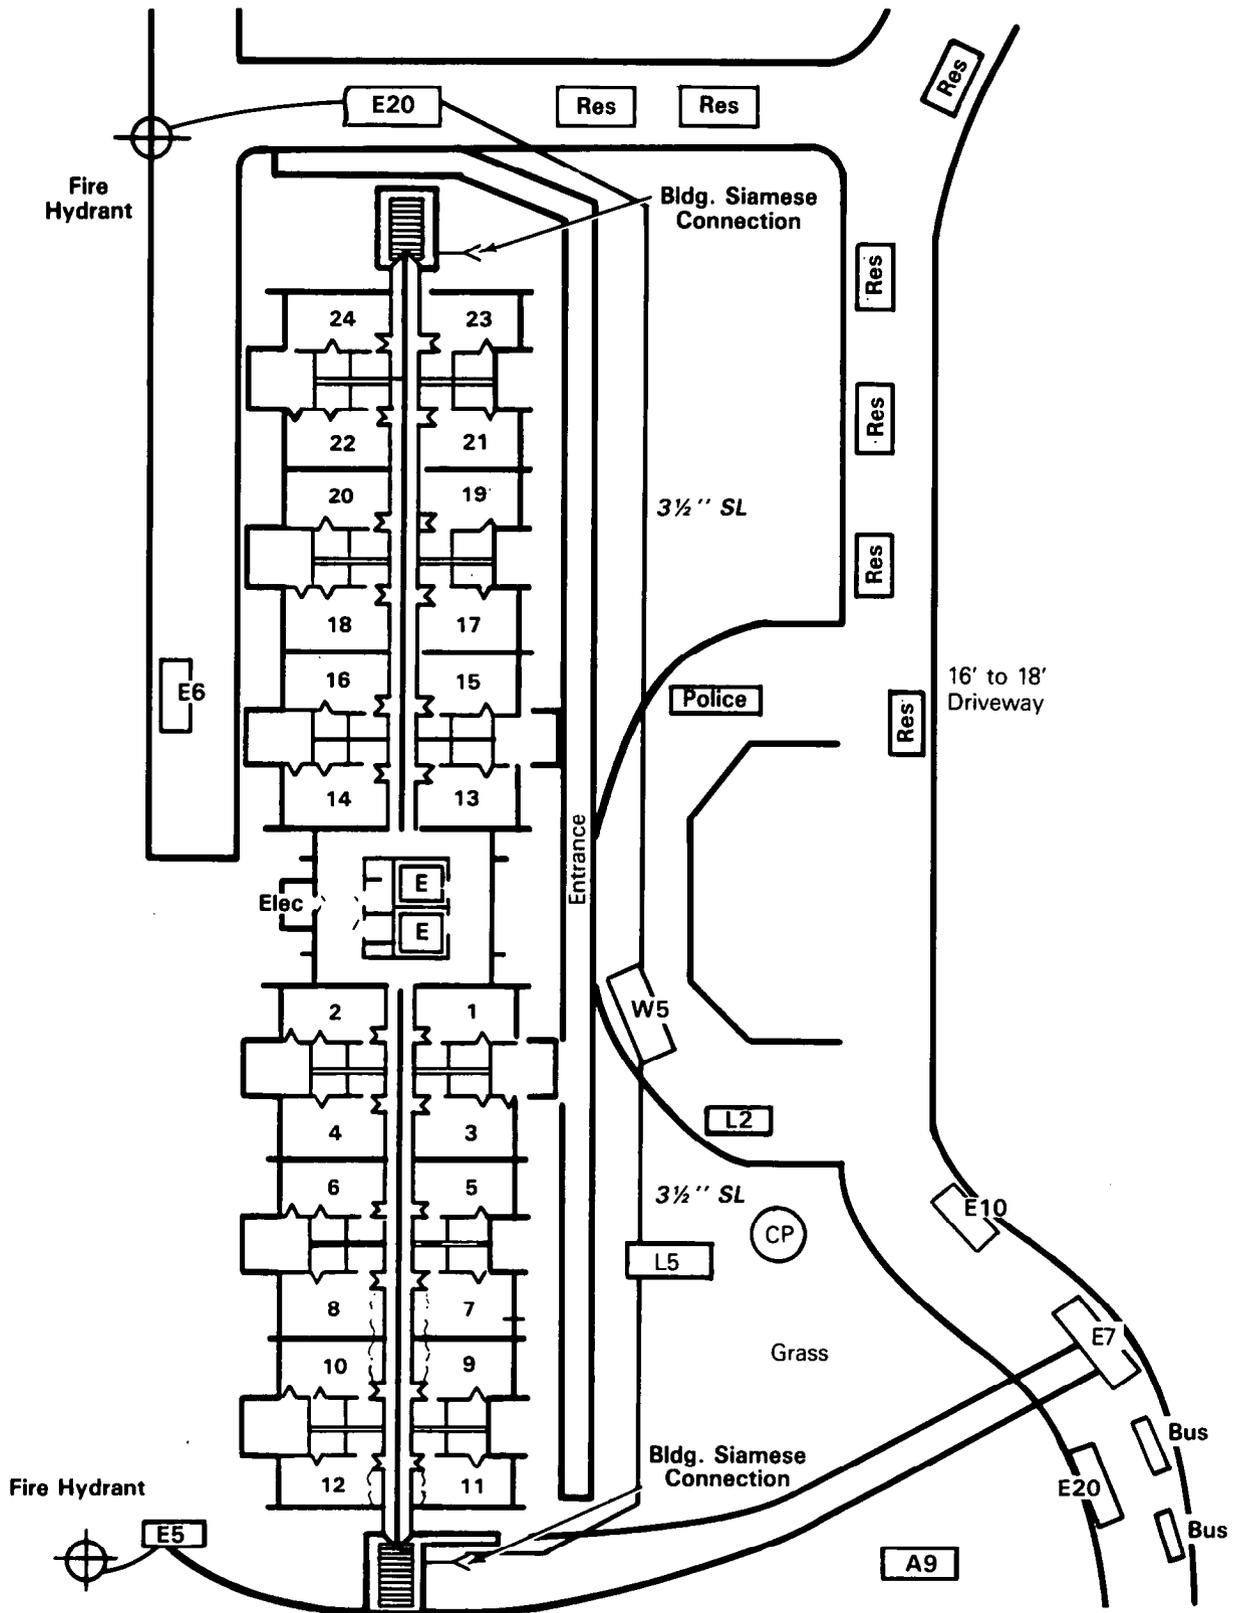
Appendix D

The emergency vehicle access designed for the Shenandoah Homes building is inaccessible at best. It only affords vehicle access to a very small portion of the structure and to one fire hydrant. This problem was most apparent when fire apparatus had to be placed on a snow-covered lawn in order to reach the building and to use the fire hydrant. A complete review of other existing structures that present similar problems should be taken without delay.

Fire Ground Diagram Showing Position of Fire Units at Scene
