# **Shenandoah Retirement Home Fire Roanoke County, Virginia (December 14, 1989)**

**Investigated by: Randolph E. Kirby**

**This is Report 038 of the Major Fires Investigation Project conducted by TriData Corporation under contract EMW-88-C-2649 to the United States Fire Administration, Federal Emergency Management Agency.**

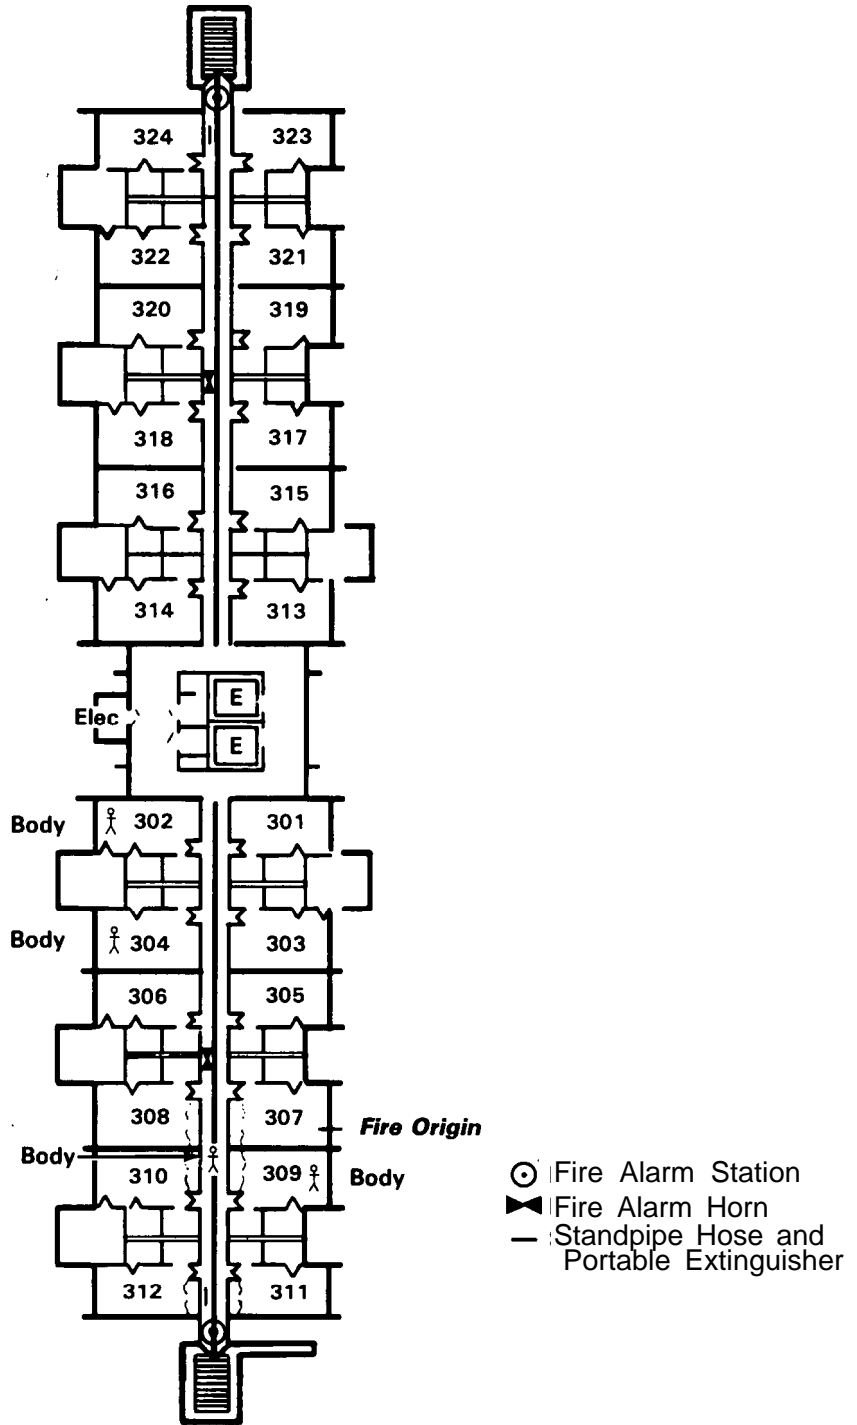
Appendix A

Four elderly residents from the third floor died as a result of smoke inhalation -- three women and one man, ranging in age from 79 to 87 years. The body of the resident of Apartment 307, (area of origin), who was confined to a wheelchair, was found in the hall a few feet south of his apartment door. One female victim of apartment 309 was found in her unit on the floor next to her bed. The third victim (female) was found in Apartment 302. The fourth victim, (female), was found in Apartment 304, between the rear of the television and the window. This person was actually having a telephone conversation with the fire dispatcher while fire operations were taking place in the building. She was provided with instructions by the dispatcher regarding covering her nose and putting towels under the apartment door. Meanwhile, the dispatcher was advising firefighters on the scene of the woman's situation and her location. Because of heavy smoke conditions and locked doors, rescuers were unable to locate her in time to save her (see Appendix A).

Shenandoah Retirement Home  
Third-Floor Plan and Location of Fatalities

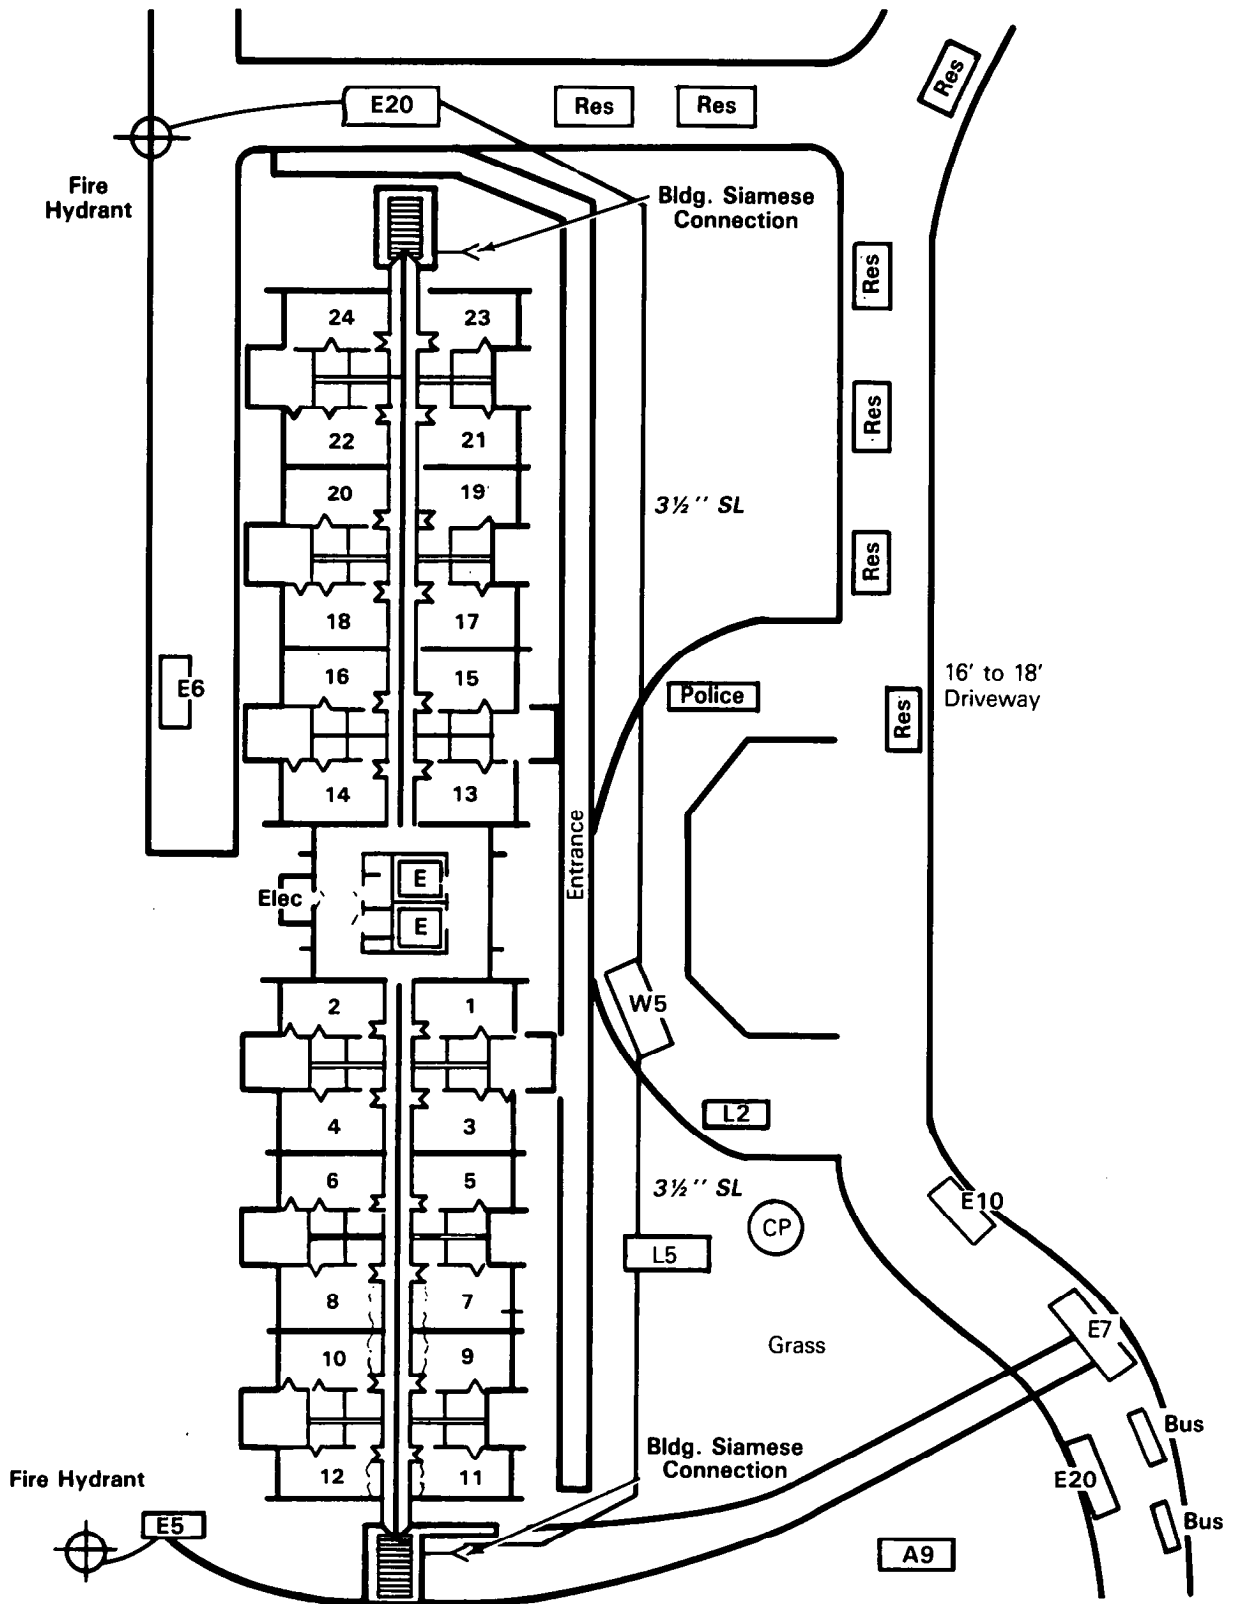
Appendix D

The emergency vehicle access designed for the Shenandoah Homes building is inaccessible at best. It only affords vehicle access to a very small portion of the structure and to one fire hydrant. This problem was most apparent when fire apparatus had to be placed on a snow-covered lawn in order to reach the building and to use the fire hydrant. A complete review of other existing structures that present similar problems should be taken without delay.

Fire Ground Diagram Showing Position of Fire Units at Scene
