### Indianapolis Athletic Club Fire Indianapolis, Indiana

**Indianapolis Athletic Club Fire  
Indianapolis, Indiana  
(February 5, 1992)**

**Investigated by: Mark Chubb**

**This is Report 063 of the Major Fires Investigation Project conducted by TriData Corporation under contract EMW-90-C-3338 to the United States Fire Administration, Federal Emergency Management Agency.**

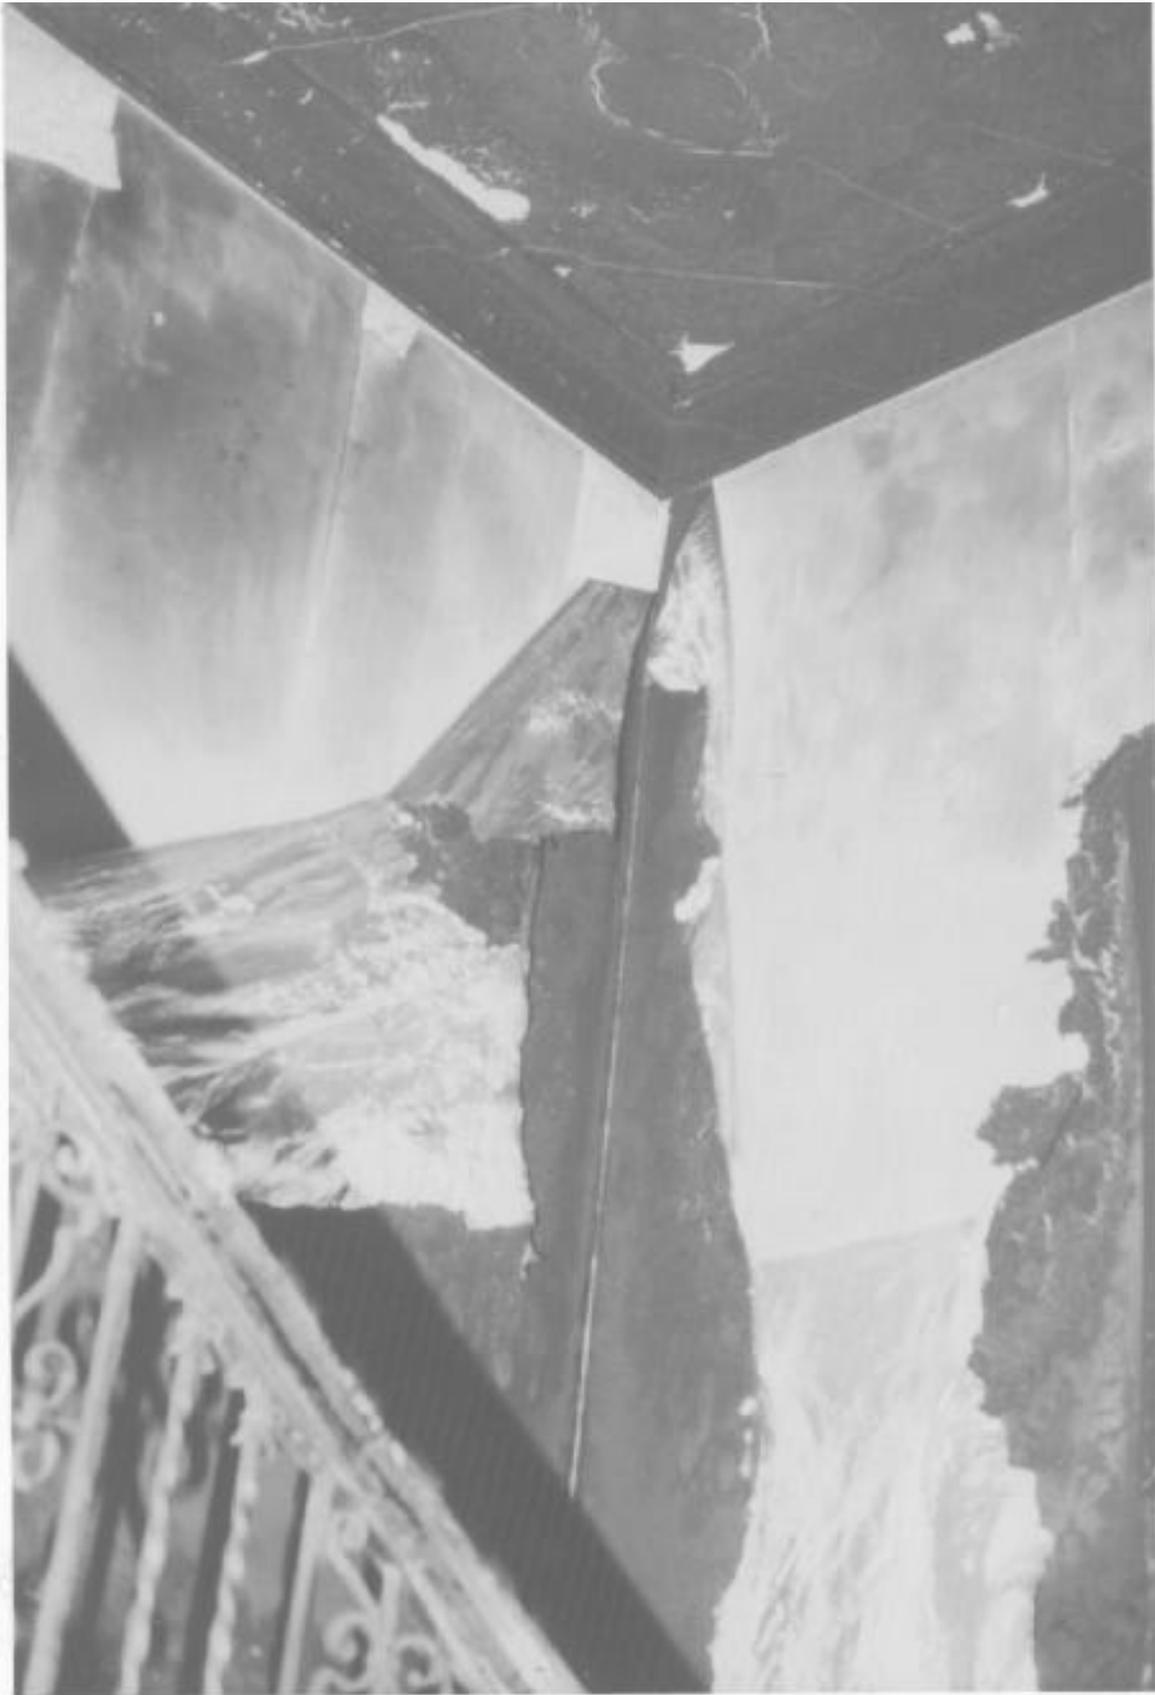
This view from the monumental stairway looking up toward third floor ceiling shows relatively light damage to the cornice, but heavy damage to the combustible foil-backed wallcovering.

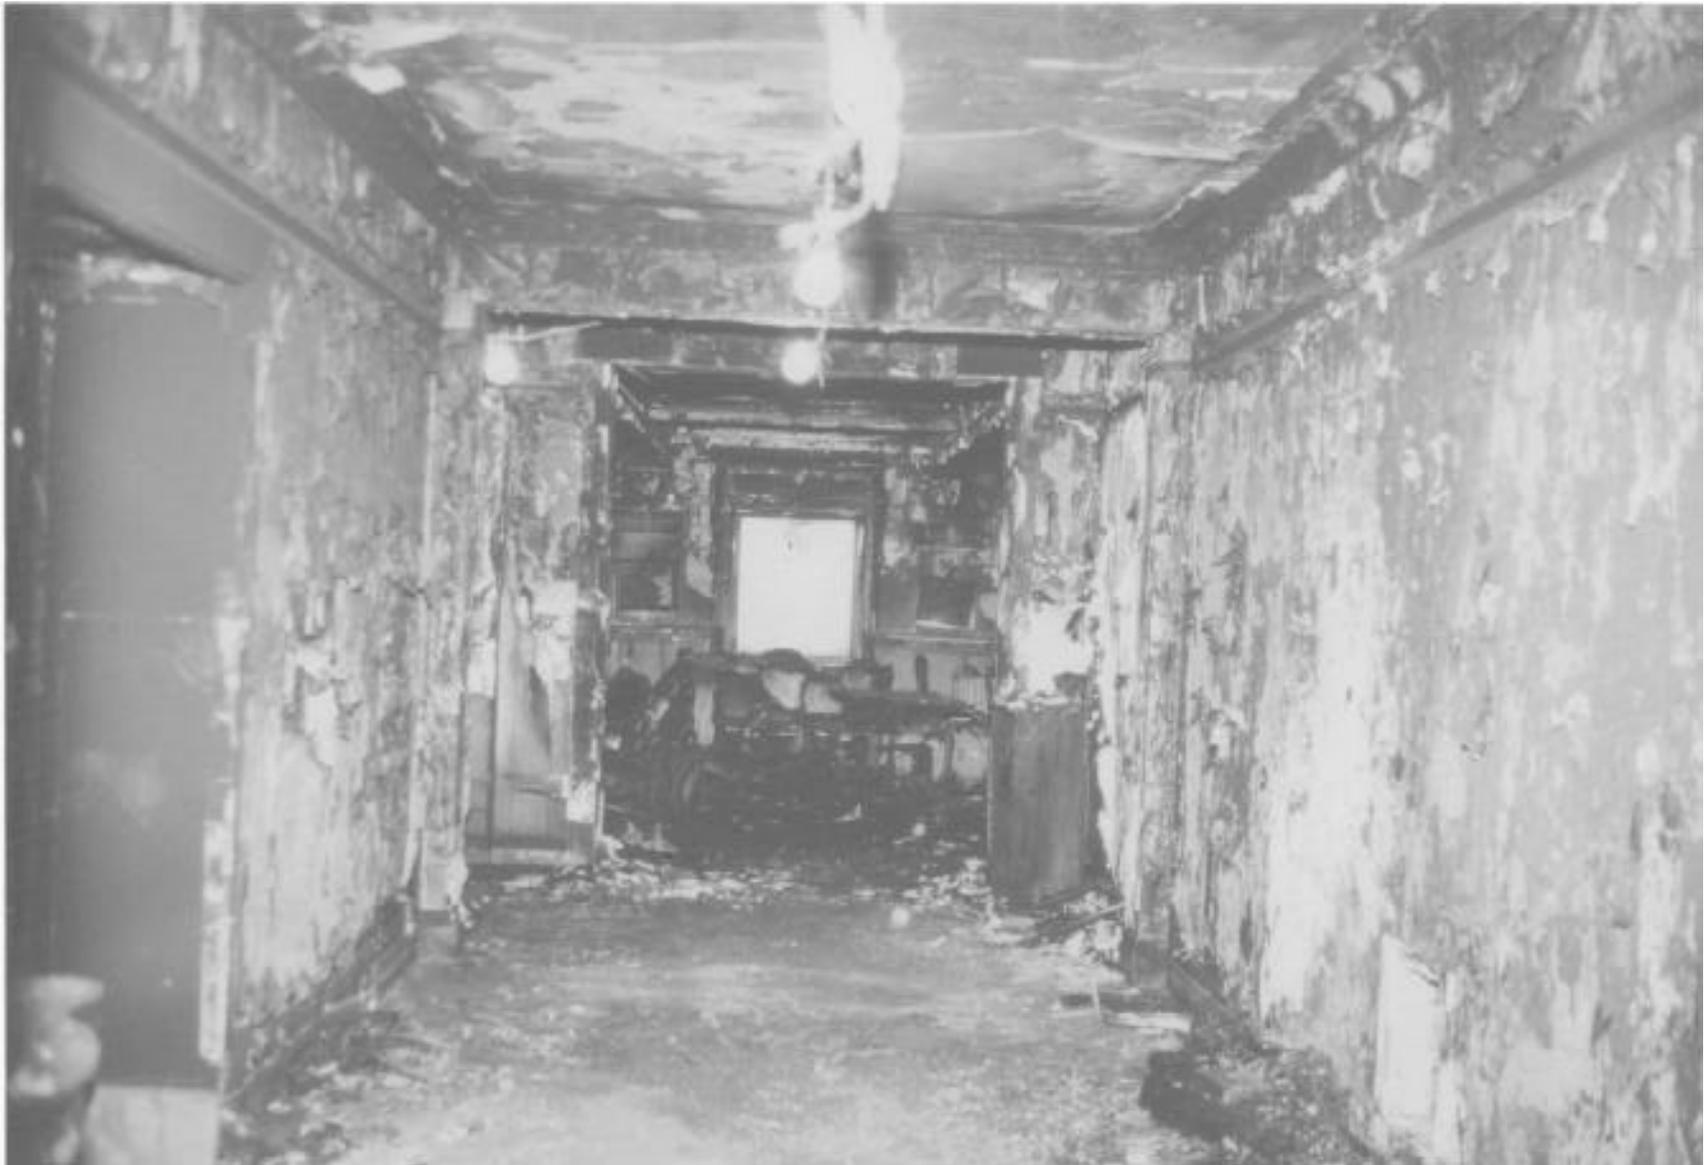
This view of the third floor corridor looking east toward the large dining room shows the extensive damage to combustible wallcoverings.

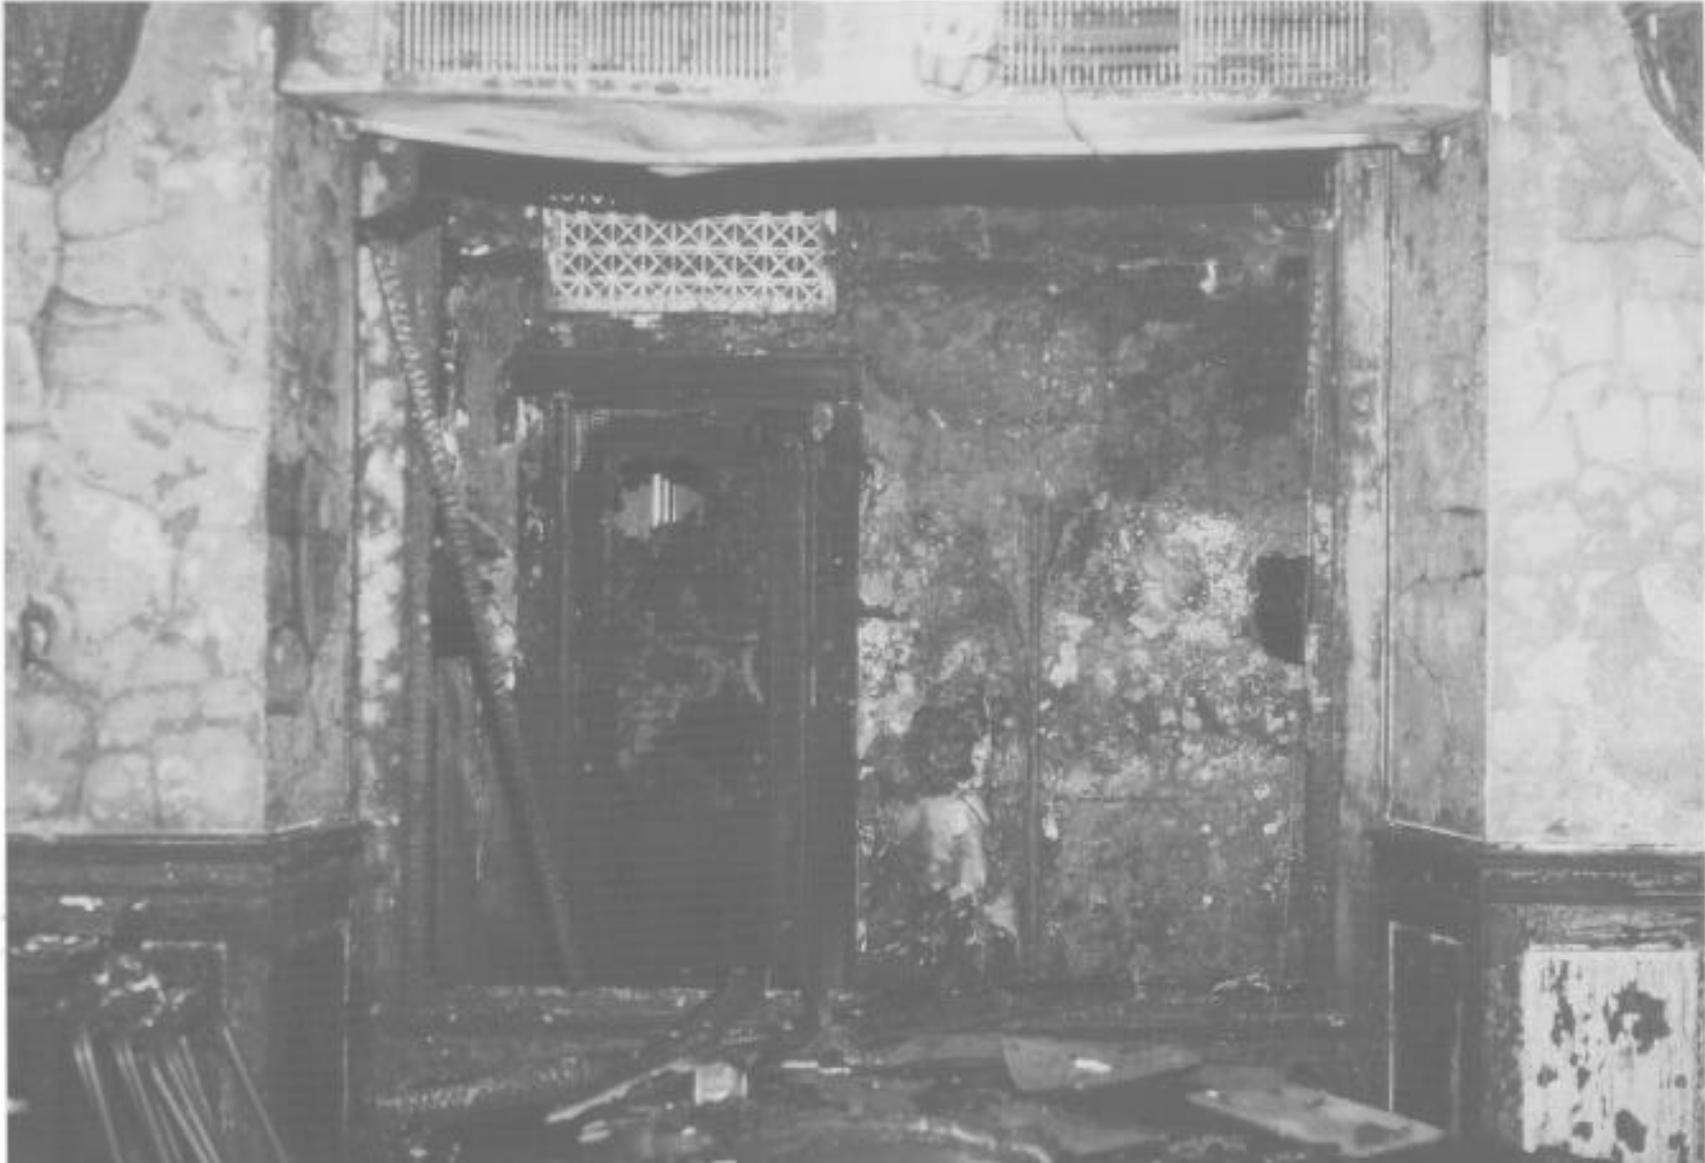
Entrance to ladies room adjacent to the dutch-style service door to the bar (room of fire origin). Note the air return register over the door and the air supply register over the opening to the dining room.

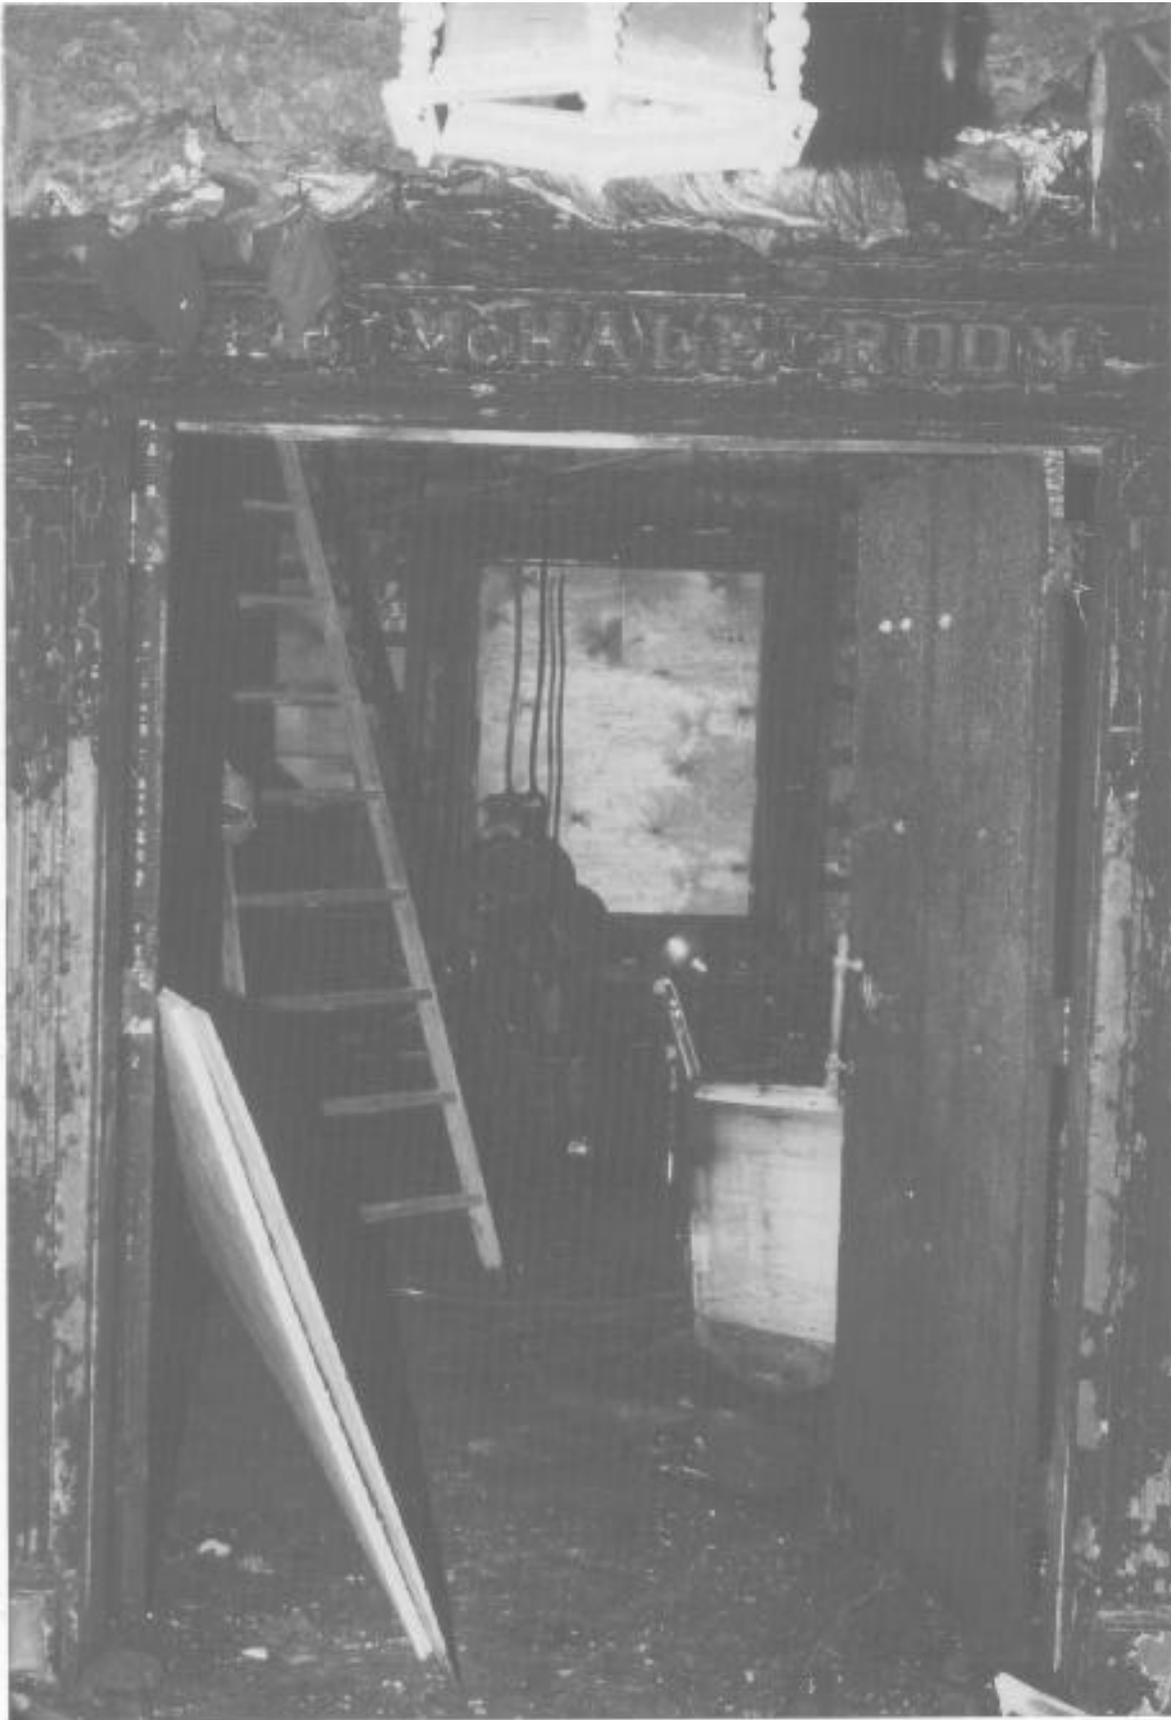
Entrance to the McHale Room looking north from the elevator lobby. Note the fire damage to the wall coverings above the door and the relatively light charring of the door frame.

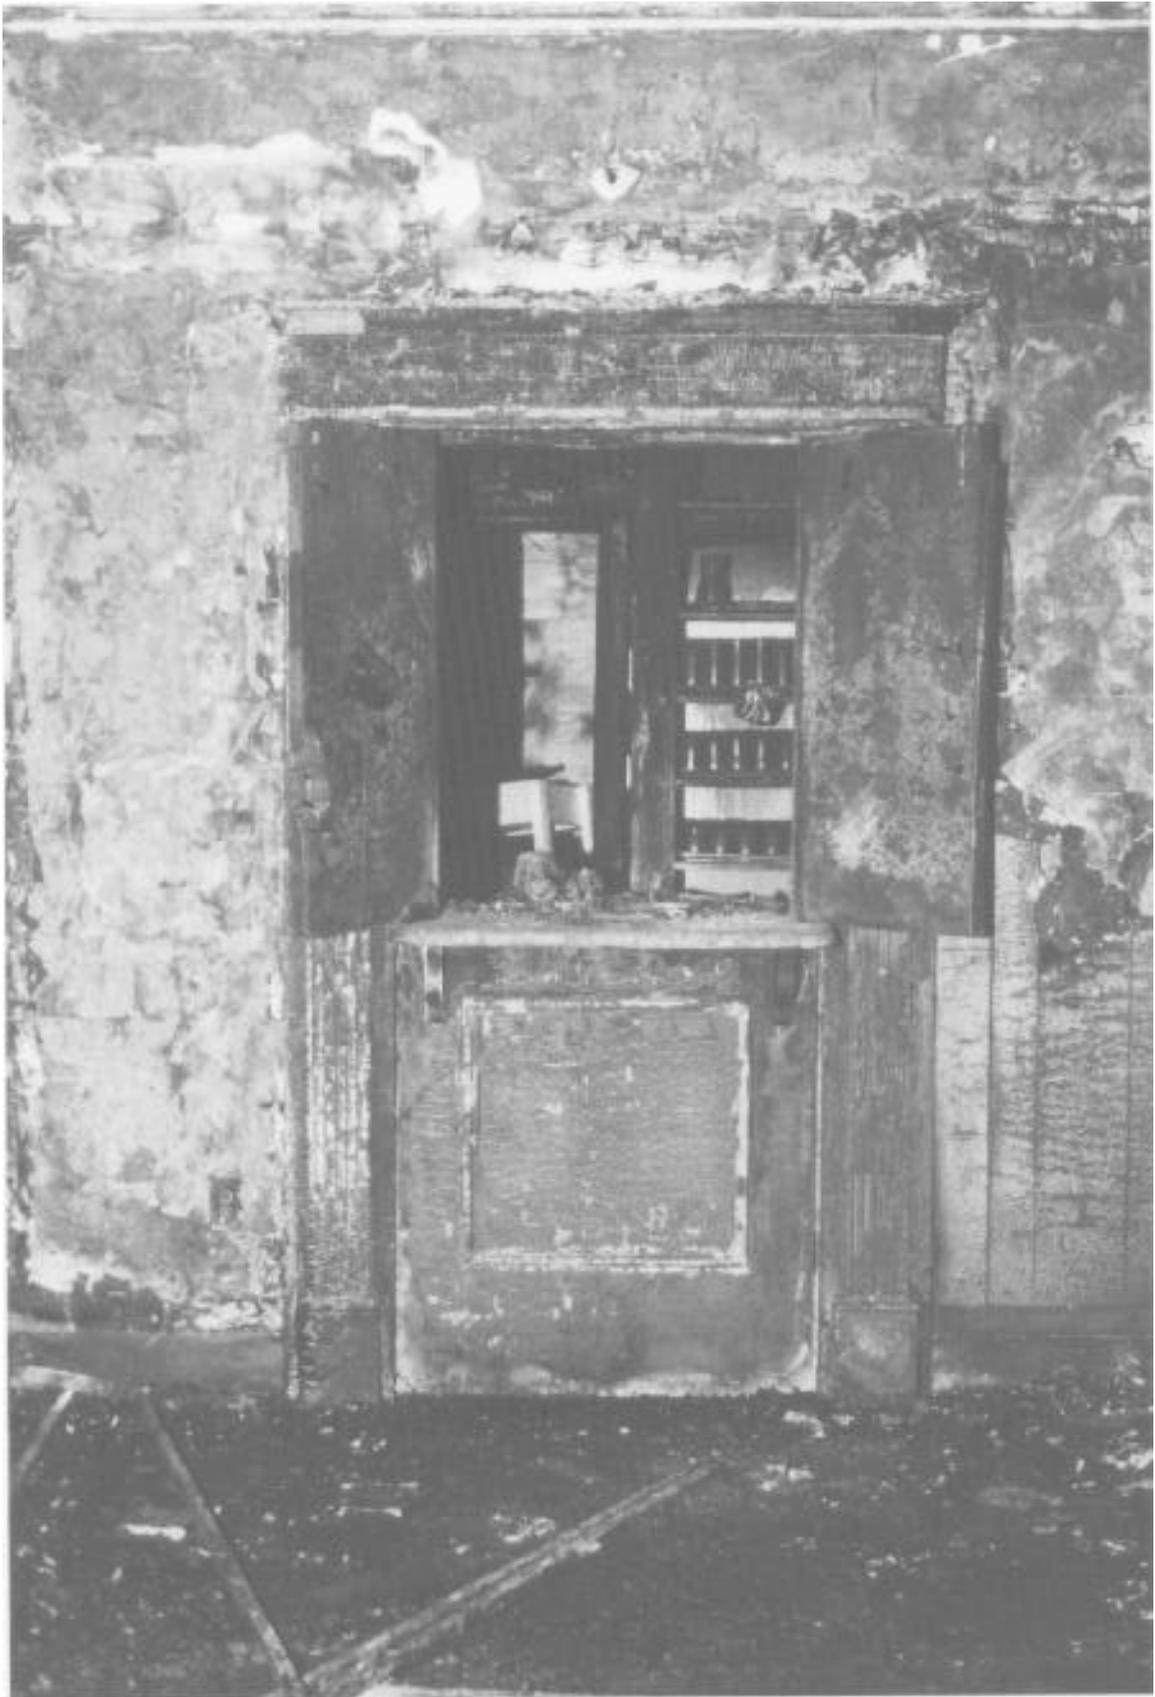
This view of the dutch-style service door to the bar room shows the deep charring to the door frame above the opening and the plywood paneling on the lower right side of the door opening.

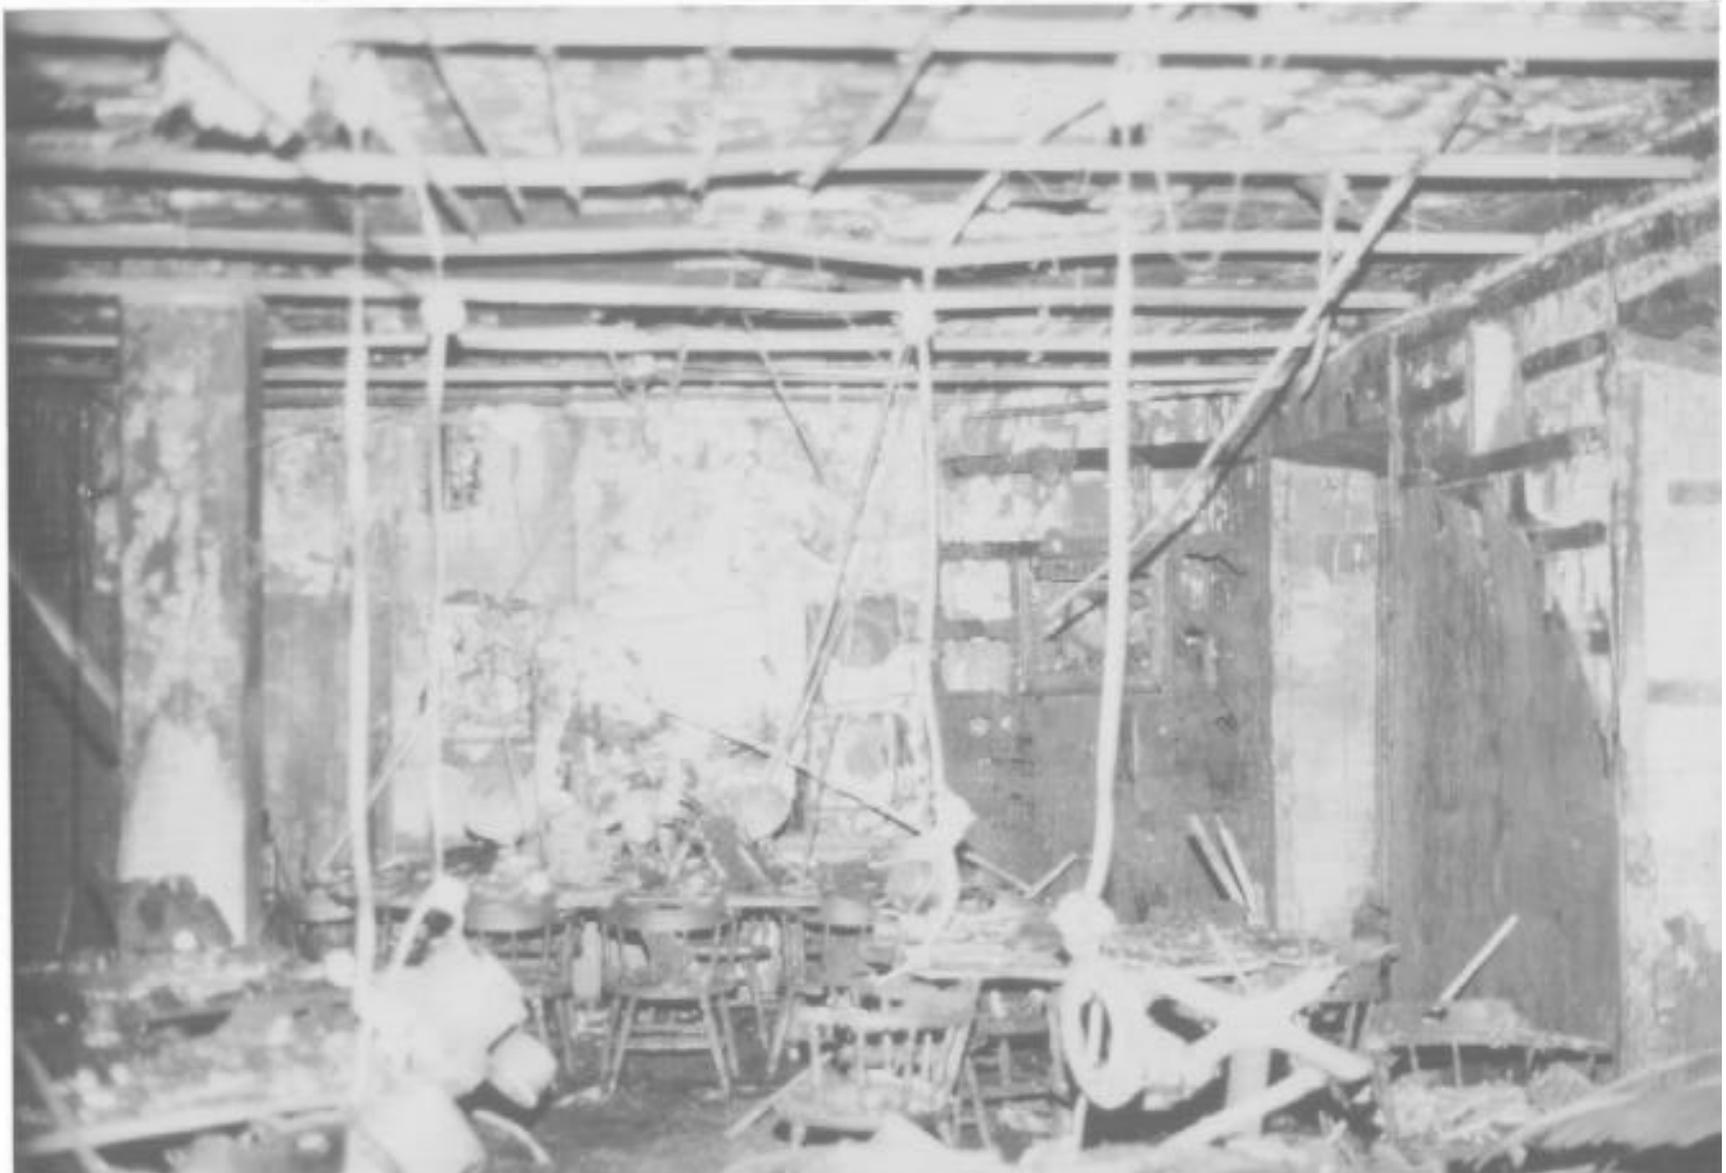
The inside of the McHale Room looking west. Shows the use of furring strips under the wall paneling. Much of the paneling at the remote west end of the room remains intact. Also note that the tops of the chair backs are only slightly blistered.

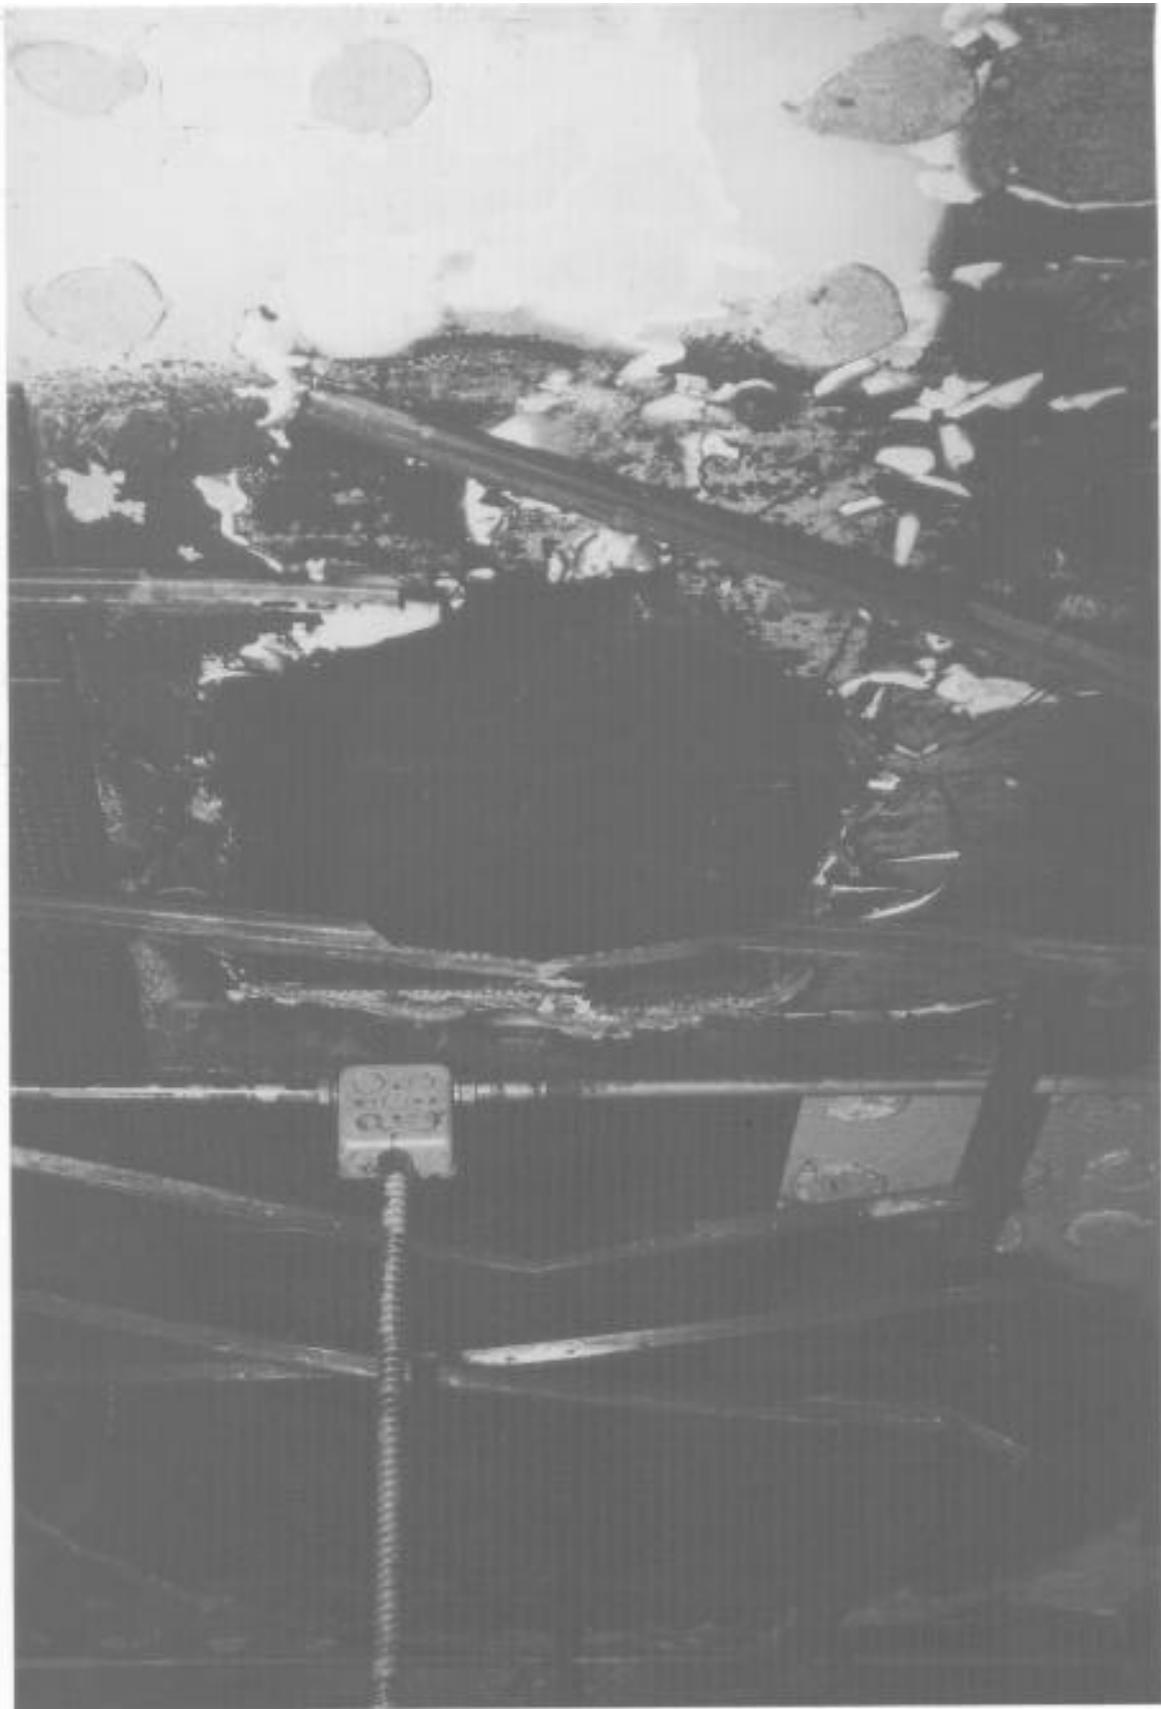
View of opening in suspended ceiling in the McHale Room. Note the charred 1-foot ceiling tiles (at left) glued to the underside of the plaster suspended ceiling and the remnants of the aluminum suspended ceiling frame.

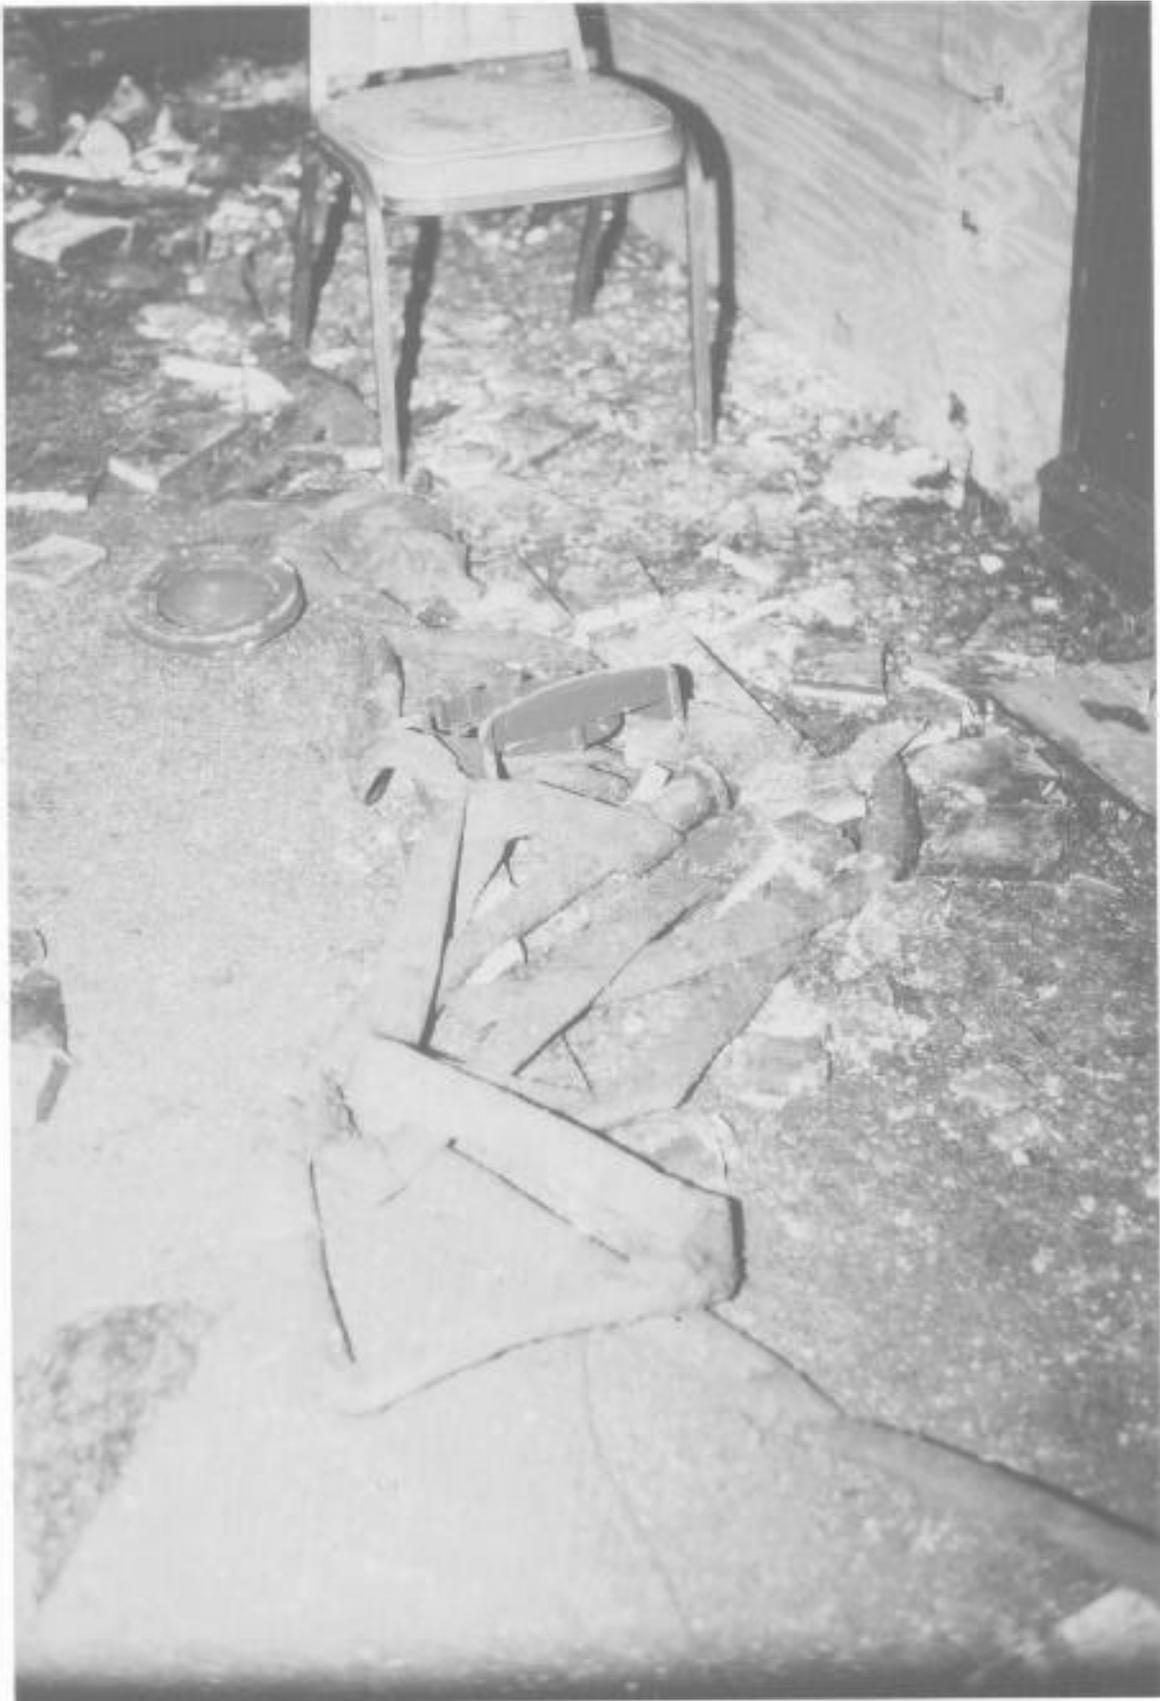
Remnants of occupant use standpipe hoseline used by Engine 7 and Truck 13 firefighters in the initial attack. Note the plastic adjustable-stream fog-nozzle attached to the end (near center of photo).

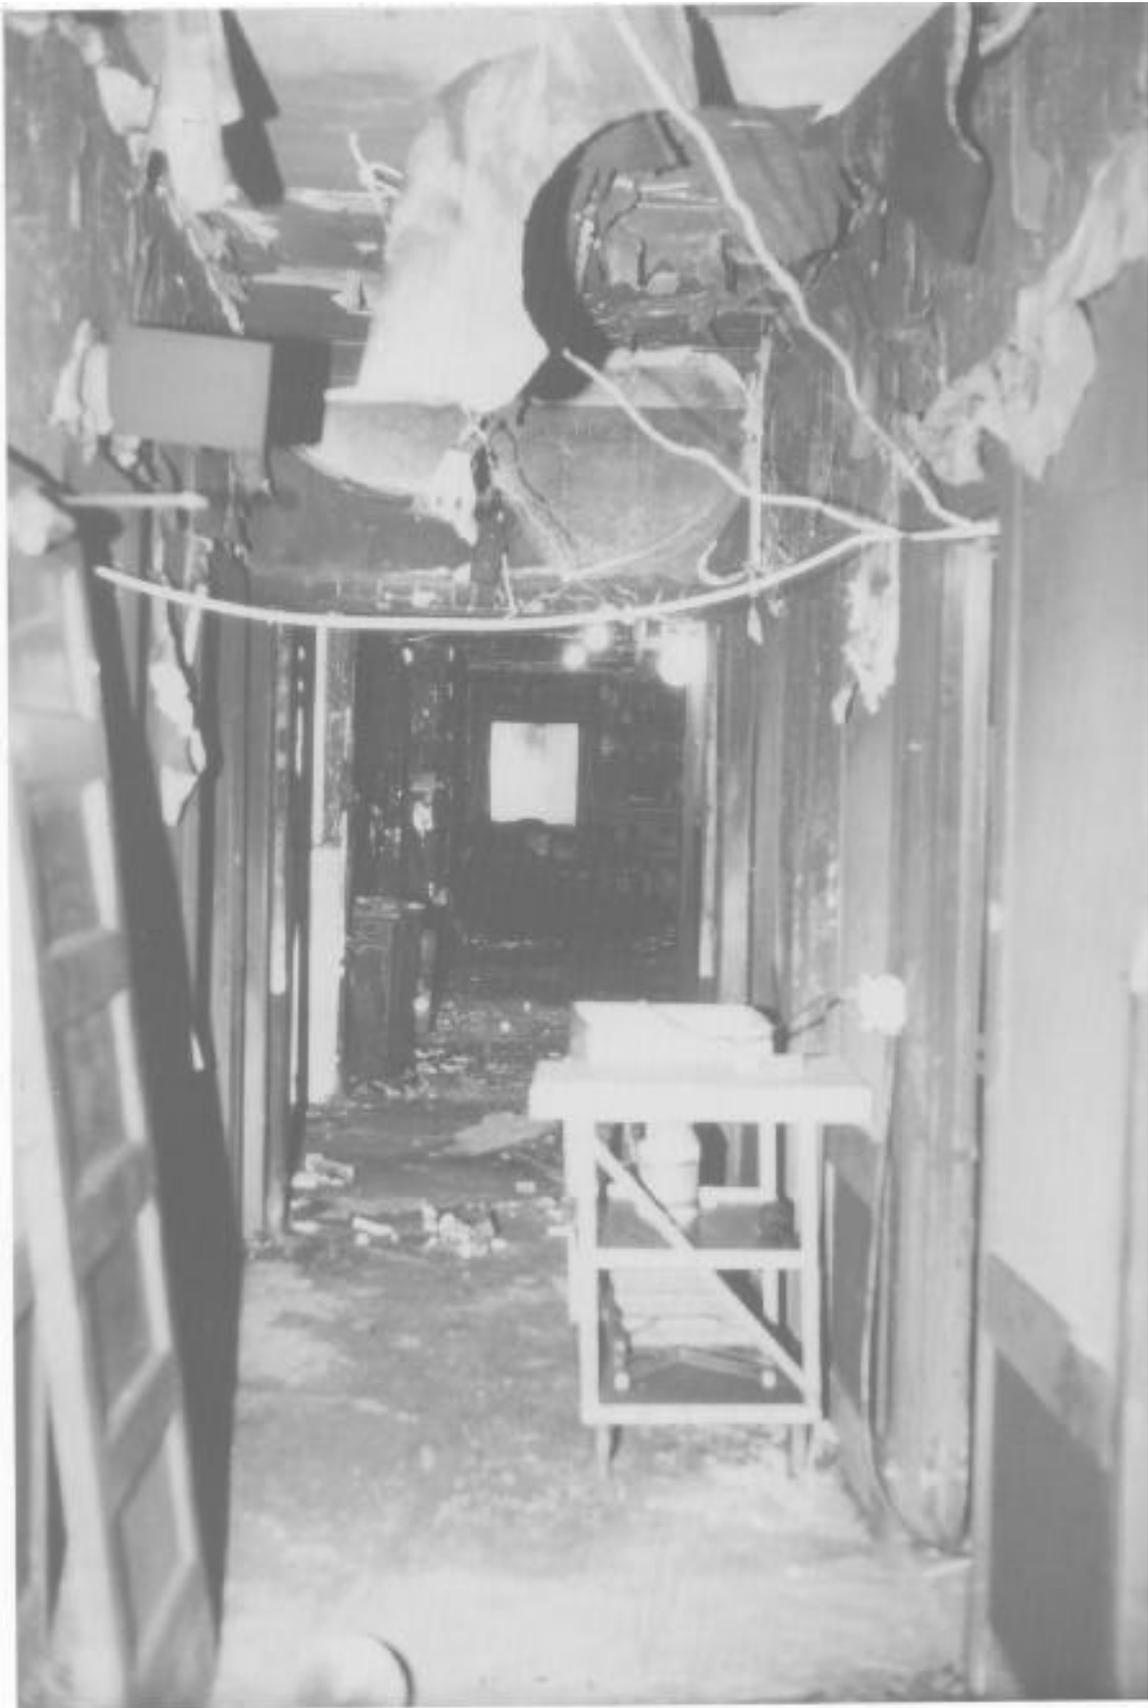
View of third floor service corridor looking east from standpipe cabinet. Note the relatively minor damage. Most of the damage is confined to wall and ceiling finish materials.

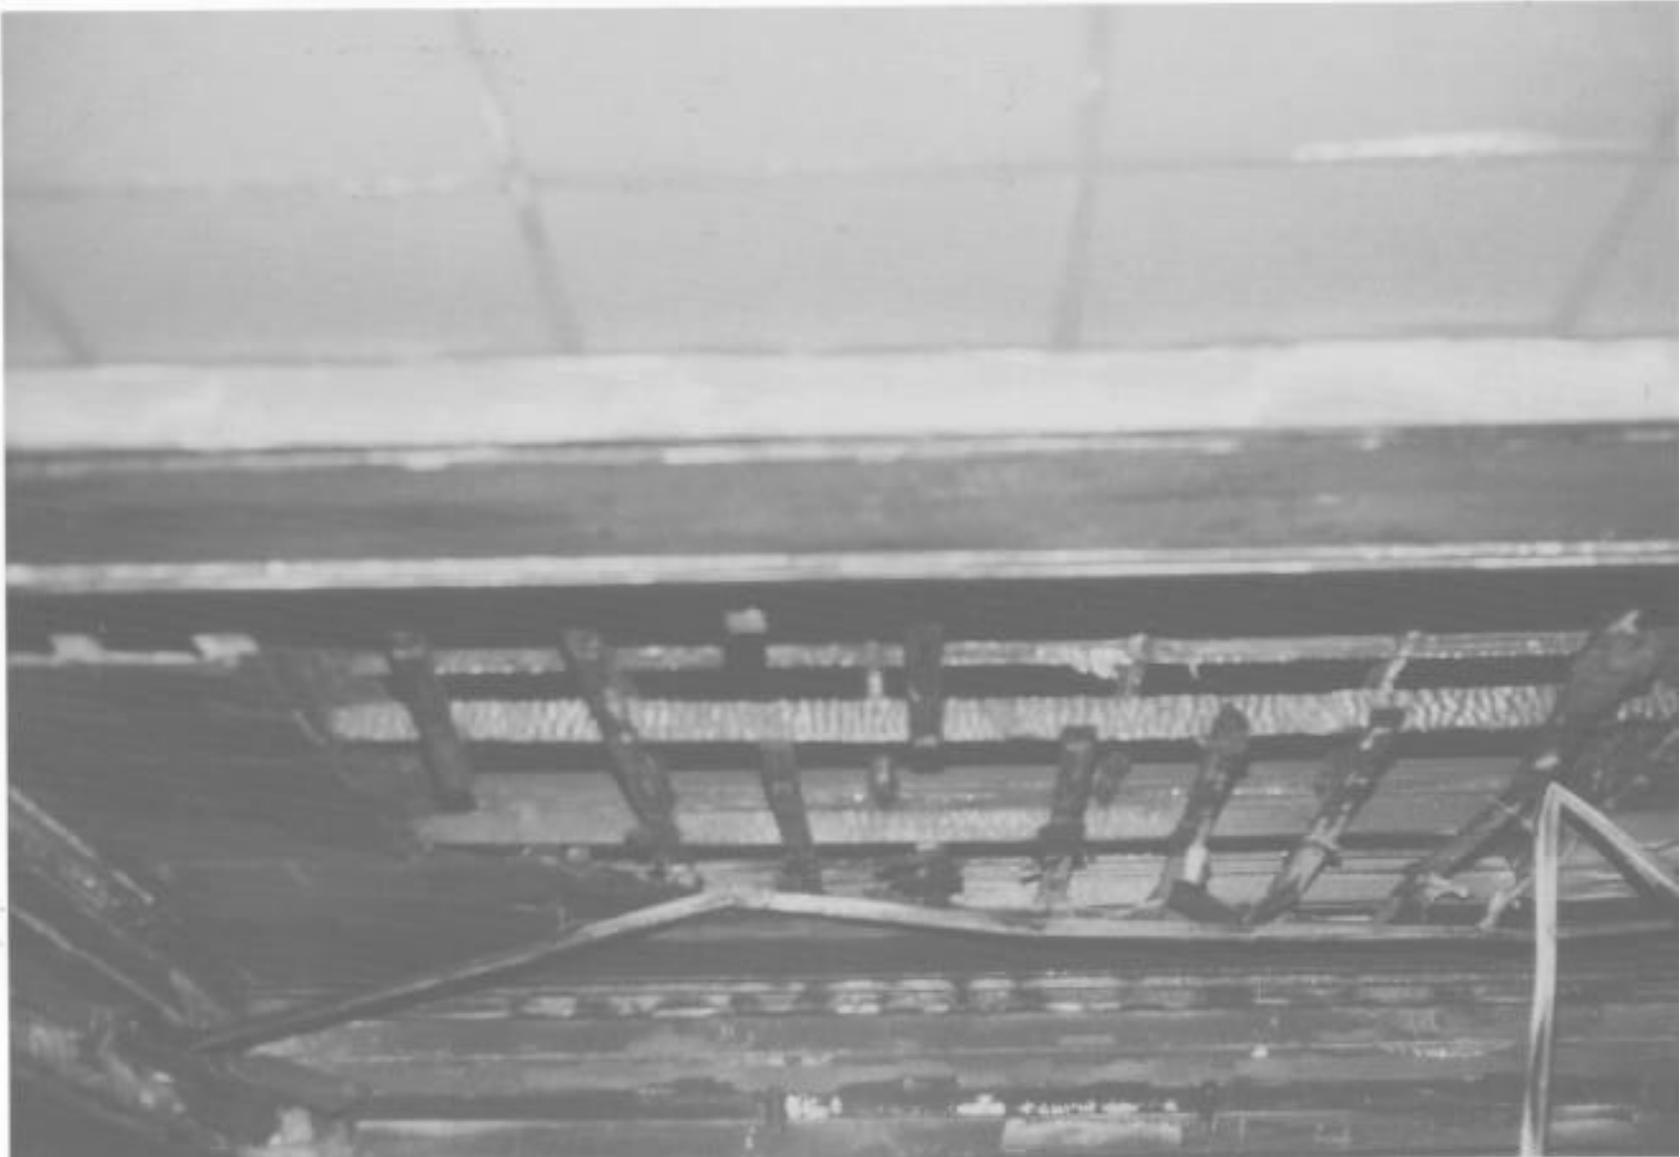
View of suspended ceiling damage above the location in the grill room where Captain Spalding was found unconscious and covered in debris.

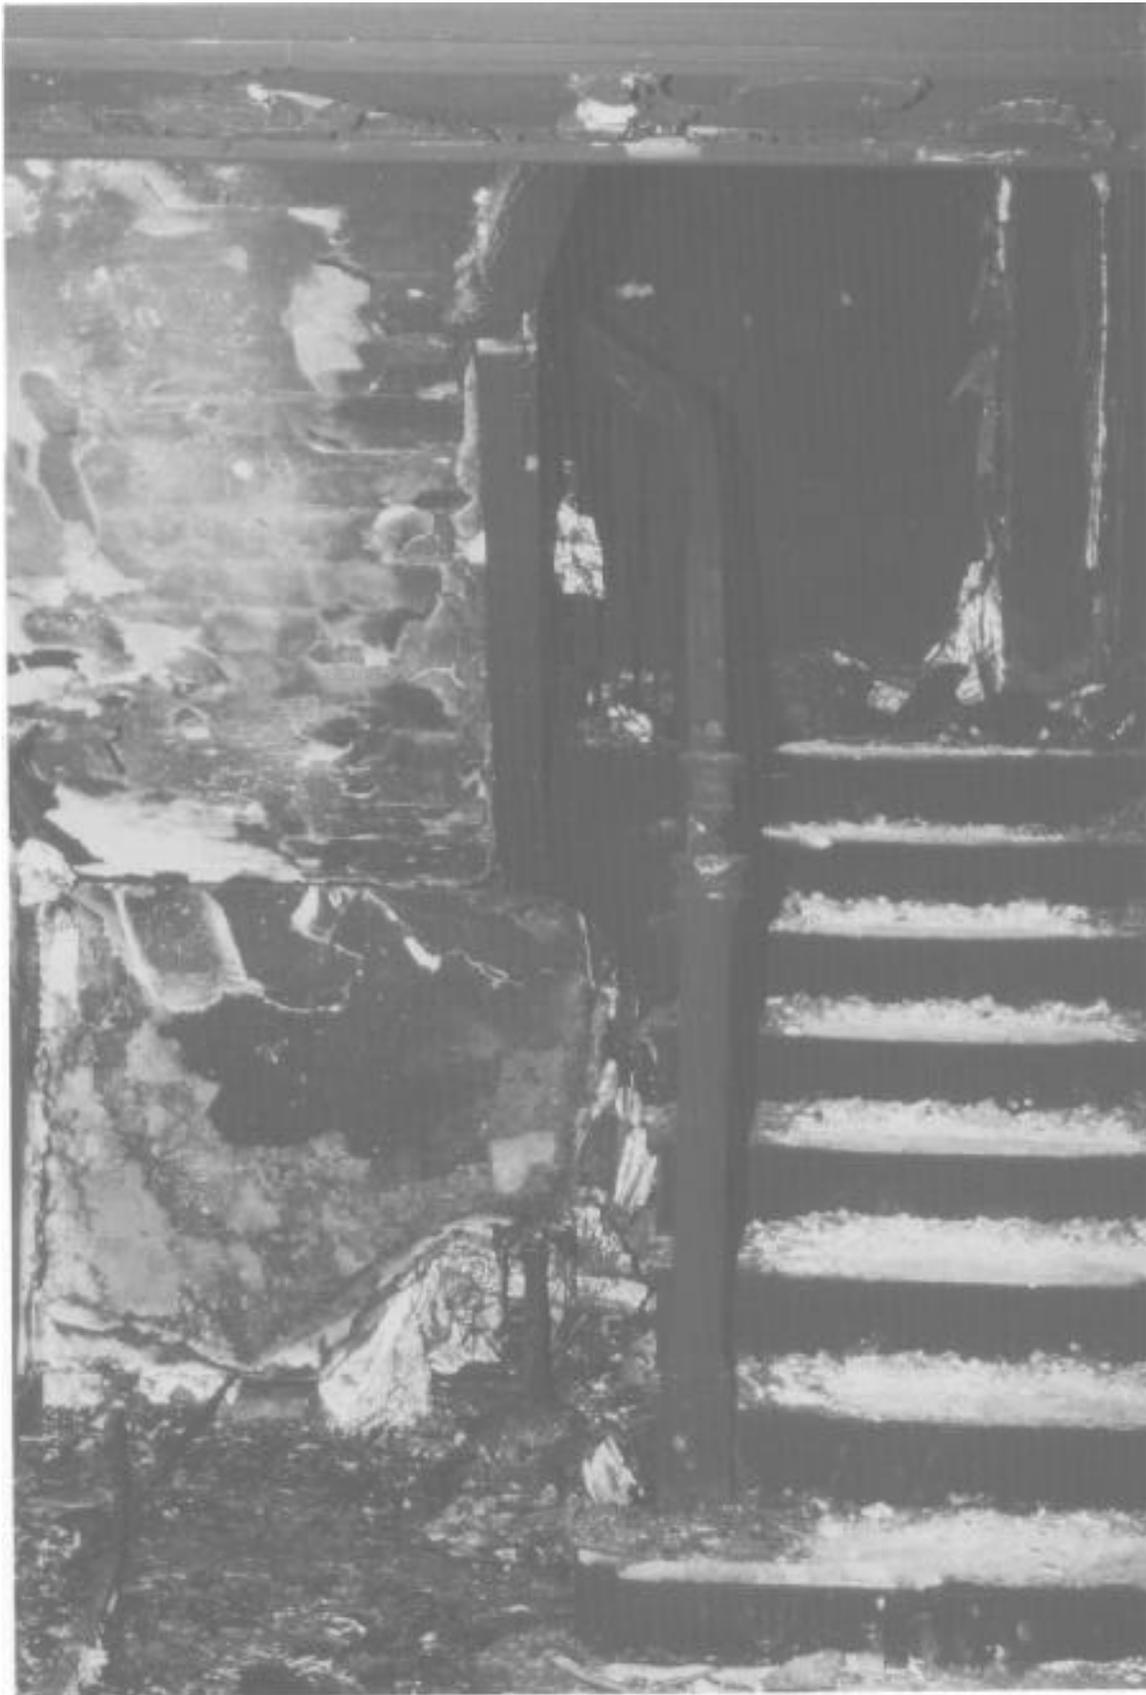
View of east stairway connecting third through ninth floors. This stairway was open on the third floor (shown here) and the fourth floor permitting the stairway to fill with smoke and the fire to spread vertically to the fourth floor.
