### Indianapolis Athletic Club Fire Indianapolis, Indiana

**Indianapolis Athletic Club Fire  
Indianapolis, Indiana  
(February 5, 1992)**

**Investigated by: Mark Chubb**

**This is Report 063 of the Major Fires Investigation Project conducted by TriData Corporation under contract EMW-90-C-3338 to the United States Fire Administration, Federal Emergency Management Agency.**

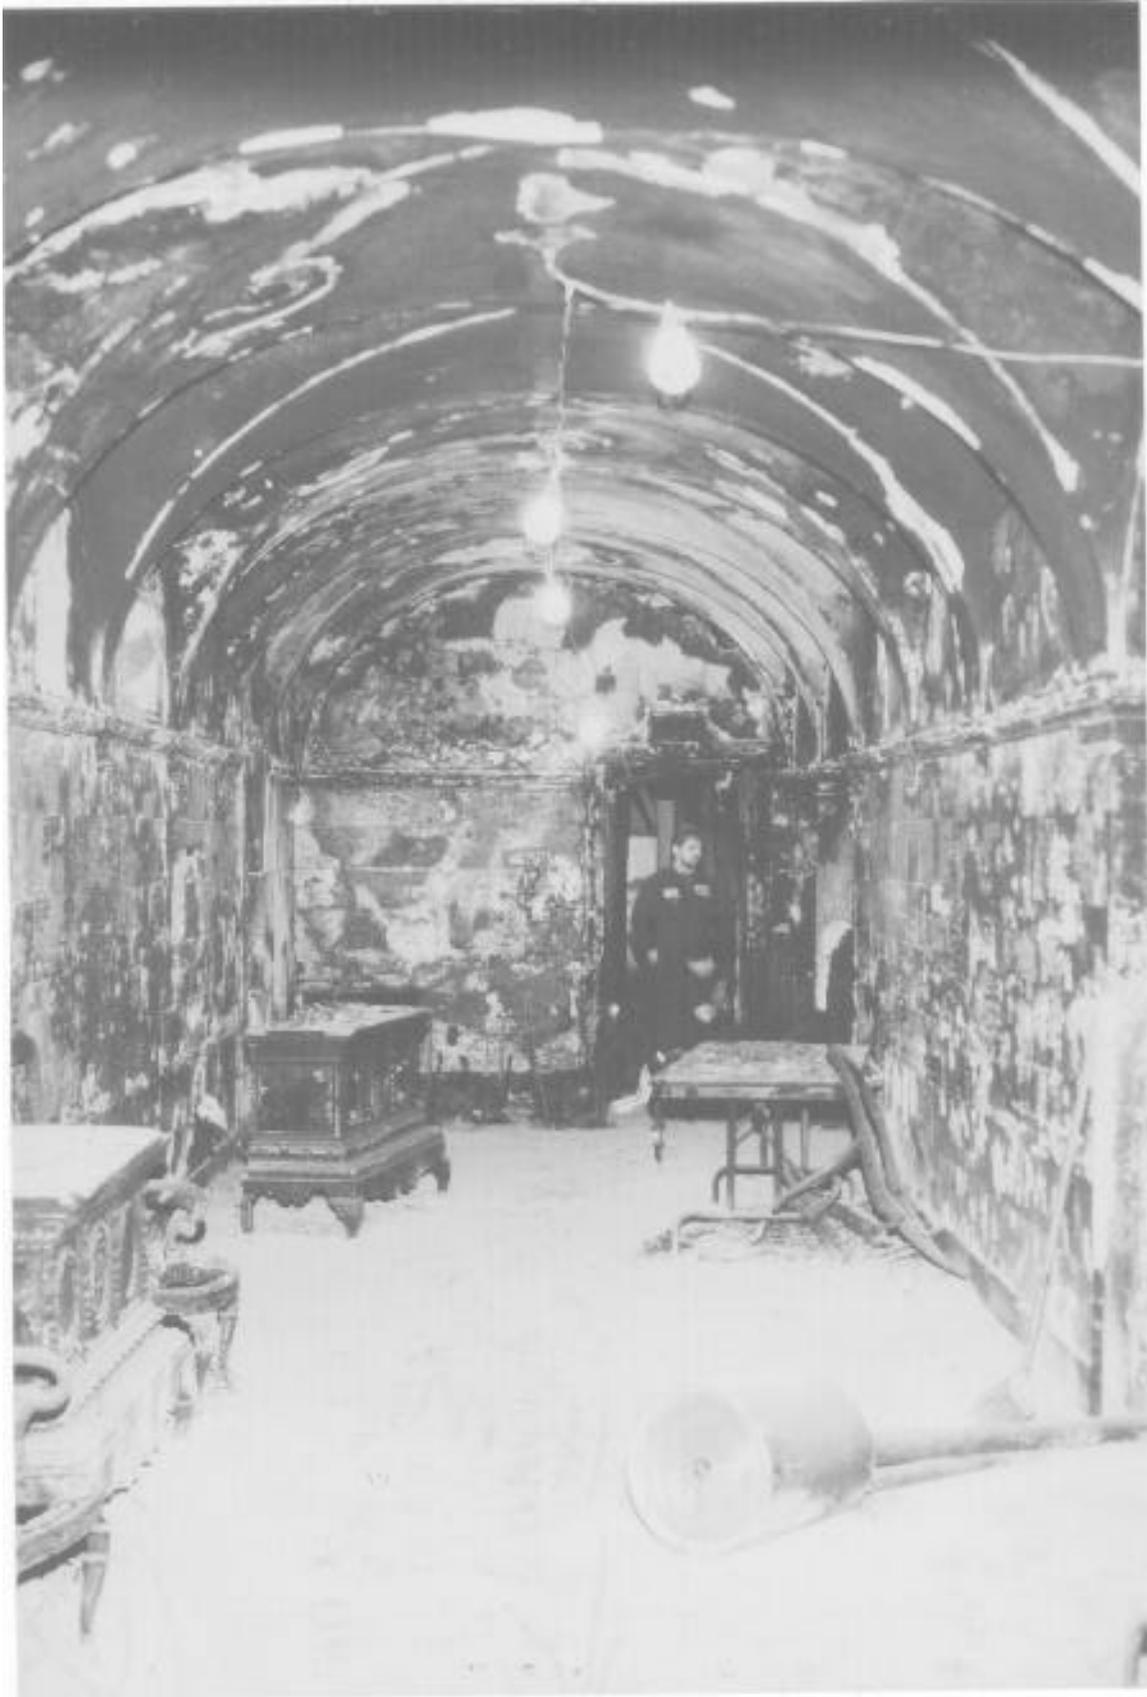
View of fire damage in the fourth floor corridor looking west toward the center of the building.

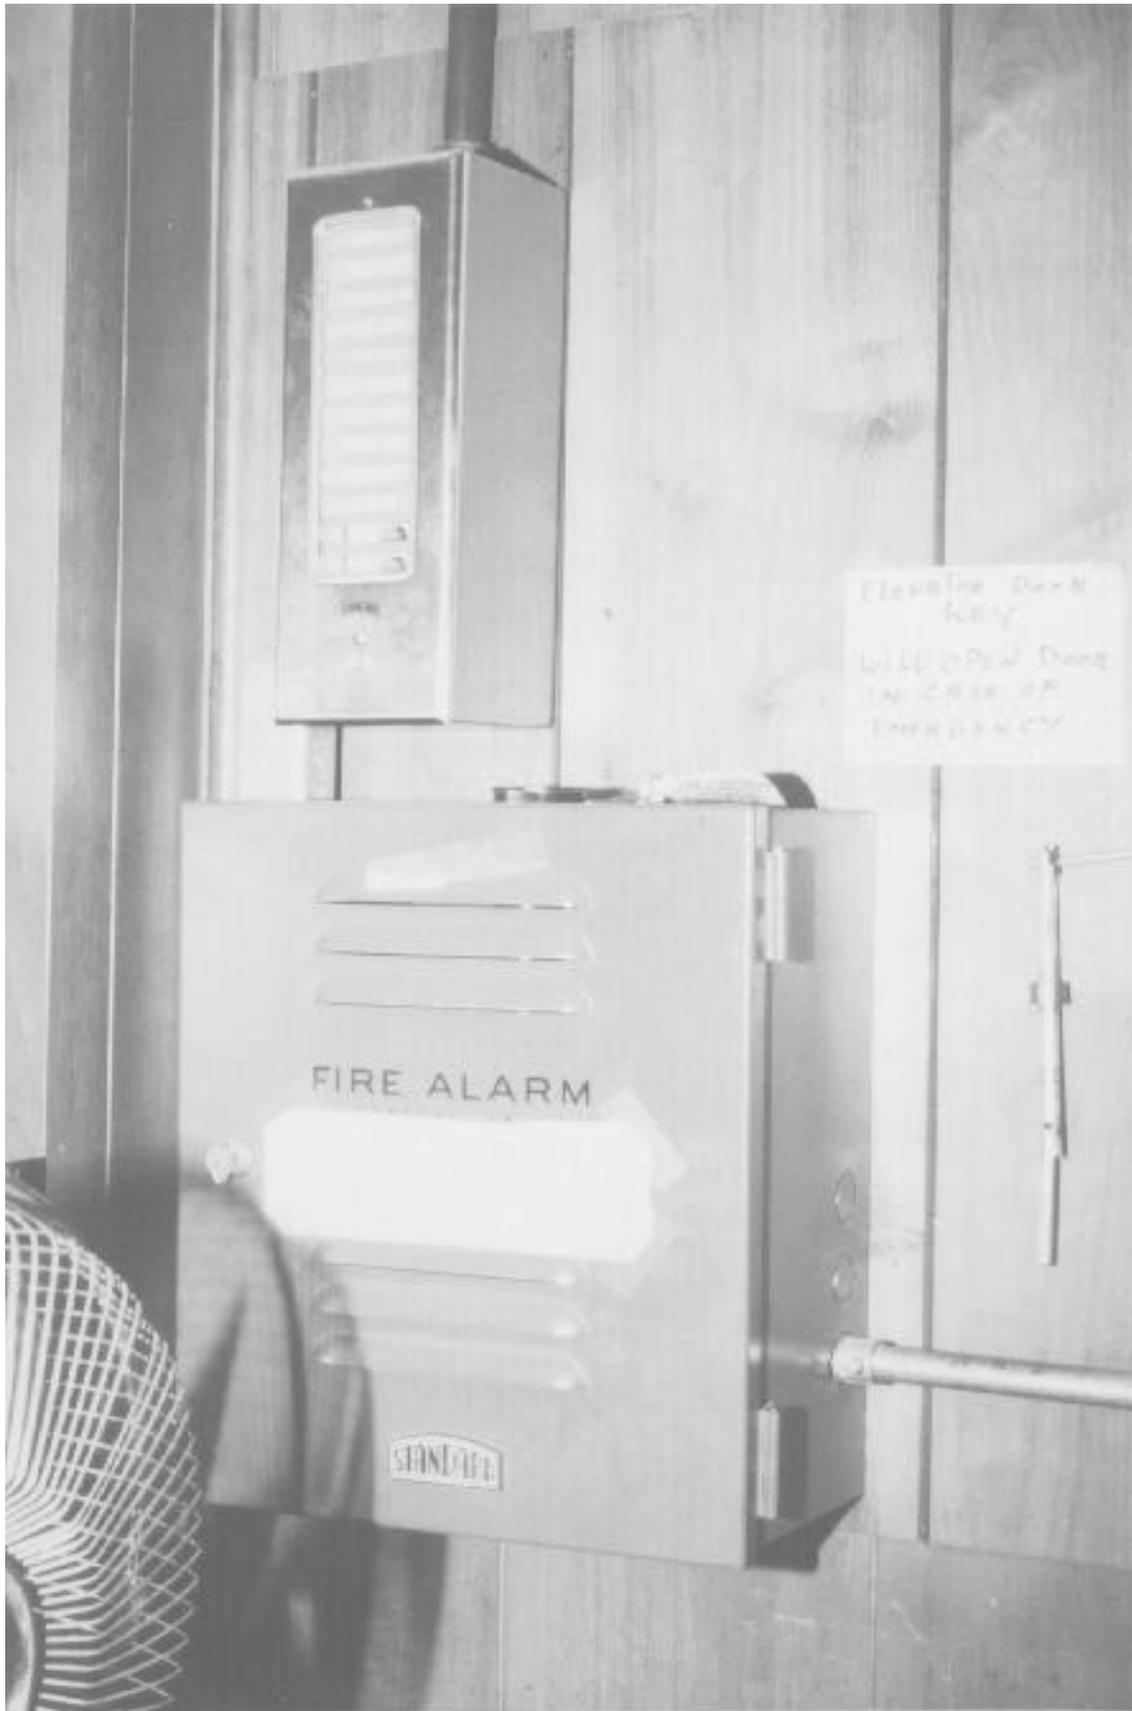
Manual fire alarm system cabinet and tabular fire alarm annunciator above. This system provided power to the fire alarm signals on all floors.

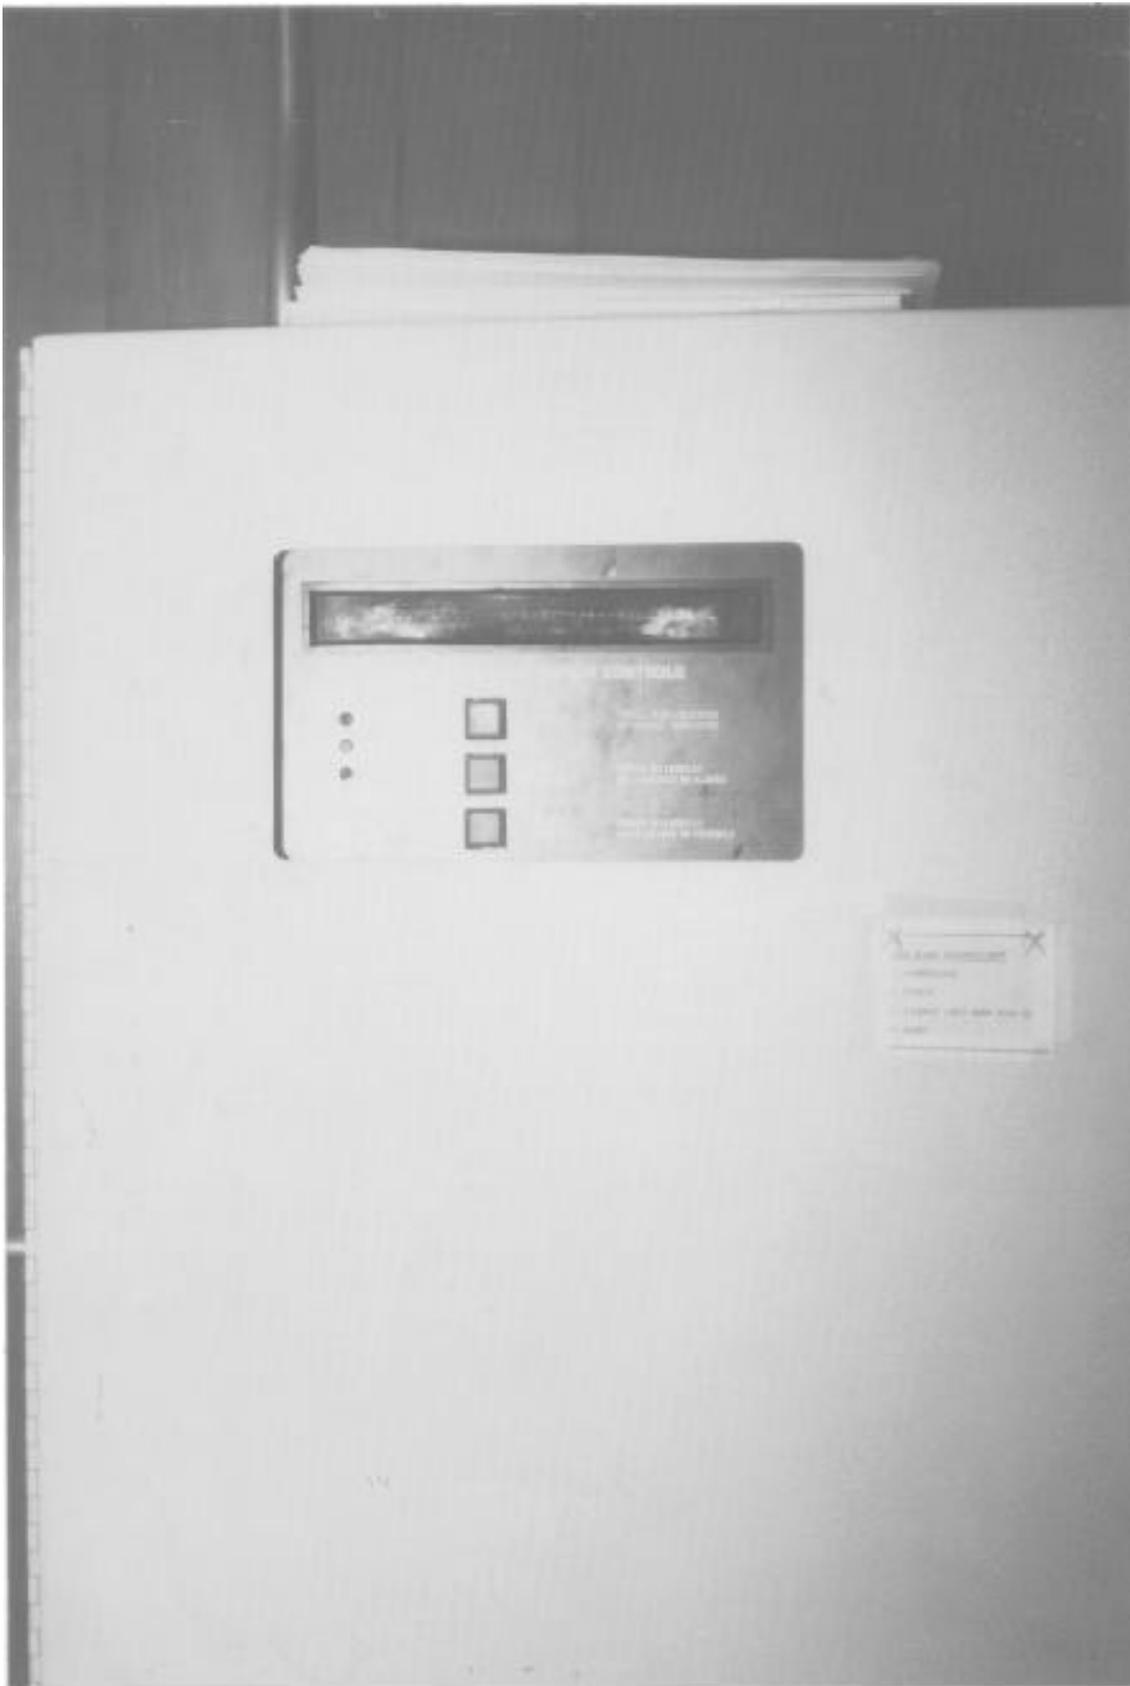
Analog addressable smoke detector control unit. This unit powered and supervised the in-room and basement smoke detectors as well as monitoring the conventional zoned control units which powered the corridor smoke detectors.
