Technical Report Series

Ten-Fatality Board and Care Facility Fire Detroit, Michigan

Ten-Fatality Board and Care Facility Fire Detroit, Michigan (June 2, 1992)

**This is Report 066 of the Major Fires Investigation Project conducted
by TriData Corporation under contract EMW-90-C-3338 to the United
States Fire Administration, Federal Emergency Management Agency.**

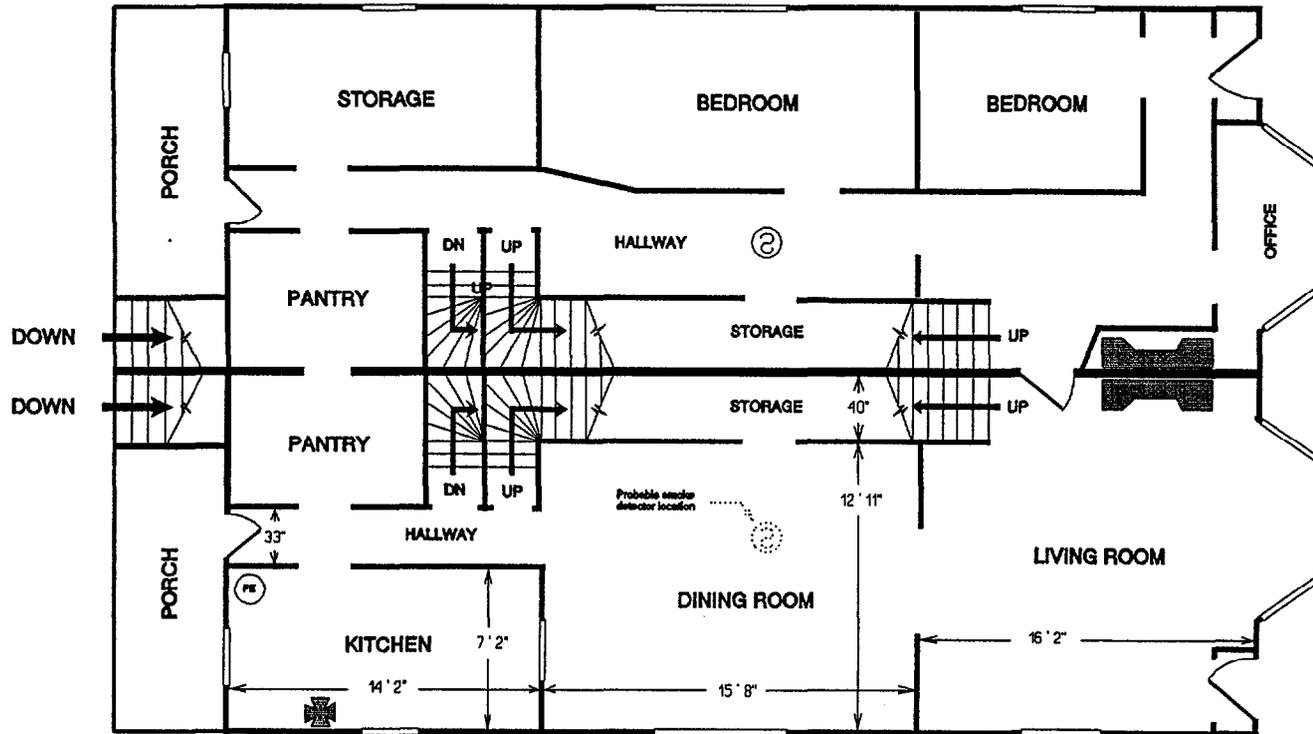
NU-WAY DEVELOPMENT CENTER
 88-90 PINGREE STREET, DETROIT, MICHIGAN
 FIRST FLOOR

The fire originated in combustibles near the stove of the 1st floor kitchen located in the Northwest corner of the dwelling. The fire extended to and throughout the kitchen and then to and throughout the 1st, 2nd and 3rd floors of the entire dwelling. (a detailed report of the fire spread is contained in the follow up report submitted by Lt Paul Green and attached to this report) The fire extended to fatal smoke and burn injuries to 10 occupants of the dwelling. All ten victims were dead at the scene. Two other occupants received smoke inhalation injuries and were transported to Ford Hospital for treatment.

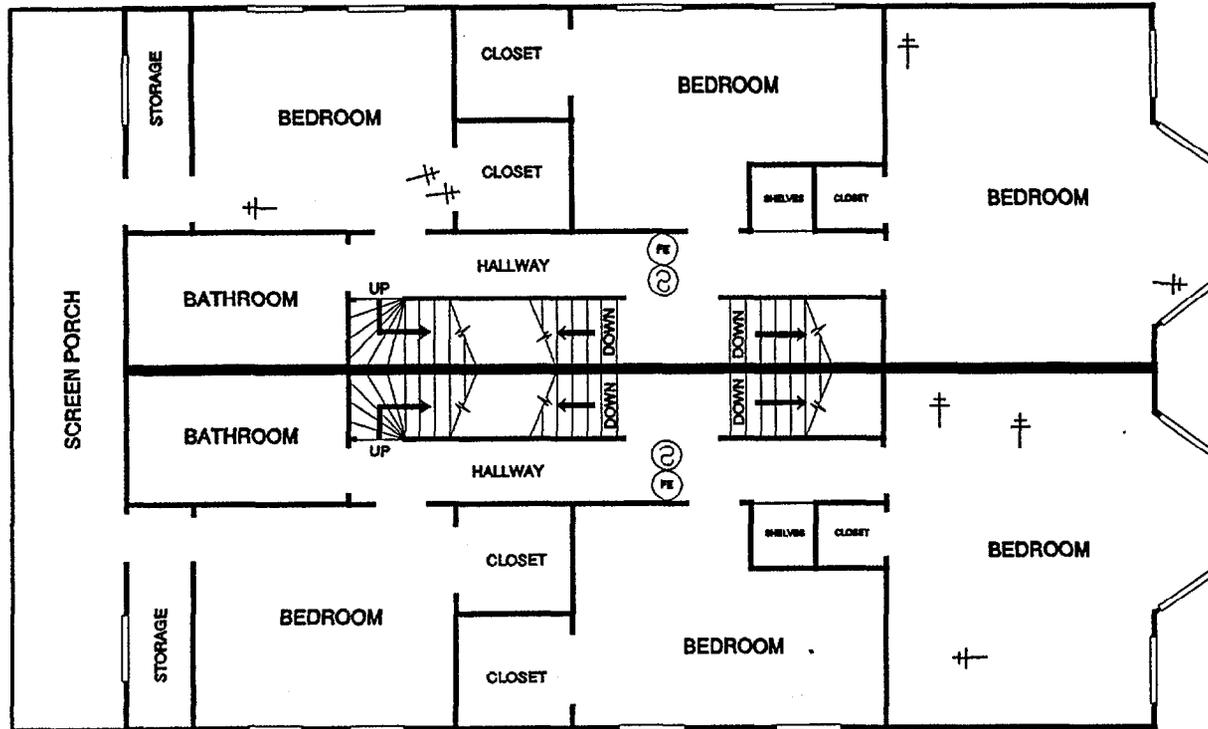
SECOND FLOOR

The floor plan in Appendix A shows the locations of the victims. They were distributed throughout the building. The same number of victims was found on the east side as the west side and in the front part of the building as the rear. Eight of the victims were found on the second floor and two on the third floor.

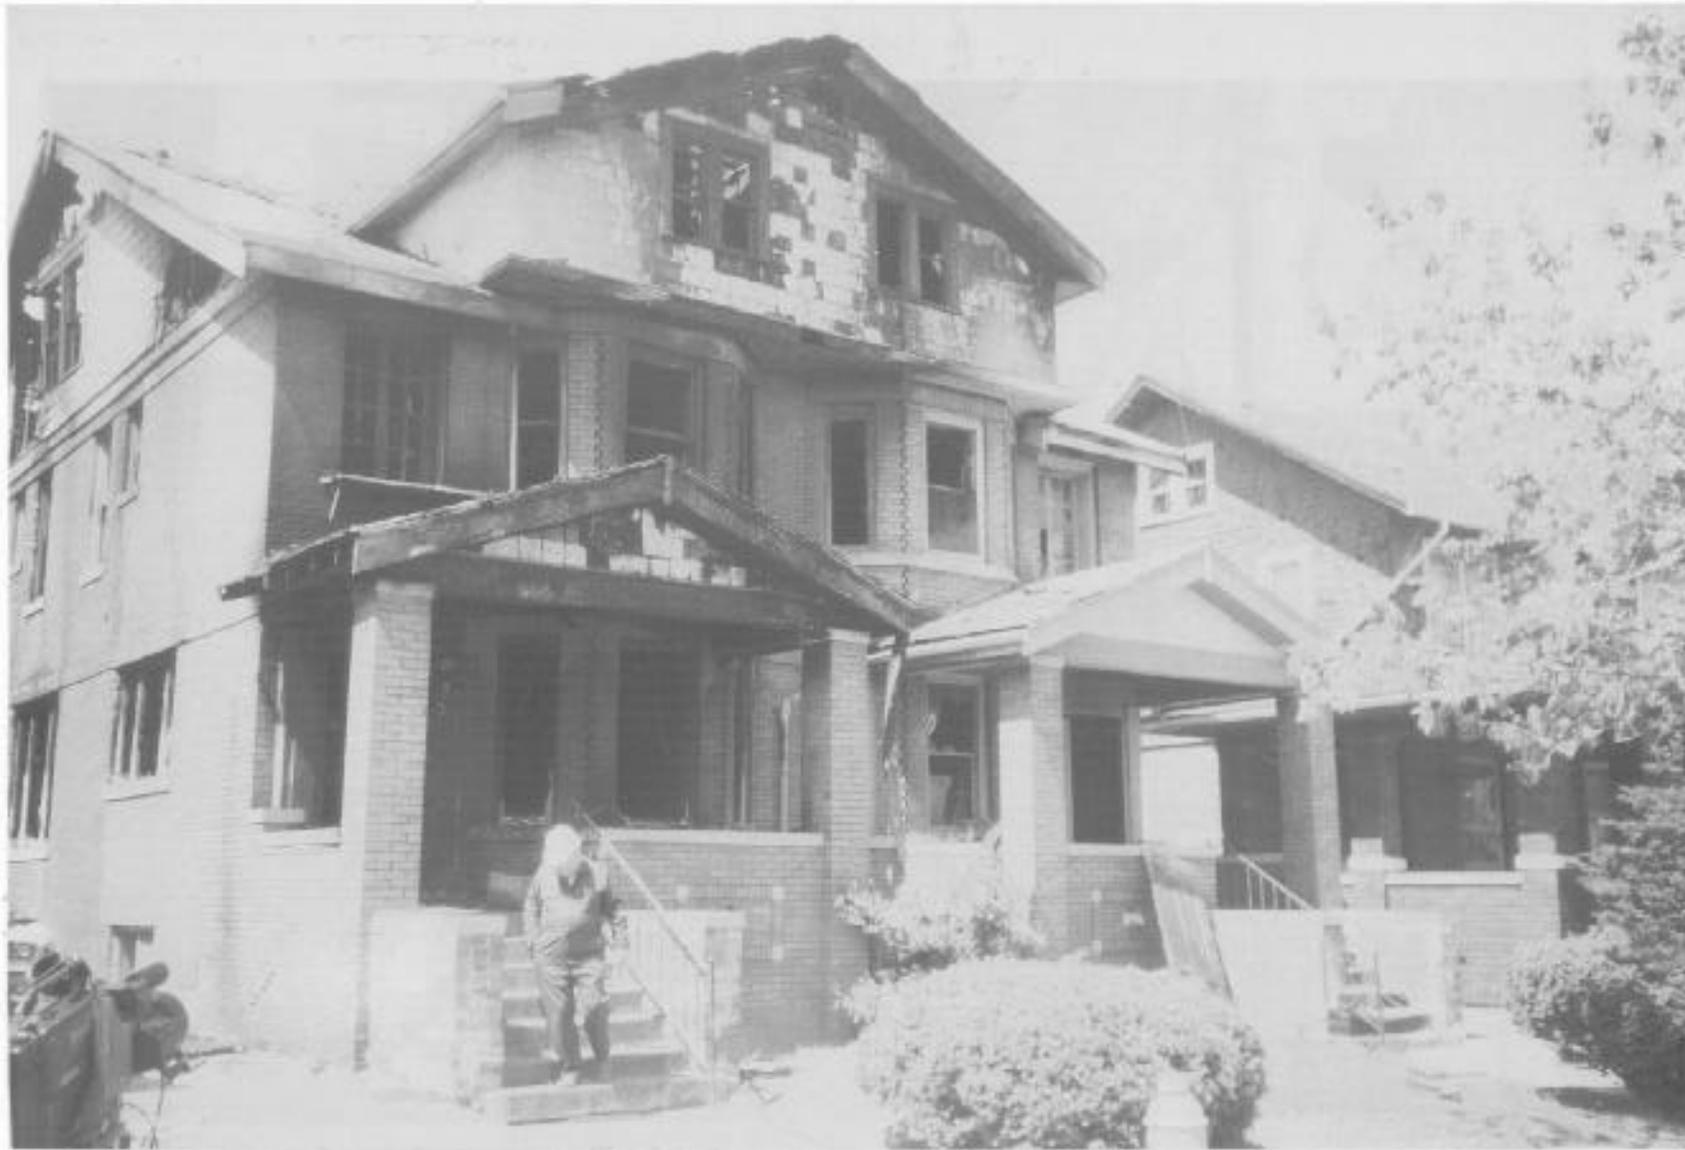
Exterior of 88-90 Pingree Street (structure faces south). Firefighters found fire showing from the first floor west and front, with heavy smoke showing from the second and third floors.

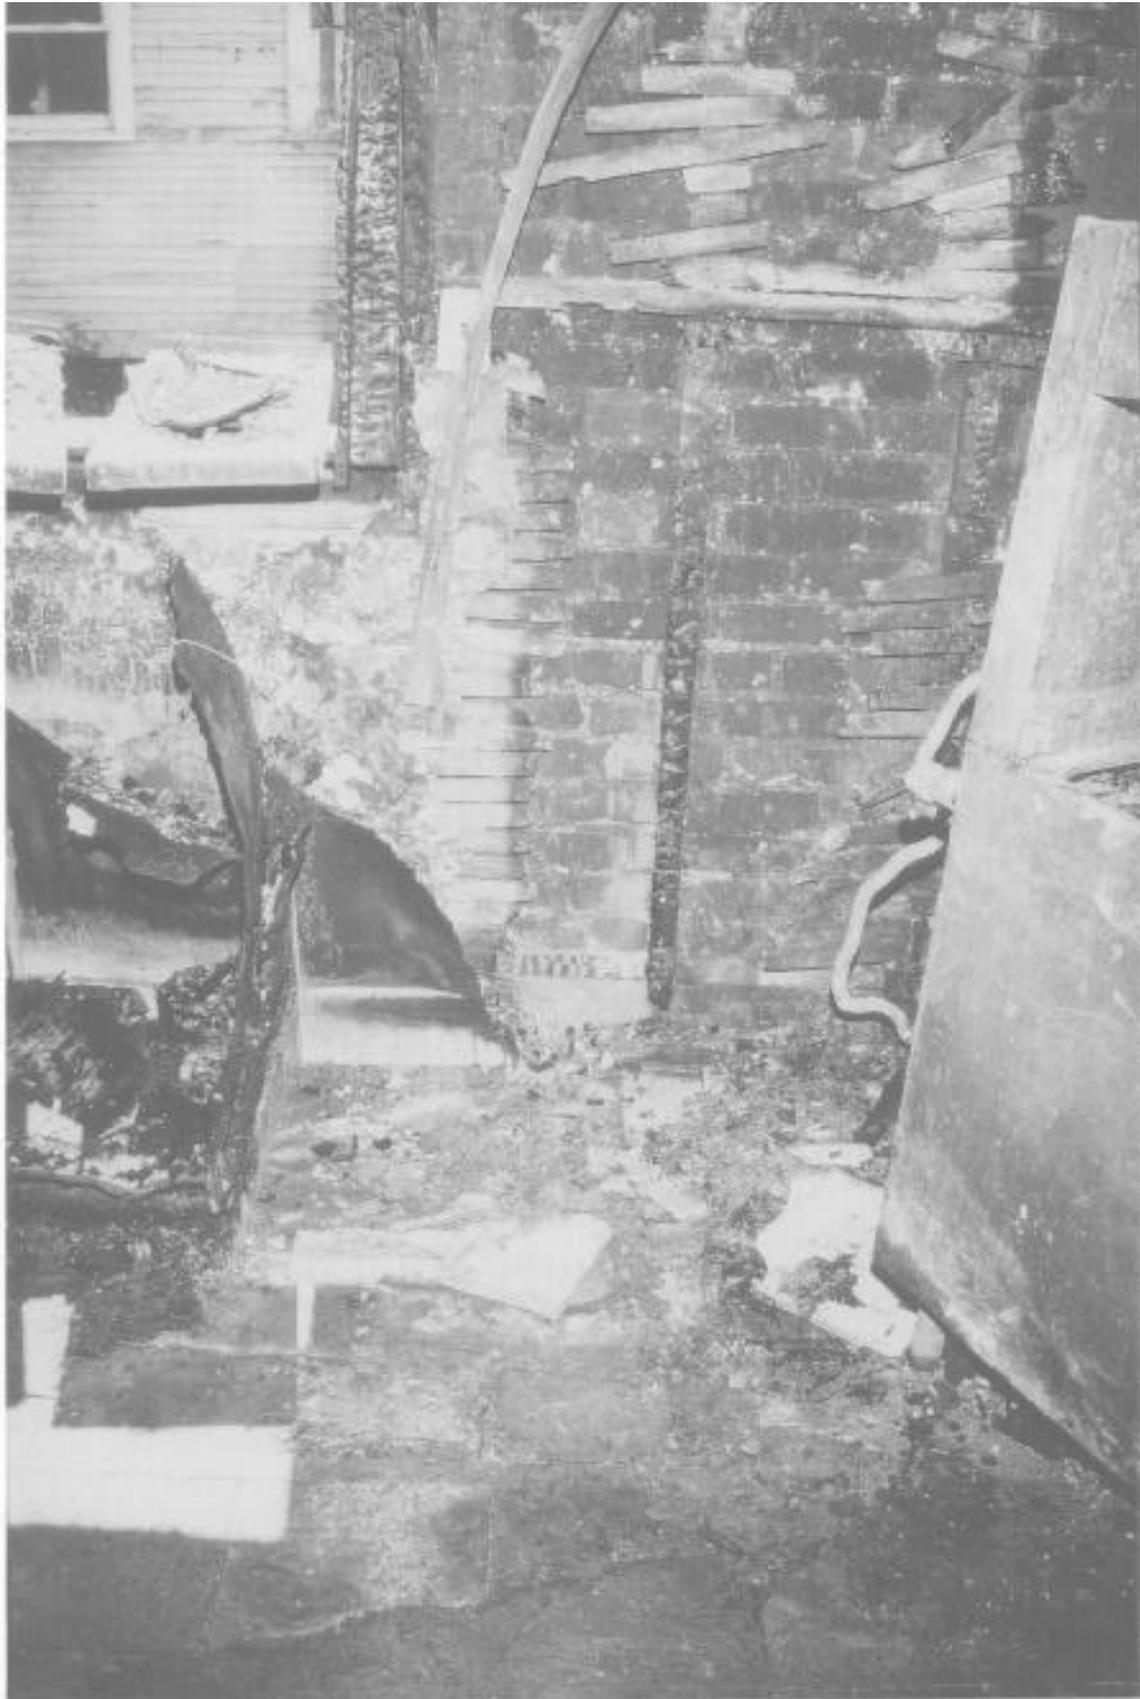
Detroit fire investigators believe the fire started when carelessly discarded smoking materials ignited trash in a kitchen waste receptacle. Investigation revealed that the fire started in the kitchen near the floor between the stove and kitchen counter on the east side of the room. (For floor plans, see Appendix A.) A distinctive V-shaped burn pattern was clearly evident on the outside wall adjacent to this area pointing to the likely point of origin. Combustible interior finish on this wall likely provided additional fuel as the fire grew and spread. Other combustibles, including containers of cooking fat on a shelf directly above the point of origin, 'probably became involved allowing the fire to grow rapidly. The

Point of origin in kitchen showing evidence of low burn near the baseboard.

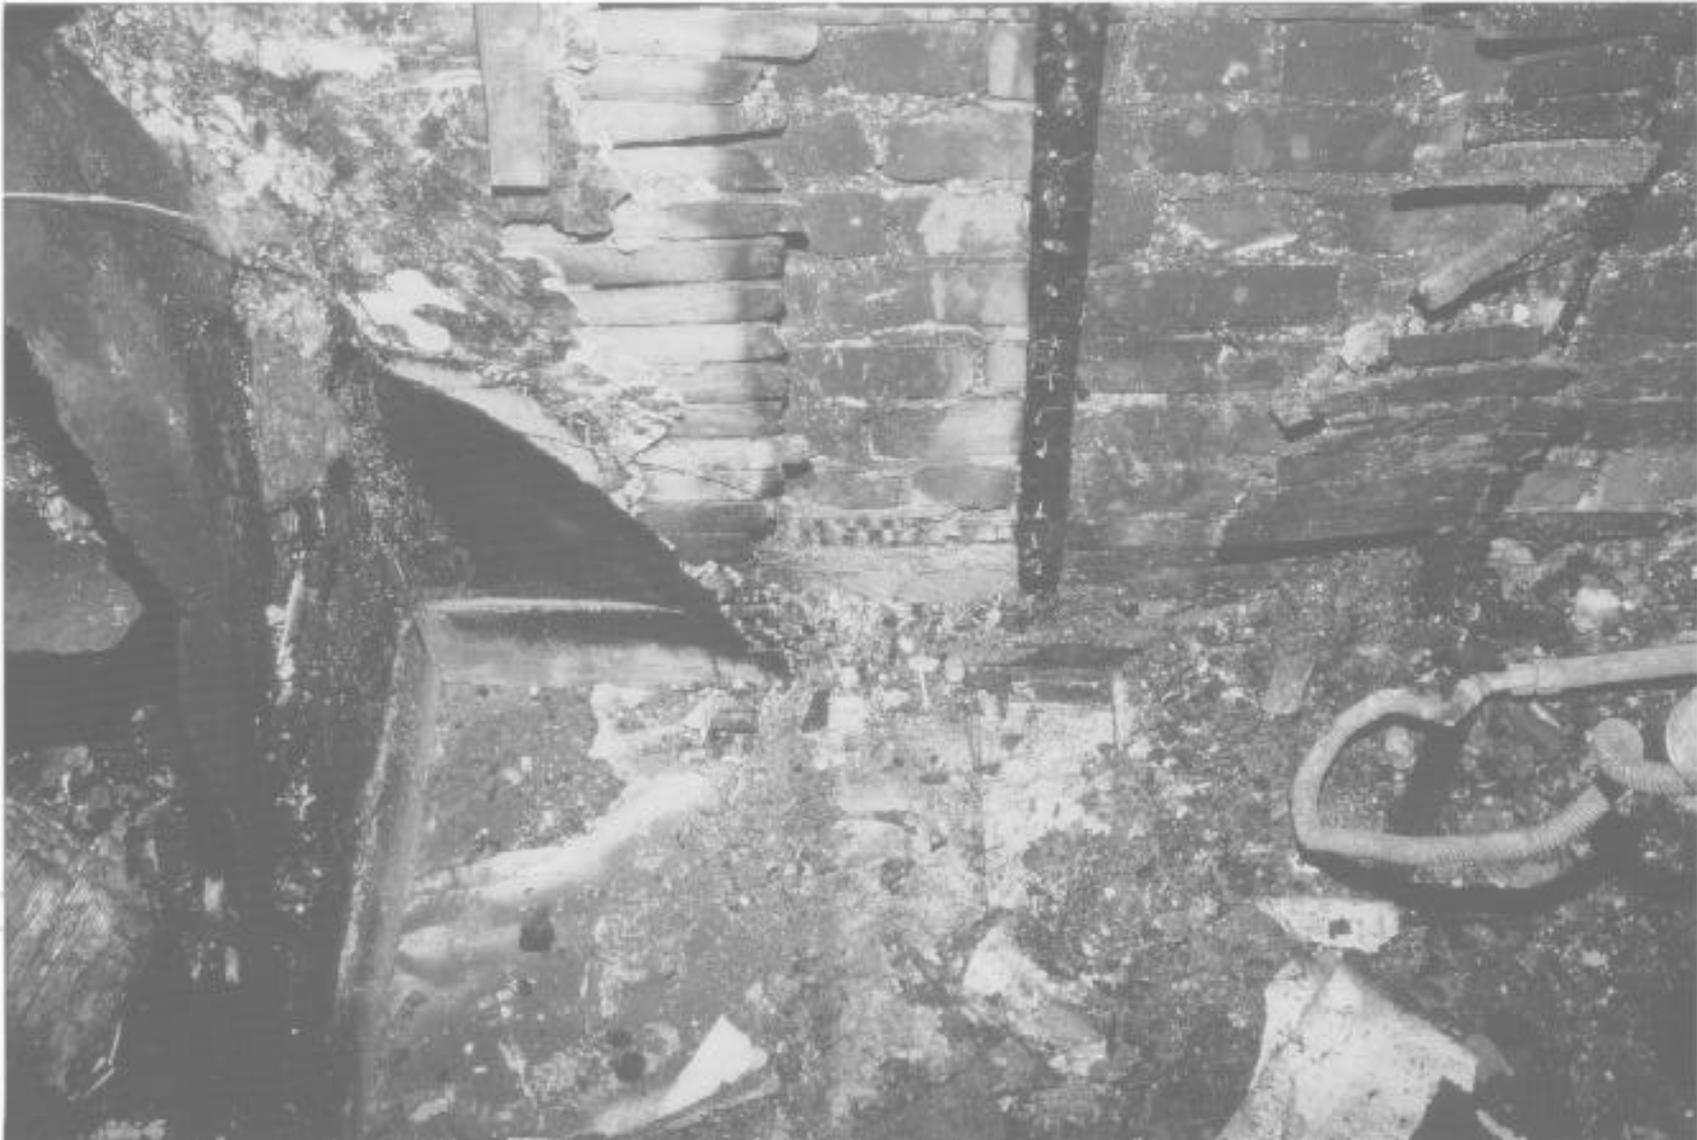
Interior Finish - Combustible interior finish had been installed in the kitchen and rear hallways during earlier renovations, possibly at the time the building was converted to an adult foster care facility. In most cases, the wall finish materials consisted of 1/8-inch plywood paneling. Investigators also uncovered 1/2-inch particle board behind the stove in the kitchen. Paneling was also found elsewhere in the occupancy, usually where there was evidence of remodeling work to cover cosmetic defects in the original construction. These materials generally have flame spread index ratings between 100 and 150, and appeared to contribute to fire growth in the kitchen and fire spread elsewhere in the occupancy.

Close-up of the point of origin. A small triangular section of the particle board installed over the plaster and lath remains in the lower center portion of the picture.

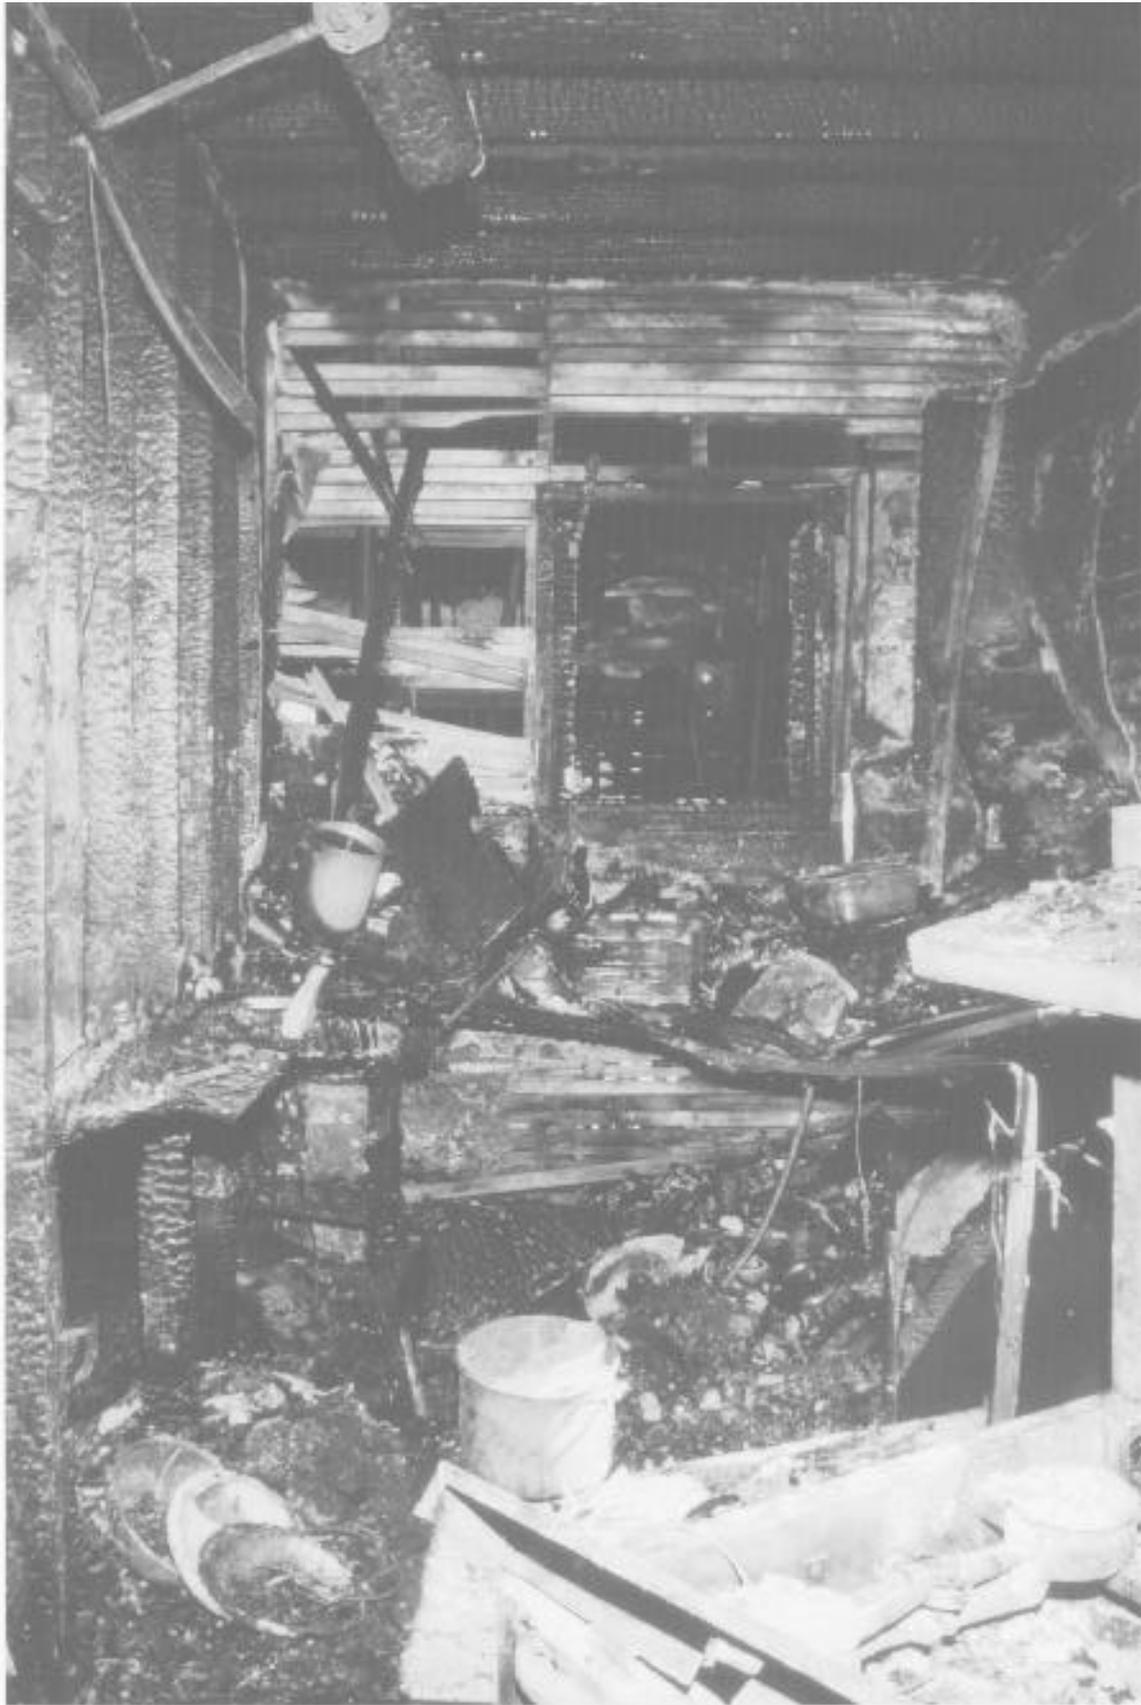
View from the kitchen looking south through the pass-through window into the dining room. The fire was observed through this window by Mr. Fluckes and Mr. Gregory.

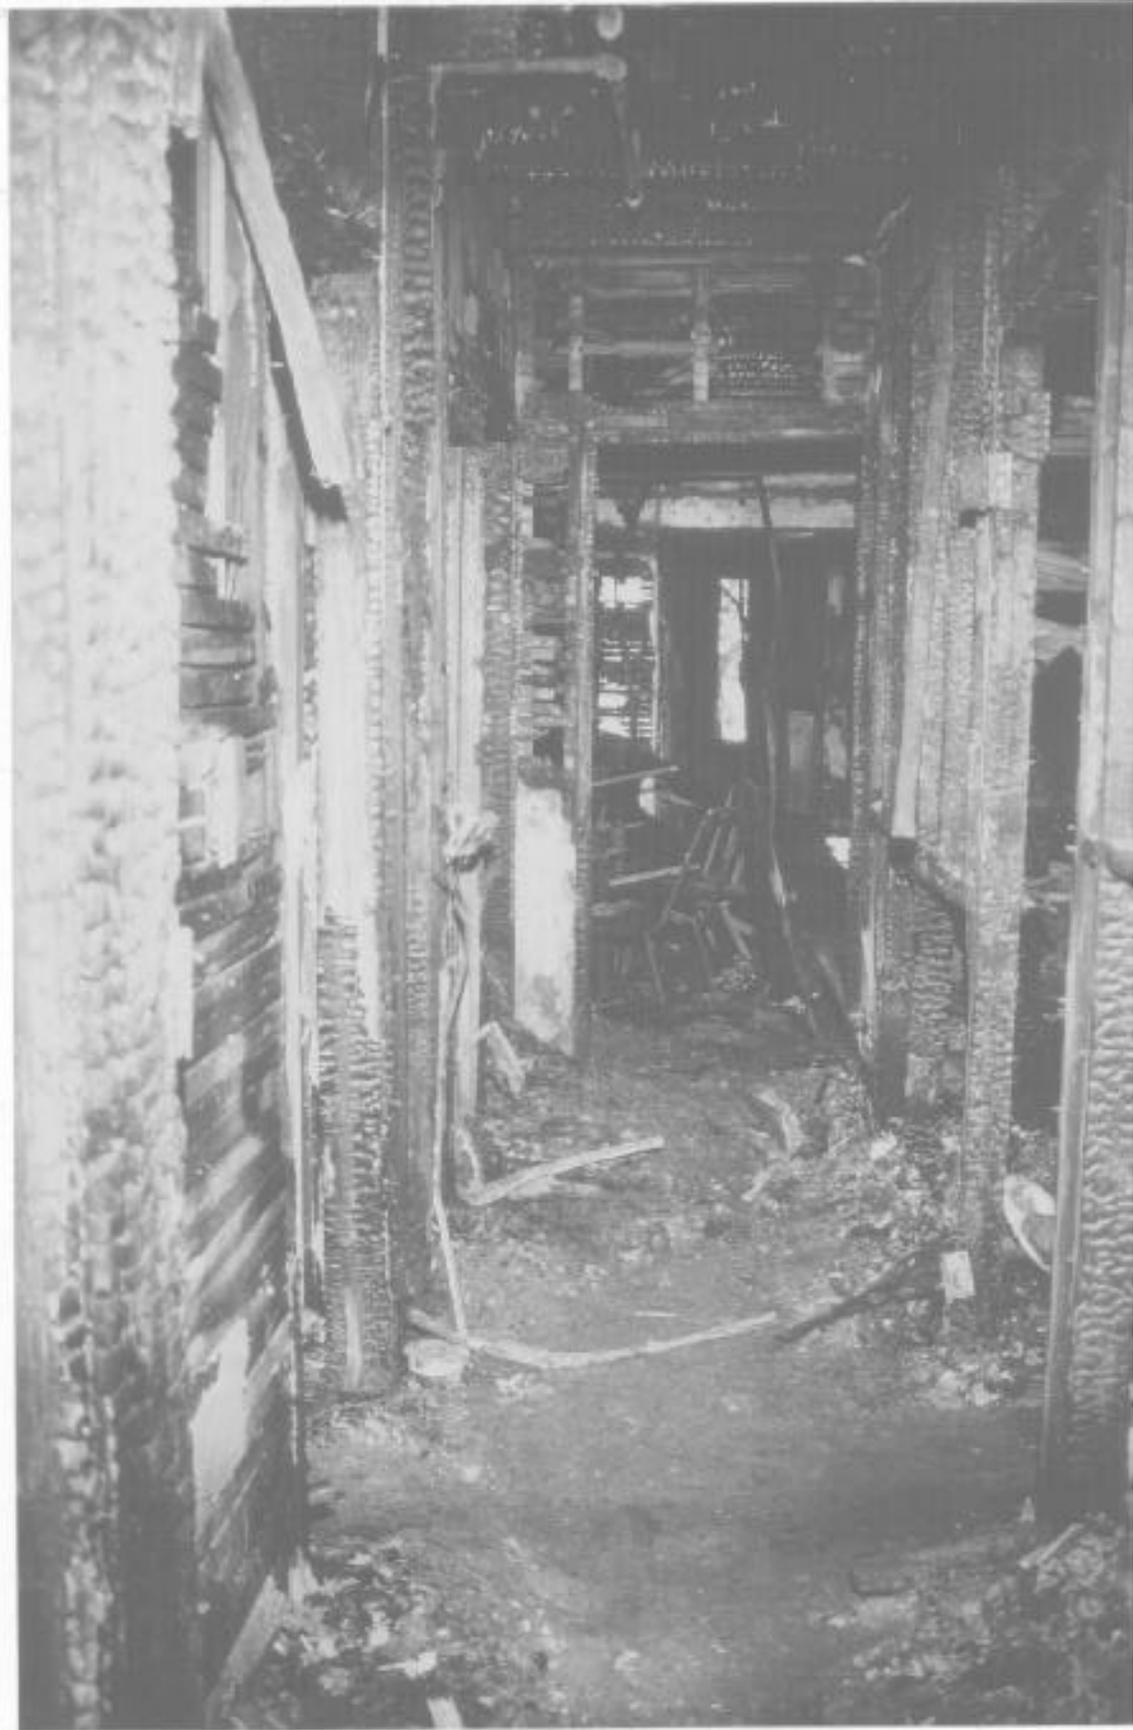
View looking south down the rear corridor adjacent to the kitchen showing heavy damage to the wall studs near the floor level. Also visible through the door opening at the south end of the corridor is heavy fire damage in the dining room.

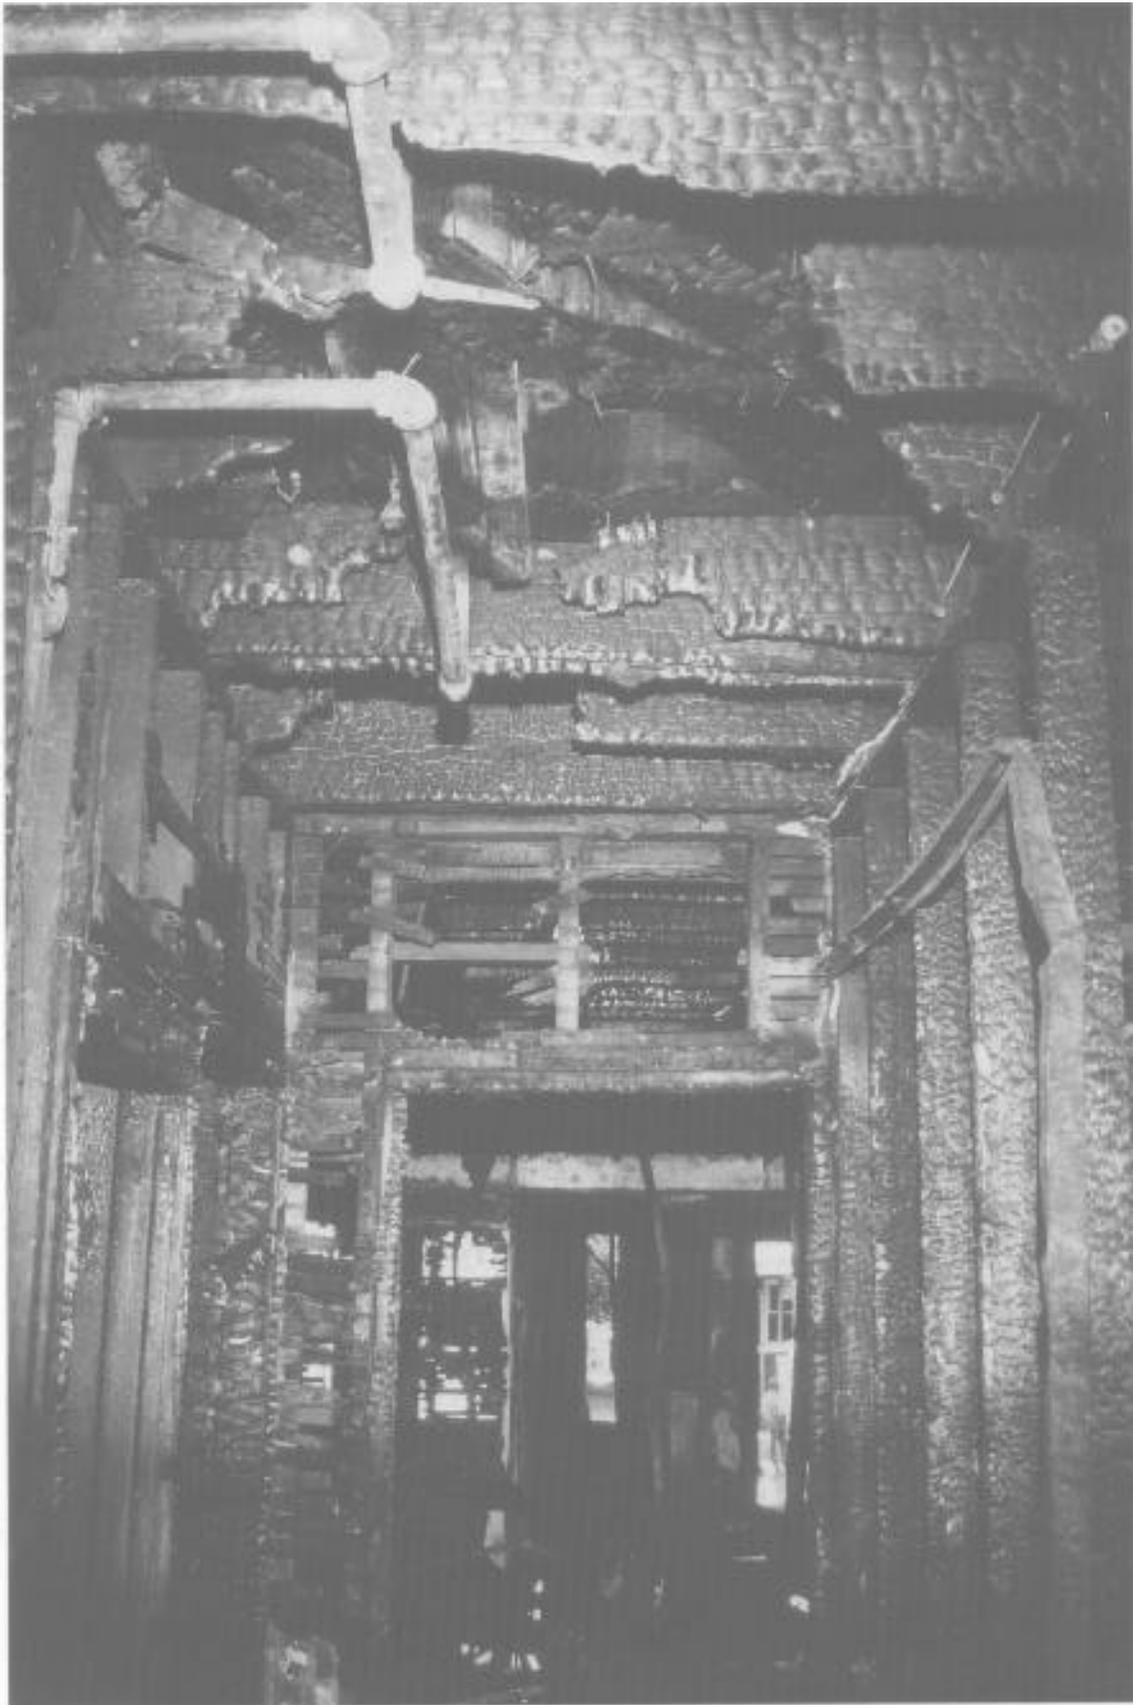
Openings in the party wall and voids in the floor and wall assemblies permitted the fire to spread vertically and horizontally after flashover occurred in the kitchen. Combustible structural elements, including floor joists and wall studs, exposed when the suspended ceiling in the kitchen and first floor rear corridor failed, fueled the fire as it advanced throughout the dwelling. Before firefighters brought the fire under control, approximately half of the third floor at the rear of the building the roof had collapsed.

Close-up of fire damage to the ceiling area in rear corridor next to kitchen. Pipe penetrations were one avenue of fire and smoke spread to the second floor.

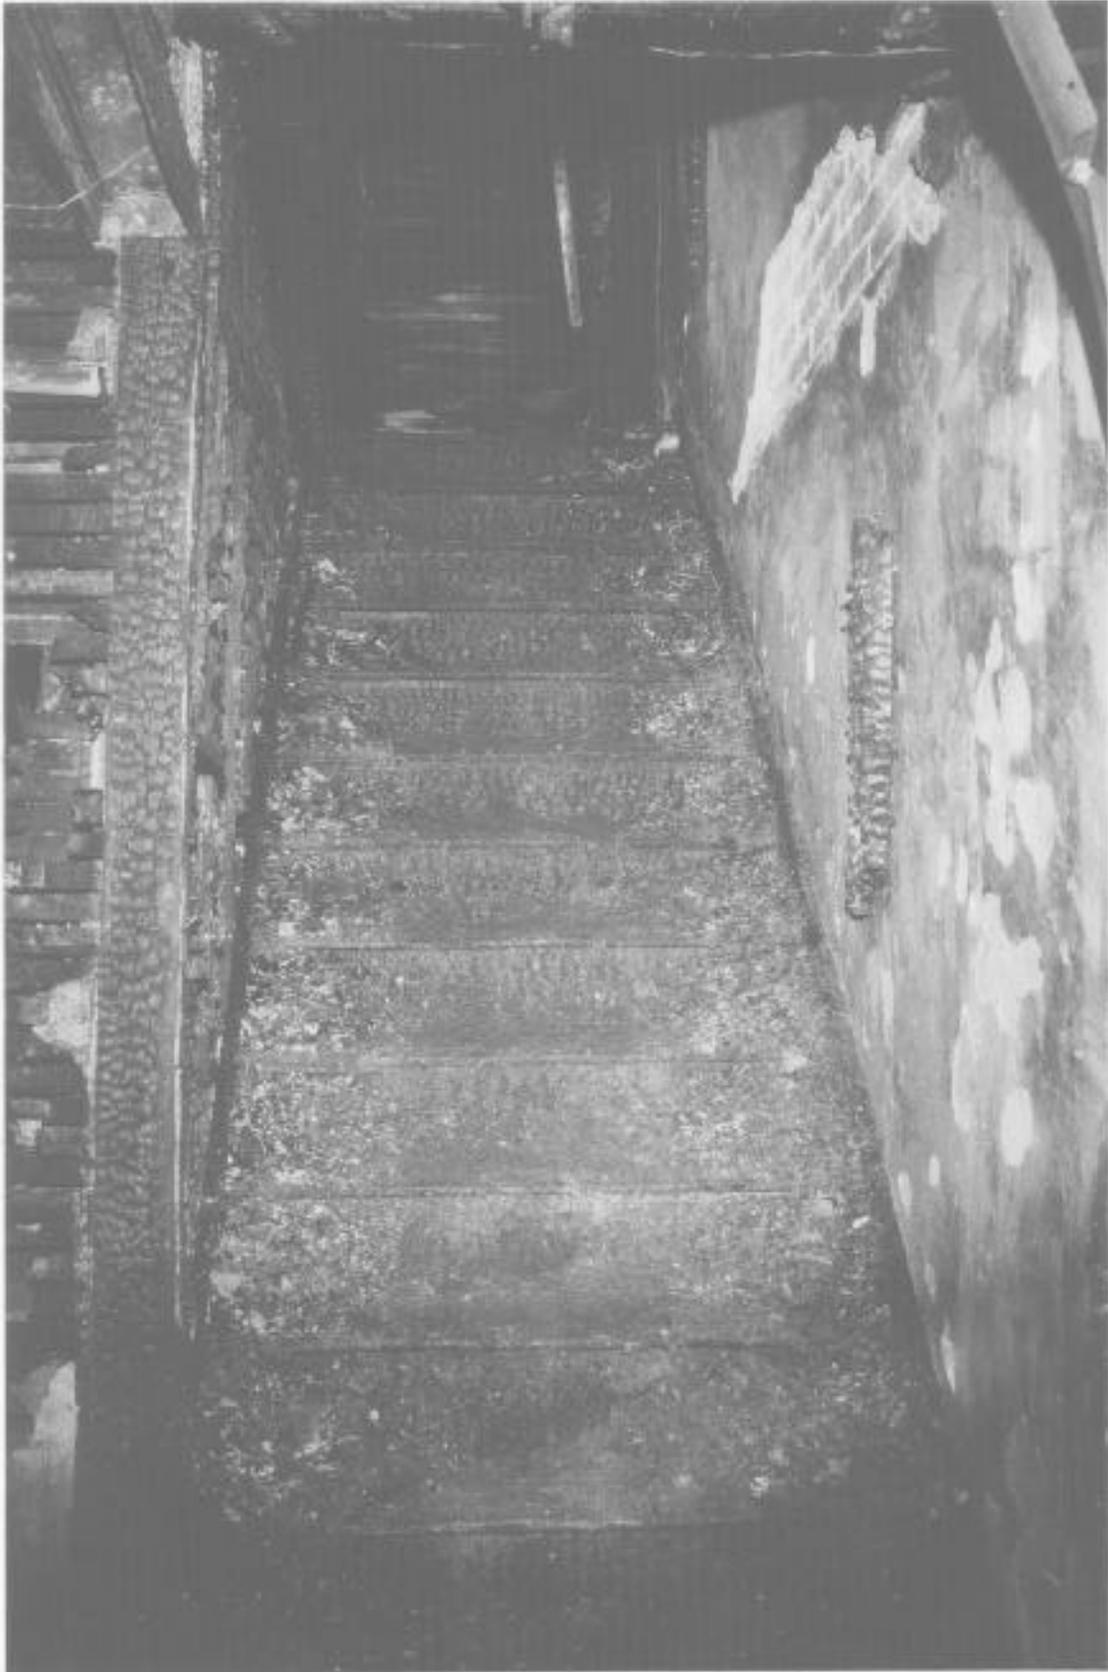
West stairway leading from the first floor living room to the second floor shows extensive charring to the stair risers, evidence of intense radiant heat exposure as the fire spread vertically cutting off the egress path.

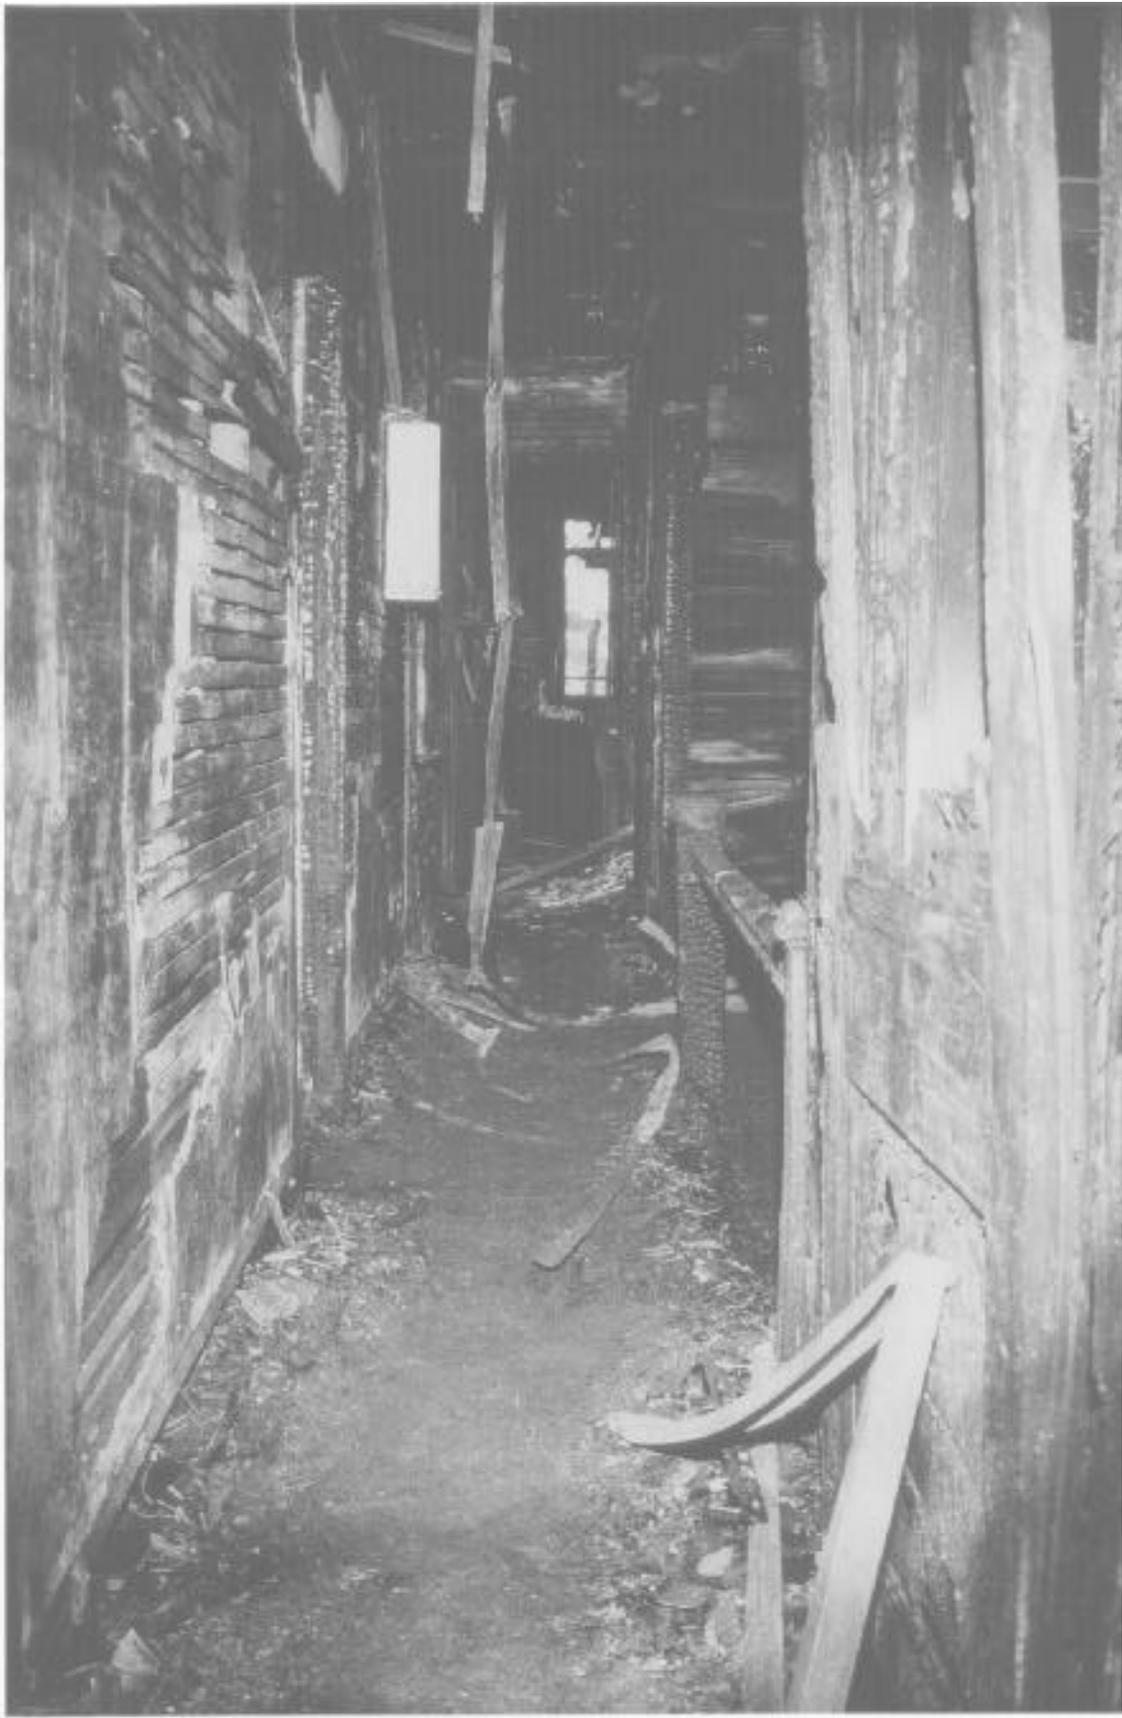
Second floor west corridor looking south shows the heavy fire damage resulting from vertical fire spread via the front stairway.

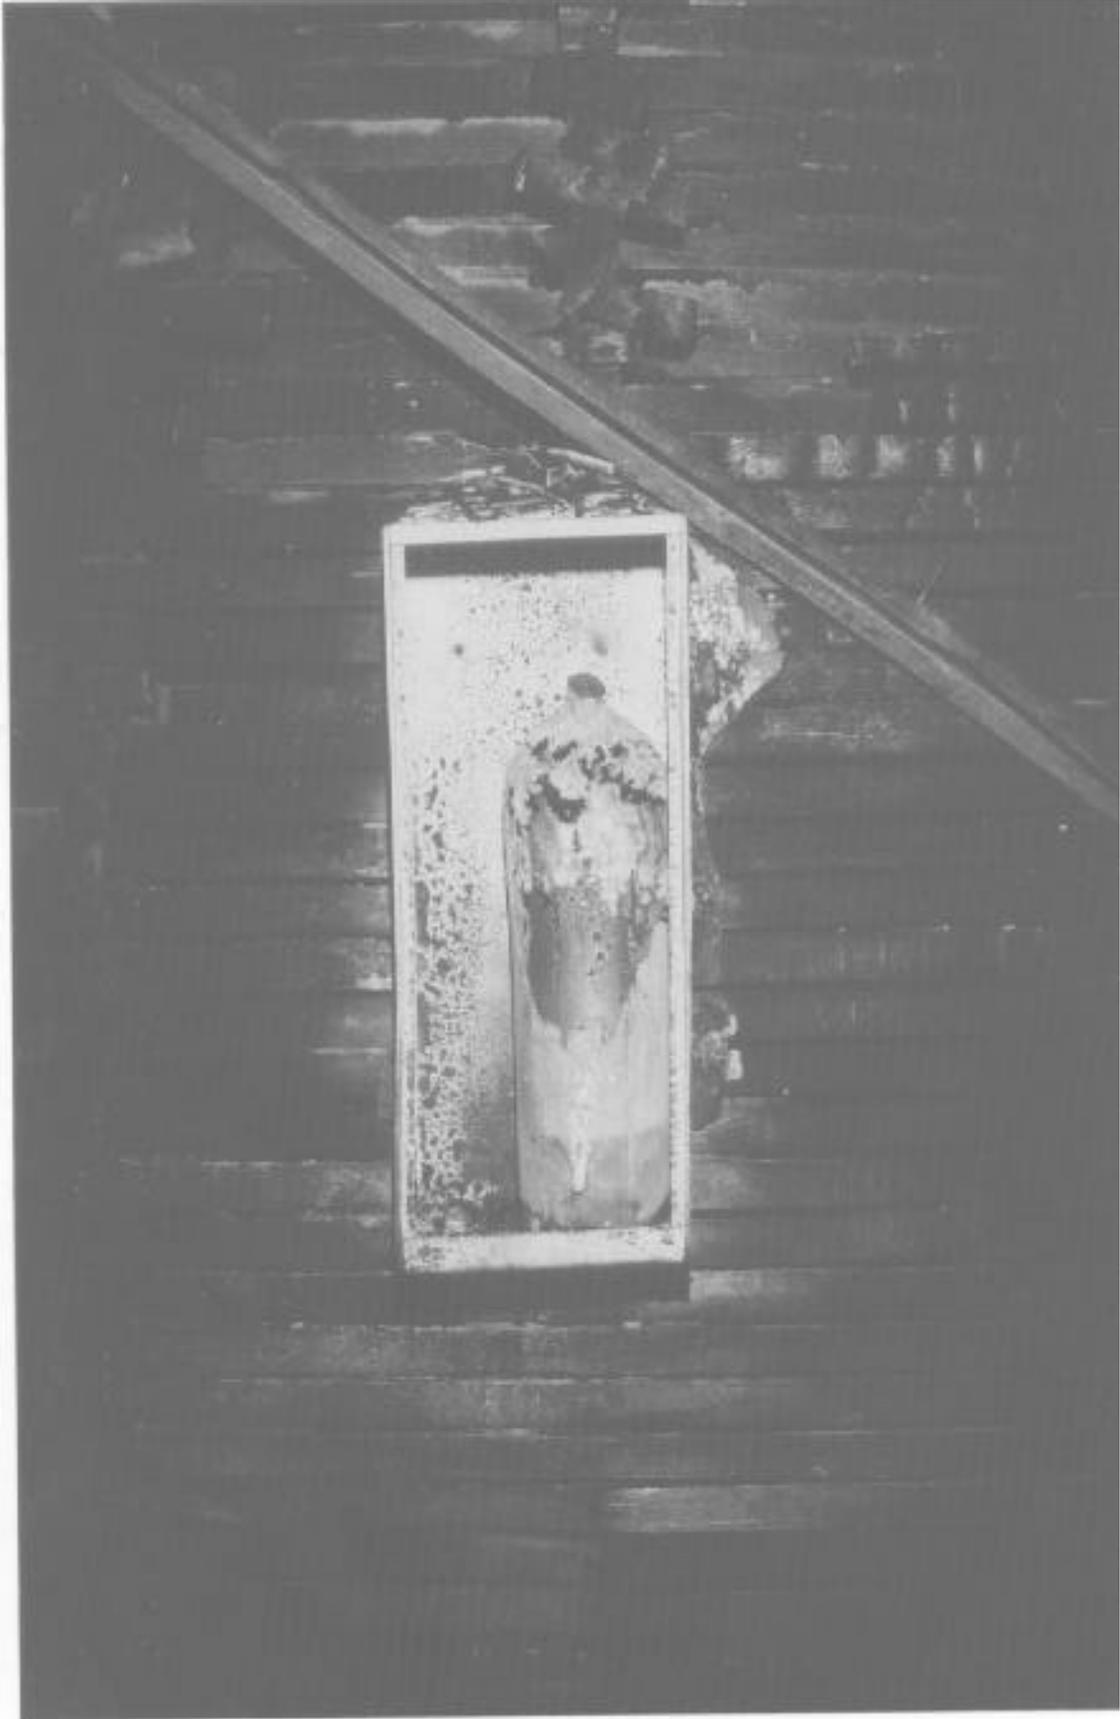
The remains of a melted aluminum fire extinguisher shell in a cabinet on the second floor west side.

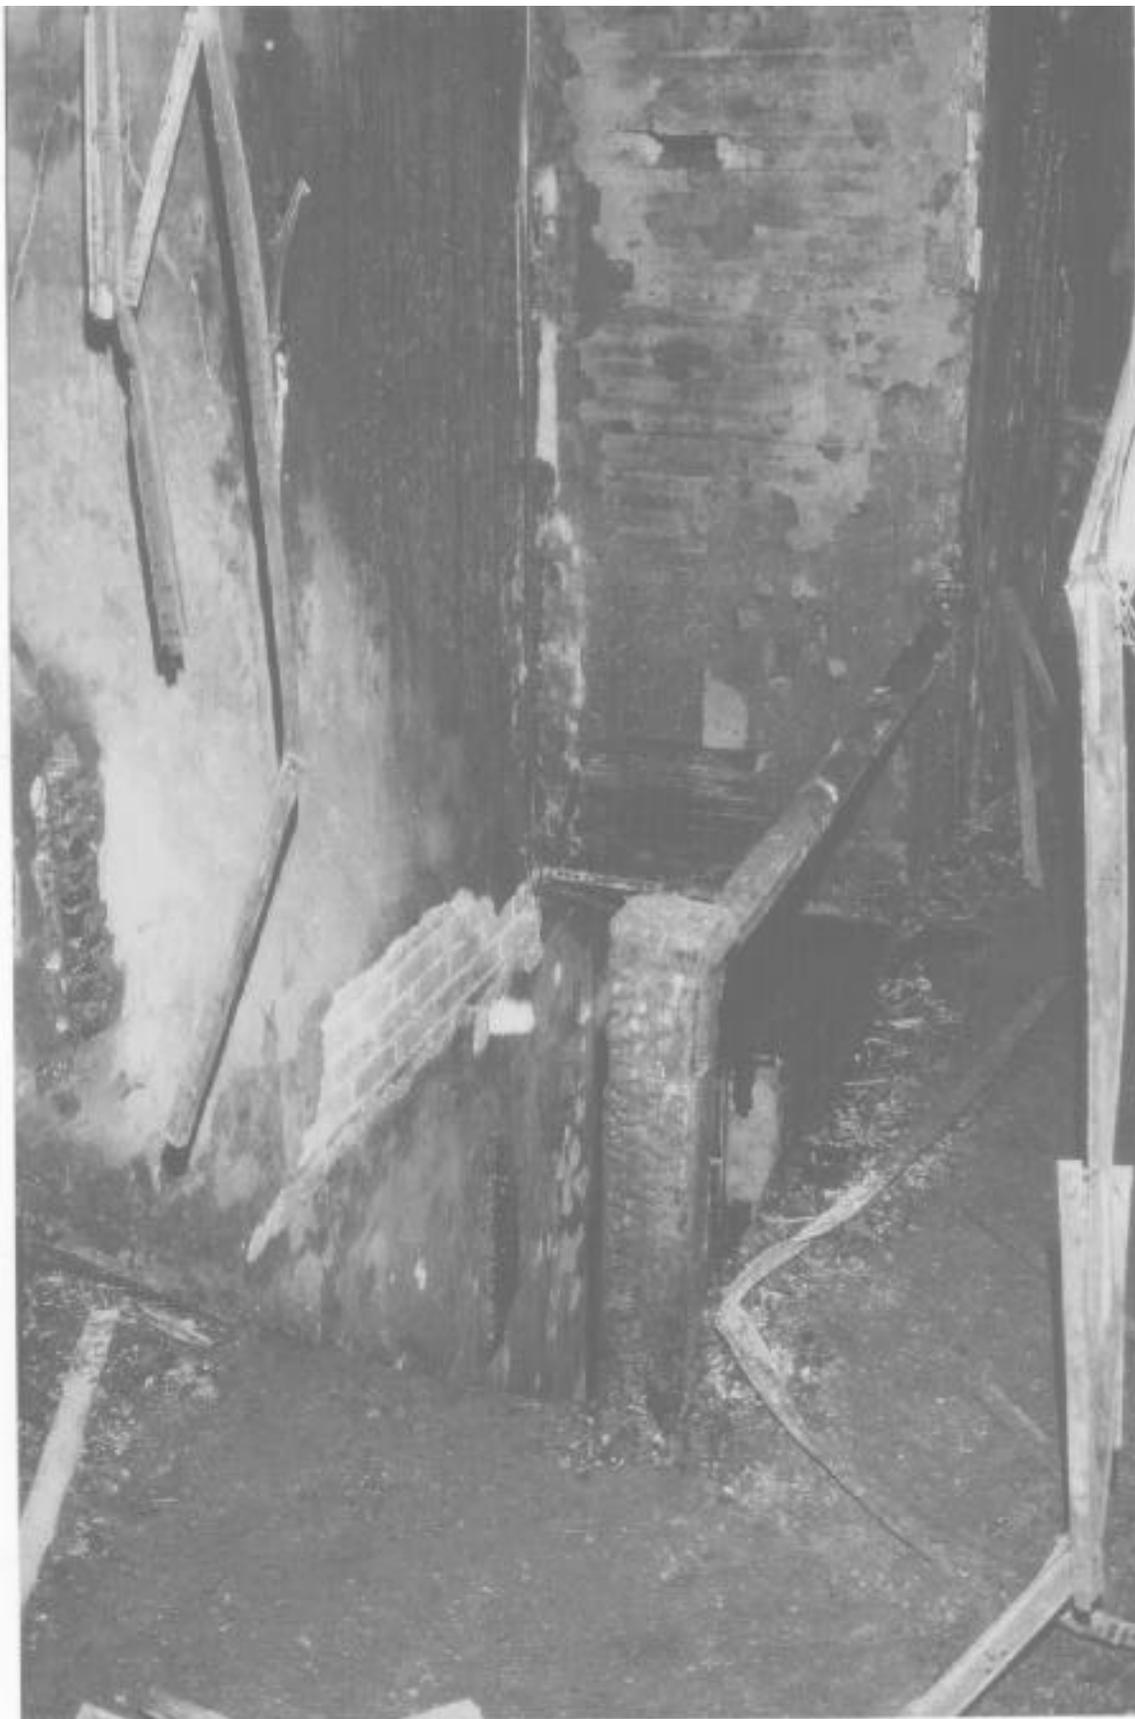
West side rear stairway looking down from second floor. Extensive charring and plaster spalling provide evidence of the fire spread which cutoff access to both the front and rear stairways.
