Technical Report Series

Ten-Fatality Board and Care Facility Fire Detroit, Michigan

Ten-Fatality Board and Care Facility Fire Detroit, Michigan (June 2, 1992)

**This is Report 066 of the Major Fires Investigation Project conducted
by TriData Corporation under contract EMW-90-C-3338 to the United
States Fire Administration, Federal Emergency Management Agency.**

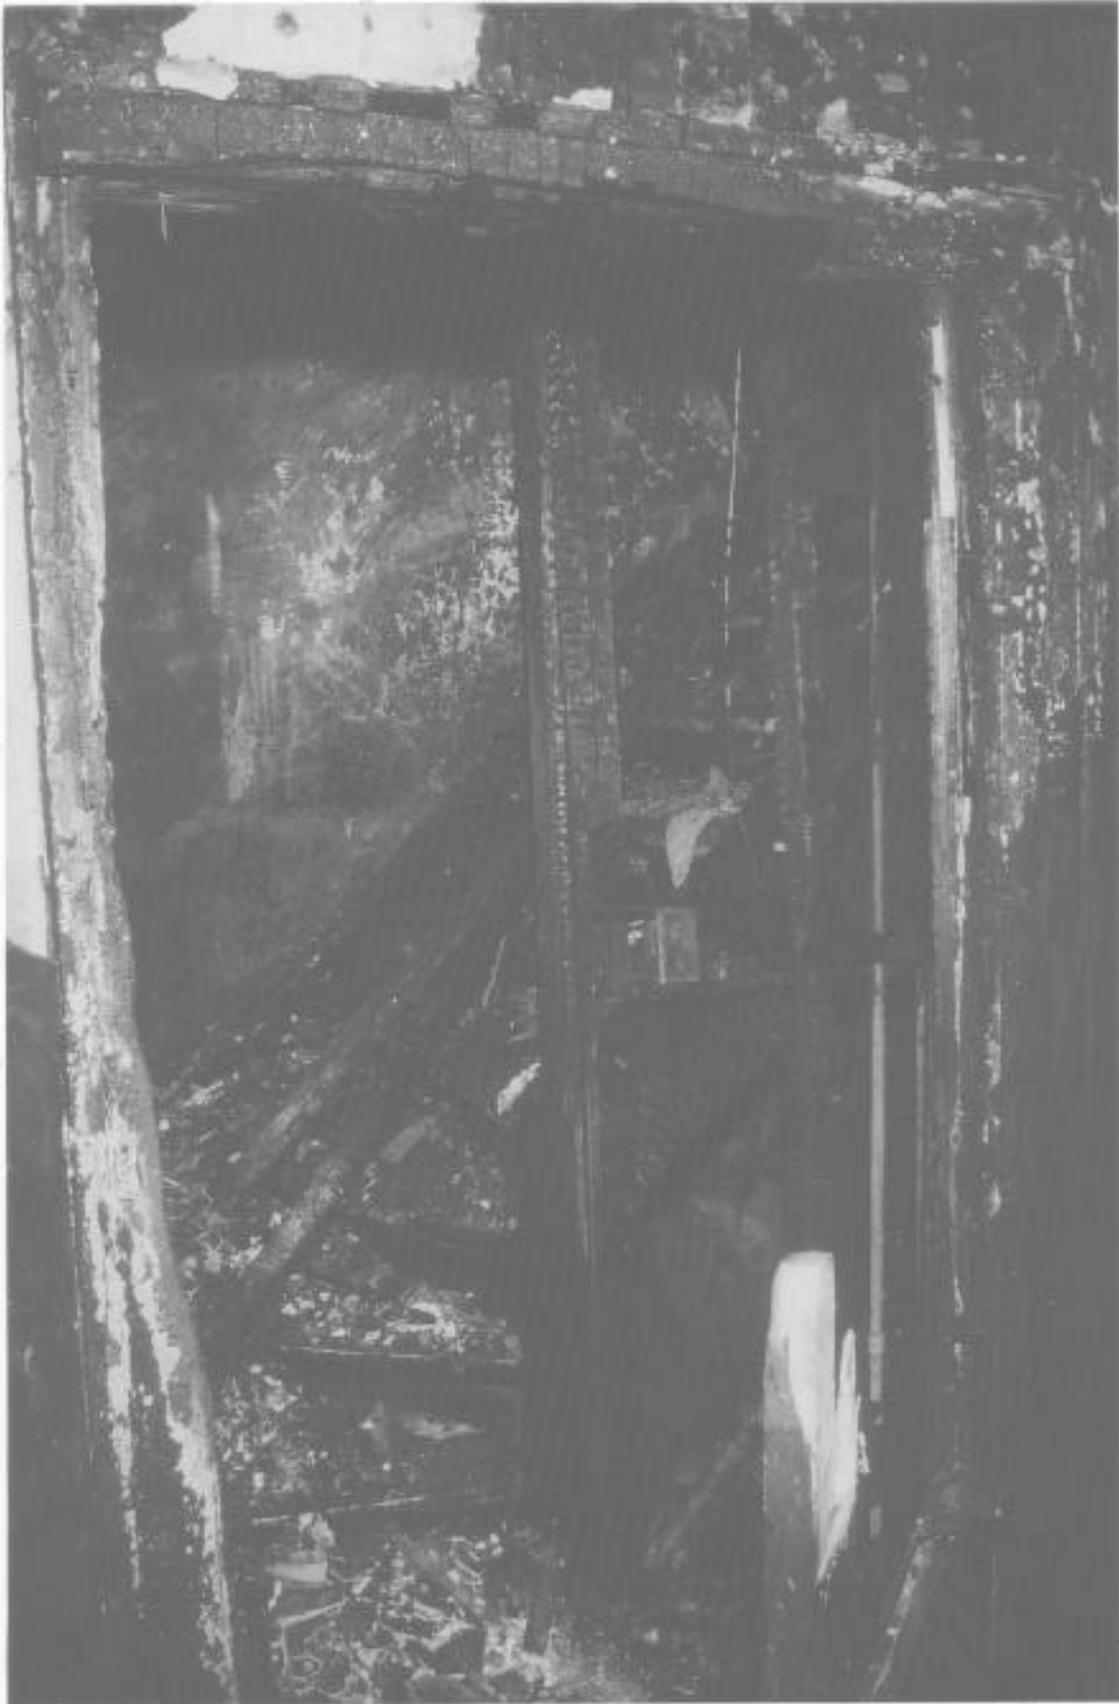
View of west side stairway leading to the third floor. Once again, heavy fire damage to the door lintel and framing indicate that fire spread via this route was extensive.

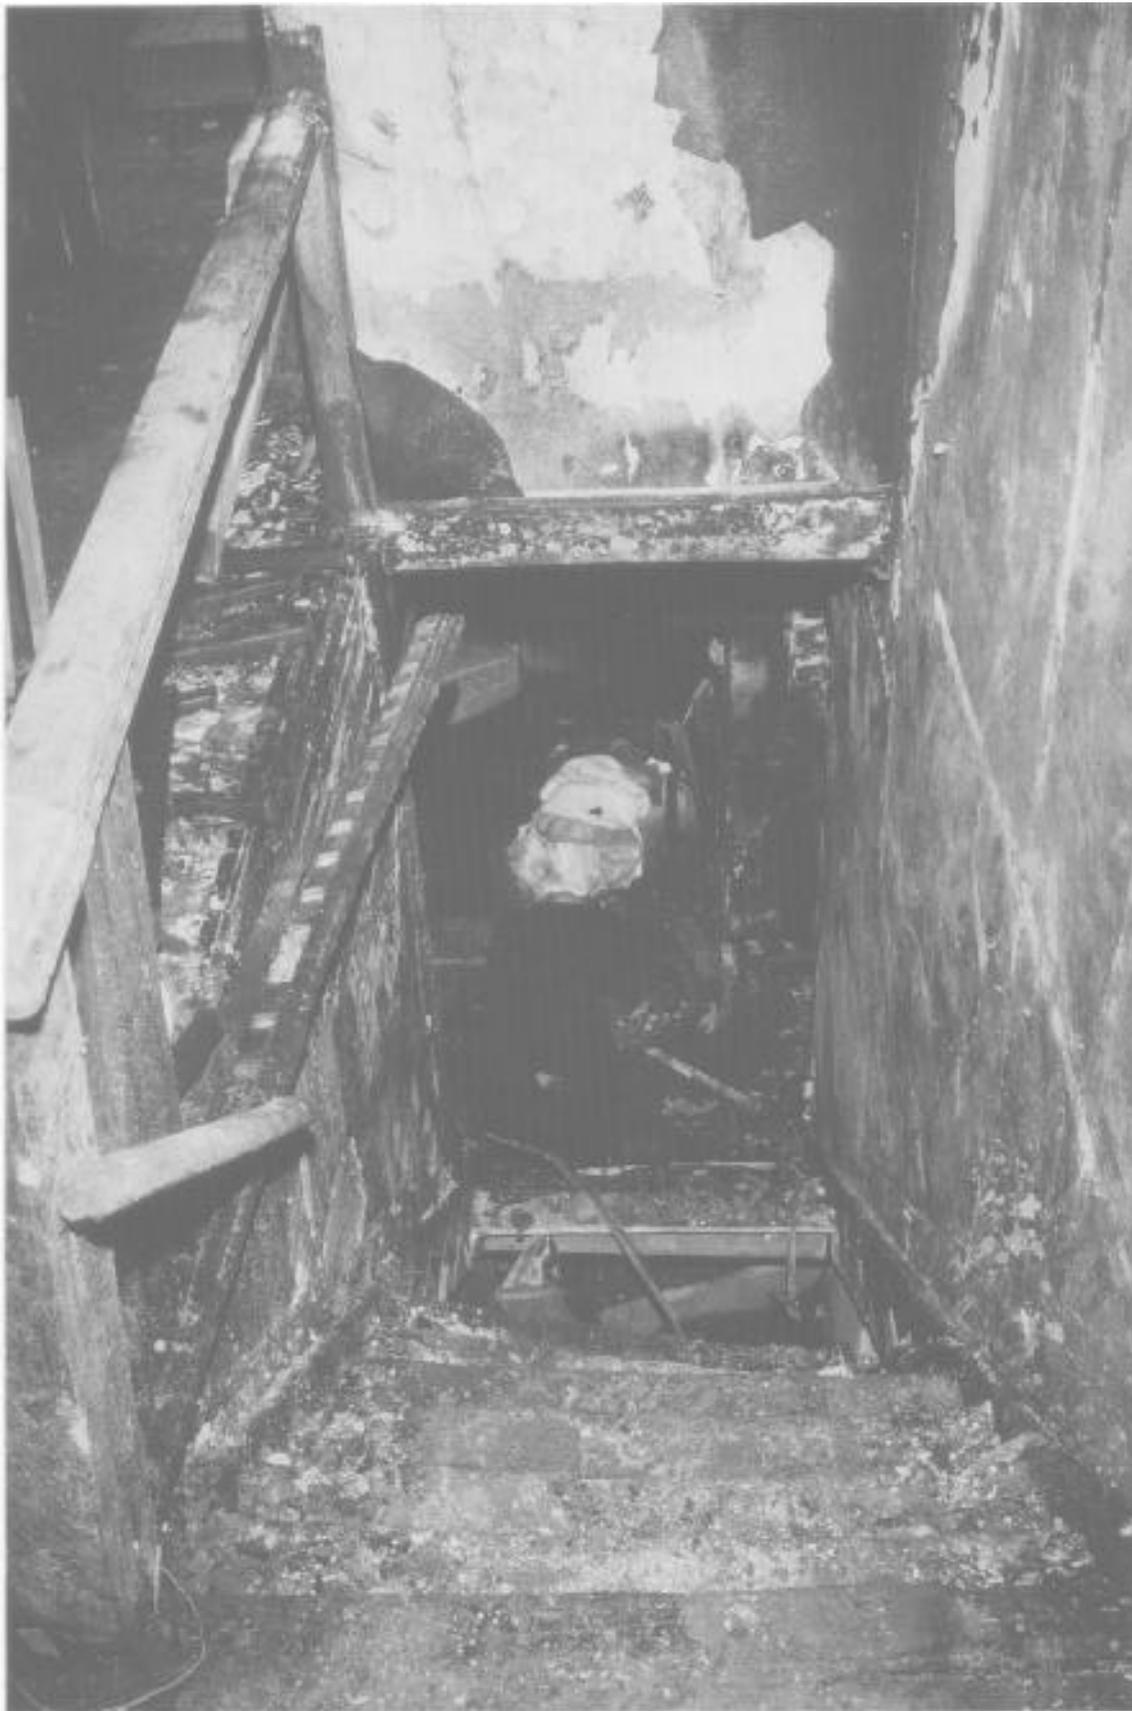
View of east side front stairway looking down from second floor. Although heat damage is slightly less intense here, evidence of extensive heat and smoke spread is clear.
