Wood Truss Roof Collapse Claims Two Firefighters Memphis, Tennessee

Wood Truss Roof Collapse Claims Two Firefighters (December 26, 1992)

Investigated by: J. Gordon Routley

This is Report 069 of the Major Fires Investigation Project conducted by TriData Corporation under contract EMW-90-C-3338 to the United States Fire Administration, Federal Emergency Management Agency.

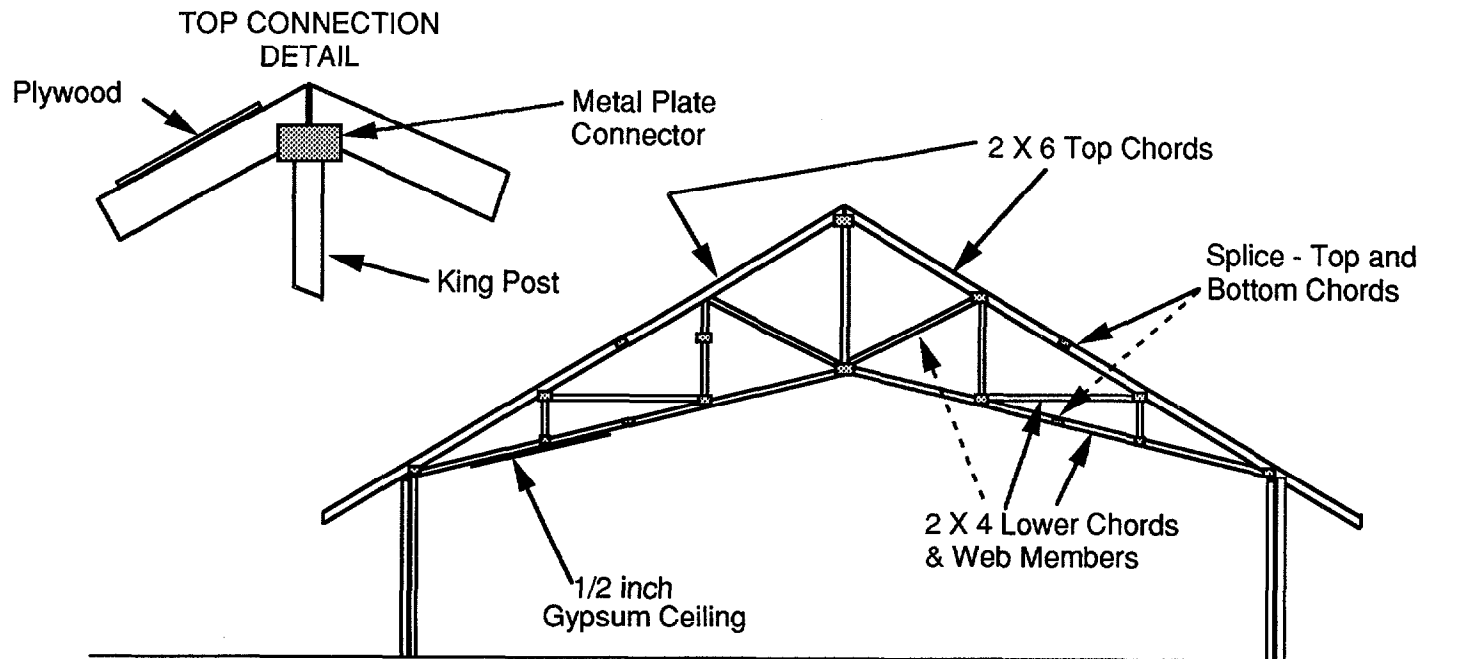
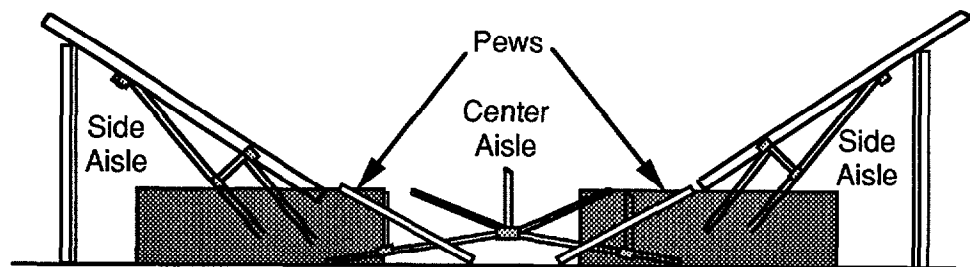
WOOD ROOF TRUSS DETAILS

The trusses were pre-engineered metal plate connected wood trusses, spanning a distance of 40 feet. The trusses over the main part of the church, where the collapse occurred, were scissors design (see diagram on the following page) to provide a slightly vaulted ceiling. The trusses over the adjacent areas were conventional peaked trusses with a horizontal bottom chord to create a flat ceiling. All of the trusses were spaced at 24 inch centers.

The trusses were shop fabricated from ordinary dimension lumber with 2X6 top chords; the bottom chords and web members were fabricated from

2X4 sections. All of the connectors were stamped metal gusset plates providing 3/8 inch penetration of the pointed ends into the wood. All observed connectors were fabricated with gusset plates on both sides of each connection point.

The attachment of the trusses to the 1/2 inch plywood roof decking maintained their alignment. There was no evidence of stringers or cross braces to maintain the spacing and redistribute loads among the trusses. Without cross bracing, the trusses were not constrained from roll-over, which can result in a “domino effect” collapse when a partial failure occurs. Cross bracing can allow a group of trusses to act as a system, with several trusses working together to support the load.

Cross bracing the trusses can reduce the probability of a sudden catastrophic failure and is more likely to result in visible sag before collapse. Without such load transfer mechanisms, the failure of any one truss can be sudden and catastrophic and can initiate the failure of a series of adjacent trusses in rapid succession, particularly if they are partially weakened and already close to their own point of failure.

The fire appears to have travelled along the underside of the roof, following the peak from east to west. The tops of all of the trusses were completely burned away for approximately 12 to 18 inches below the top connection point and could not be retrieved from the rubble. All of the lower connections could be located and most were still in tact. The depth of char varied from almost full depth on the remnants of the higher members near the center of the span to almost no sign of burning on the lower and outer sections.

All of the top and bottom chords had splices near the mid-span points on each side of the trusses and most of these splices had failed, dropping the center section all the way to the floor, while the ends only rotated on their wall supports.

Many of the gusset plate connectors had failed, either by completely disengaging from the wood or by allowing one or more of the members to work free from a connection point. At the higher points the wood was charred beyond the depth of penetration of the gusset plate points, leaving empty pits in the charred wood where the gusset plates had been attached. As noted previously, virtually all of the top connection points were completely burned away. Some of the kingpost members were charred to a depth of more than 1/2 inch before the remaining unburned wood had broken; the diminished cross section of unburned wood fractured when it

The roof collapse can be directly attributed to failure of the top connection points of the trusses, where the kingpost meets the top chord sections. It cannot be determined precisely which truss failed first and whether the gusset plates came loose from the top connection or the kingpost snapped and pried the gusset plates loose. The top connection is a critical point in each truss and its failure would result in the failure of that truss. It appears that several trusses failed in rapid succession - almost simultaneously following the first. All of the trusses would have been close to the point of failure and unable to support any additional load, so the load shift that occurred with the first failure probably caused several more trusses to collapse.
