New York City Bank Building Fire: Compartmentation vs. Sprinklers

New York City Bank Building Fire: Compartmentation vs. Sprinklers (January 31,1993)

Investigated by: J. Gordon Routley

This is Report 071 of the Major Fires Investigation Project conducted by TriData Corporation under contract EMW-90-C-3338 to the United States Fire Administration, Federal Emergency Management Agency.

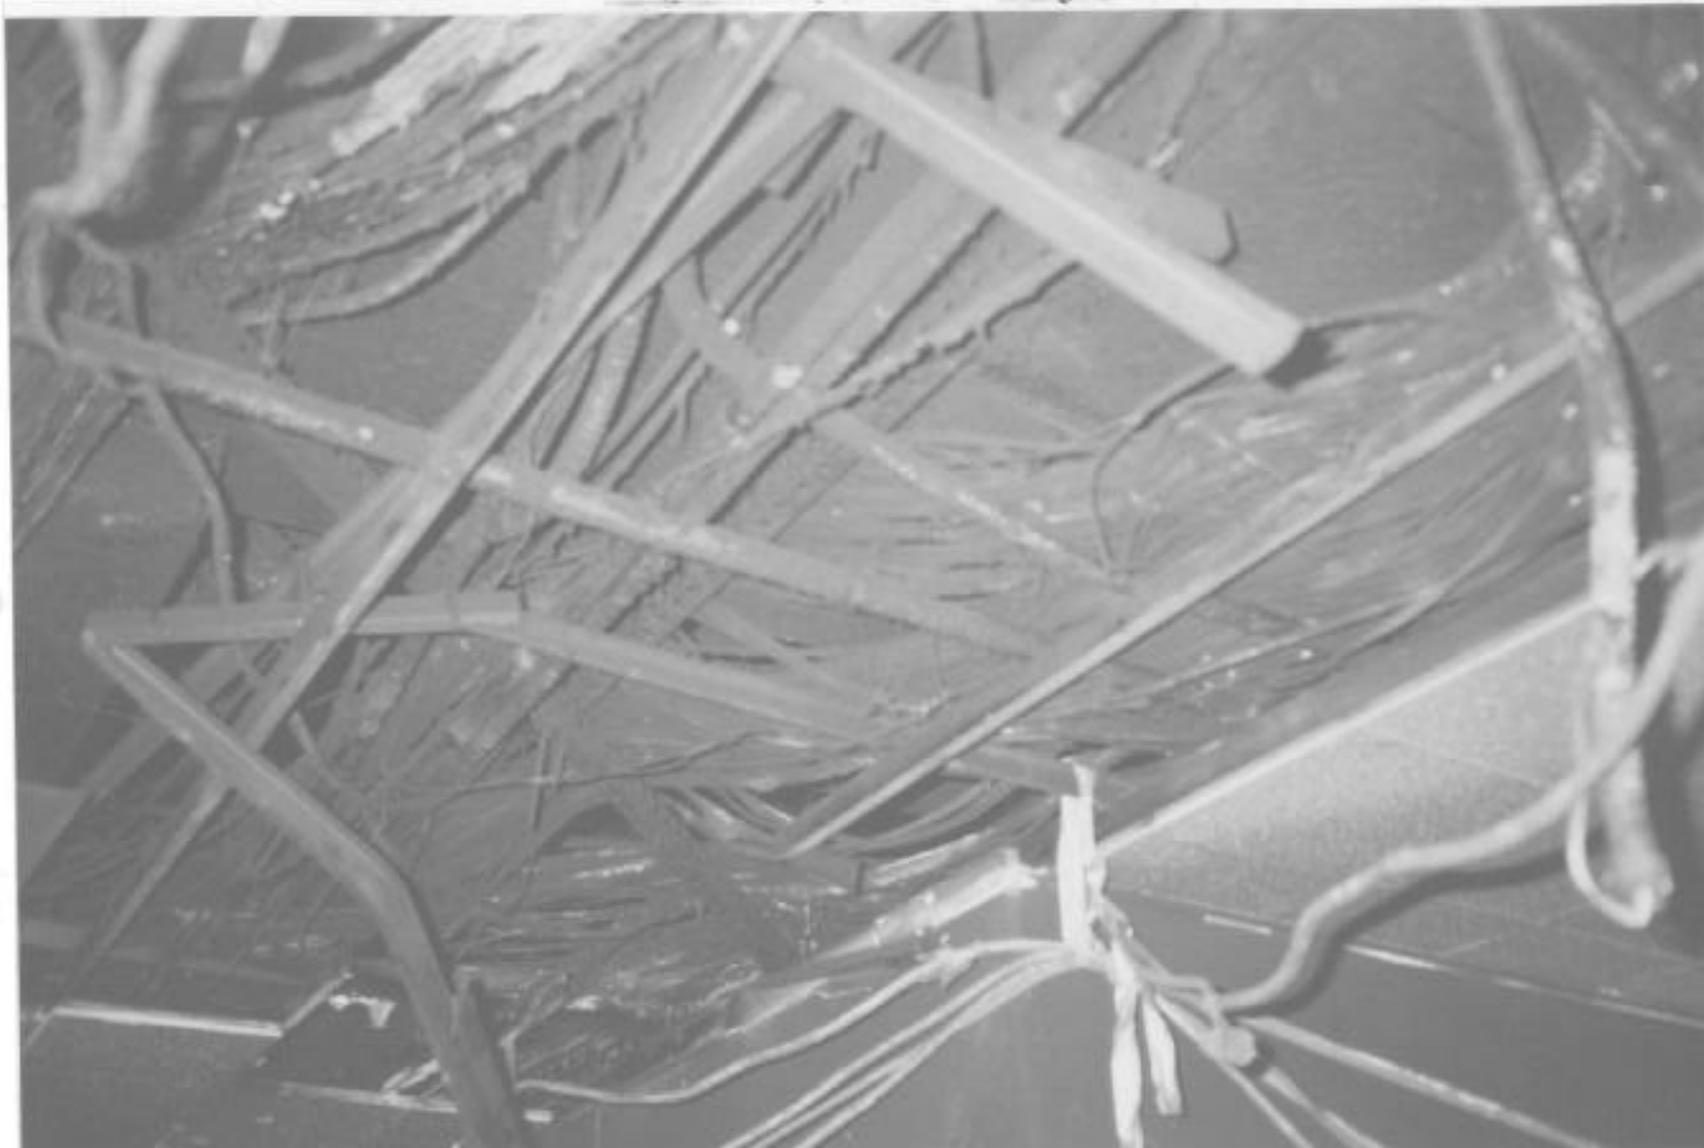
Photo shows the accumulation of combustible wiring that was in the ceiling plenum on the sixth floor at the edge of the fire area.

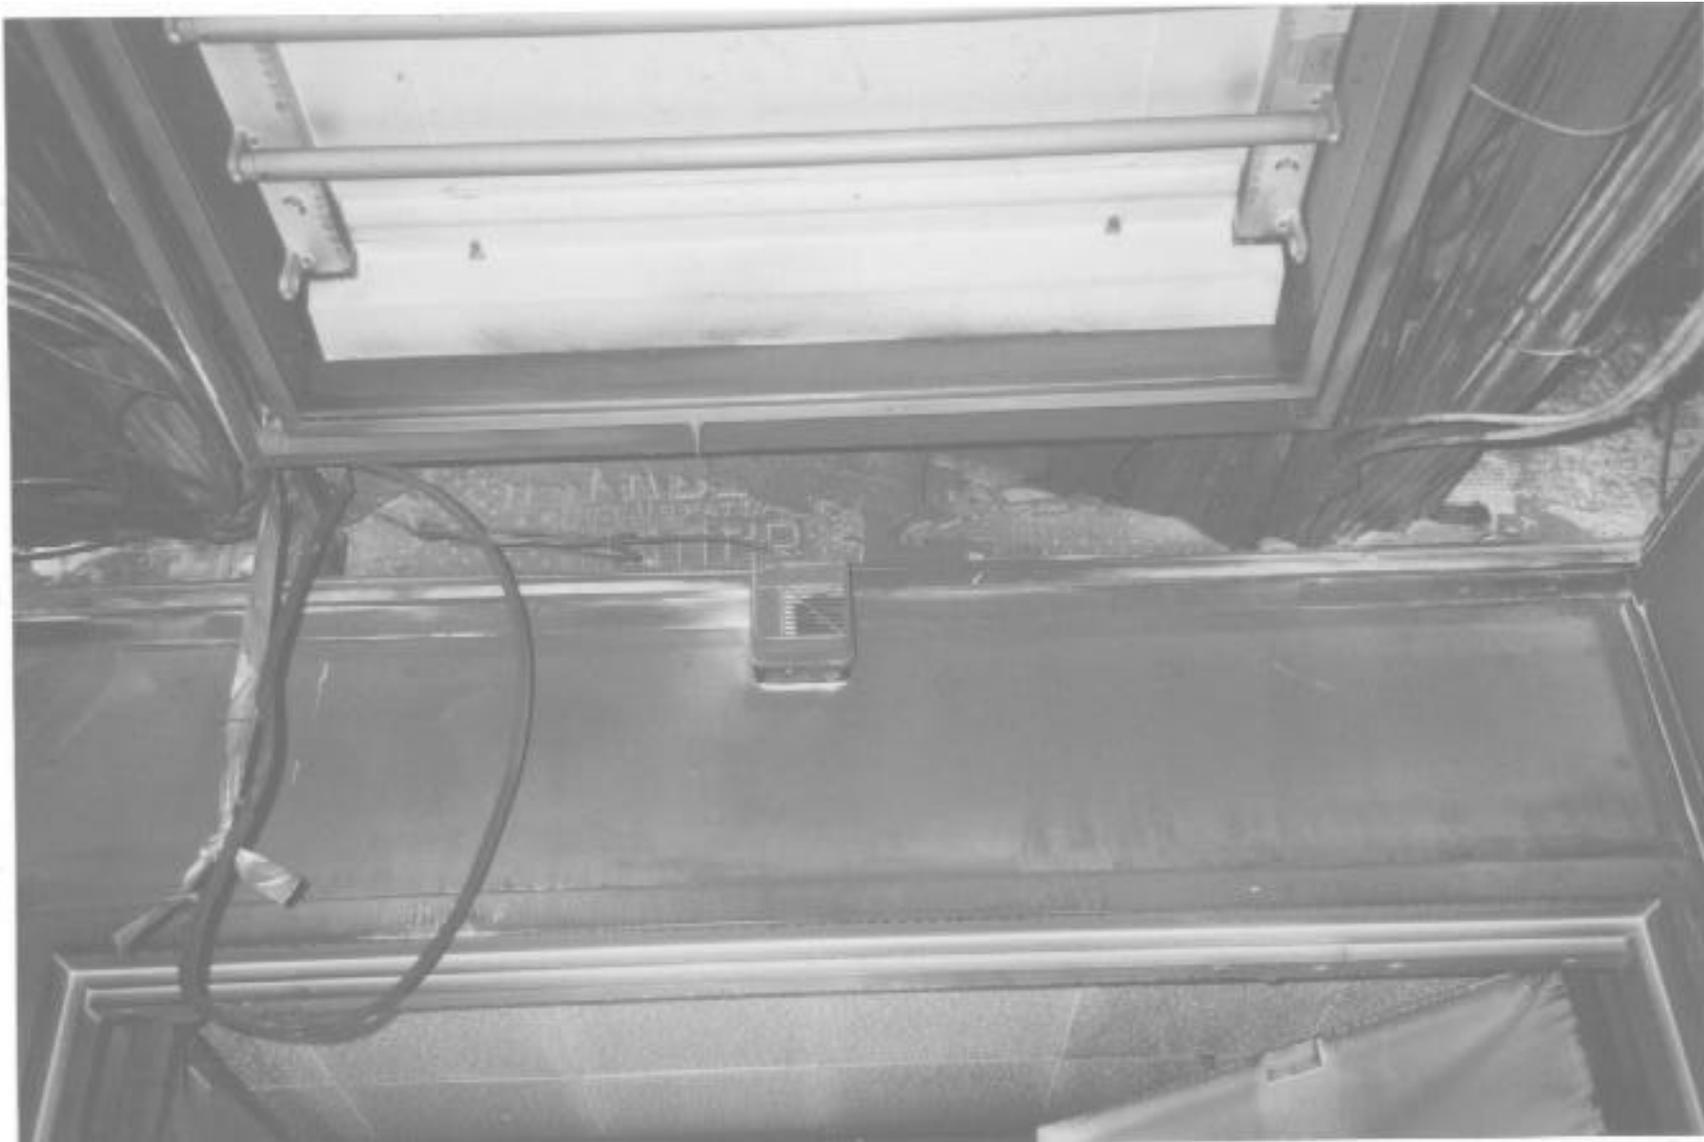
Fuel Load in Ceiling Plenum — The space above the ceiling in the fire area and adjacent areas was used for electrical wiring and communications cables. The amount of communications wiring in this type of occupancy is often a problem. It appears that over the years the amount of communications wiring in the plenum has grown, as old runs have been replaced by new wiring, but the old cables were not removed. The fuel load provided by the insulation on the wires contributed to the fire origin and intensity. The cable runs also made it impossible to fully seal the openings in fire separation walls above the ceilings, allowing smoke to migrate from one compartment to another and contributing to the secondary damage.

View of the ceiling plenum at the fire division wall shows the accumulation of electrical and communication wiring that penetrates the interior fire division wall above the doorway on the sixth floor.

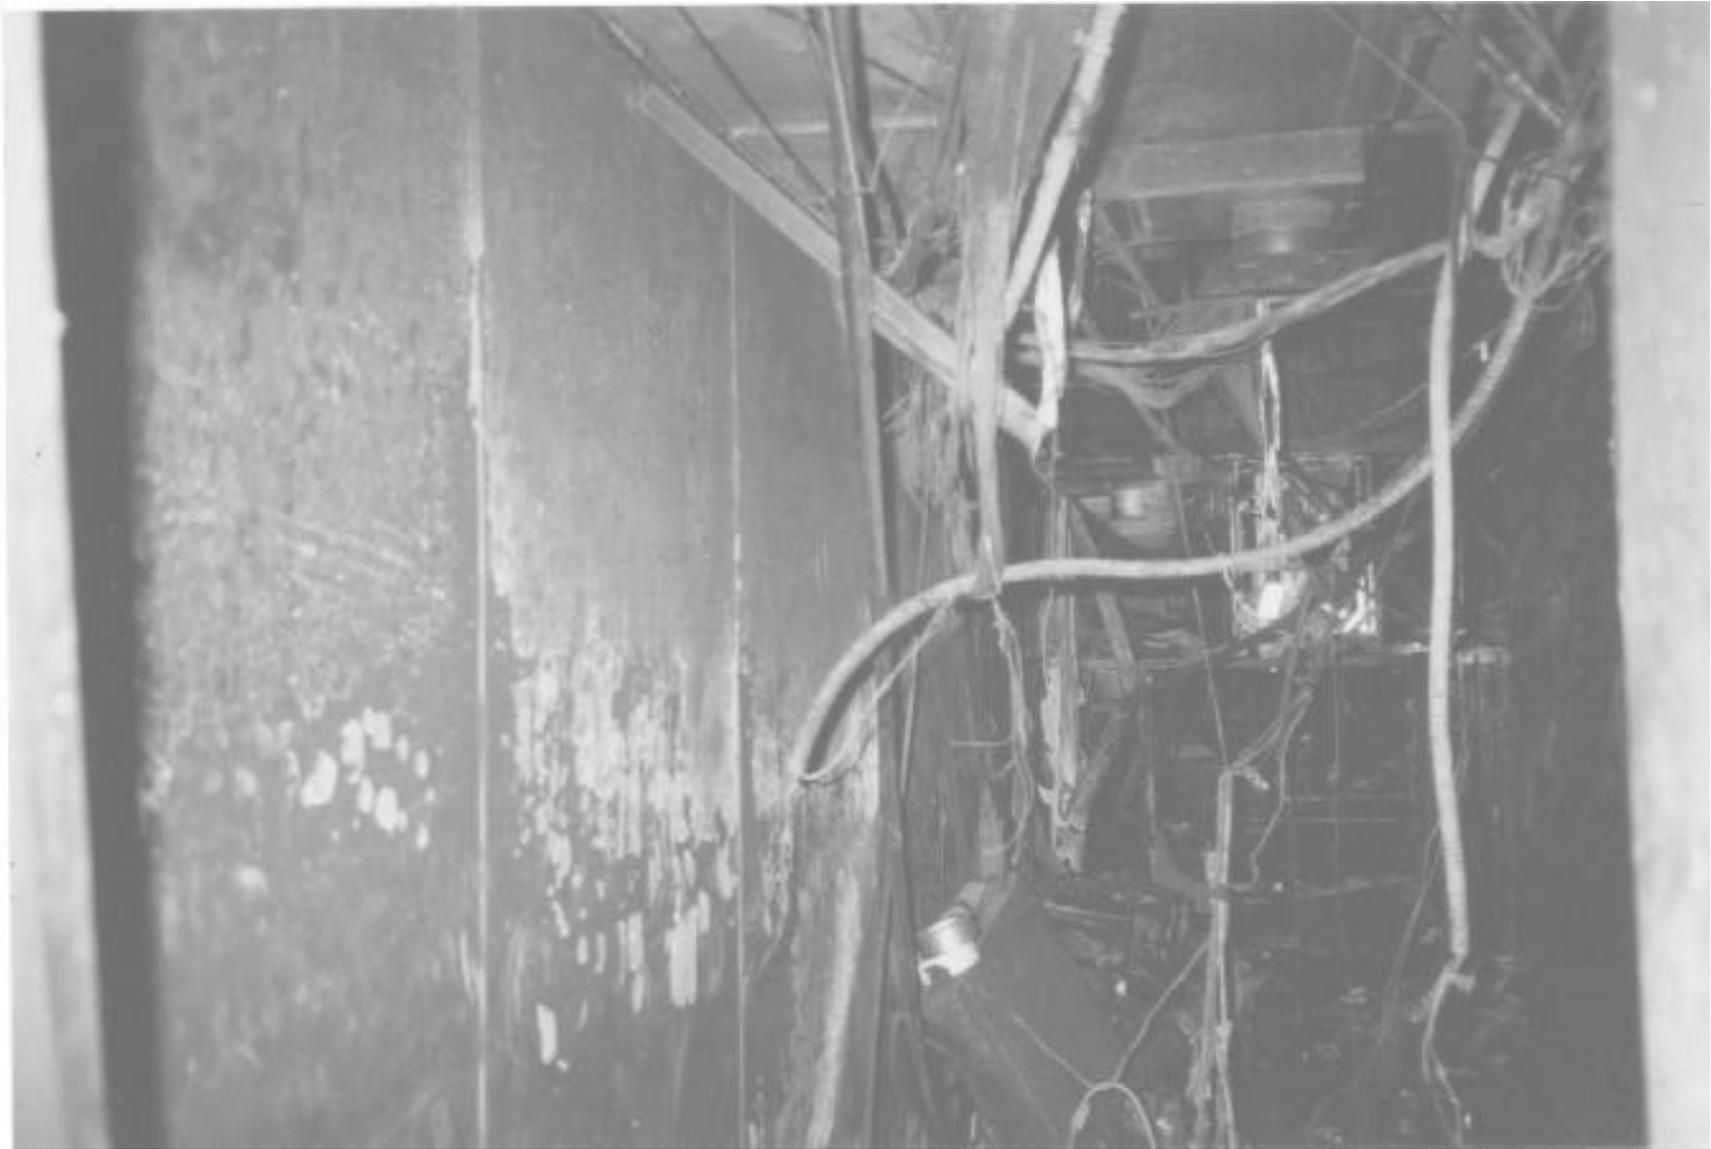
Corridor on the sixth floor where Engine 65 attempted to advance a 2 1/2 inch attack line.

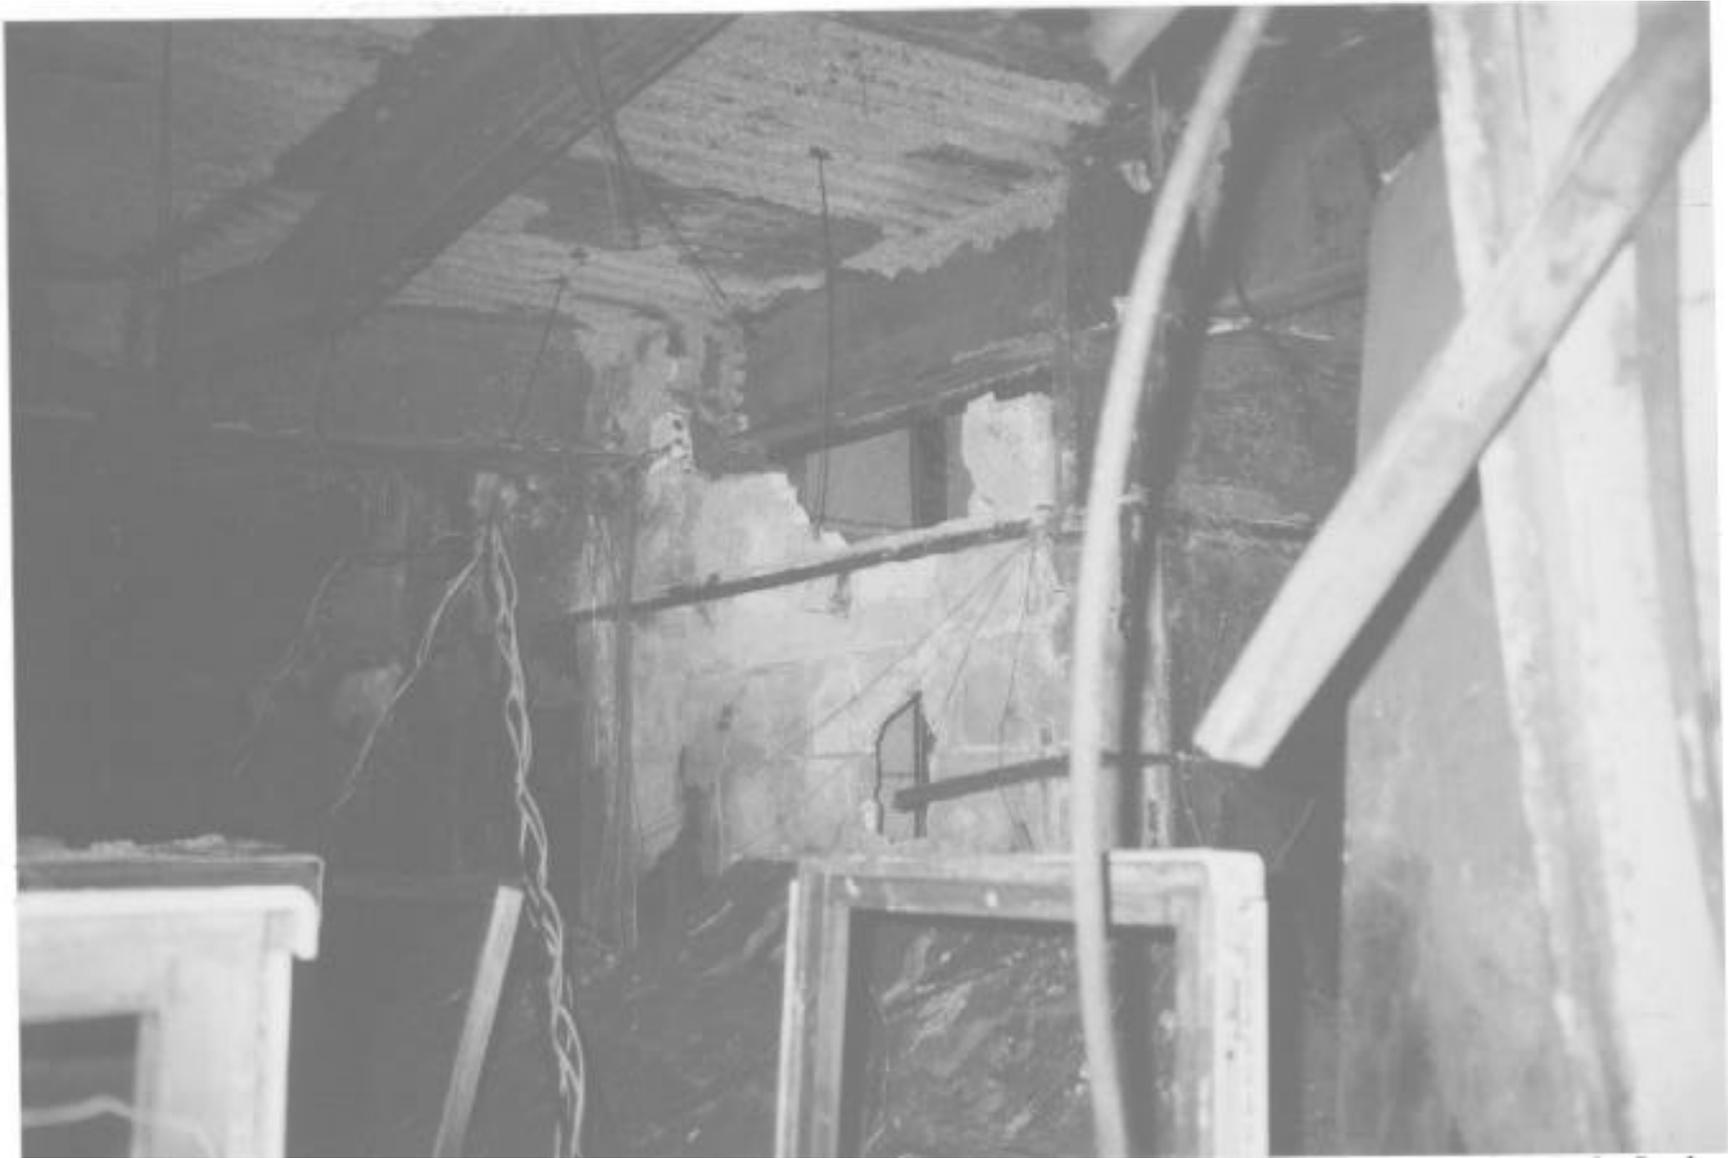
The master streams also punched a hole in the block wall enclosing the elevator shafts, directly opposite the windows, causing the blocks to fall on top of the elevator cars that were parked at the lobby level. Water runoff damaged most of the lower floors of the west tower. Electrical and telephone systems in the west tower were disrupted and needed major repairs.

Area on the sixth floor showing penetration into the elevator shafts caused by the high pressure master streams.

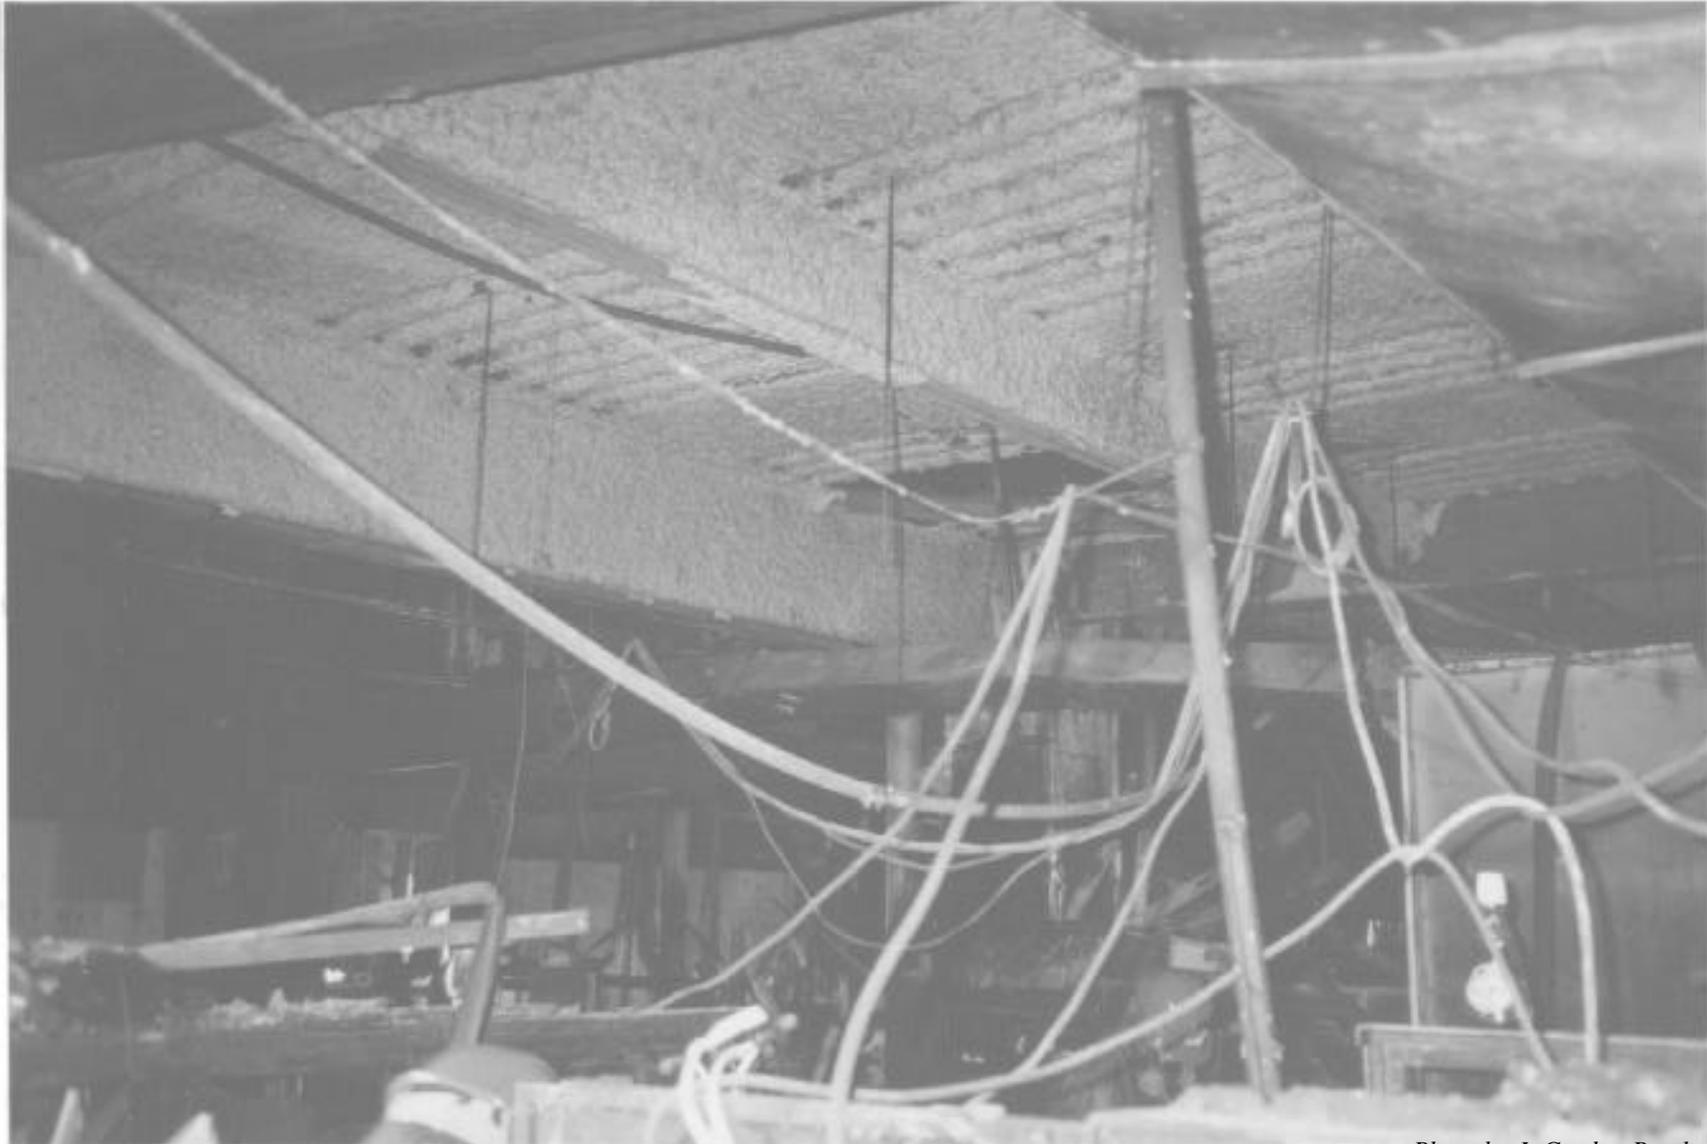
On the sixth floor, this is a view of the structural steel from the underside showing where the sprayed on asbestos fireproofing material remained attached to the steel in an area that was not exposed to water streams.

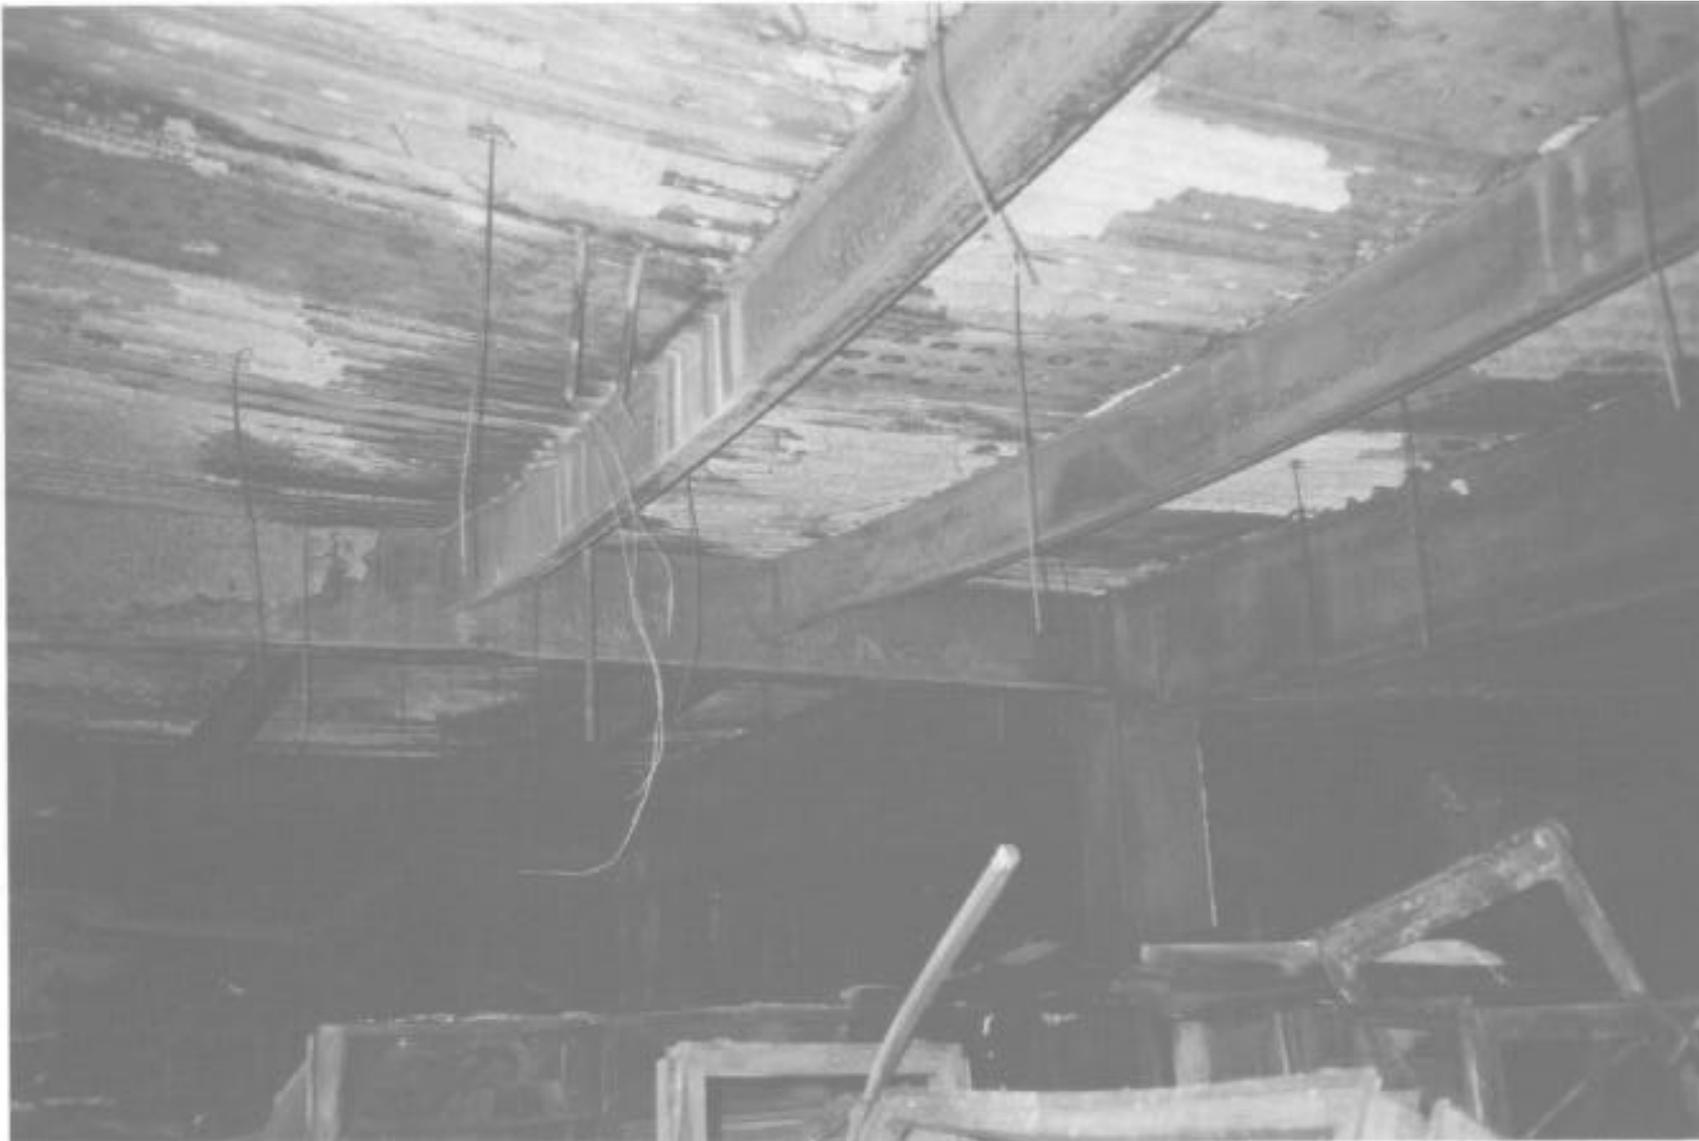
Most of the structural damage was confined to the underside of the seventh floor assembly. There was minor warping and sagging of the steel beams and larger girders, as well as sagging of the steel Q-deck between the beams. One of the smaller beams was detached from the supporting girder at one end of its span, apparently from the force of a master stream hitting it while it was heated. The deformation of the deck was most pronounced along the joints where fire had been observed extending through to the seventh floor; a variation in the floor level of three to six inches remained after the fire.

On the sixth floor, this view shows that virtually all the asbestos fireproofing was washed off the steel that was exposed to water streams. Photo also shows the deflection of the beams and floor deck above due to heat.

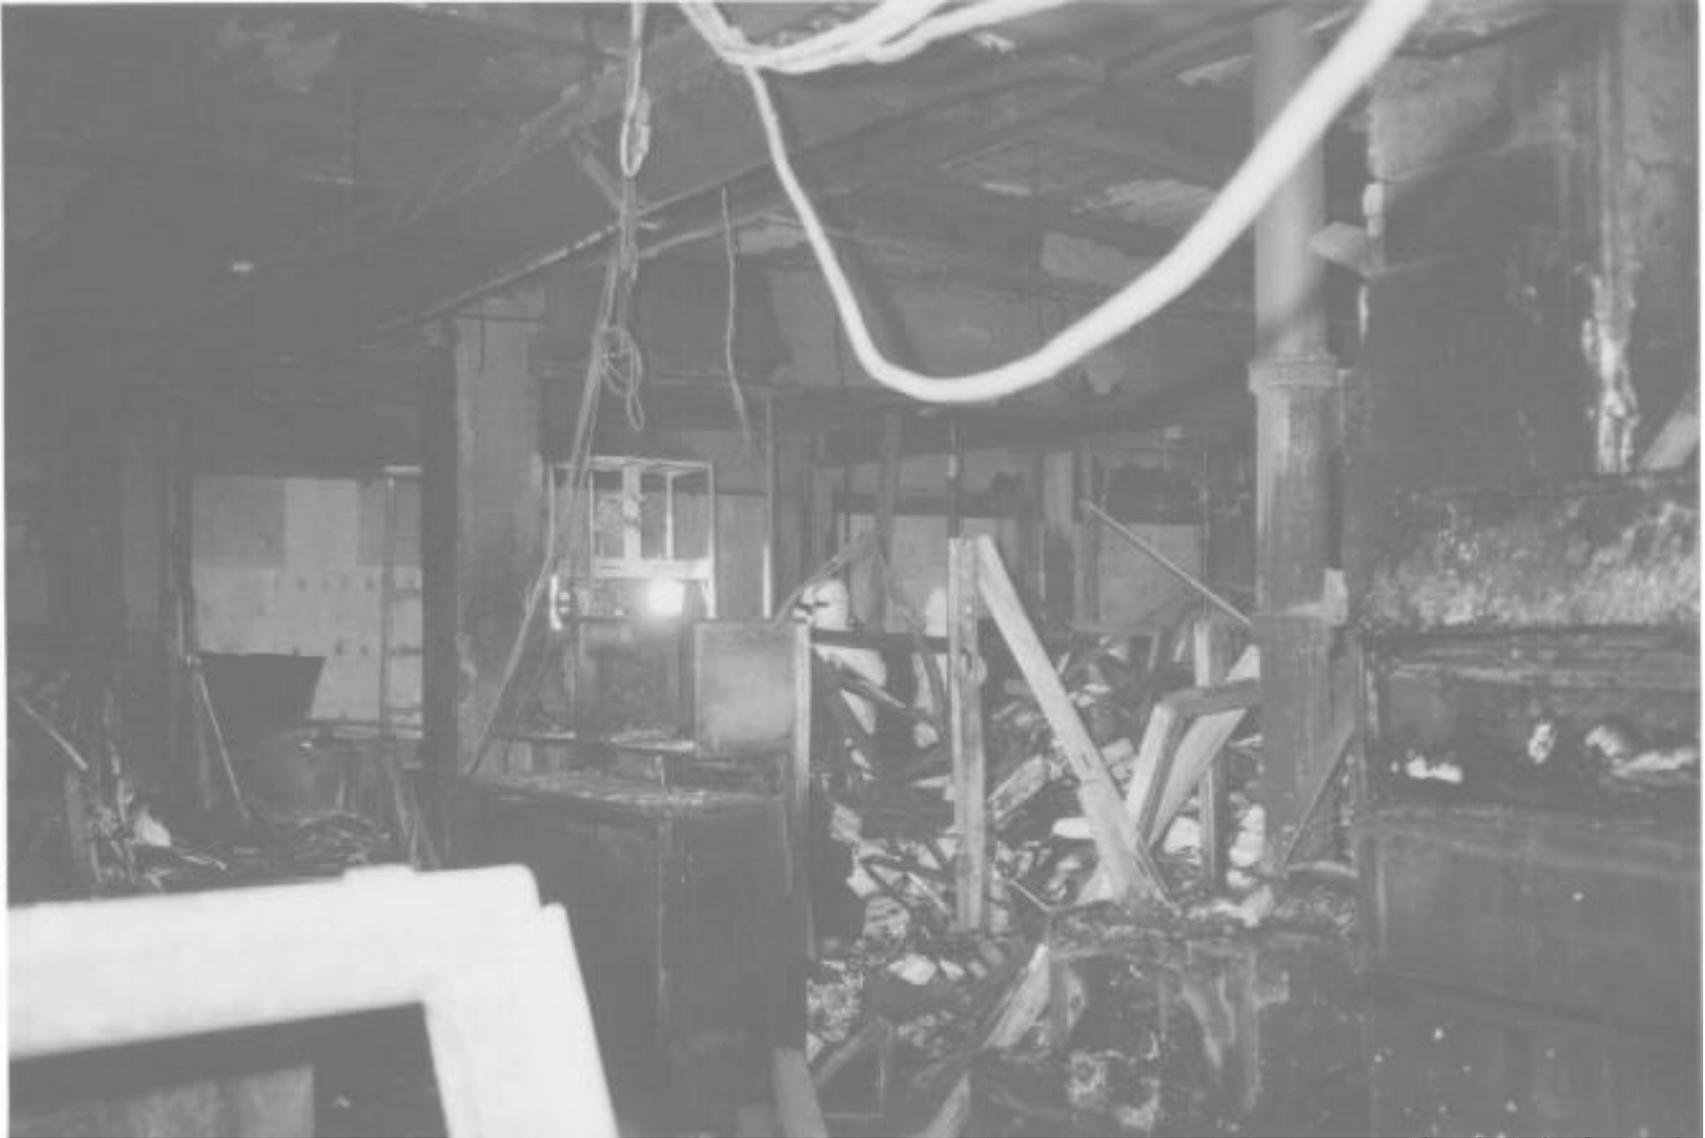
The main fire area on the sixth floor looking toward the windows on the 48th Street side of the building.
Note the degree of fire damage to contents and exposure of the structural steel above the ceiling.

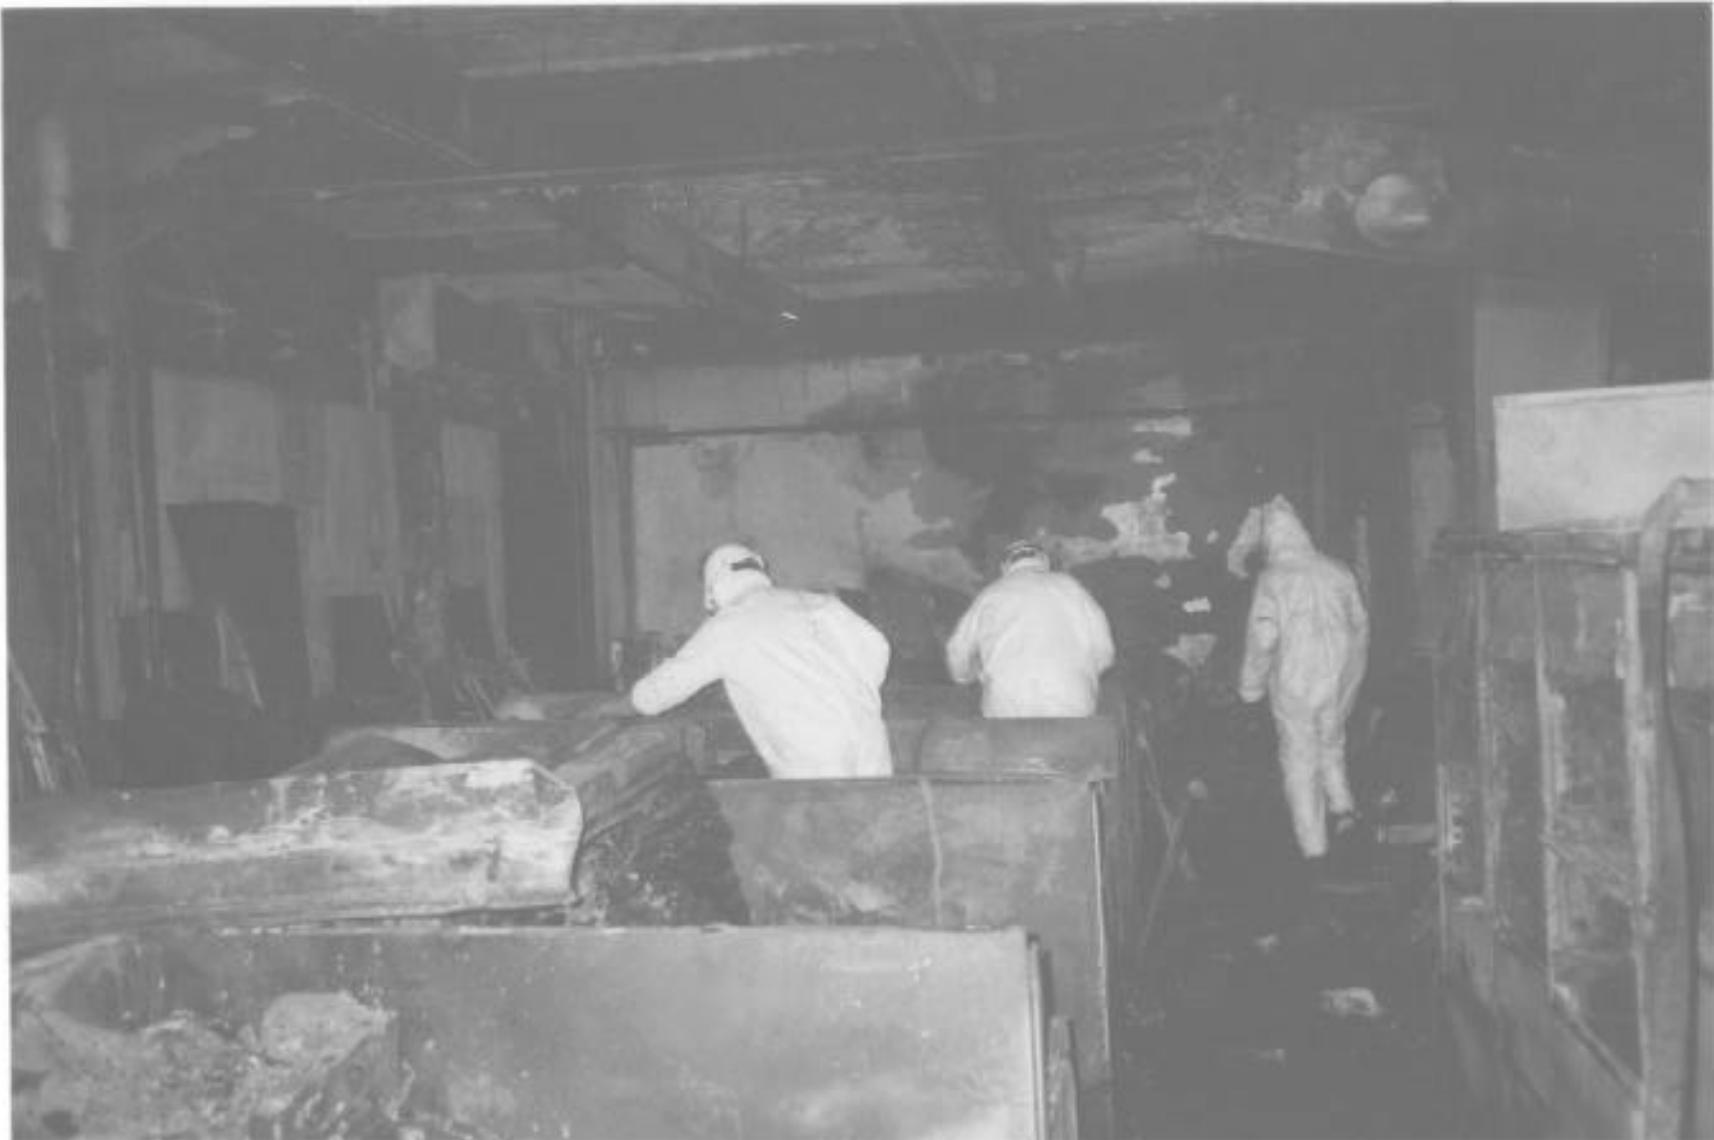
The asbestos problem continued through the investigation stage. Investigators could not enter the fire area to determine the cause and origin of the fire until the asbestos problem had been addressed. The building owners brought in an asbestos removal and decontamination contractor to remove the free asbestos from the fire area and from the rest

Investigators working in the area of fire origin wearing protective clothing due to asbestos contamination.
