Nine-Fatality Apartment House Fire Ludington, Michigan

Nine-Fatality Apartment House Fire Ludington, Michigan (February 28, 1993)

This is Report 072 of the Major Fires Investigation Project conducted by TriData Corporation under contract EMW-90-C-3338 to the United States Fire Administration, Federal Emergency Management Agency.

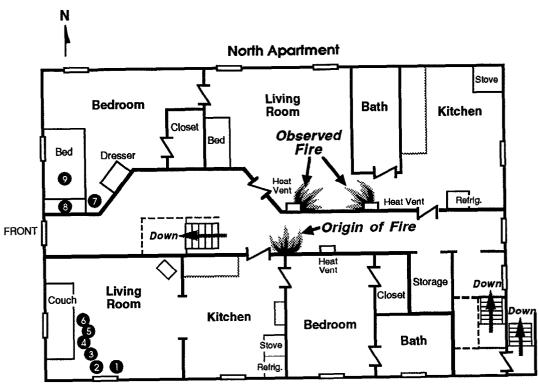
SECOND FLOOR PLAN

The fire is believed to have been of accidental nature, originating in or around a 2nd floor corridor wall light fixture located in the vicinity of the entrance door to the south apartment. Bum patterns reveal the source of the fire originating at this location and moving east down the corridor, igniting plywood paneling on the walls and combustible ceiling tiles. Fire developed very rapidly due to the presence of sufficient fuel and the lack of early detection. It quickly penetrated the upper ceiling joist area and gained entrance into the two 2nd floor apartments by way of the wood panel doors and in and around air-transfer vents that were exposed once the paneling had burned away.

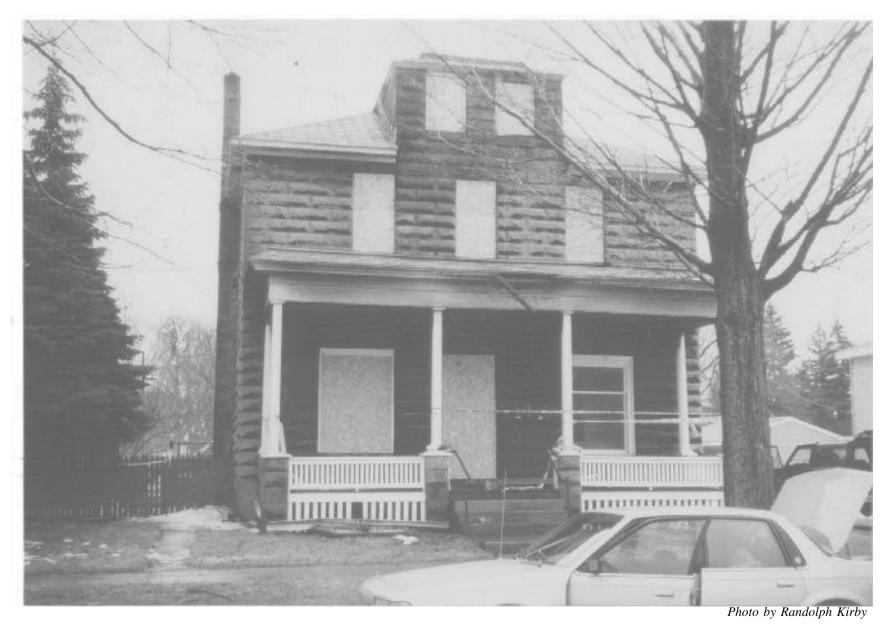
Front of building facing James Street.

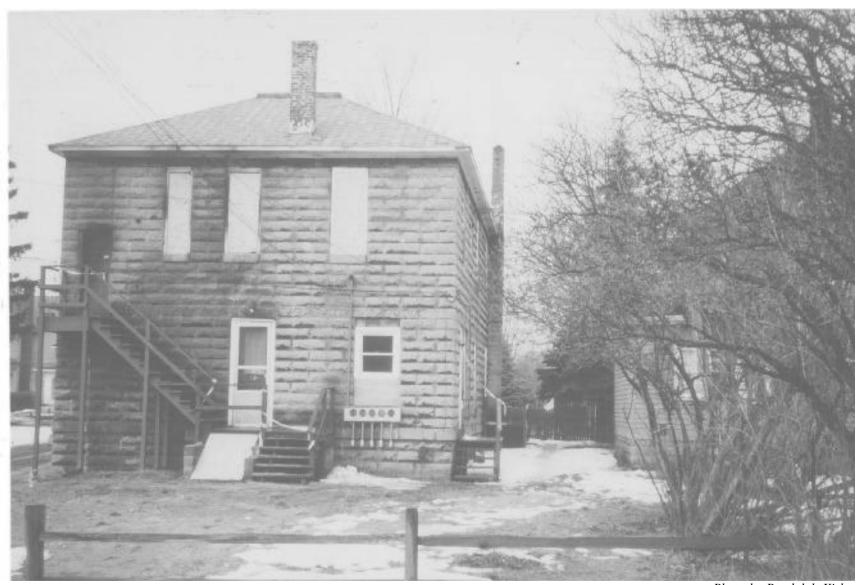
Separate entrance to first floor rear apartment and wooden fire escape to second floor.

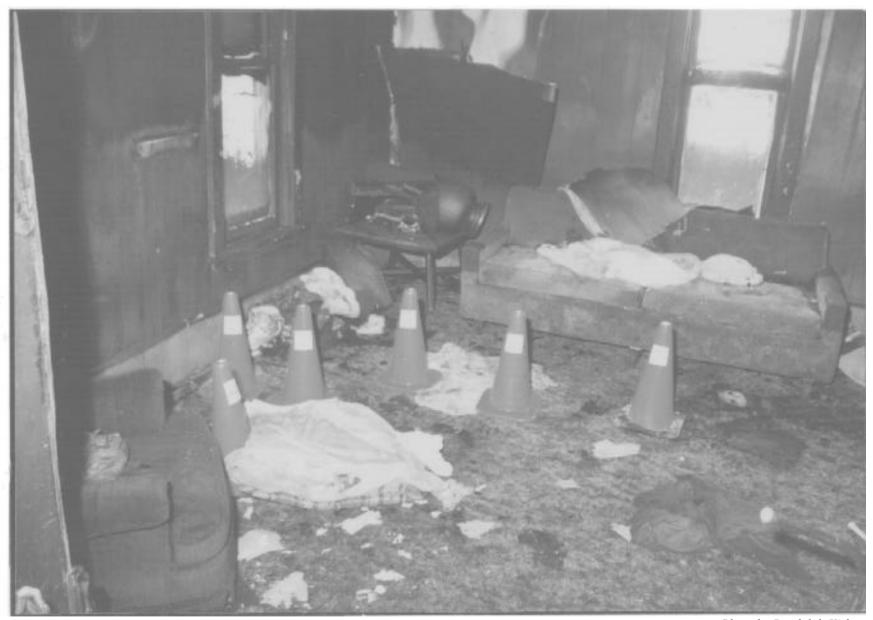
The positions of the victims located in the south apartment indicate, with one exception, that all were asleep on the living room floor and never woke up. Some were still clutching stuffed animals or other objects children normally sleep with.

Area on second floor south apartment living room where six fatalities were found. Notice little or no actual fire damage.

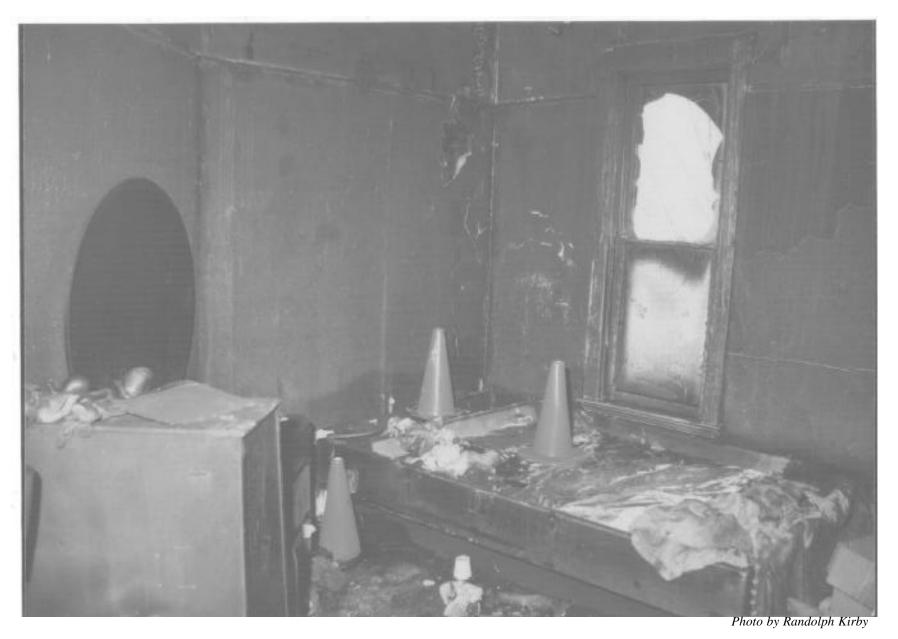
Bed in living room of second floor north apartment; area where three fatalities were discovered. Notice heat and smoke damage only.

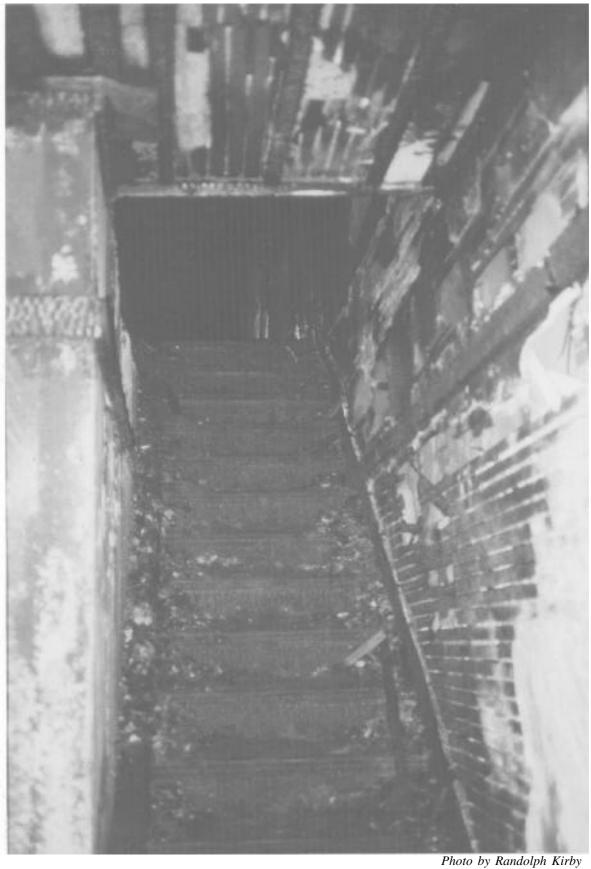
Stairway from first to second floor showing burn damage to staircase, wall, and ceiling.

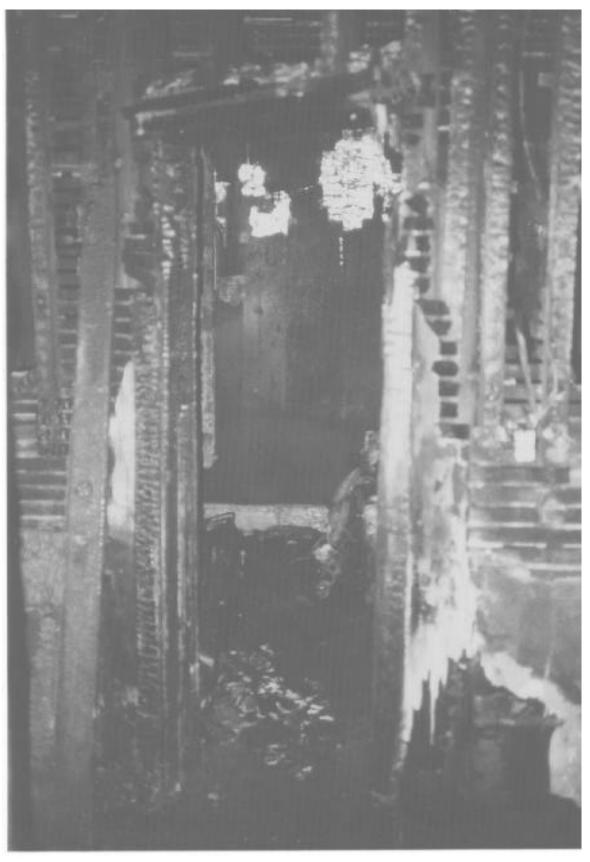
Fire damage to entrance doorway and walls of the second floor north apartment living room. Notice height of burn patterns and suspected area of origin.

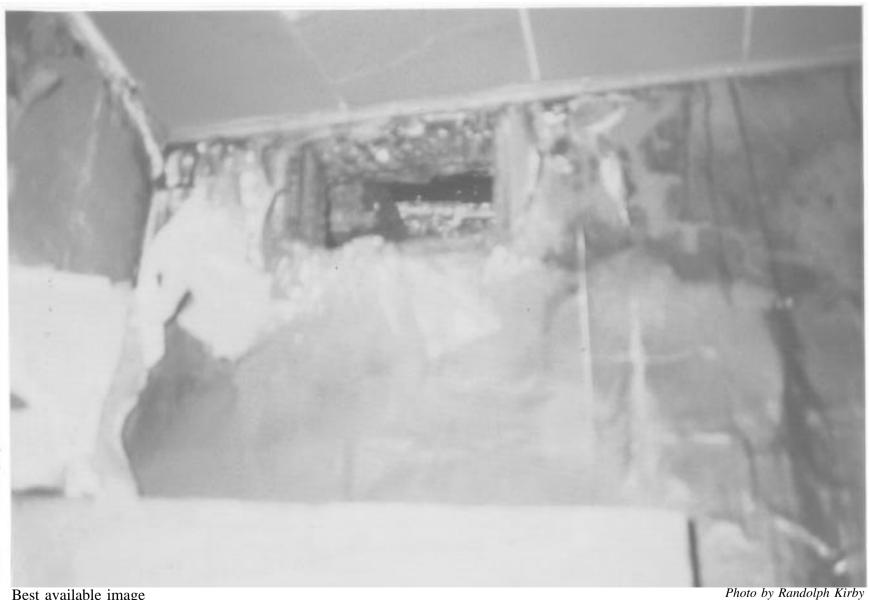
The building is equipped with louver openings approximately 13 by 9 inches. They are located between the living units and corridors at various points and are wall-mounted just below the ceiling. The louvers

were in the closed position. They had been covered over with wood paneling on the corridor side and with wall paper on the room side.

Smoke and heat traveled through air transfer vent from corridor to second floor south apartment bedroom.

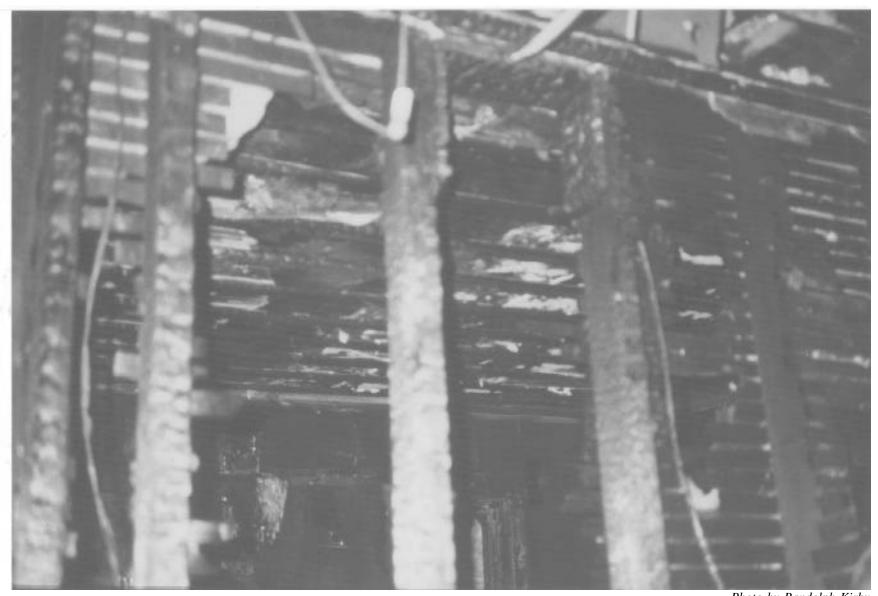
Fire traveled through air vent from suspected area of origin into second floor north apartment living room. Again, notice high burn pattern.

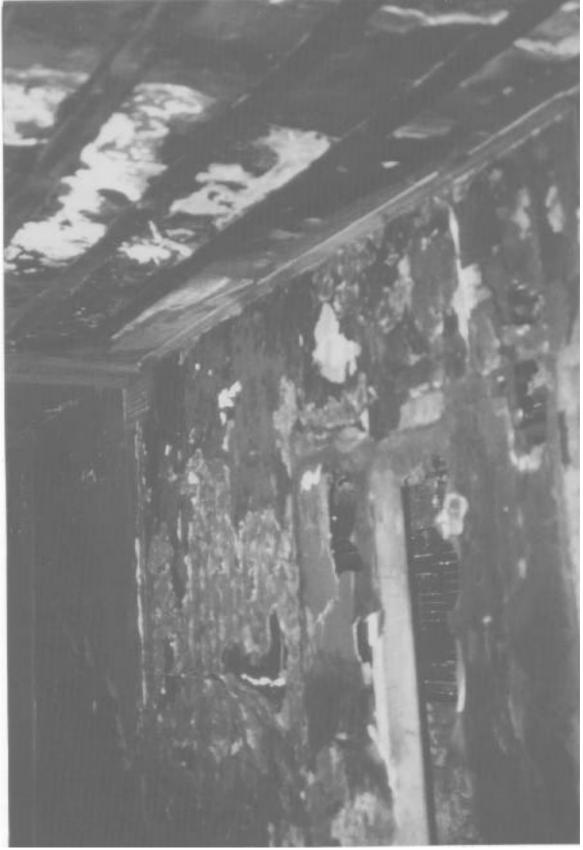
Fire damage revealed that the fire originated in the corridor at or below the ceiling level in the vicinity of a light fixture on the south wall. Fire progressed rapidly because of the highly combustible wood paneling and wood fiber ceiling tiles. It was aided by an additional supply of oxygen as a result of the occupant leaving both his apartment door and the front door open when exiting the building. It was allowed to penetrate the north and south apartments at an early stage, burning through wooden doors and through air-transfer grills that were installed in the corridor walls that separated the living units.

Fire damage to second floor corridor walls and ceiling. Notice fire penetration through wall into north apartment.
