Live Oak/Milstar Complex and Carpet Service Center

LaGrange, Georgia

UNITED STATES FIRE ADMINISTRATION FIRE INVESTIGATIONS PROGRAM

This is Report 086 of the Major Fires Investigation Project conducted by Varley-Campbell & Associates, Inc. under contract EMW-94-C-4423 to the United States Fire Administration, Federal Emergency Management Agency.

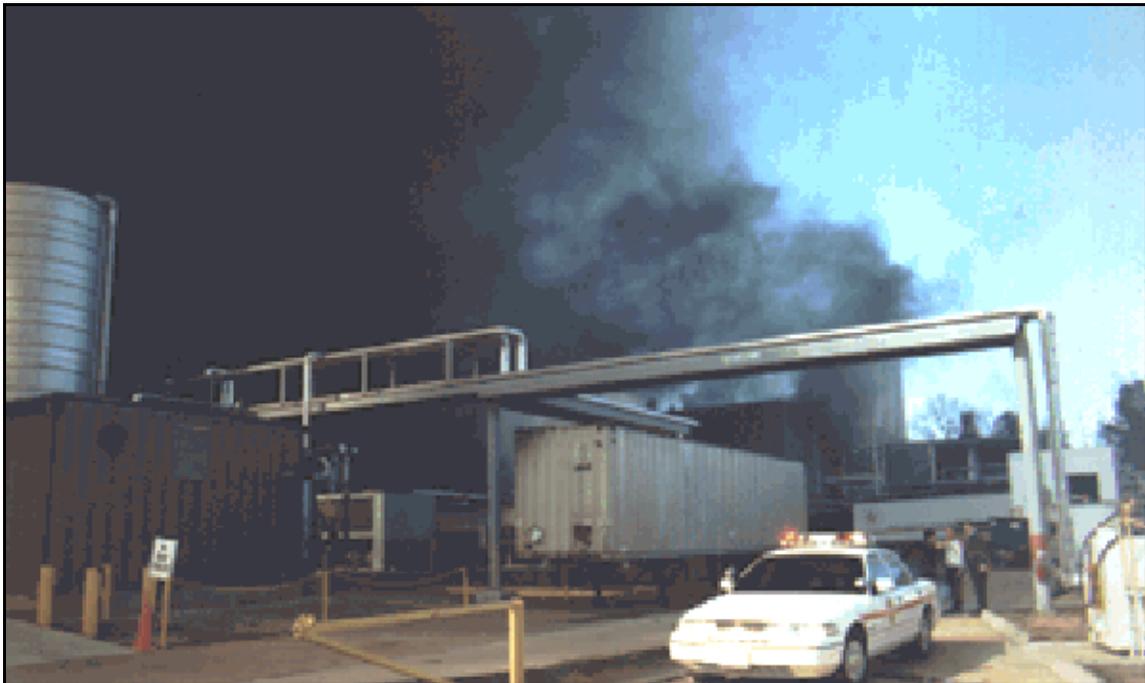
2. The location of Incident Command on the east side of the building. The truck trailer with the star (above the car's warning lights) is in photograph 1.

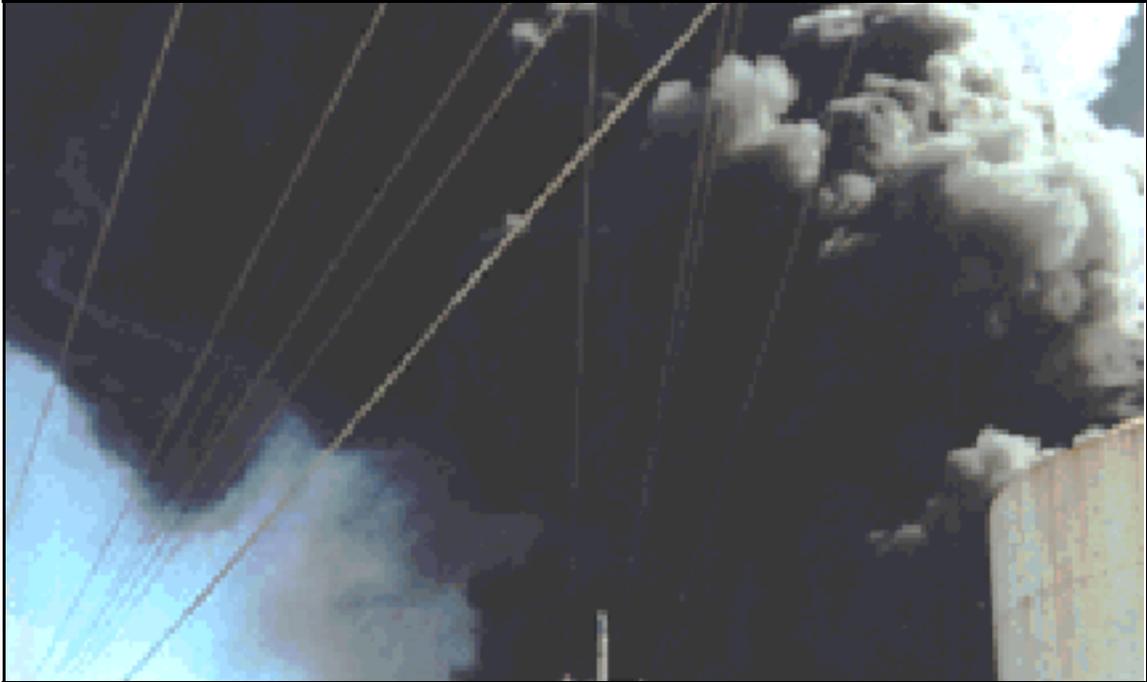
3. Conditions along the north side of the plant looking from west to the east. The photograph was taken very early in the fire and represents conditions not long after fire department arrival.

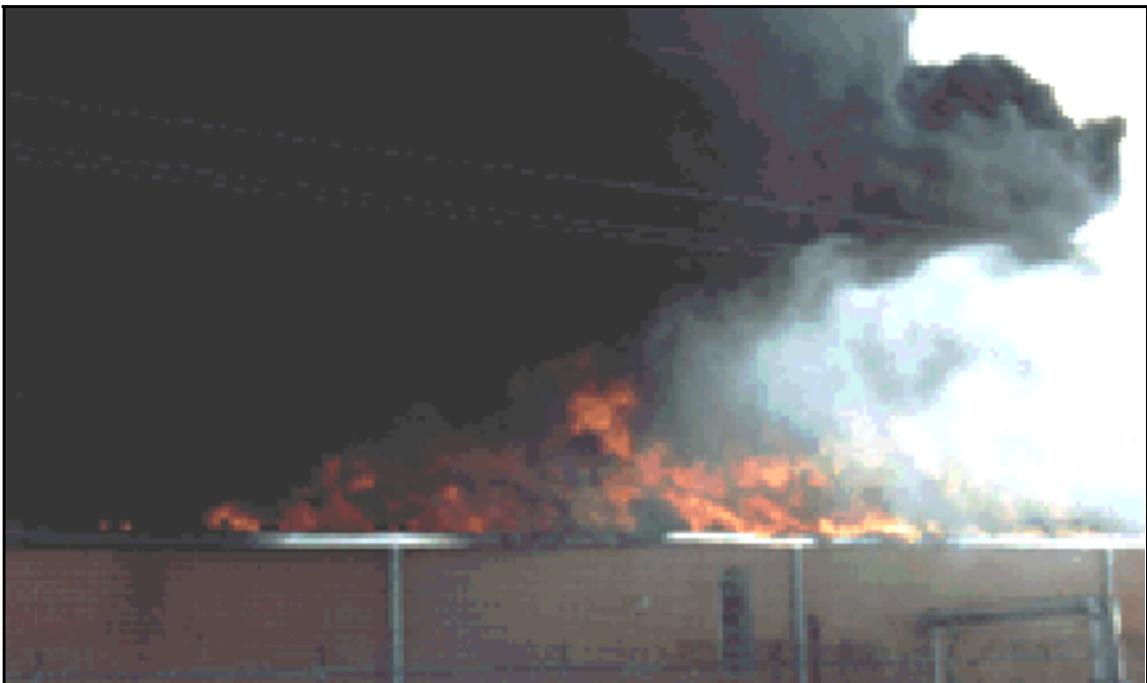
4. One of the early master streams on the fire on the north side. There is an elevation drop of 15 to 20 feet between street level and ground level at the brick wall. One of the heat transfer fluid boilers is in the background just off the engine's tail board.

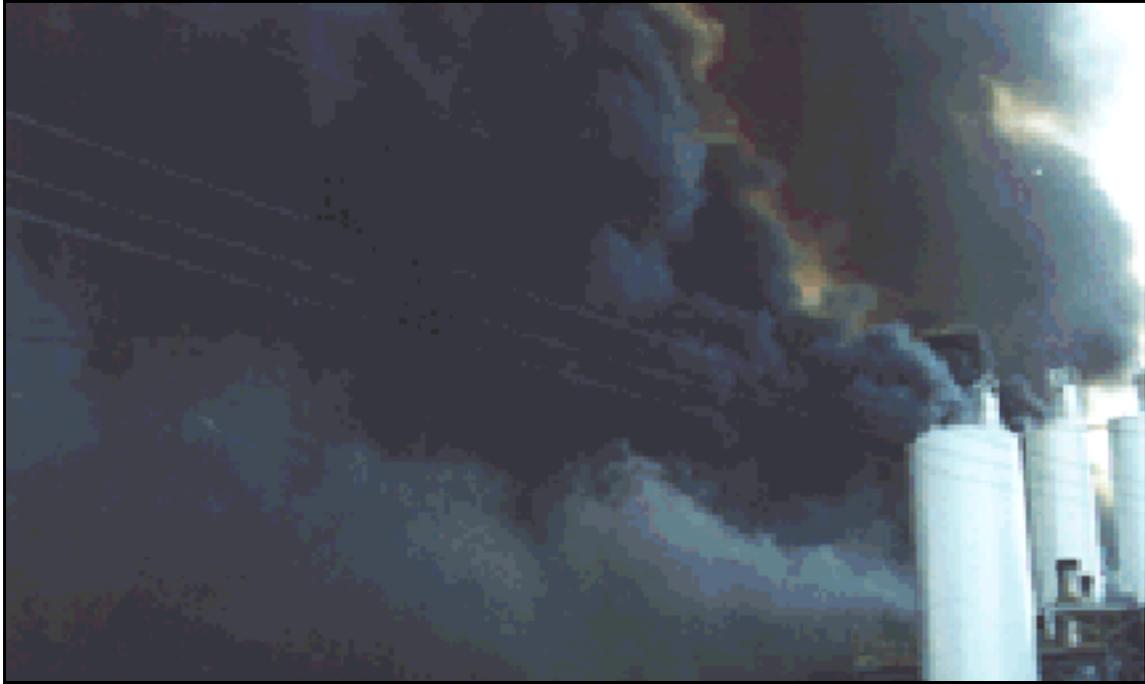
5. Conditions along Swift Street northeast of the plant. The large diameter supply line is in place to supply Engine 4 operating in the corner.

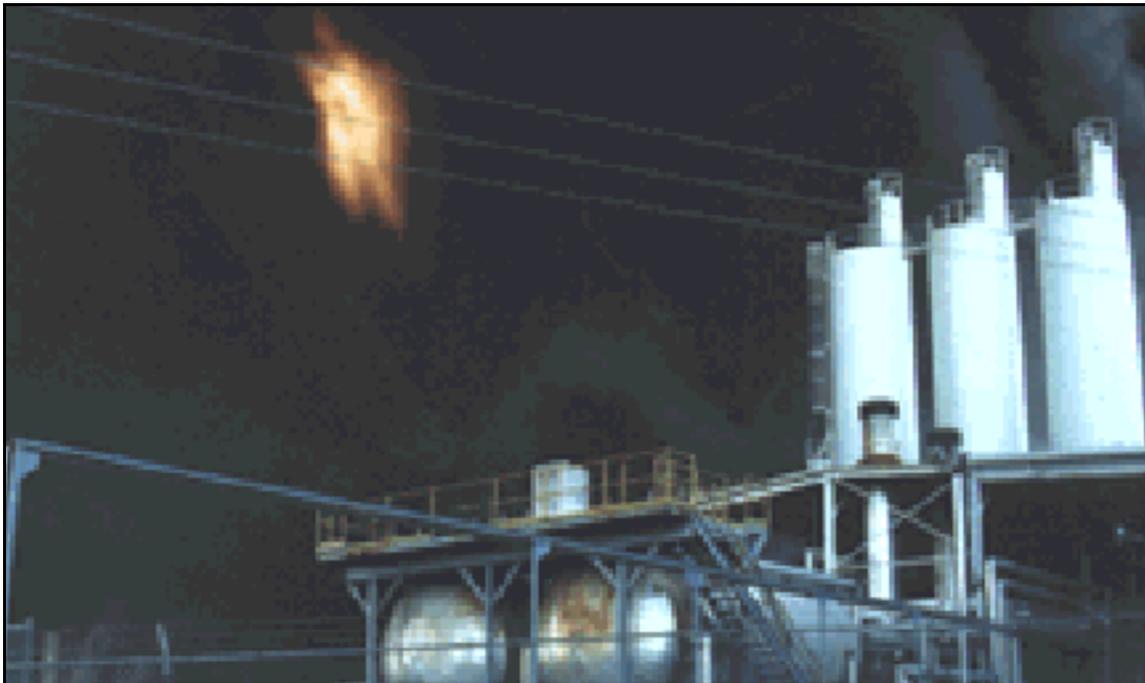
6. The two heat transfer fluid boilers and support equipment that supplied the carpet making range initially involved in the fire. Engine 4 is behind the concrete embankment.

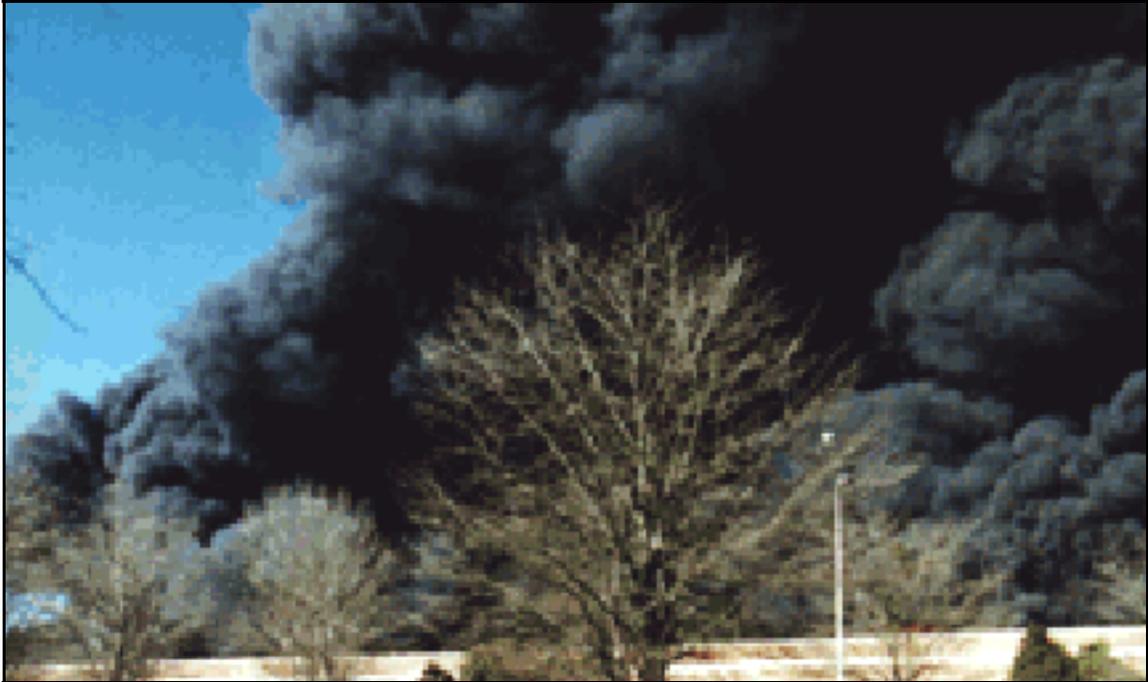
7. Conditions on the south side of the complex looking north from a position out from the northeast corner. At this point, the fire involves most of the 1972 addition.

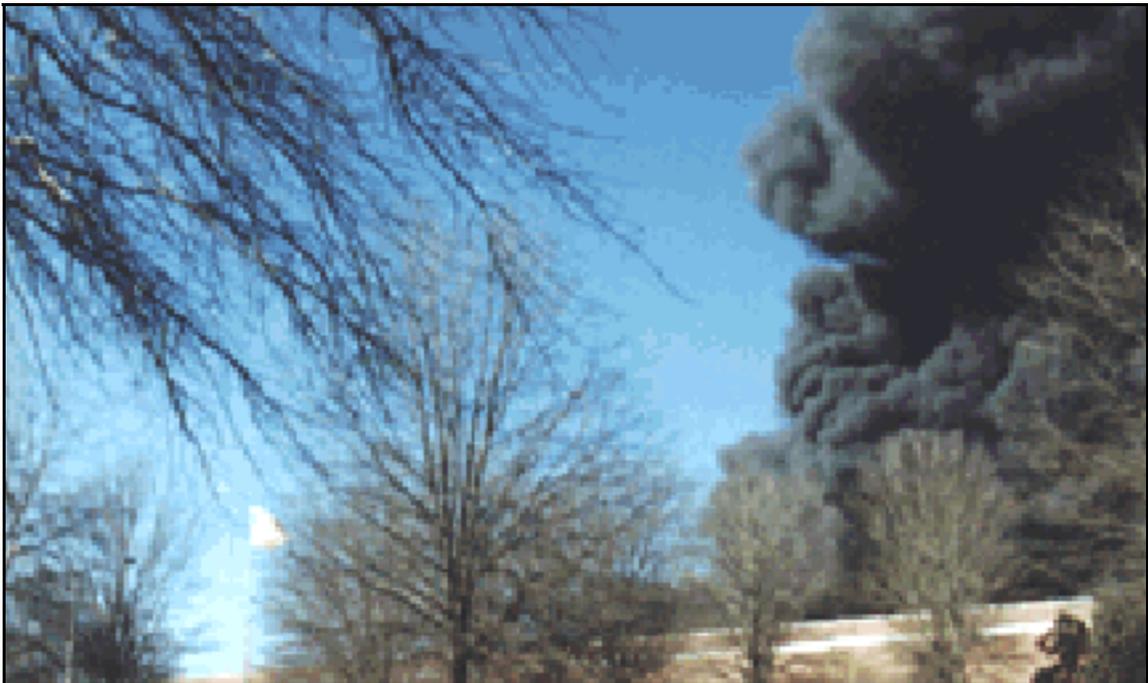
8. Conditions on the south side of the complex looking north from a position out from the northeast corner. At this point, the fire involves most of the 1972 addition.

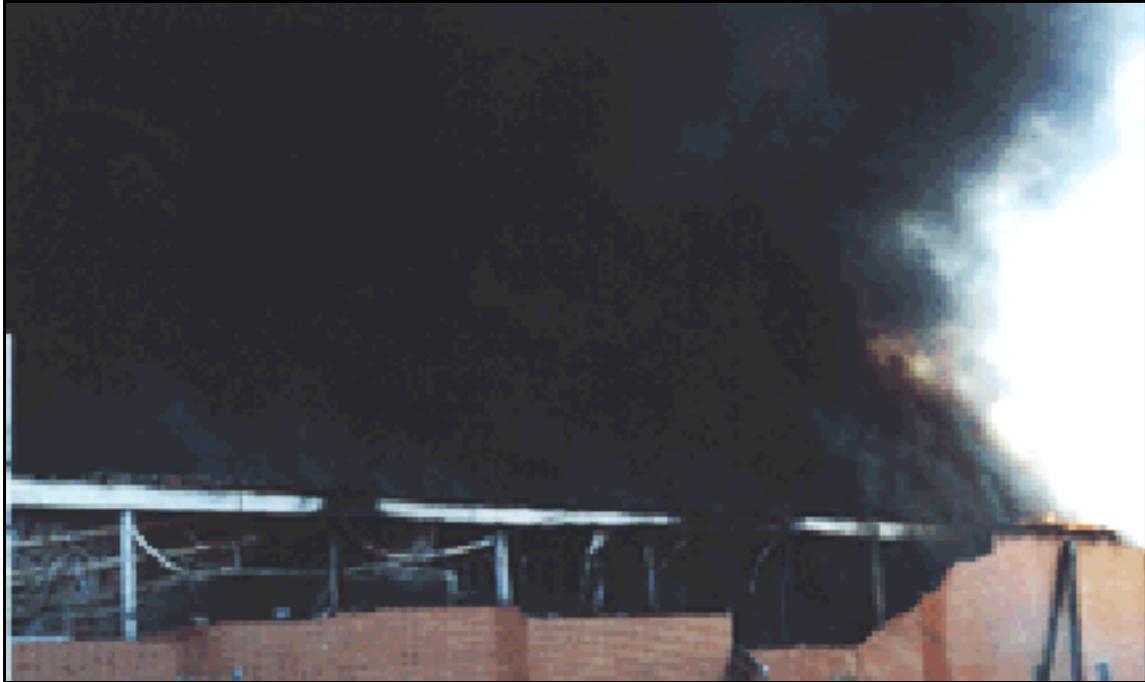
9. Conditions at the northwest corner of the building looking west from near Swift and Polk Streets. The outside post indicator valves (PIV's) and outside flow alarm bells for the sprinkler risers can be seen.

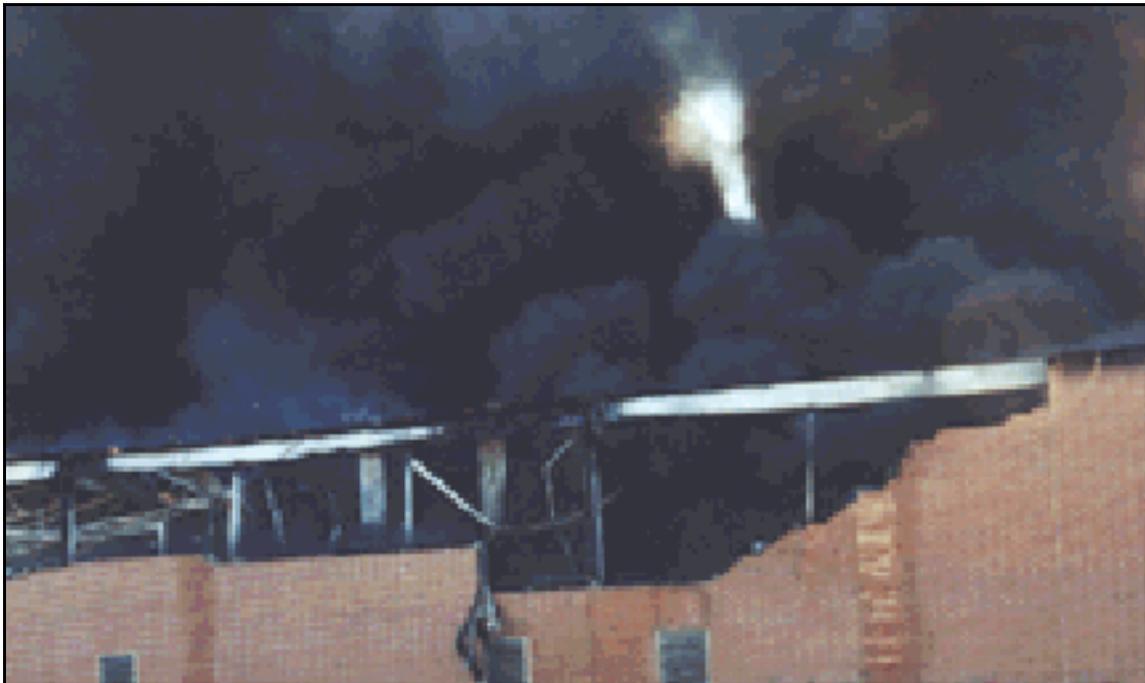
10. Close-up of the area in photograph 9. In addition to the flow alarm bells and PIV's, the top of a yard hydrant is in the lower left corner.

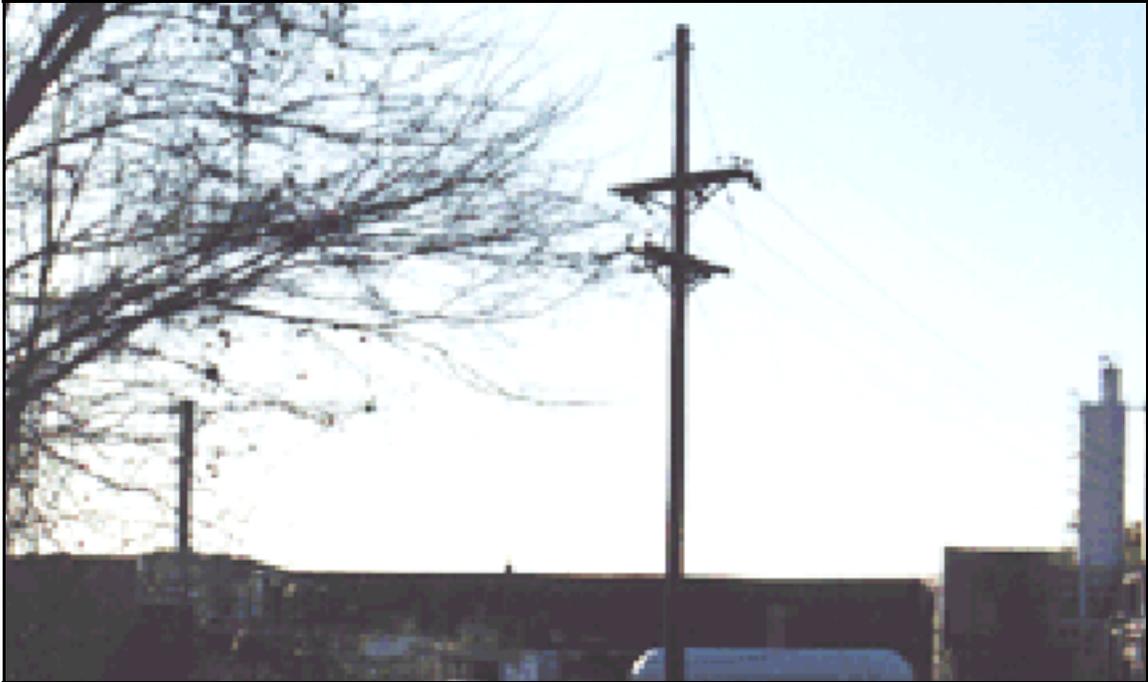
11. Several days after the fire, the northeast corner of the complex. The LP-gas storage tanks, raw material storage silos, and heat transfer fluid boilers and support equipment are shown. Taken from Swift Street looking west.

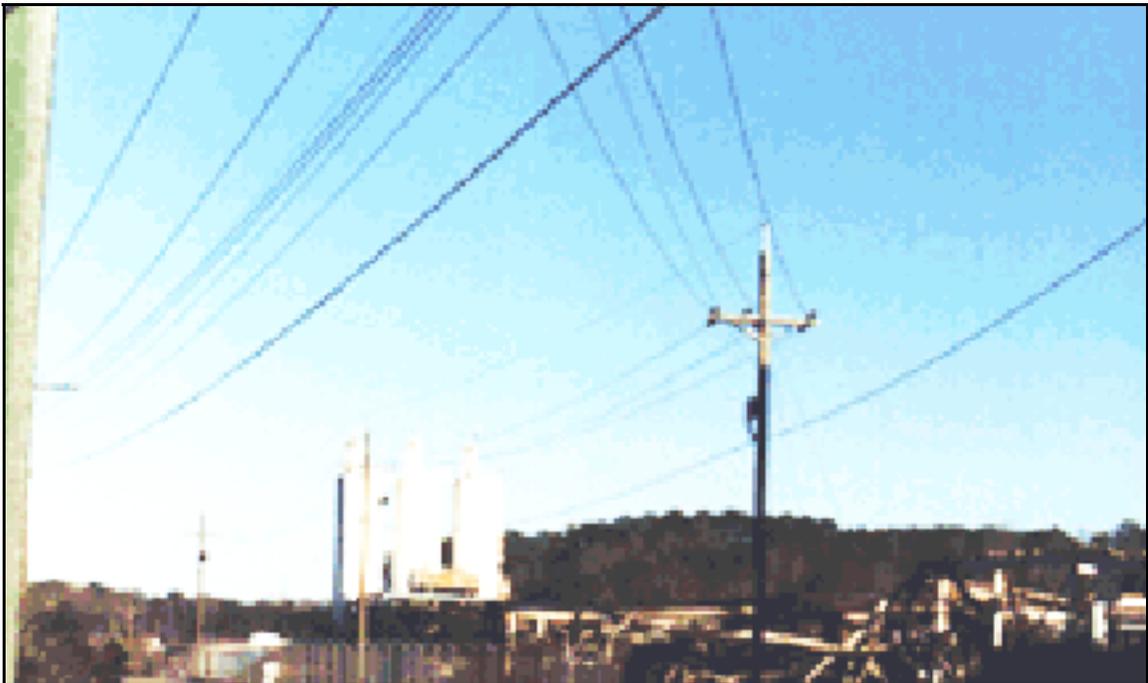
12. Nearly the same position as photograph 3. One of the fire protection water storage tanks is in the right hand side of the photograph. Taken looking east from near the intersection of Swift and Polk Streets.

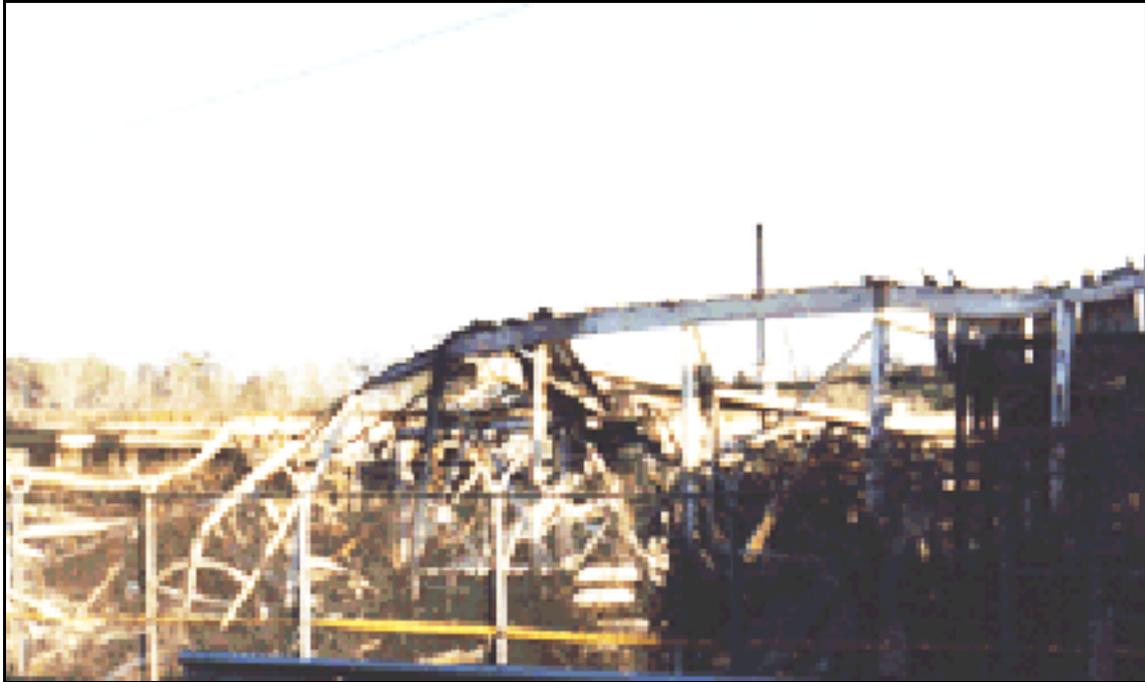
13. Some of the same area in photograph 4 but from a different angle and after the fire. In the bottom right hand corner is one of the heat transfer fluid boilers.
