## Two Fatality Board and Care Facility Fire Salvation Army Rehabilitation Center

Miami, Florida

This is Report 090 of the Major Fires Investigation Project conducted by Varley-Campbell & Associates, Inc. under contract EMW-94-C-4423 to the United States Fire Administration, Federal Emergency Management Agency.

November 11, 1995

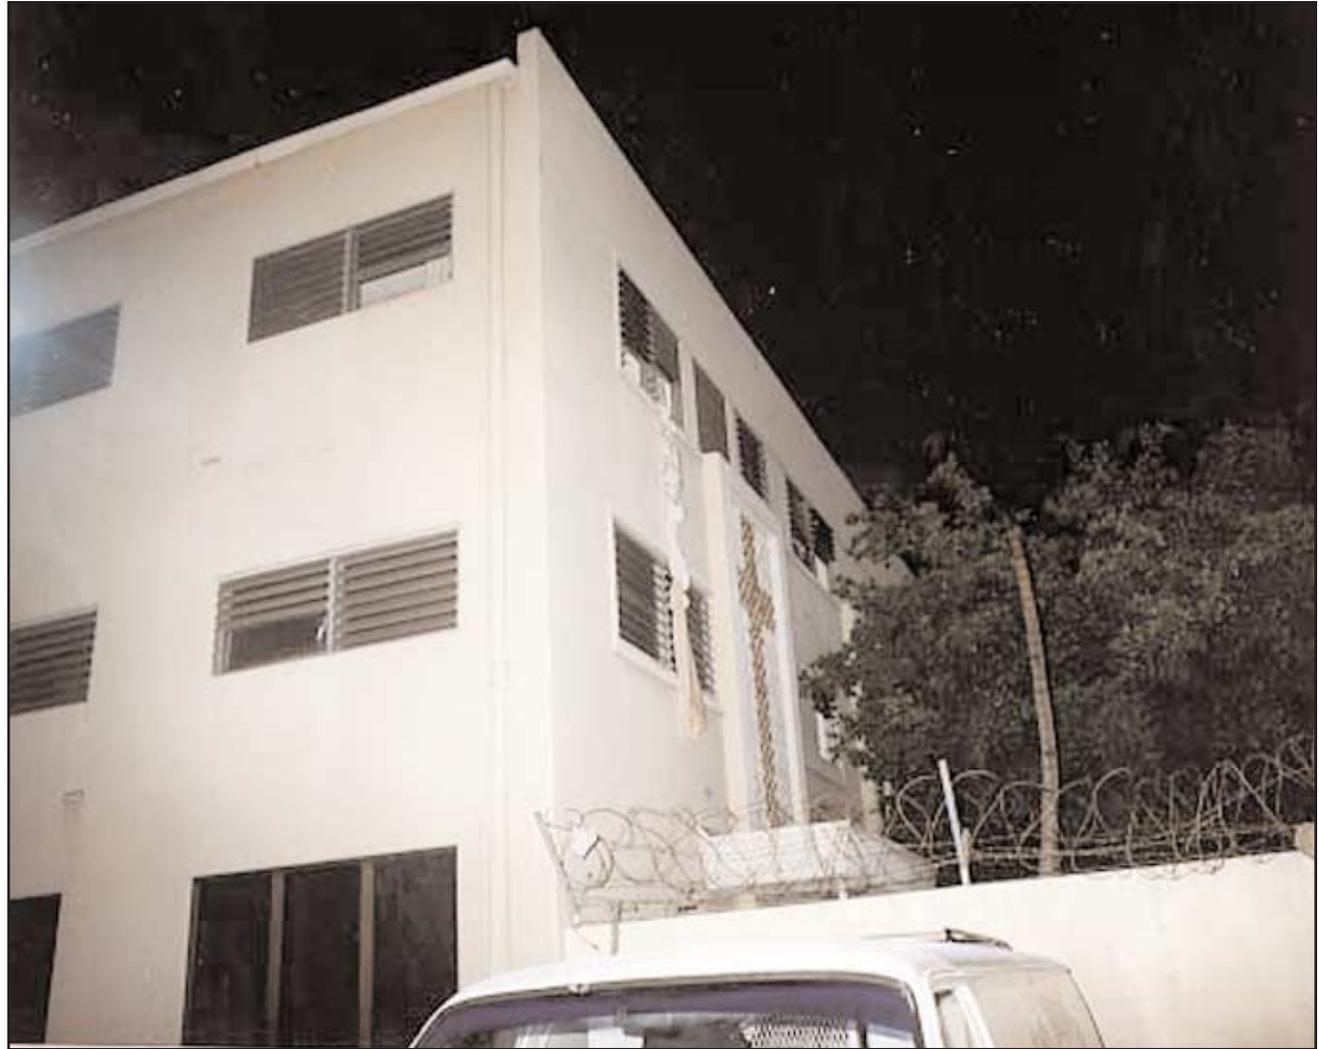
1. Southeast corner of the Rehabilitation Center. Front entrance is just north of the razor wire topped wall. Note permanent hurricane shutters installed on the outside of the windows. Some residents tied sheets together and climbed from the windows after breaking out the shutters.

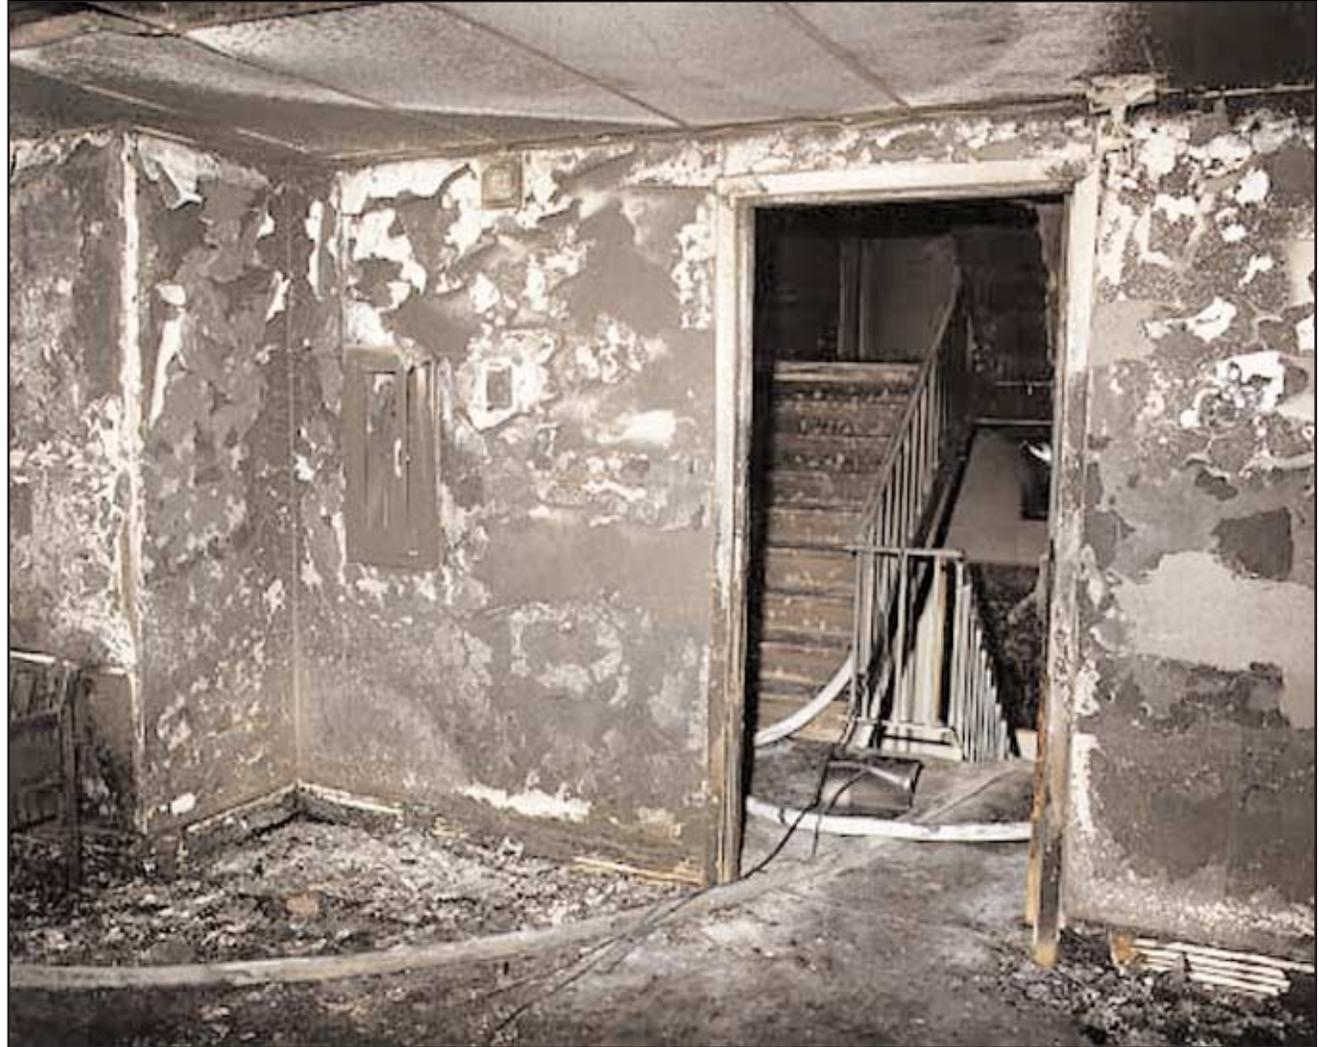
Investigators from the City of Miami Fire Department, Arson Division, established the area of origin as the office waiting area on the second floor and concluded that the fire had been deliberately set. A discharged fire extinguisher was found in the area of origin, however, it was not determined who had used it.

2. Doorway opening from SE stairway into office waiting area on second floor, adjacent to where investigators determined the fire originated.

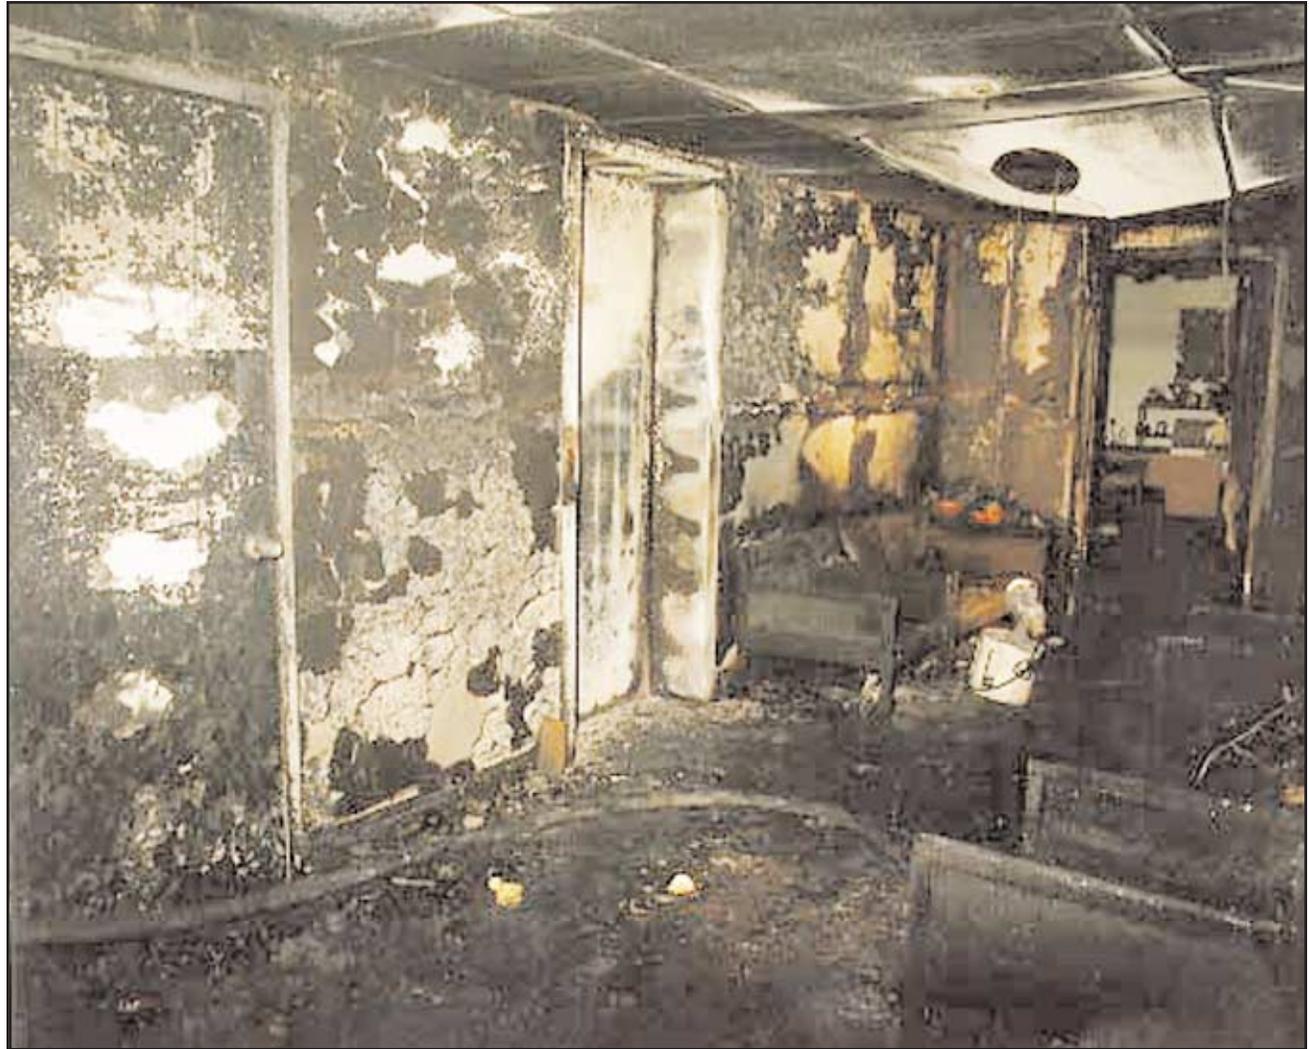
The office waiting area on the second floor where the fire originated was furnished with upholstered chairs, end tables and racks of magazines and promotional literature. Chair cushions were shown to be highly flammable in tests conducted by the fire department after the fire and shown to produce large quantities of thick black smoke.

3. View of office waiting area on second floor from the SE stairway door.

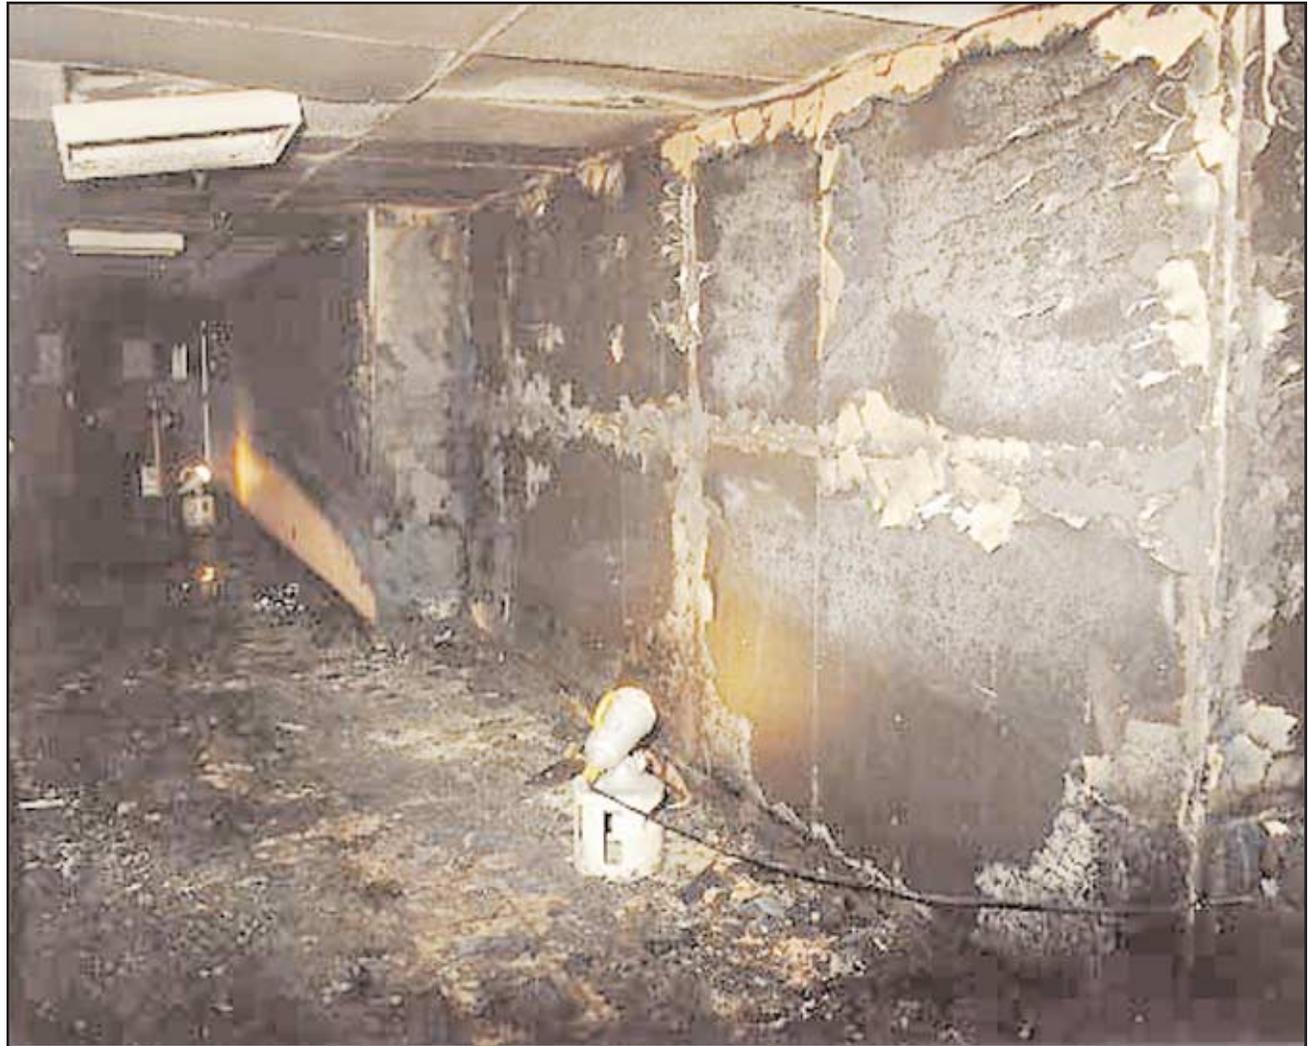
Wallcoverings in the Center varied from plywood paneling and painted gypsum wallboard to vinyl wallcoverings. Investigators observed that the vinyl wallcovering in the area of origin, and leading down the second floor hallway from the area of origin, was completely burned away.

4. First view of hallway leading from office waiting area to residential areas of the second floor.

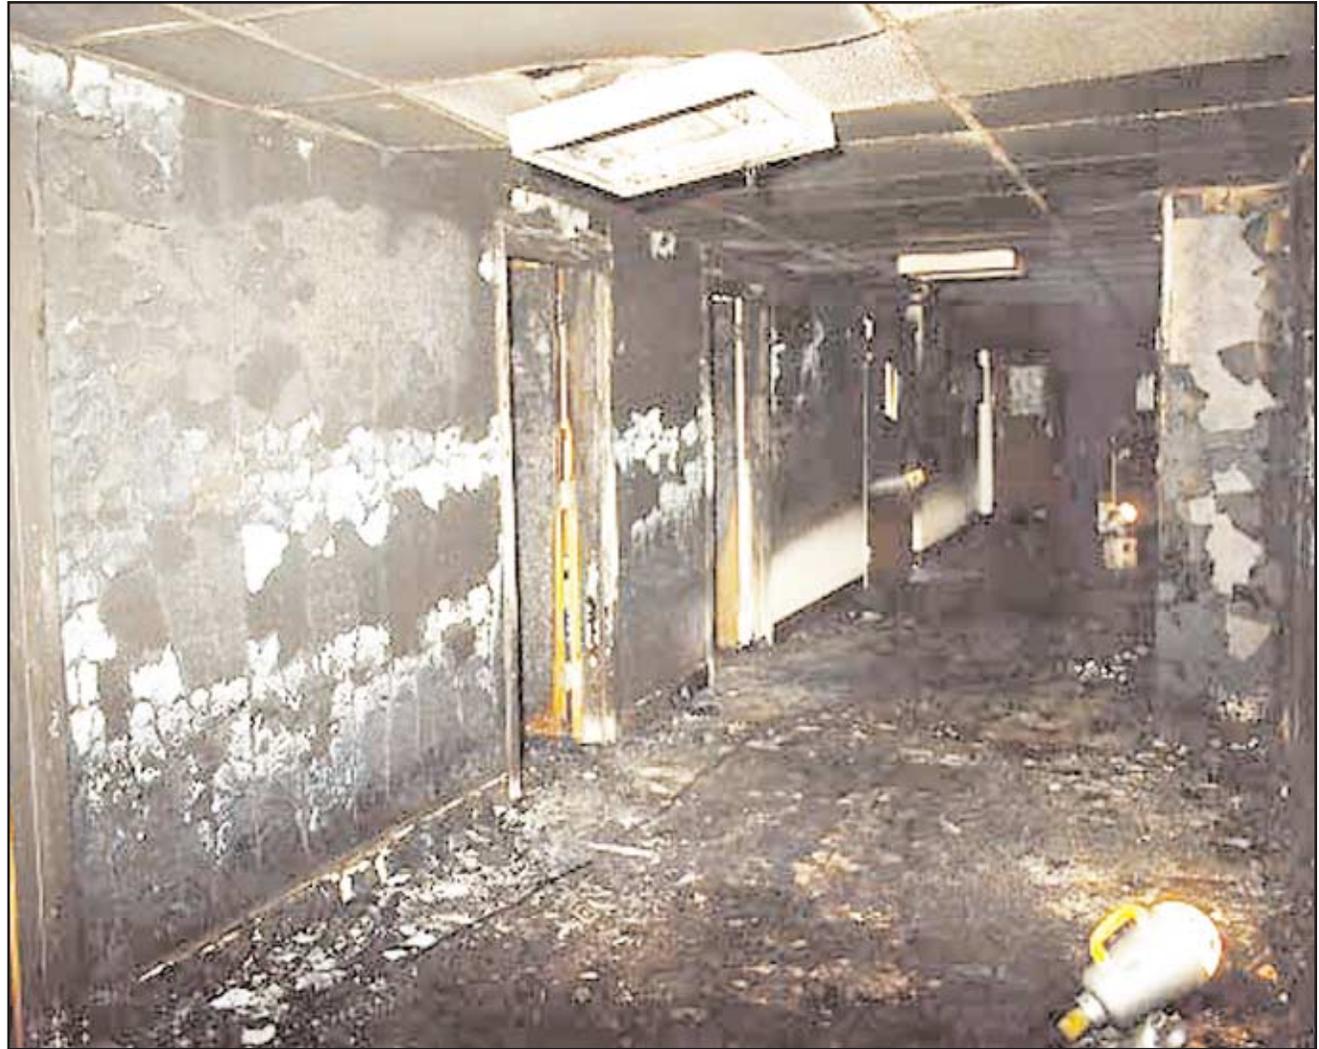
5. Second view of hallway leading from office waiting area to residential areas of the second floor.

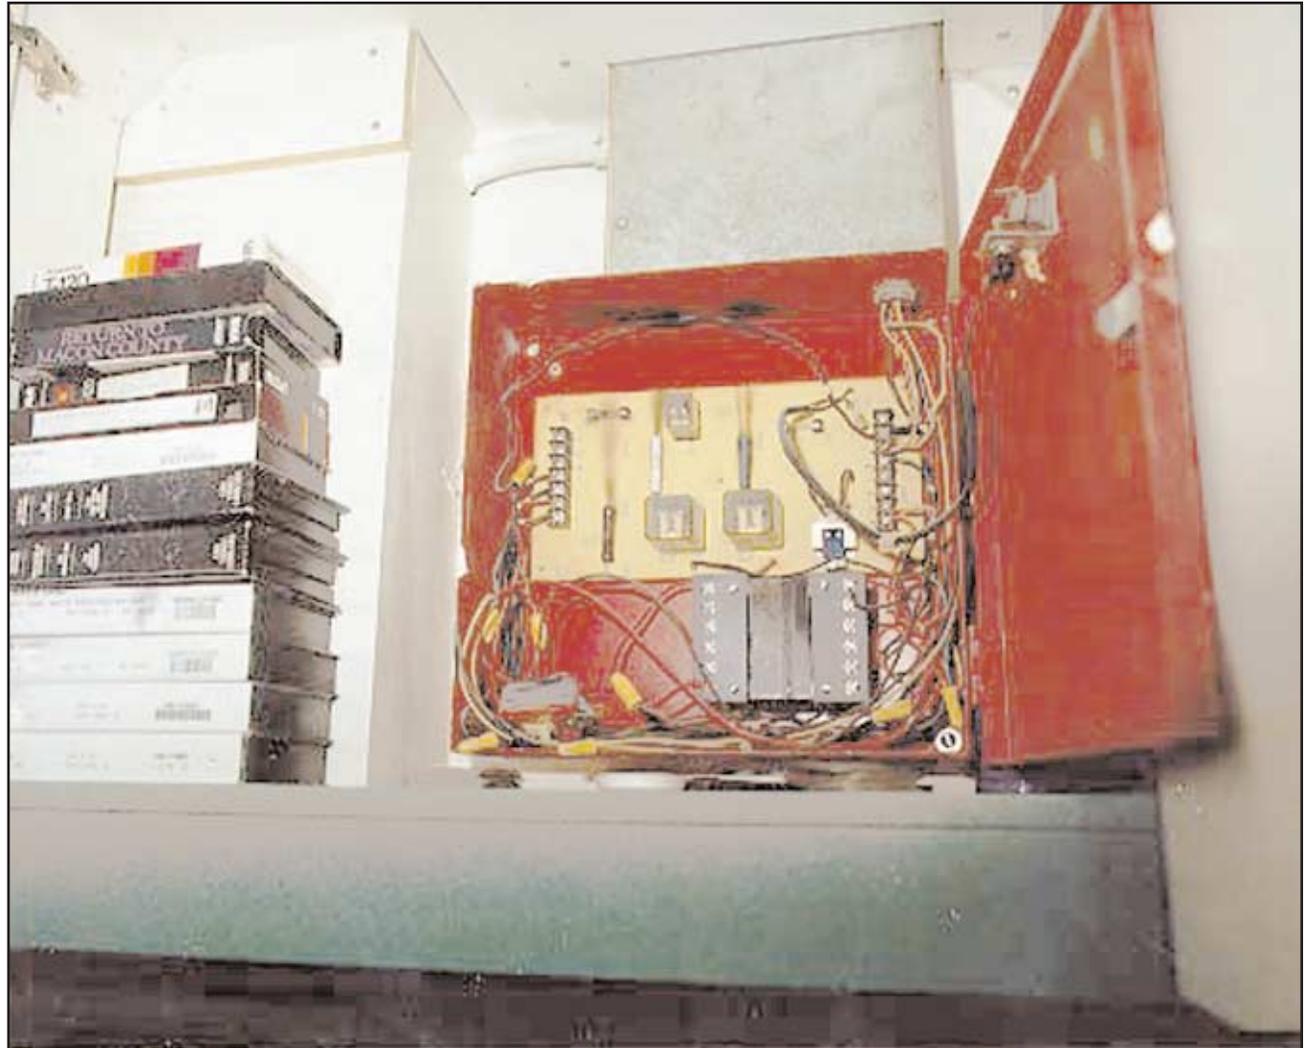
The fire alarm system control panel was mounted on a wall in a storage cabinet in the first floor watch room. The control panel was completely out of sight, hidden behind closed cabinet doors with cleaning supplies stacked in front of it. The Center staff, when questioned, was unaware of its existence. A switch of the type normally used as a wall switch had been installed in the control panel, providing an on/off switch for the system. When located after the fire, the switch was found in the “off” position.

There were no records or staff recollection to indicate when the fire alarm system had last been tested or inspected. The system was not connected to a central station or alarm monitoring service. There was no public announcement system in the building.

6. Fire alarm control panel. The panel was located inside a cabinet in the first floor front office. Note the on/off switch in the bottom left hand corner of the box.
