Broward Marine Fire Fort Lauderdale, Florida

BROWARD MARINE FIRE

FORT LAUDERDALE, FLORIDA

SEPTEMBER 5, 1996

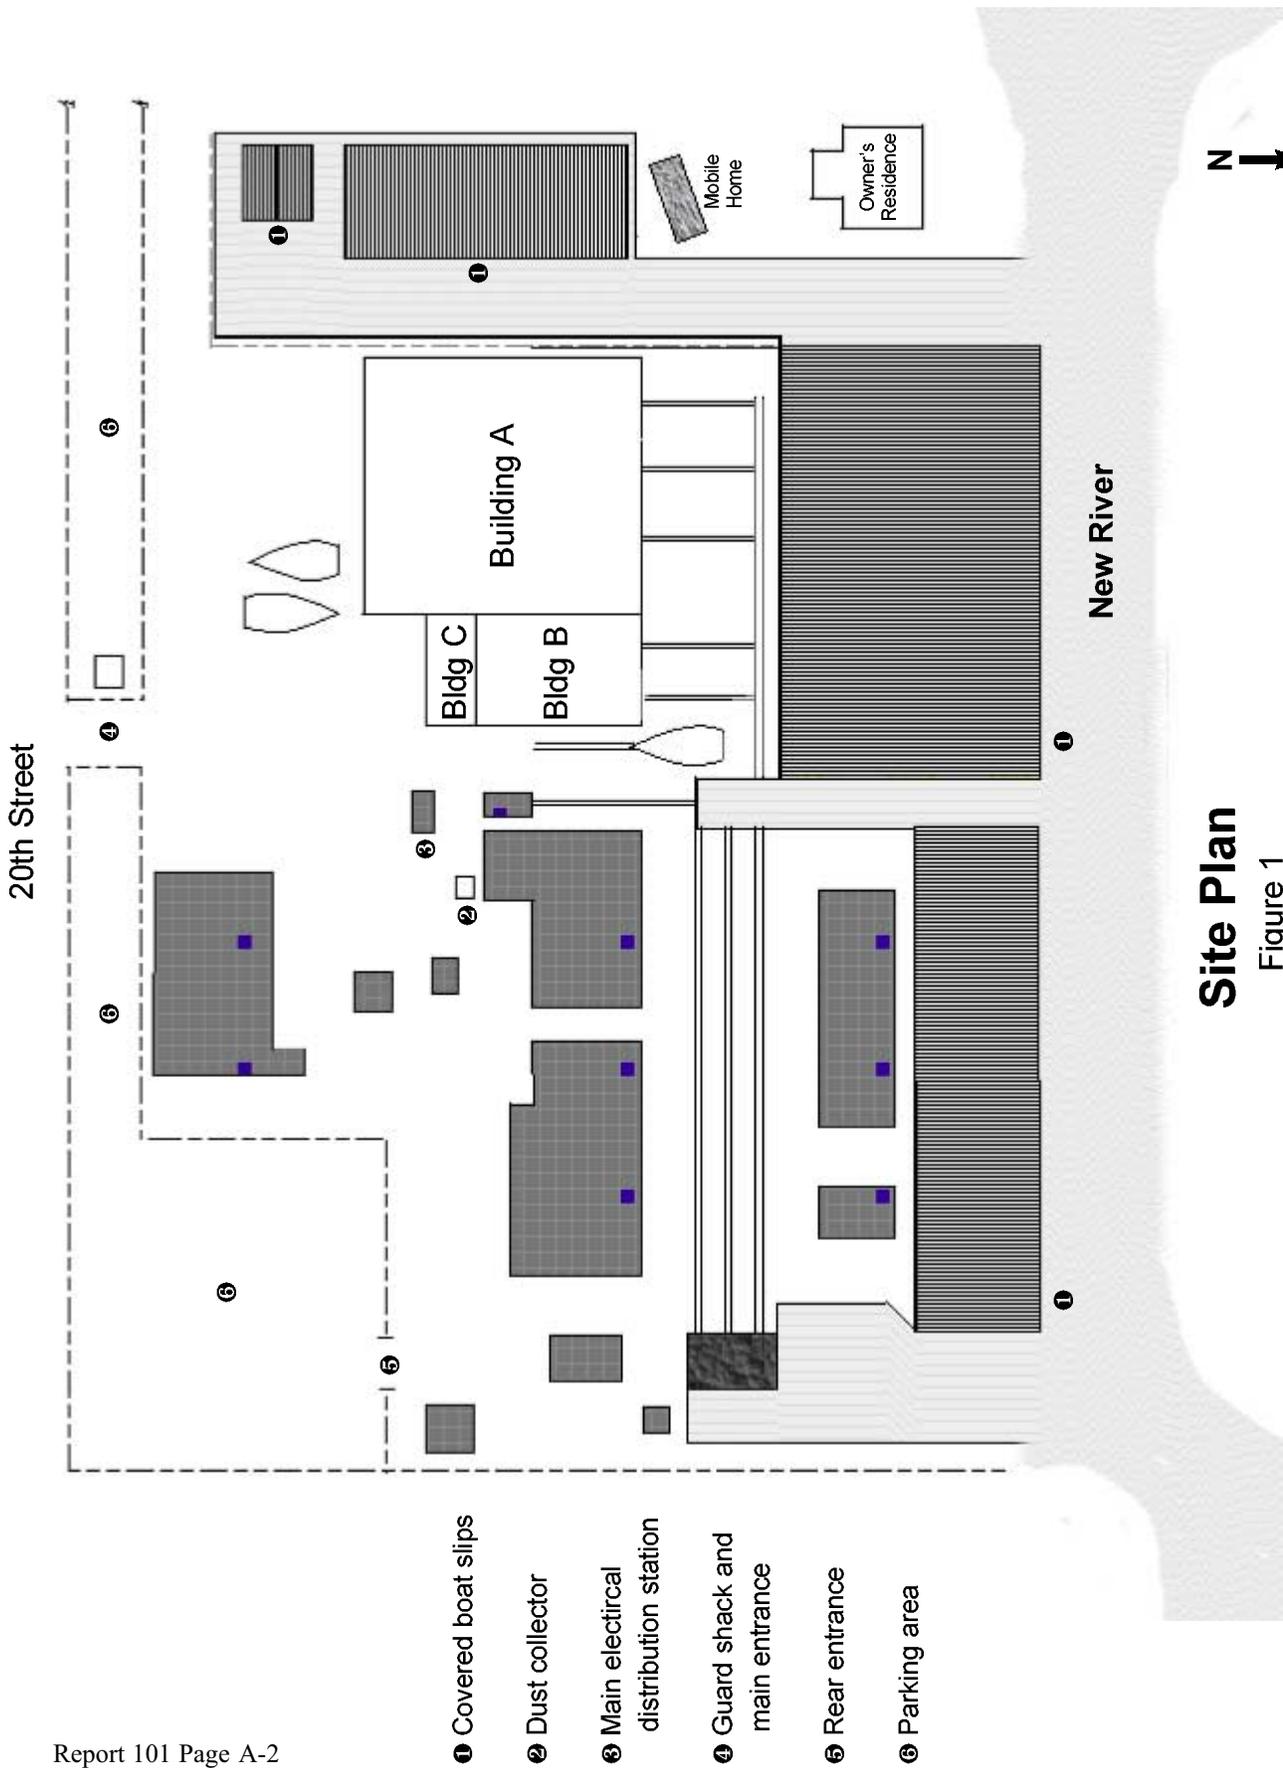
Site Plan
Figure 1

- 1 Covered boat slips
- 2 Dust collector
- 3 Main electrical distribution station
- 4 Guard shack and main entrance
- 5 Rear entrance
- 6 Parking area

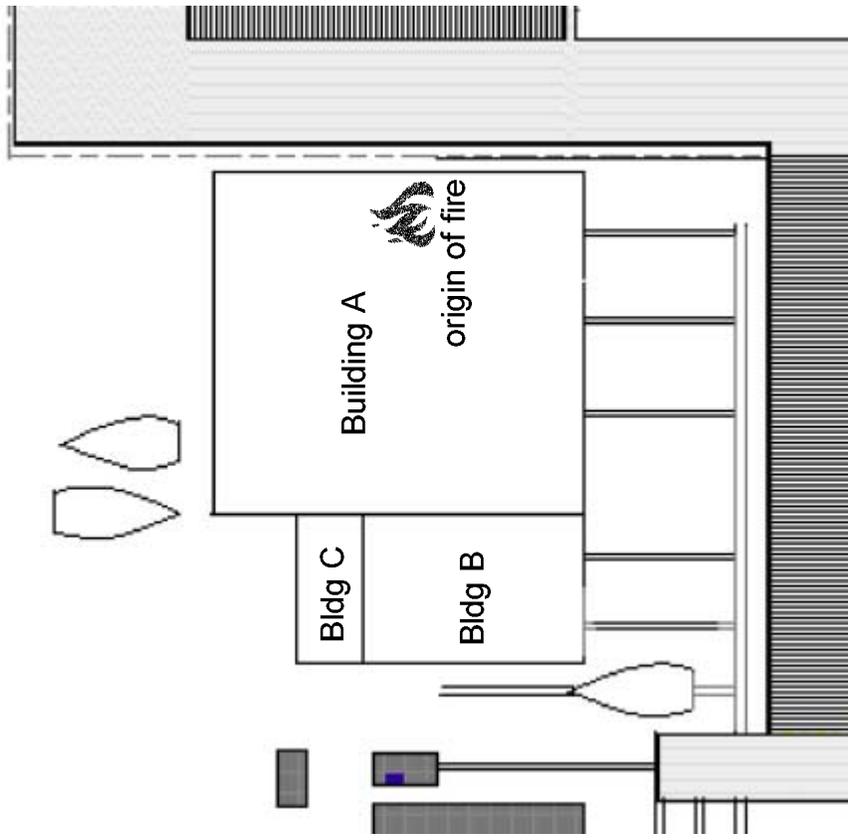
Figure 2

The teams worked until September 9, when a final meeting was held and the team attributed the cause of the fire to an electric short in the west central end of Building A. The intensity of the fire was considered increased because of poor house-keeping practices. The multiple spot fires were determined to be the result of flying embers from the fully developed fire and subsequent radiant heat.

Area of Origin

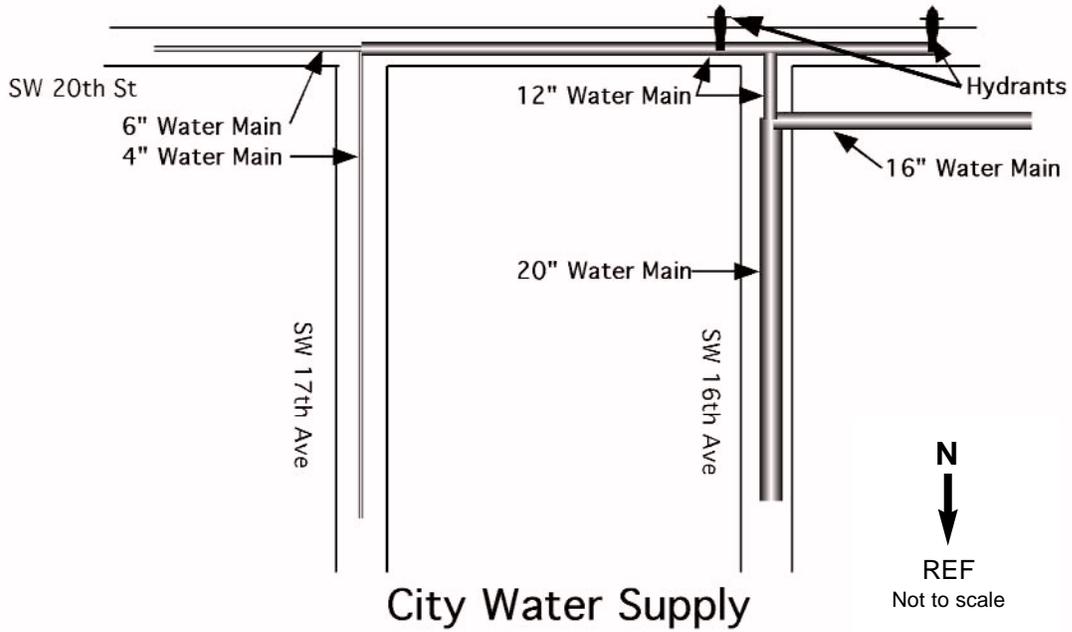
City Water Supply
Figure 3

The hydrant located at the intersection of Southwest 20th Street and Southwest 15th Avenue had a static pressure of 72 psi and a residual pressure of 65 psi at a flow of 1300 gpm. This hydrant is supplied through approximately 150 feet of 12-inch underground pipe, which is connected to a 20-inch city water main located under Southwest 15th Avenue. This 20-inch city water main also supplied a 6-inch loop to the west, which ties back into the 20-inch water main to the south. (See Figure 3)

The failure of aged supply mains and decreased flow rates are a potential critical risk. Review of water supply capabilities should be ongoing. Procedures should address drafting operations, as waterways are an obvious asset and man made obstructions can cause problems regarding access.

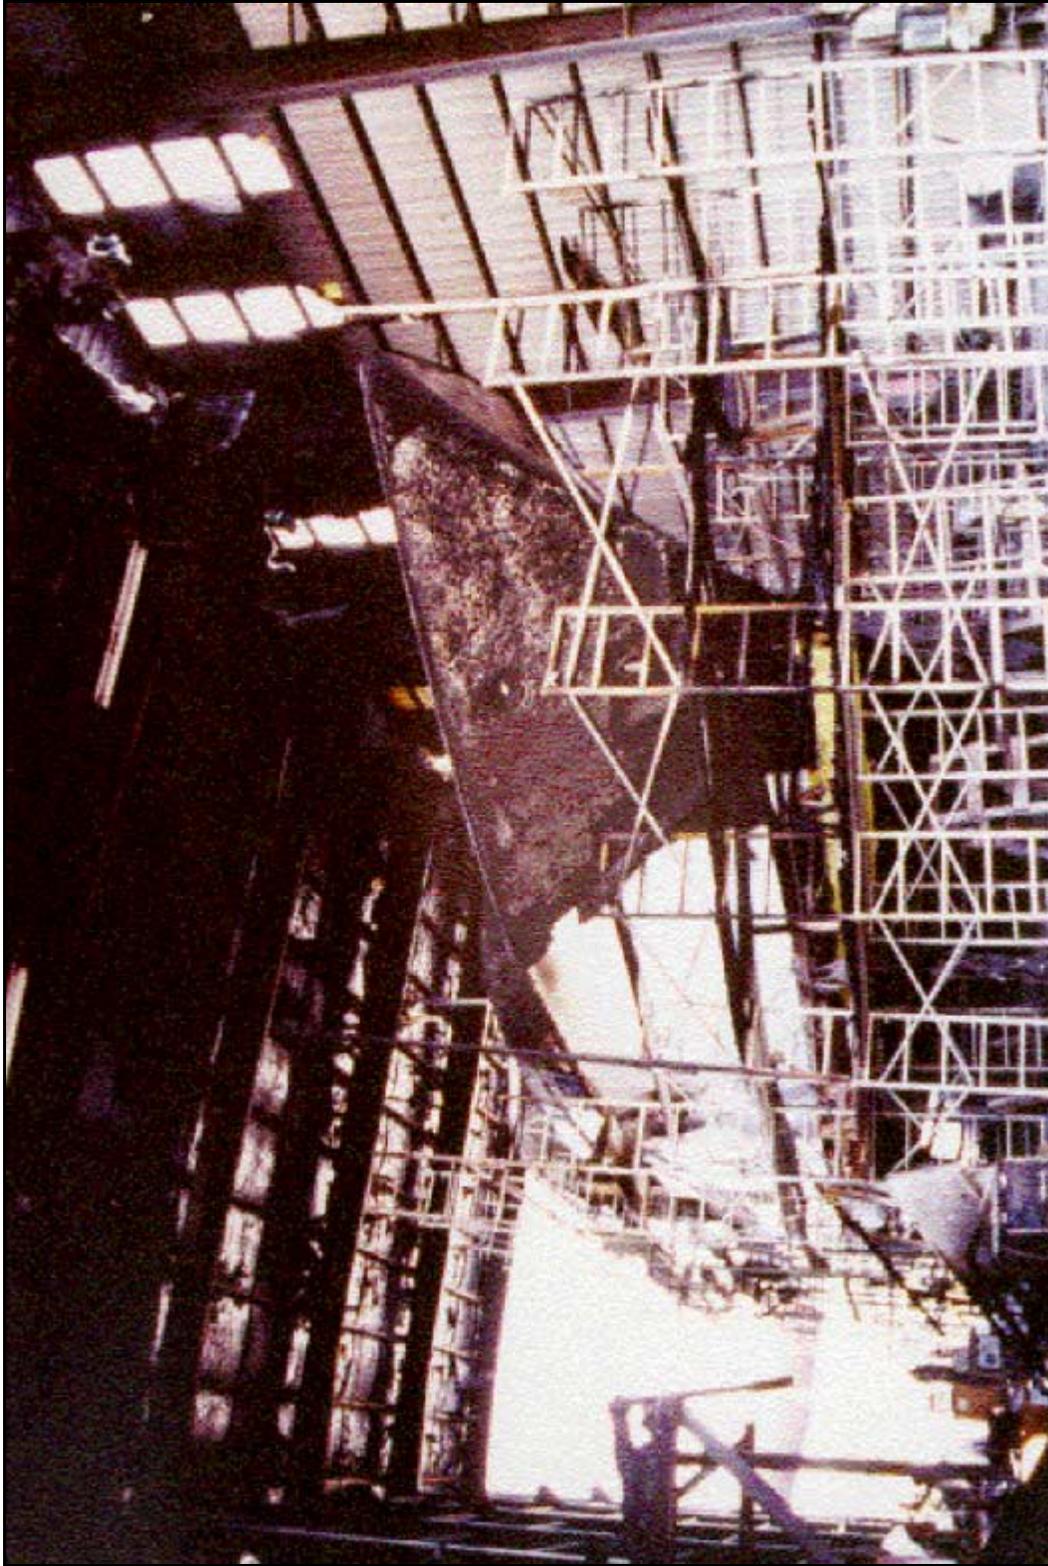
1. View of yacht under construction in Building B. Scaffolding constructed around the yacht hindered the fire-fighting efforts.

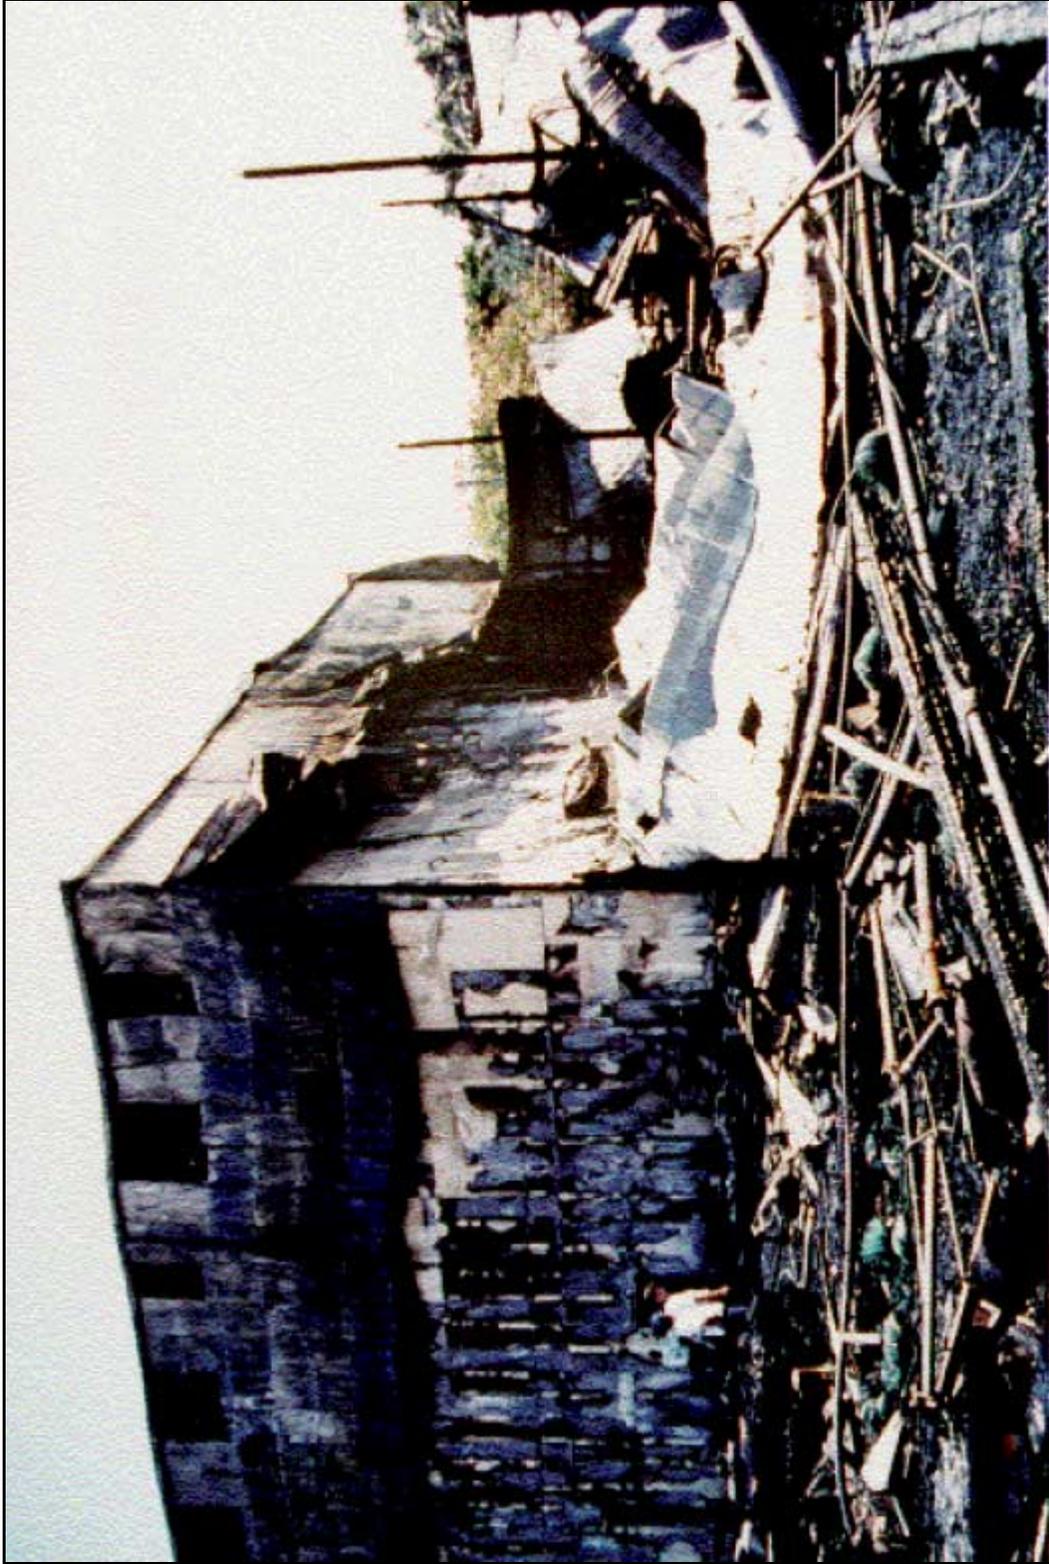
2. View looking east from Manufacturing Building (Building A) towards the destroyed Office Building (Building C).

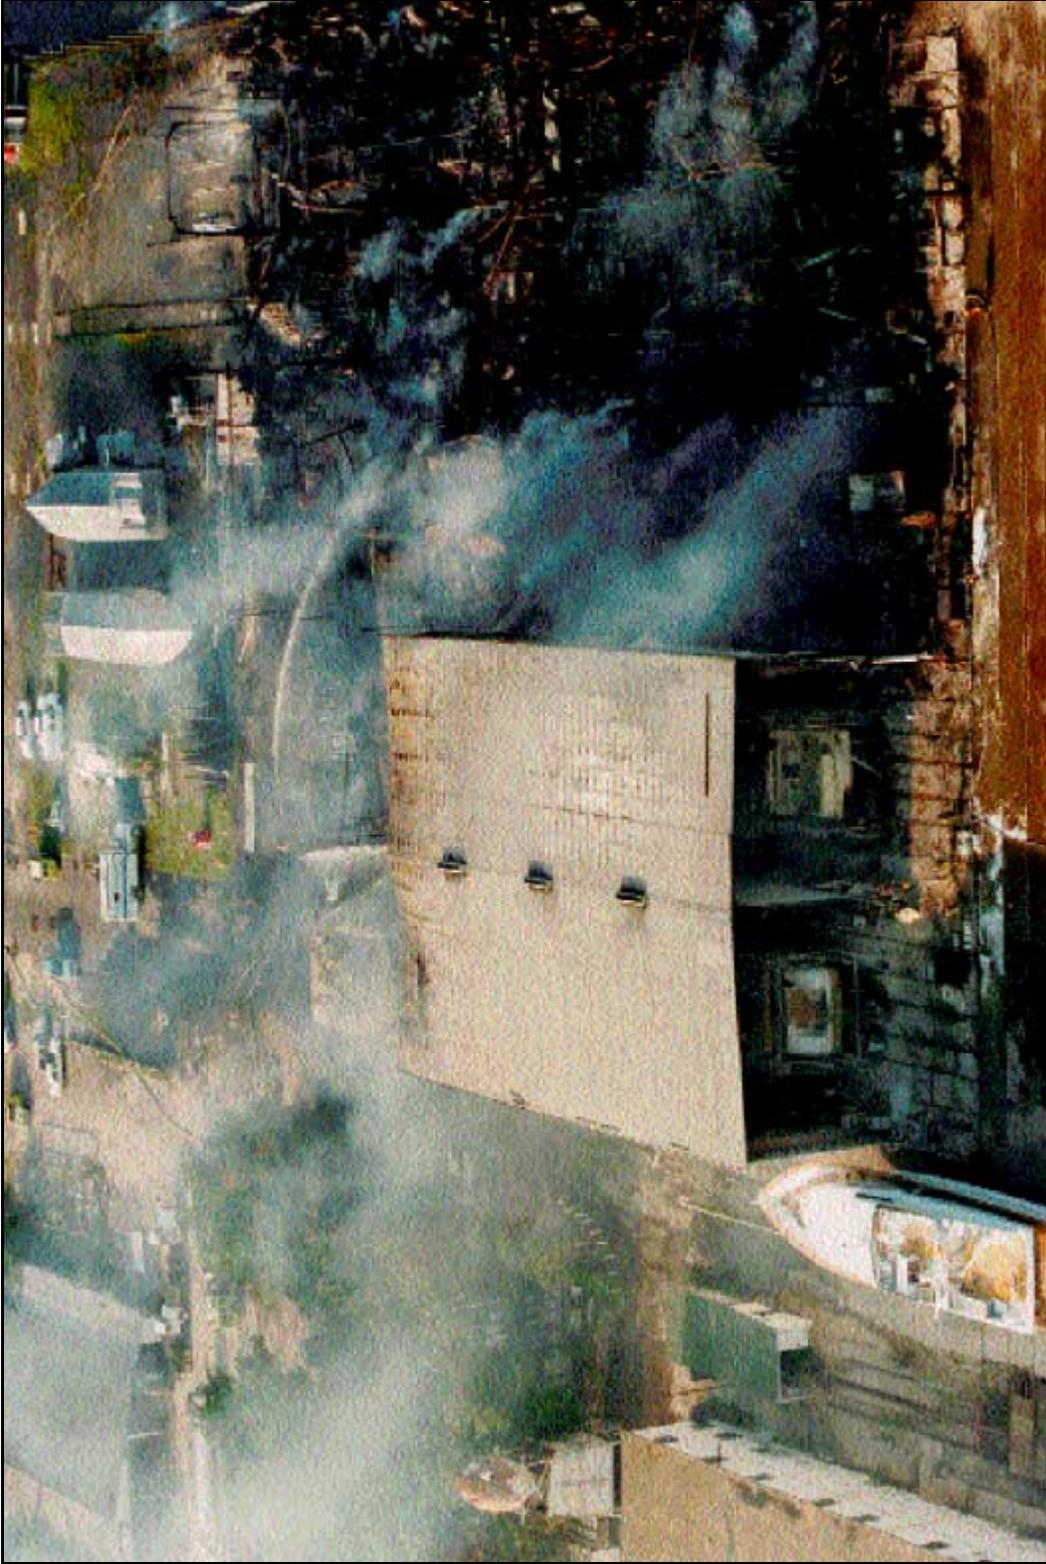
3. Aerial view of fire scene; the two boat hulls located at the top of the photograph are situated south of Building A.

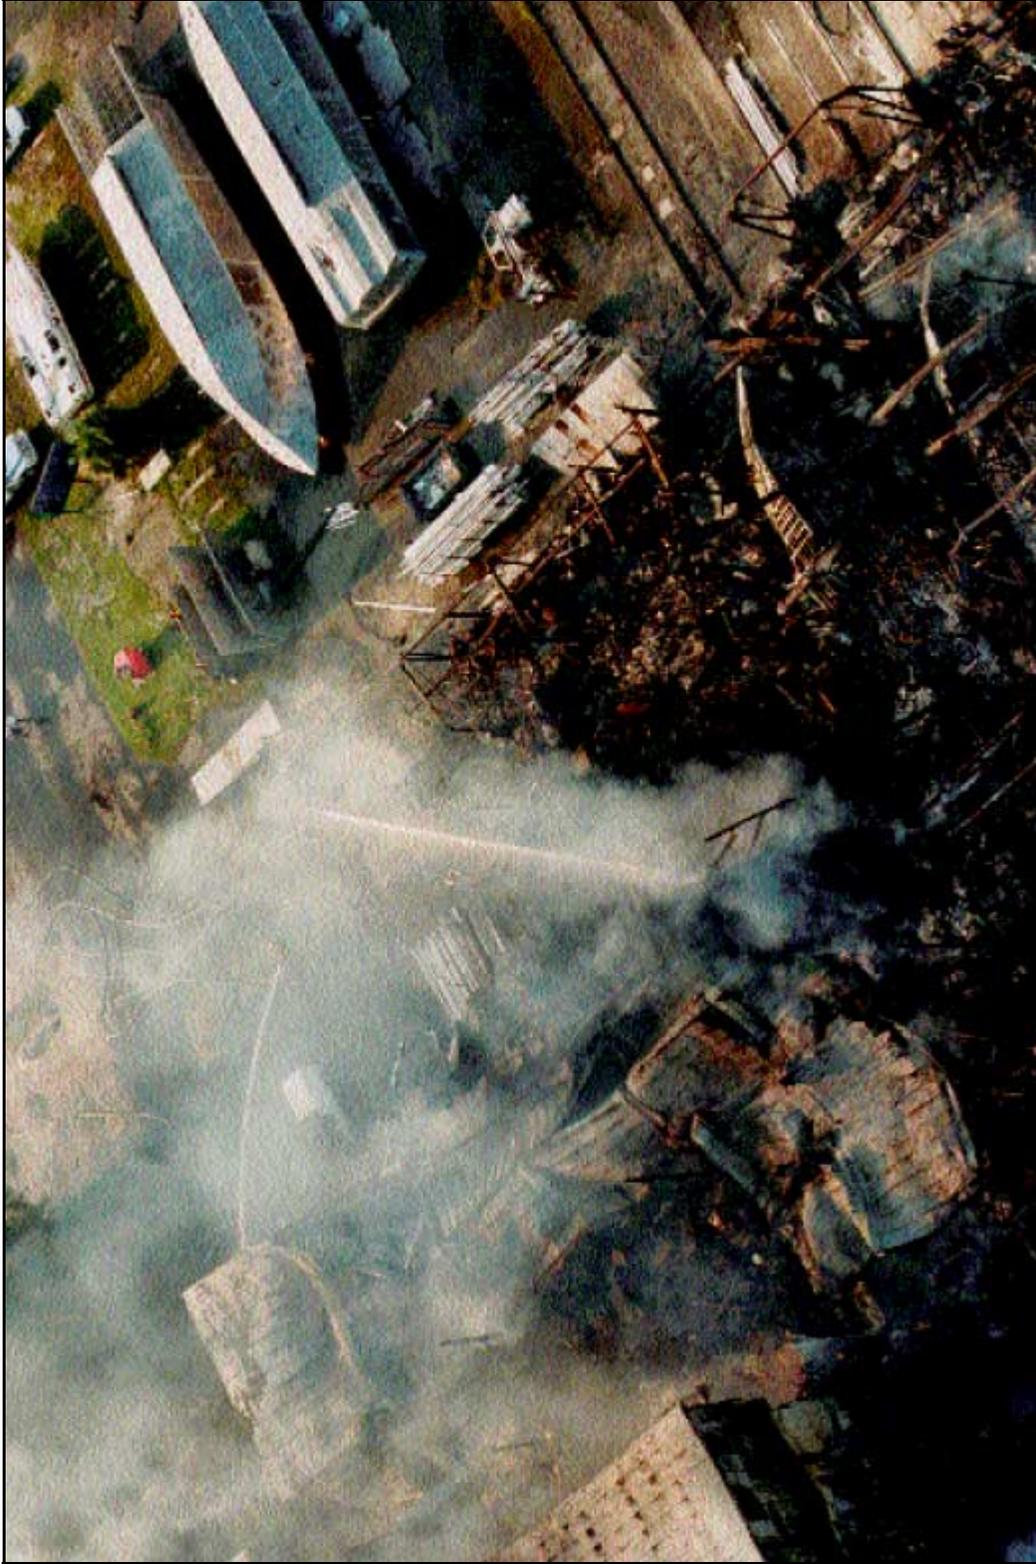
4. Aerial view of the south corner of the collapsed Manufacturing Building (Building A).

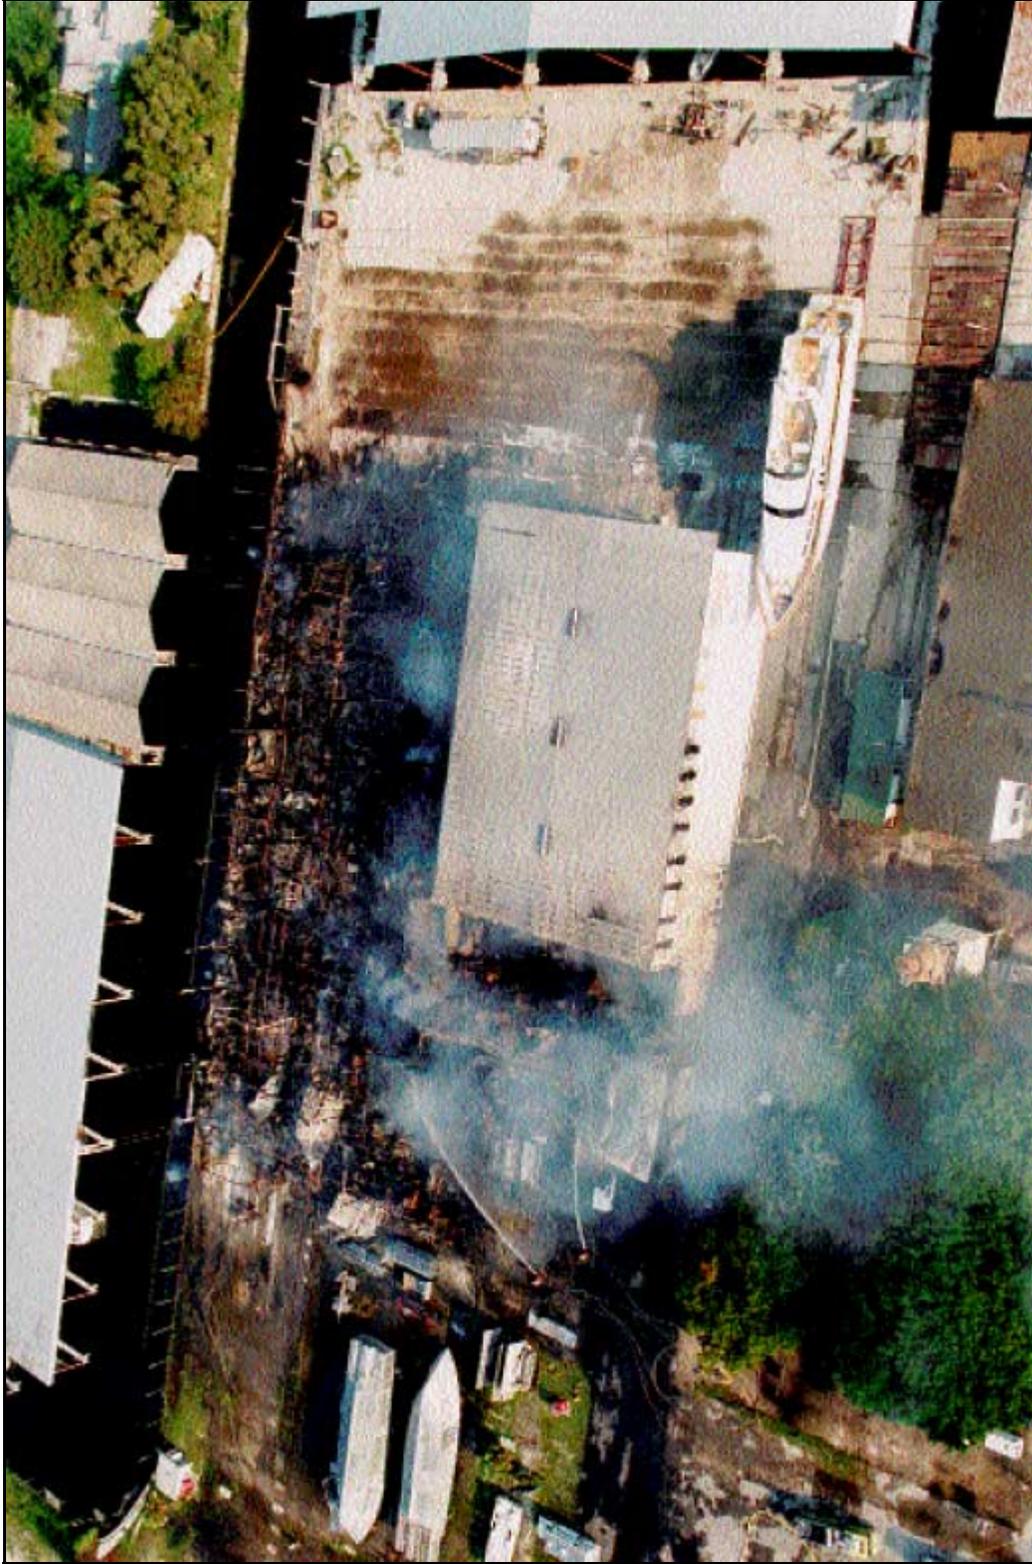
5. Aerial view of the fire scene, with the canal and neighboring covered boat slips (to the west) at top of photograph.
