Old Buckingham Station Chesterfield, Virginia

Old Buckingham Station

58 Unit Apartment Building

May 19, 1995

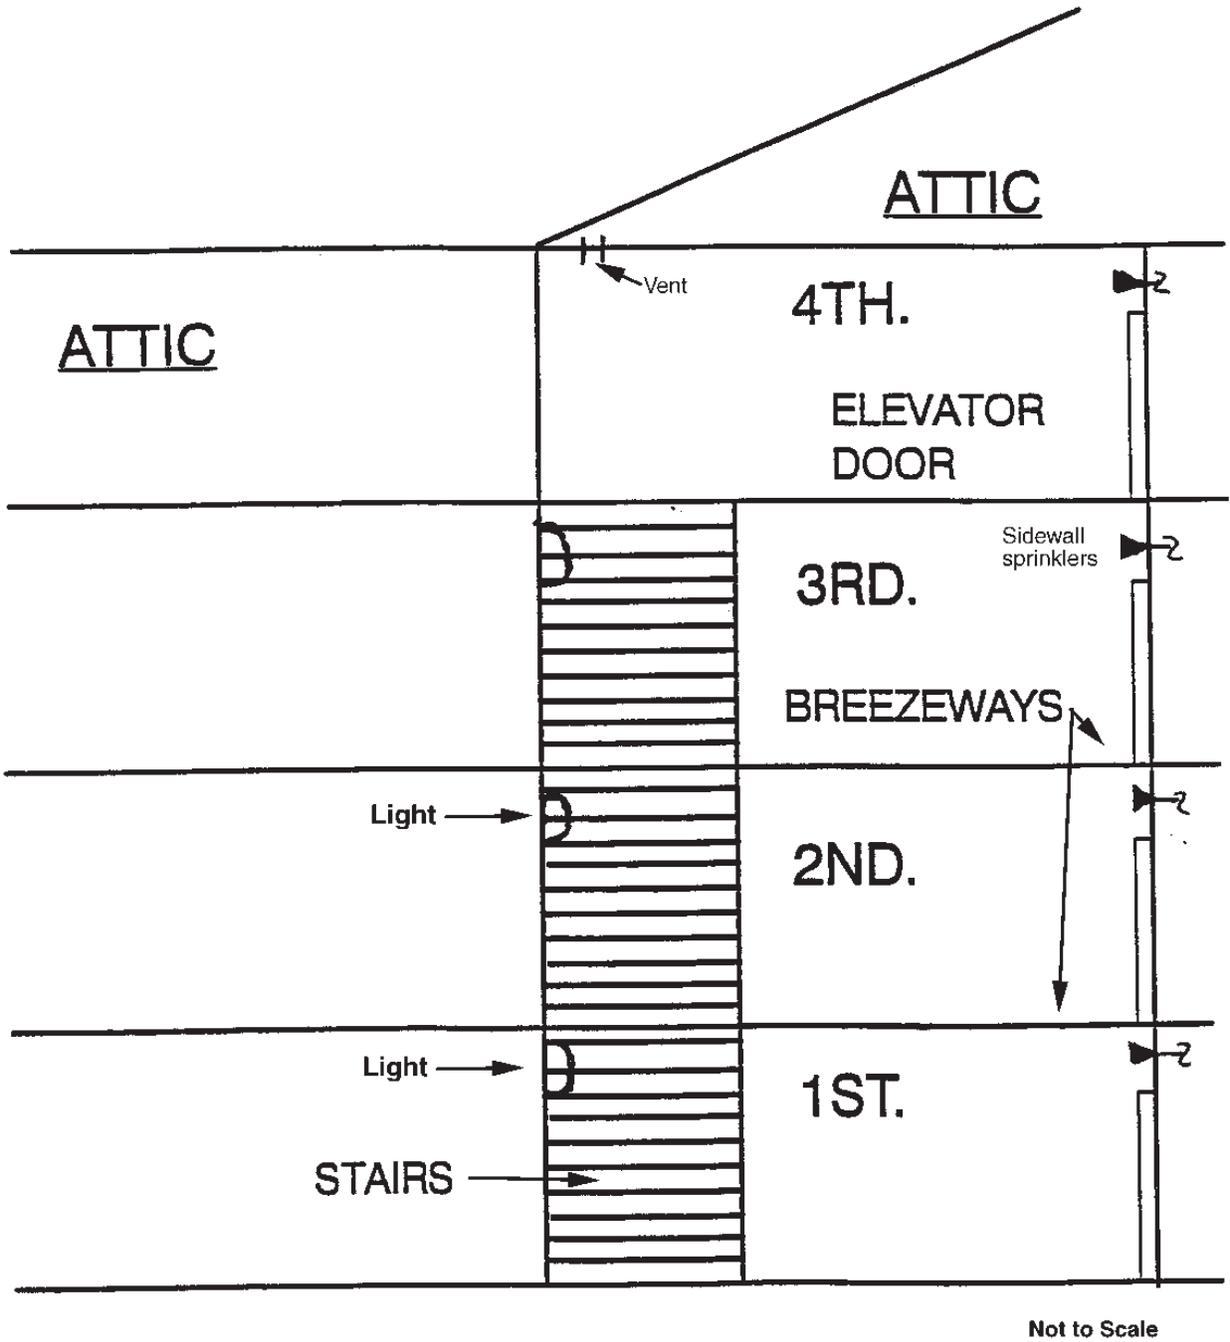
Section at Core Walkway
Lodge Building
 Appendix E

The siding fire quickly moved up the nearby open, wooden stairway before the sidewall sprinkler on the wall opposite the light fixture was able to operate. (See Appendix E for Section Drawing) The fire continued to burn upward until it reached the ceiling of the fourth floor open walkway. At this point it entered the combustible attic through a vent opening at the outside perimeter of the ceiling. The soffit vents in the fourth floor core area were located inside, rather than outside, the perimeter support beam for the roof. This design contained the heat and flames at the fourth floor ceiling and allowed them to pass through the vent into the unprotected combustible attic. Once in the attic, the fire was out of reach of the exterior sprinkler heads.

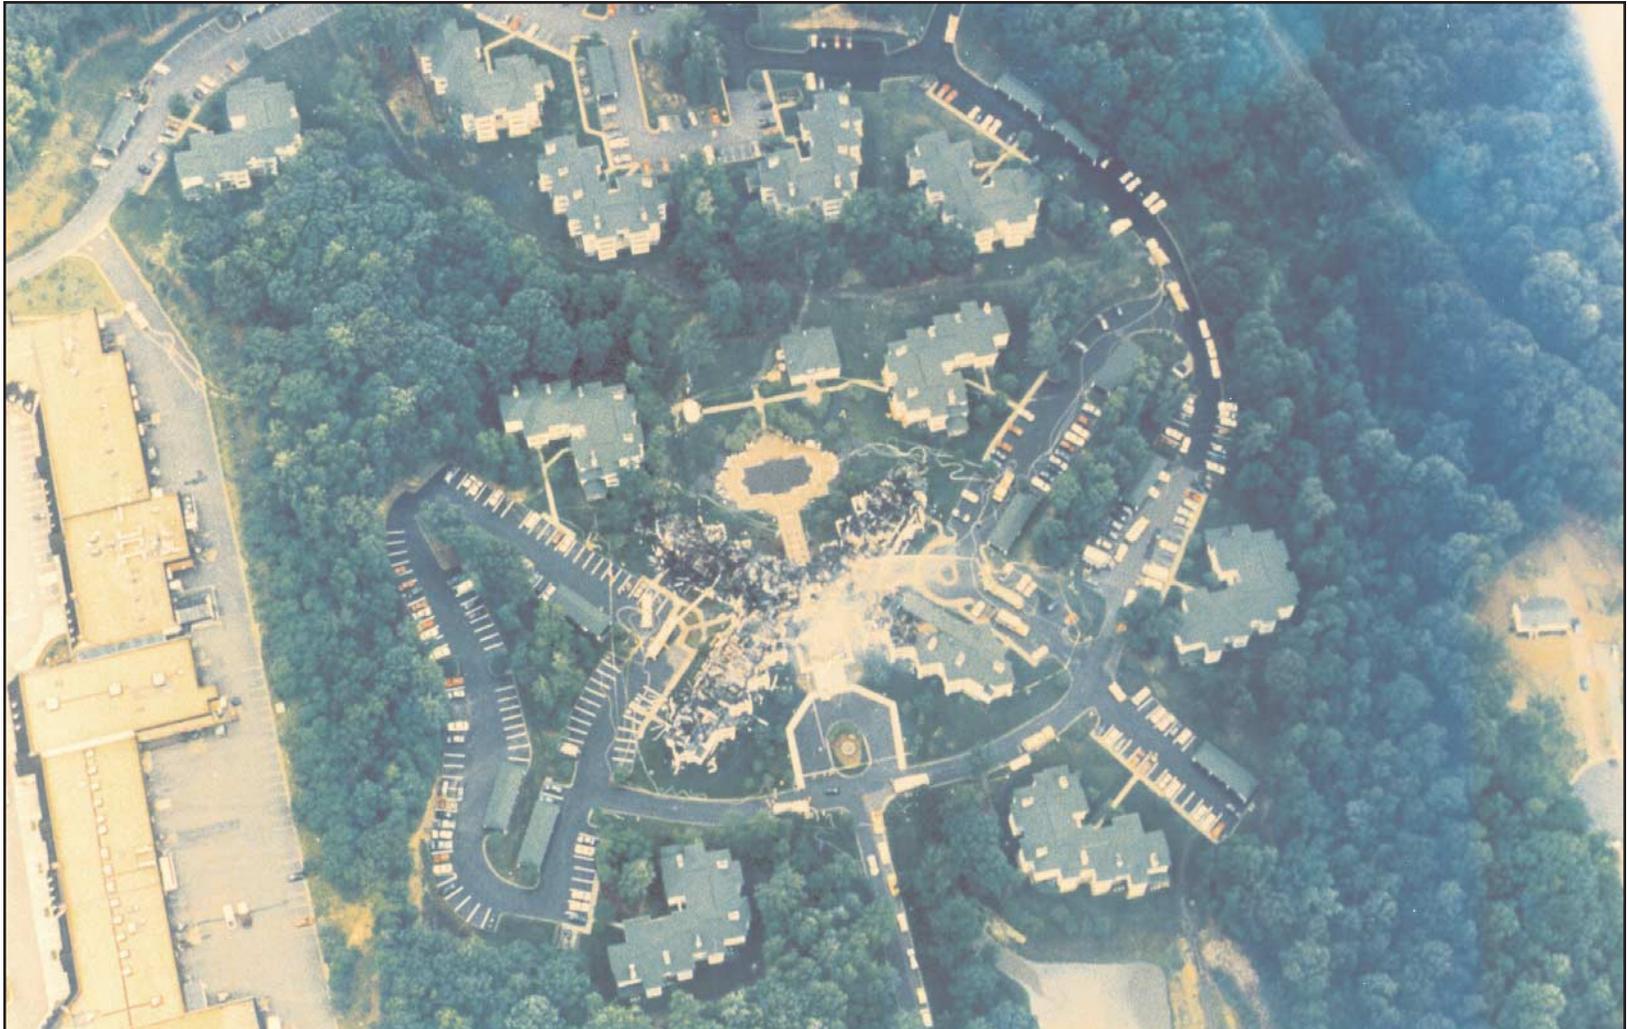
1. Site view of fire with north to the left. The shopping center and woods for the hand-stretched hose is on the left with Engine 73 still in position.

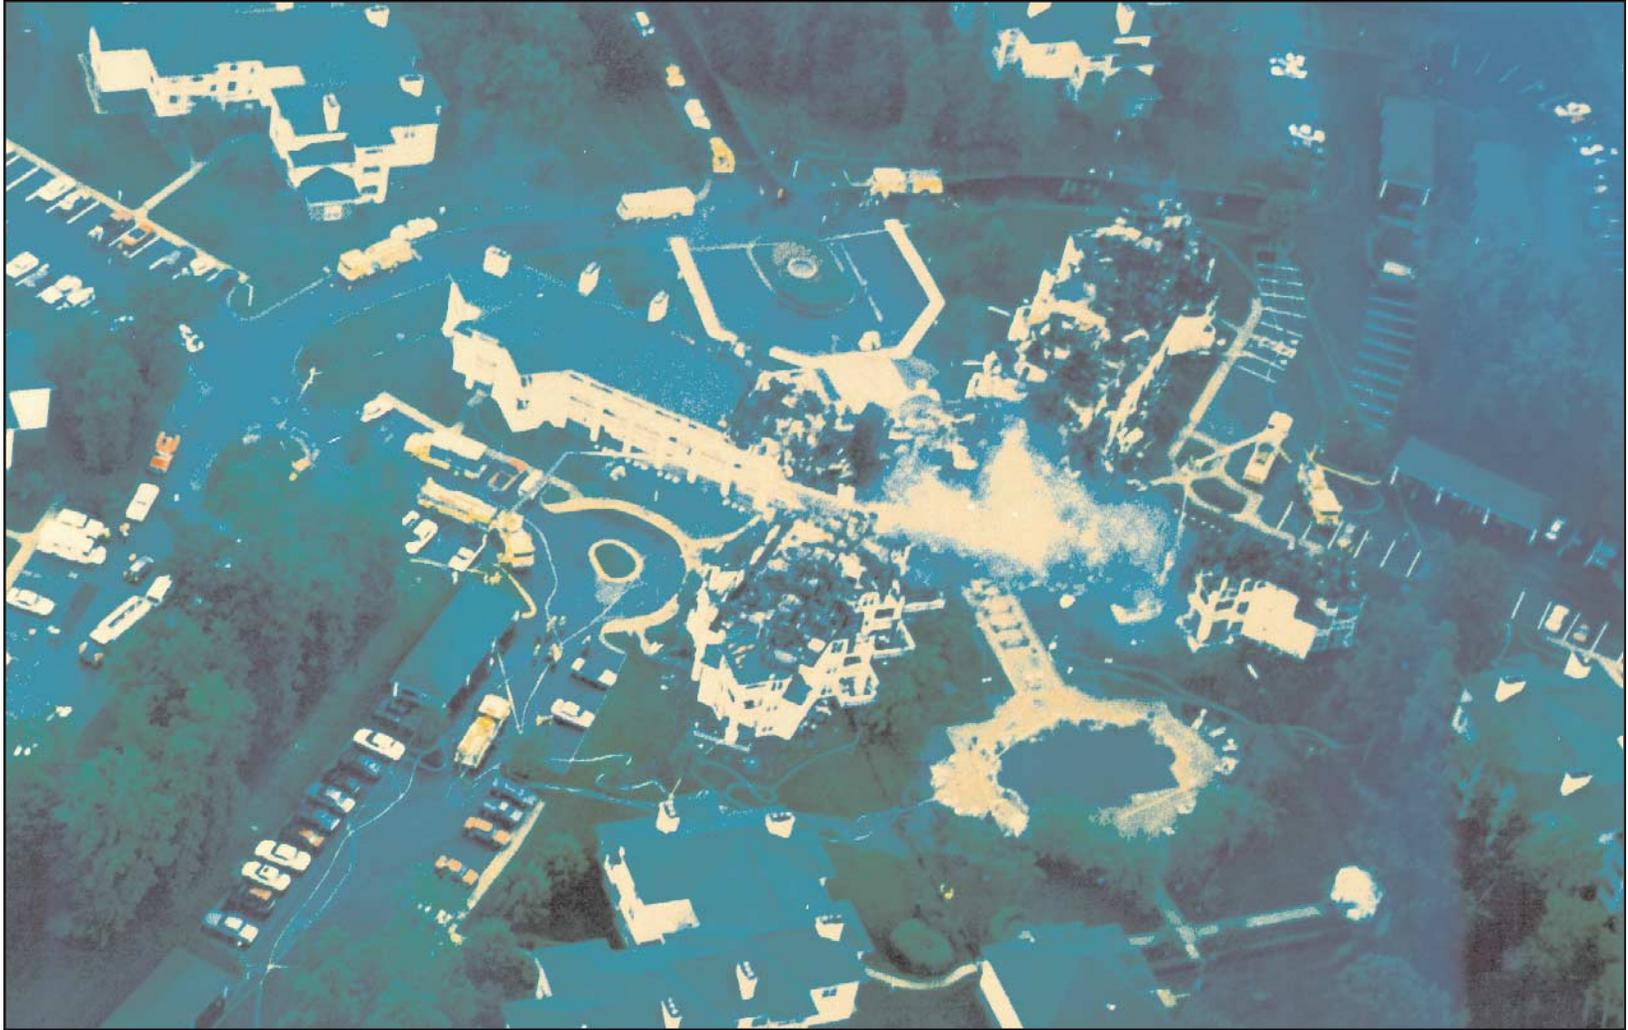
2. View of building with units still operating to complete extinguishment. North is to the left.

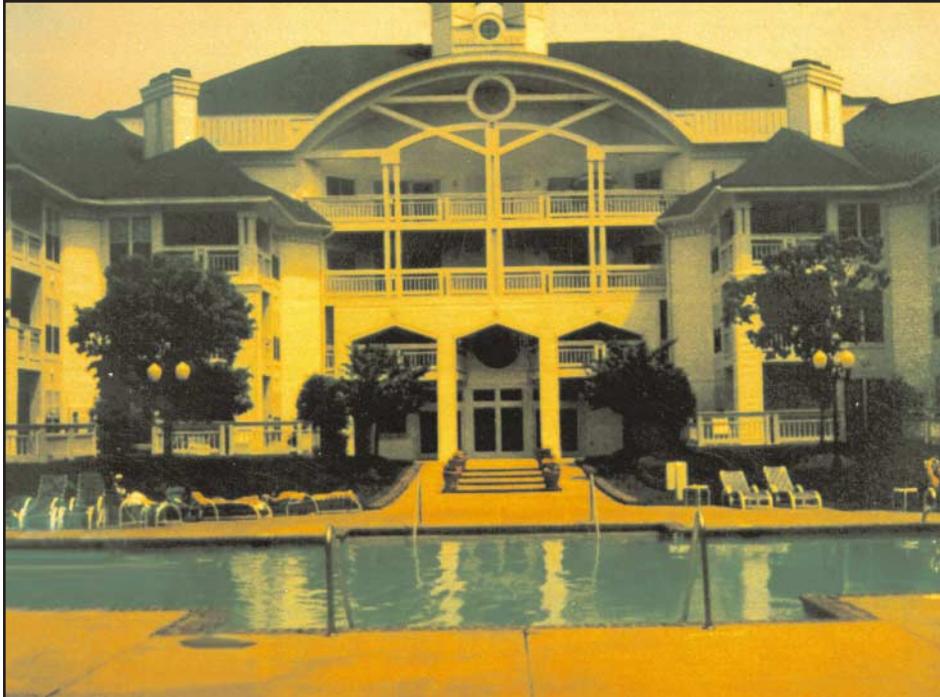
Fire investigators determined that the fire began on the second floor in a covered walkway between the northeast wing and the center core, just outside of apartment 2J. (See Appendix B for location) The cause was identified as an exterior light fixture that had been inverted from its usual operating position by one of the occupants and then wrapped with a flannel shirt to reduce the light intensity into their bedroom. The fixture's incandescent bulb was enclosed by a clear plastic globe. By inverting the fixture, the vent holes, which were intended to remove heat from the 60 watt bulb, were out of position and the plastic globe in combination with the flannel shirt held in the heat. This eventually resulted in the ignition of the shirt and the light fixture's plastic globe. The fire spread to the vinyl plastic siding and to the wooden stairway.

4. The rear or swimming pool side of the four story core building before the fire. The fire started on a second floor breezeway on the left side of this photograph.

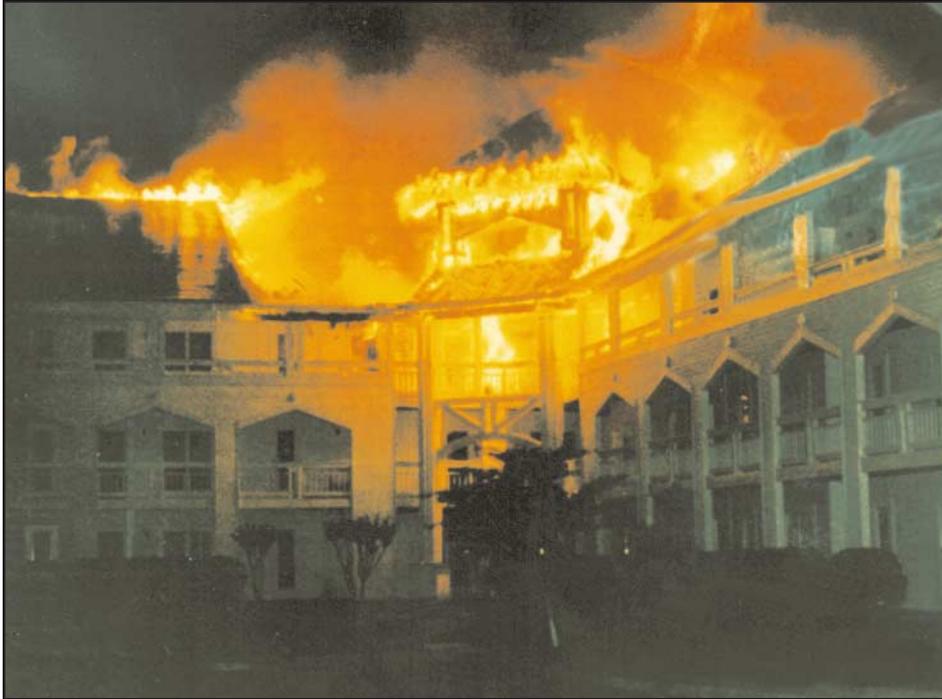
5. Fire involvement in Sector D (North side) as units were preparing to operate in this sector. The fire was well-established in the attic, third floor walkway, and fourth floor.

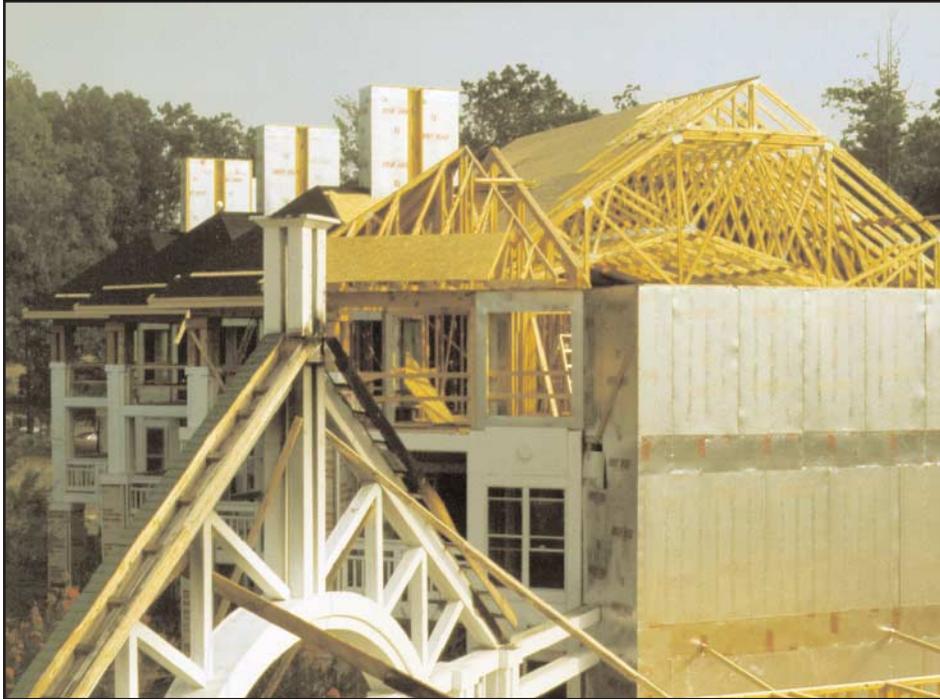
7. The remains of the front archway and the repairs and reconstruction underway for the wing in Photograph 6. The attic trusses and exterior sheathing materials are illustrated.

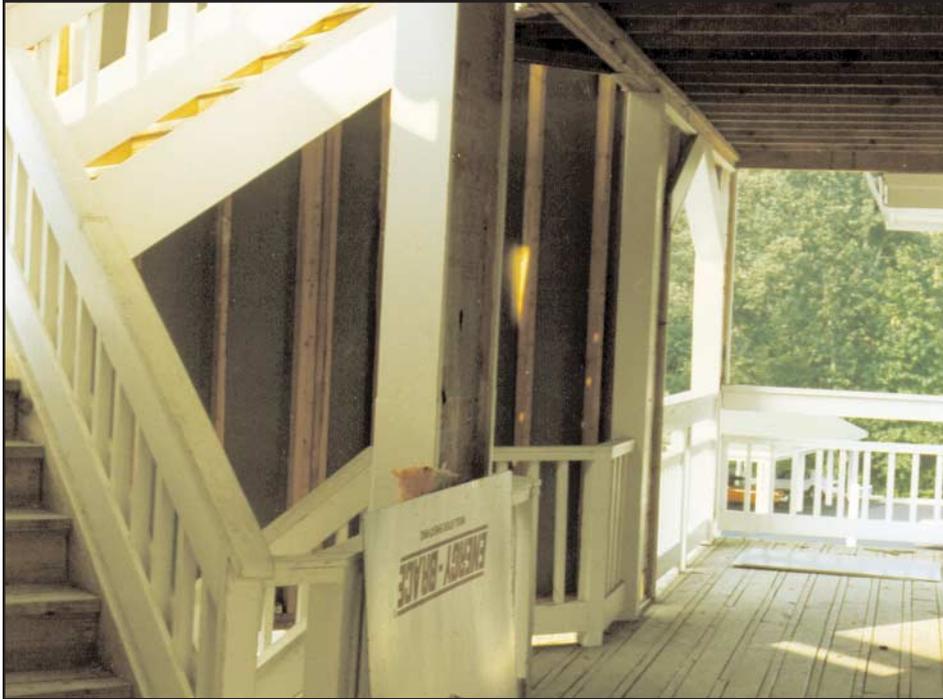
located at the core and the other at the ends of the wings (See Appendix C for diagram). The walkways were of wood construction and contained small gaps between the deck boards to permit water to drain through. With the exception of horizontal sidewall automatic sprinkler heads that were located near the two core stairways, the covered walkways were not protected by automatic sprinklers.

10. The stairway and exterior walkways used throughout the building. Note the gaps in the walkway to allow water to drain and the piece of thin exterior sheathing leaning against the stairway.

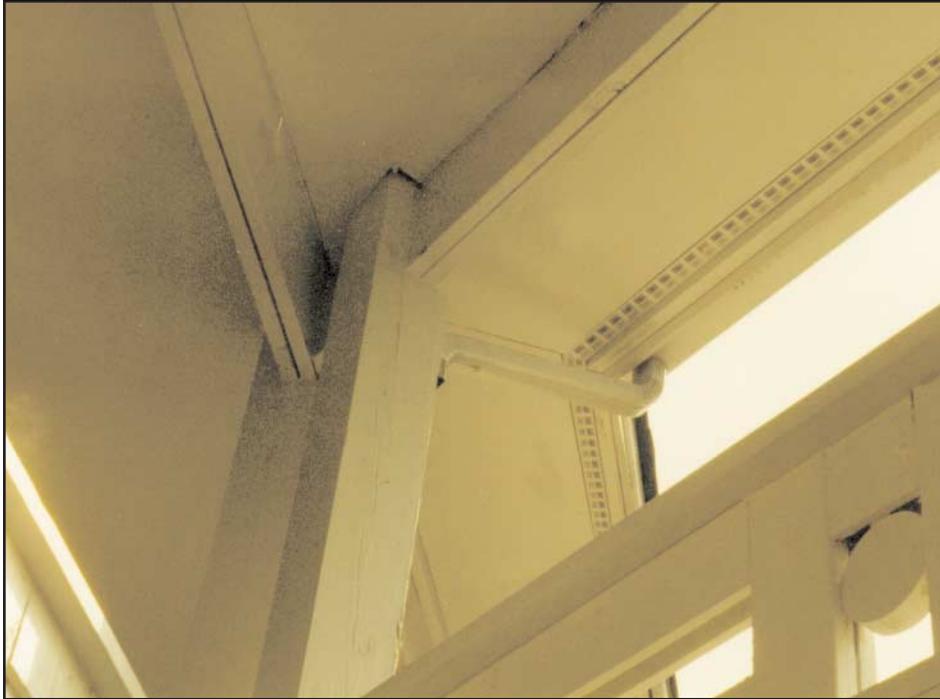
Ventilation Openings into Attic	Air vent openings at the building eaves permitted the fire to easily access the unprotected combustible attic space.
Fire Spread	The open combustible corridors and balconies and lightweight exterior wall finish supported rapid vertical and horizontal fire spread.

11. Typical eave line vents installed around the perimeter of the building. The fire is believed to have entered the attic through these vents.

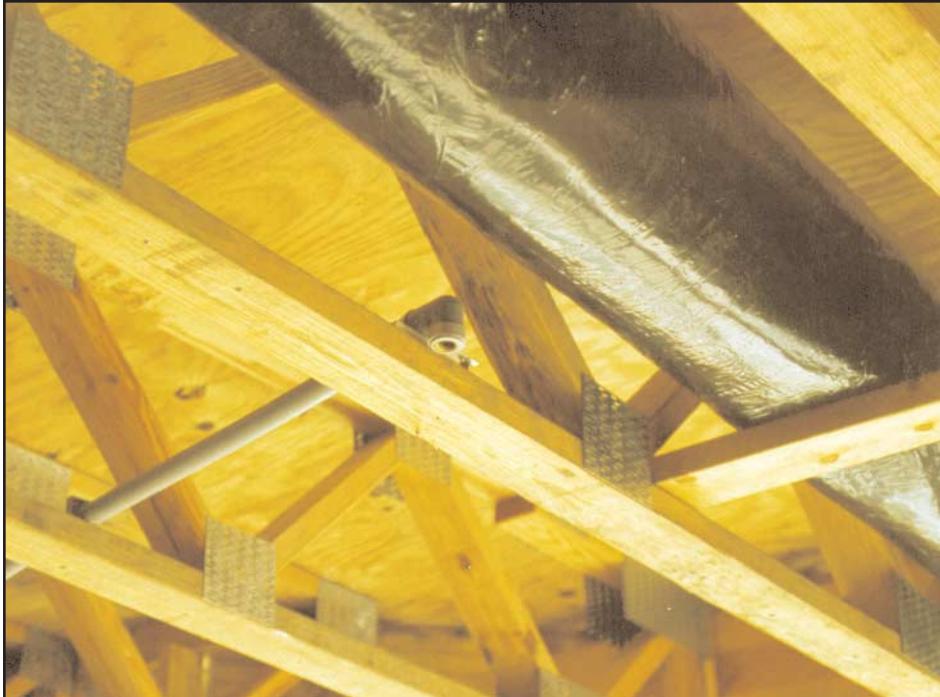
The sprinkler system used residential, quick-response sprinkler heads supplied by polybutylene piping in the apartments. The installation employed Underwriters Laboratories listed products and connection methods utilizing heat fusion rather than the mechanical type connections used with polybutylene plumbing.

12. The parallel cord wood floor trusses used in the original construction and a polybutylene automatic sprinkler line.
