St. George Hotel Complex 16 Alarm Fire

Brooklyn, New York

Investigated by Scott M. Howell

August 26, 1995

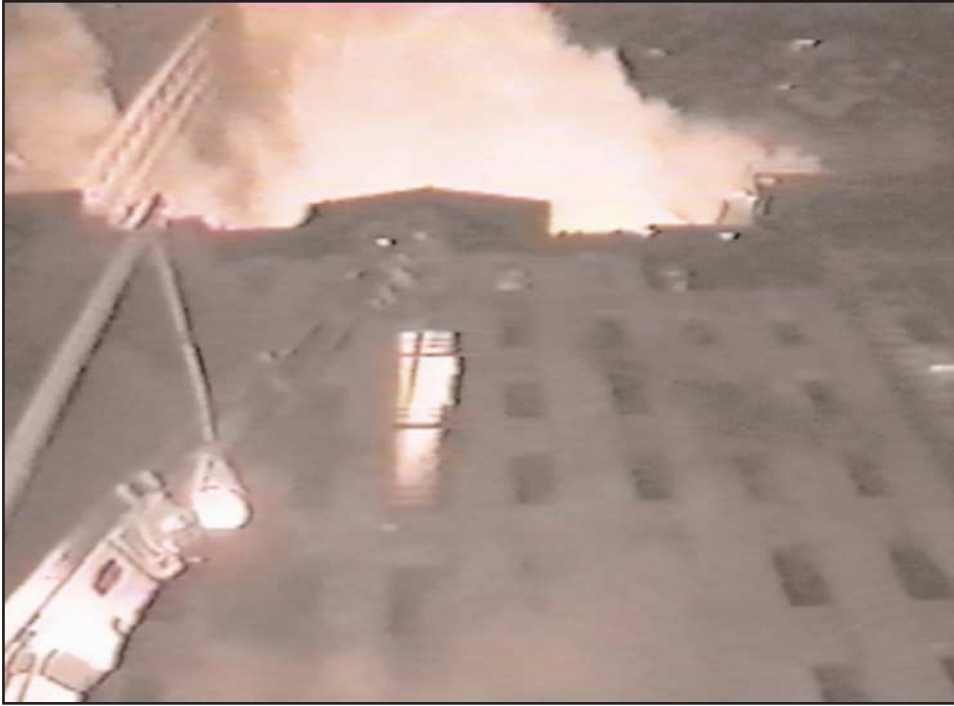
2. Later conditions on the front of the Clark building from street level.

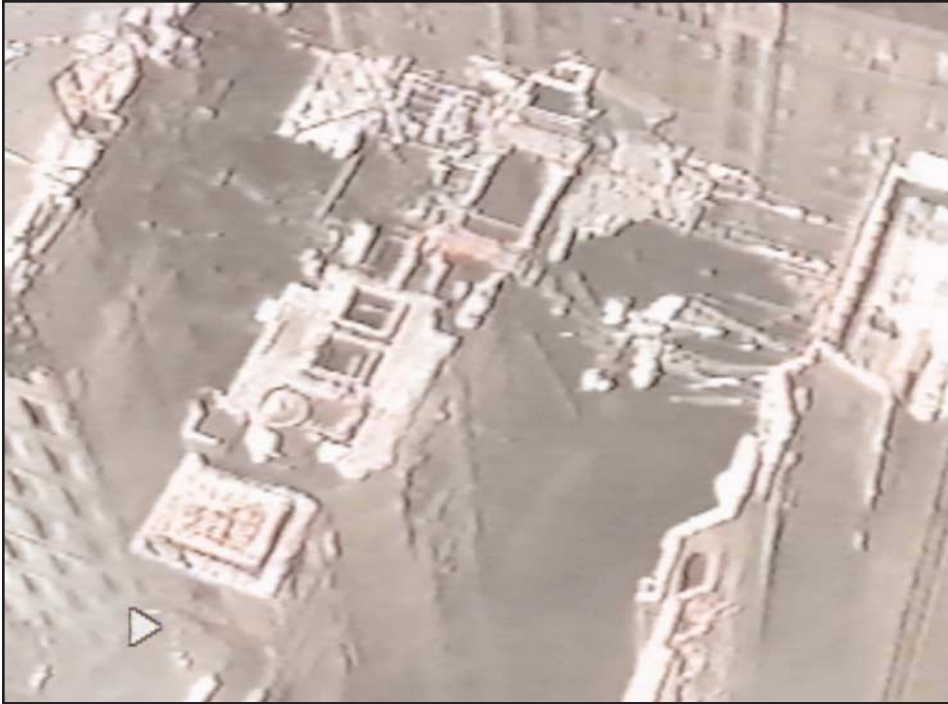
The masonry bearing walls were all that remained of the original fire building. Virtually all combustible materials had been consumed. Residents of many of the surrounding buildings were not allowed back into their apartments until the walls were demolished due to the collapse danger. Fire companies remained on the scene for several days putting out spot fires.

7. The rear of the Clark building after the fire. The Tower Building and Grill Building is out of the picture to the right.

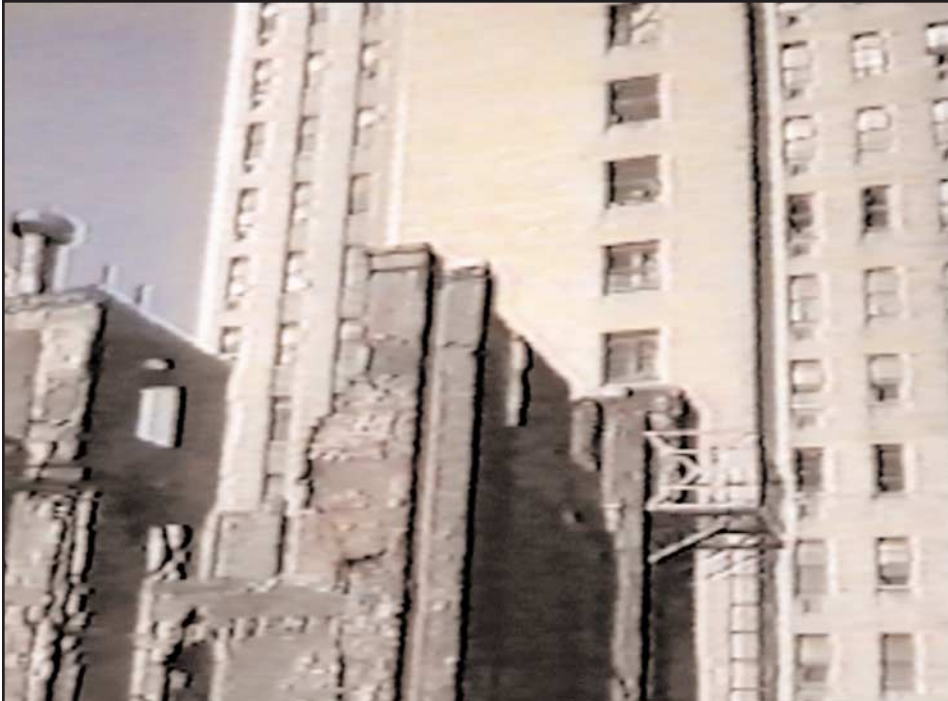
8. The Tower building and Grill Building with the 31 story Tower building in the background.
