Seven-Fatality Christmas Tree Fire Canton, Michigan

**Seven-Fatality
Christmas Tree Fire
Canton, Michigan
(December 22, 1990)**

This is Report 046 of the Major Fires Investigation Project conducted by TriData Corporation under contract EMW-90-C-3338 to the United States Fire Administration, Federal Emergency Management Agency.

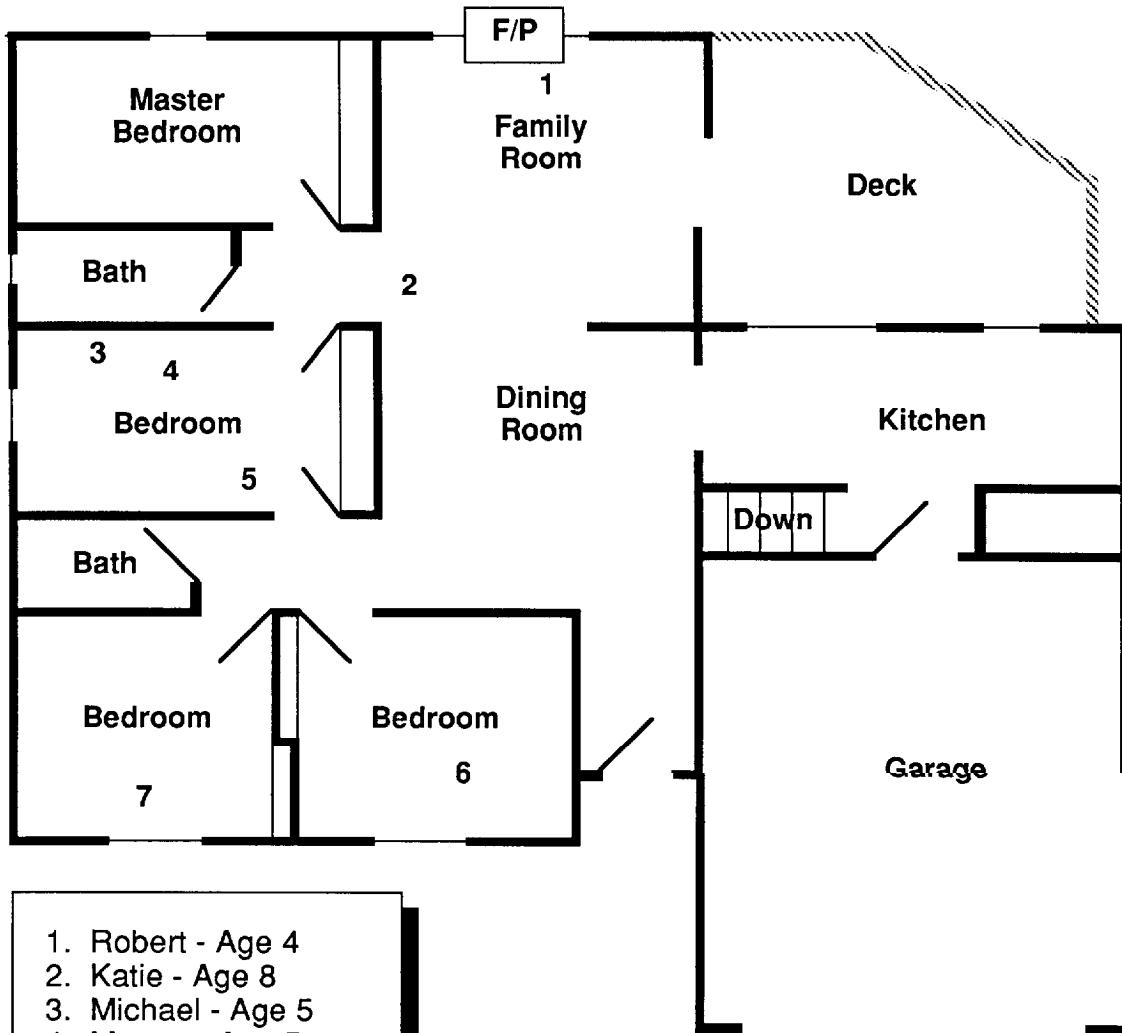
**DELL'ORCO HOME
LOCATION OF VICTIMS**

The fire was extinguished by the Canton Fire Department and the bodies of the six children and the father were located. The body of the four-year-old boy was found in the family room, he apparently could not escape or did not know what to do. One child's body was found at the juncture of the master bedroom hallway and the family room, this child apparently left the bedroom and moved toward the fire.

Three of the children's bodies were found in the fire-consumed bedroom. One was located under the bed. Another was located at roughly the center of the room and appeared to have been crawling toward the

One child's body was found in a heavily smoked front bedroom. This body was located along the edge of the bed in a head down dangling position. Apparently this child, after becoming aware of the fire, did not have time to escape.

The father's body was found in the other heavily smoked front bedroom. His body was located just a few feet from the front window. It appears that he had not gone very far in his rescue attempt.

- 1. Robert - Age 4
- 2. Katie - Age 8
- 3. Michael - Age 5
- 4. Megan - Age 5
- 5. Sara - Age 9
- 6. Bonnie - Age 12
- 7. Martin - Age 38

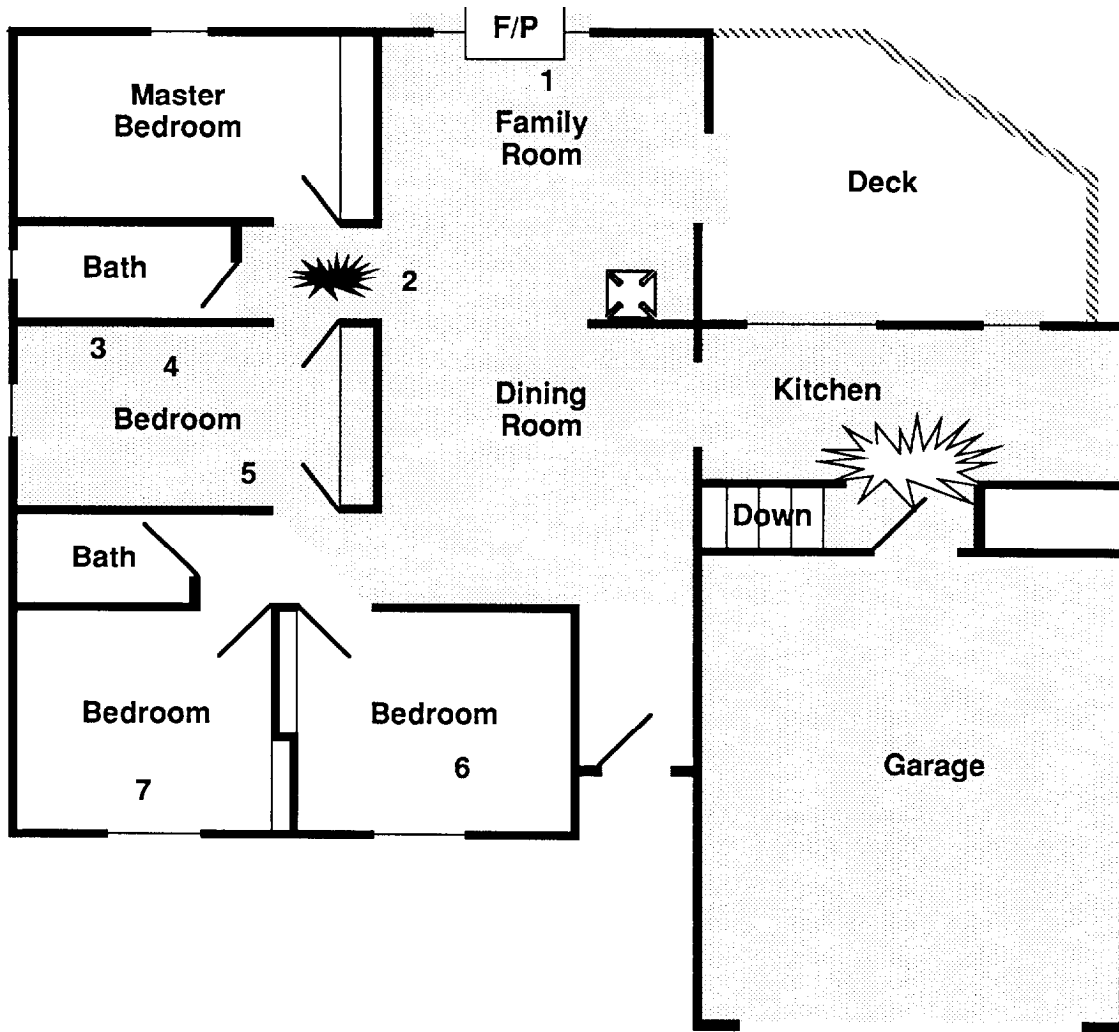
FIRE ORIGIN AND SPREAD

The Canton Fire Department has determined the origin of this fire to be a Christmas tree located in the corner of the family room adjacent to the dining room. The suspected ignition source of the fire was overheated or defective Christmas tree lights that were purchased this year and used for the first time. A contributing factor to the quick fire development was the unusual dryness of the Christmas tree. The fire consumed all available combustibles within the family room.

The horizontal fire spread was from the family room to one bedroom, dining room, kitchen, and garage. The fire consumed most of the combustible material in its path. Factors that may have influenced the horizontal fire spread could have been the wind direction and ventilation of the fire. The wind direction during the fire was not documented by the investigators but the predominate wind in this area is from the west. The fire was vented by the occupants in their attempts to remove the burning tree and the various rescue attempts that left doors and windows open.

The vertical fire spread was from the family room into the concealed attic space and then through the roof to the outside of the home. The fire spread into the attic space was through an attic fan penetration of the ceiling, which was located in the master bedroom hallway a few feet off

the family room. The fire then vented to the outside along the roof ridge above the kitchen. The structural components of the concealed space, including roof and ceiling structure, were partially consumed by fire. The structural components at the point of outside ventilation were consumed by fire.

Smoke and heat damage to the home was extensive. The remaining three bedrooms and the two bathrooms on the first floor along with their contents were not penetrated by fire. These rooms received extensive smoke damage and some heat damage as evidenced by heavy soot and minor pyrolysis of interior finishes. The basement of the home received some smoke damage and extensive water damage. The fire loss to the home is estimated by the Canton Fire Department to be \$100,000 to the structure and an additional \$50,000 to the home contents.

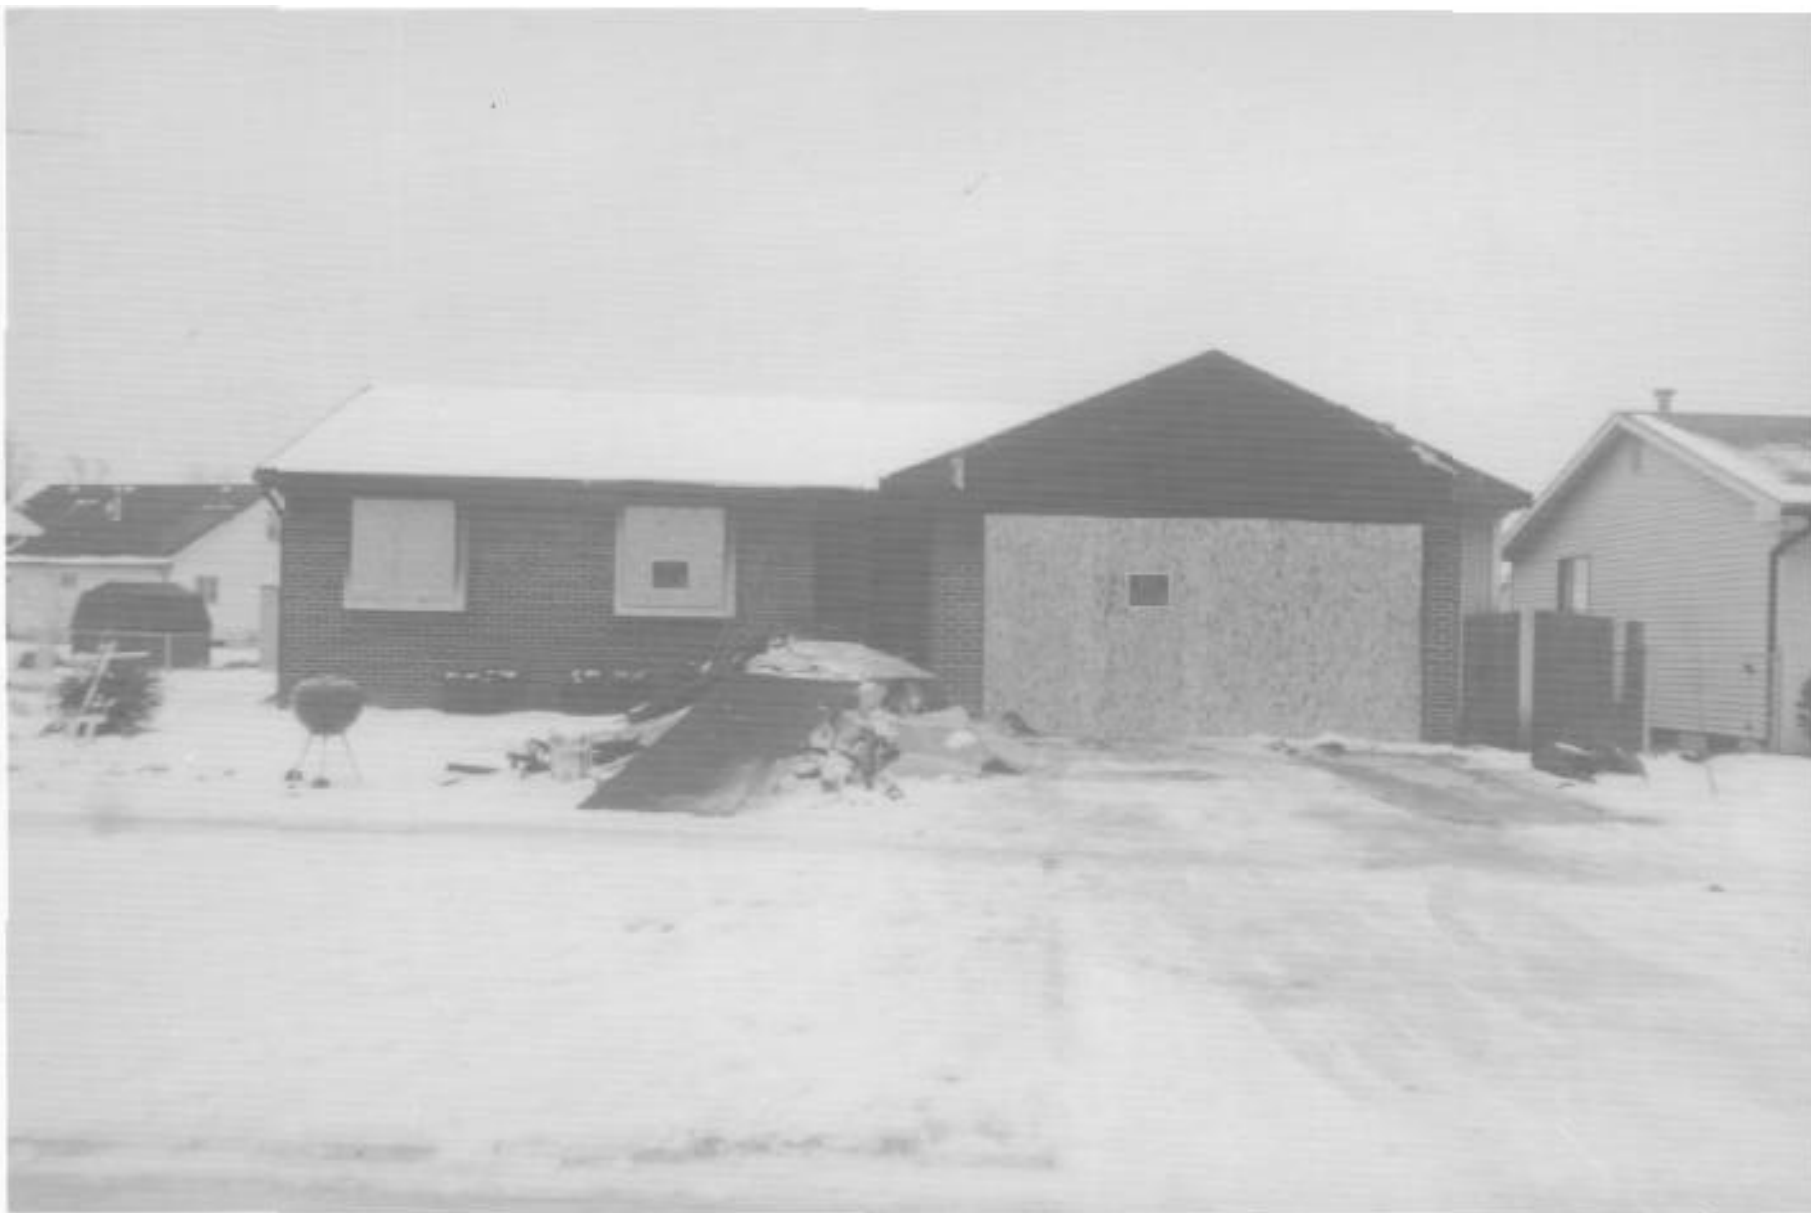
Front view of the Dell'Orco home, with evidence of fire venting through the garage door opening.

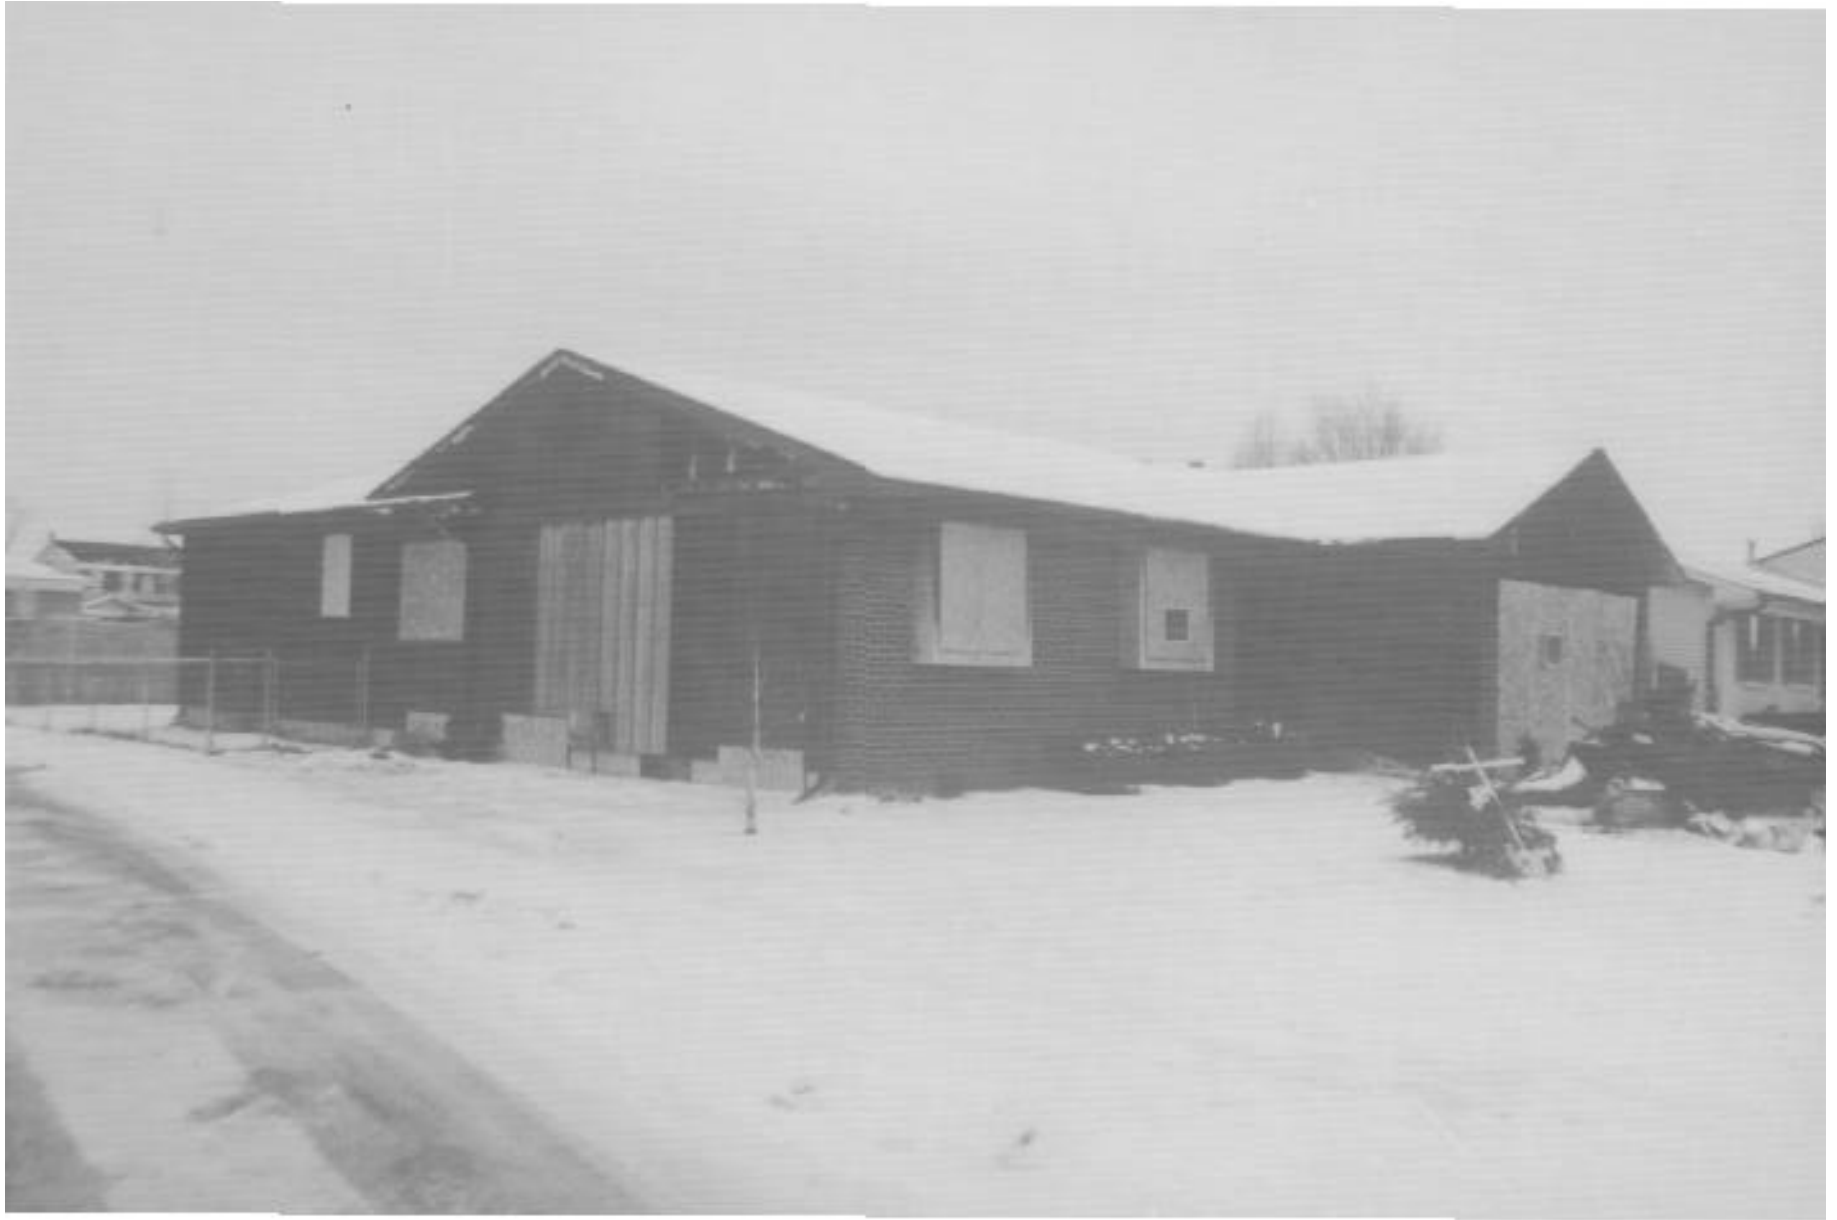
Front view of the home and exposure side two.

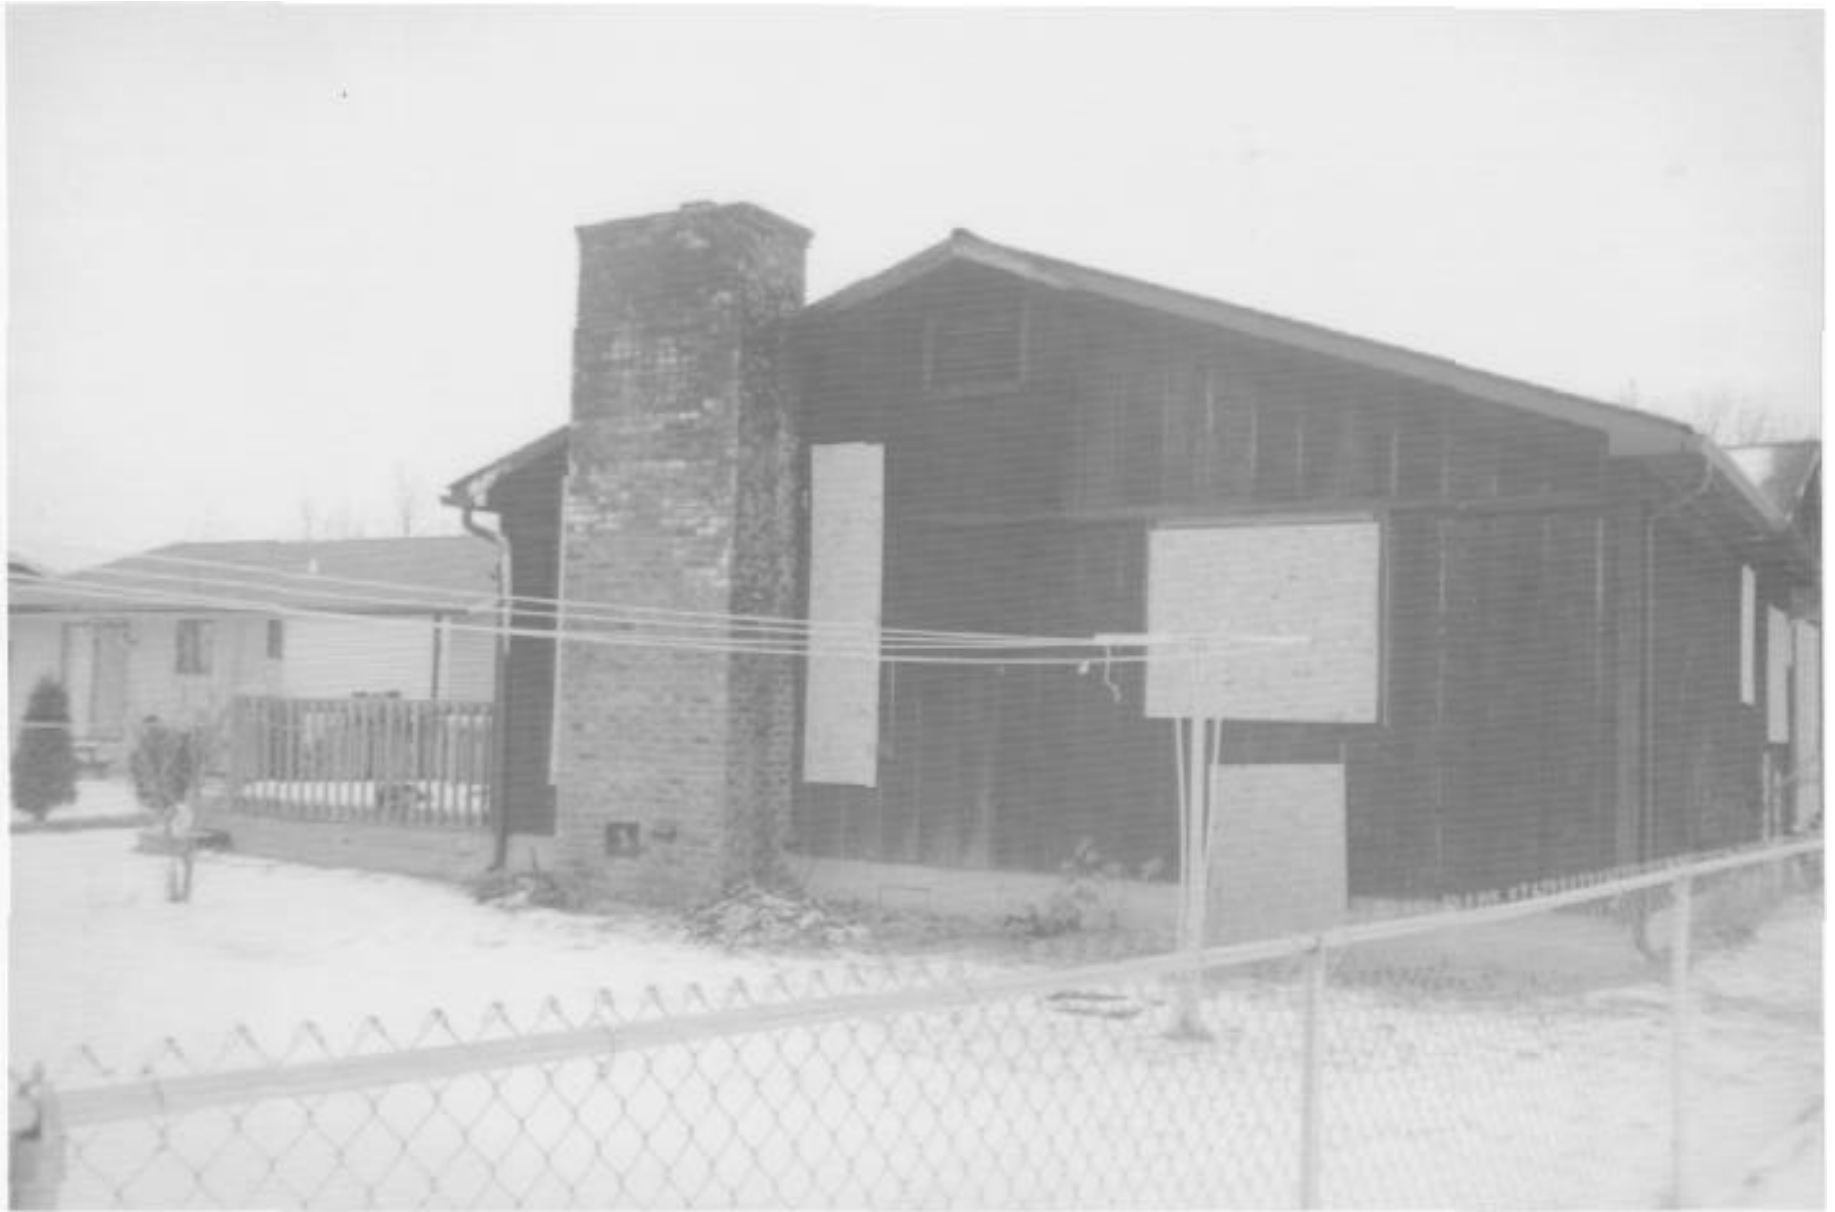
Rear view of the home, with no evidence of fire venting through the rear bedroom window.

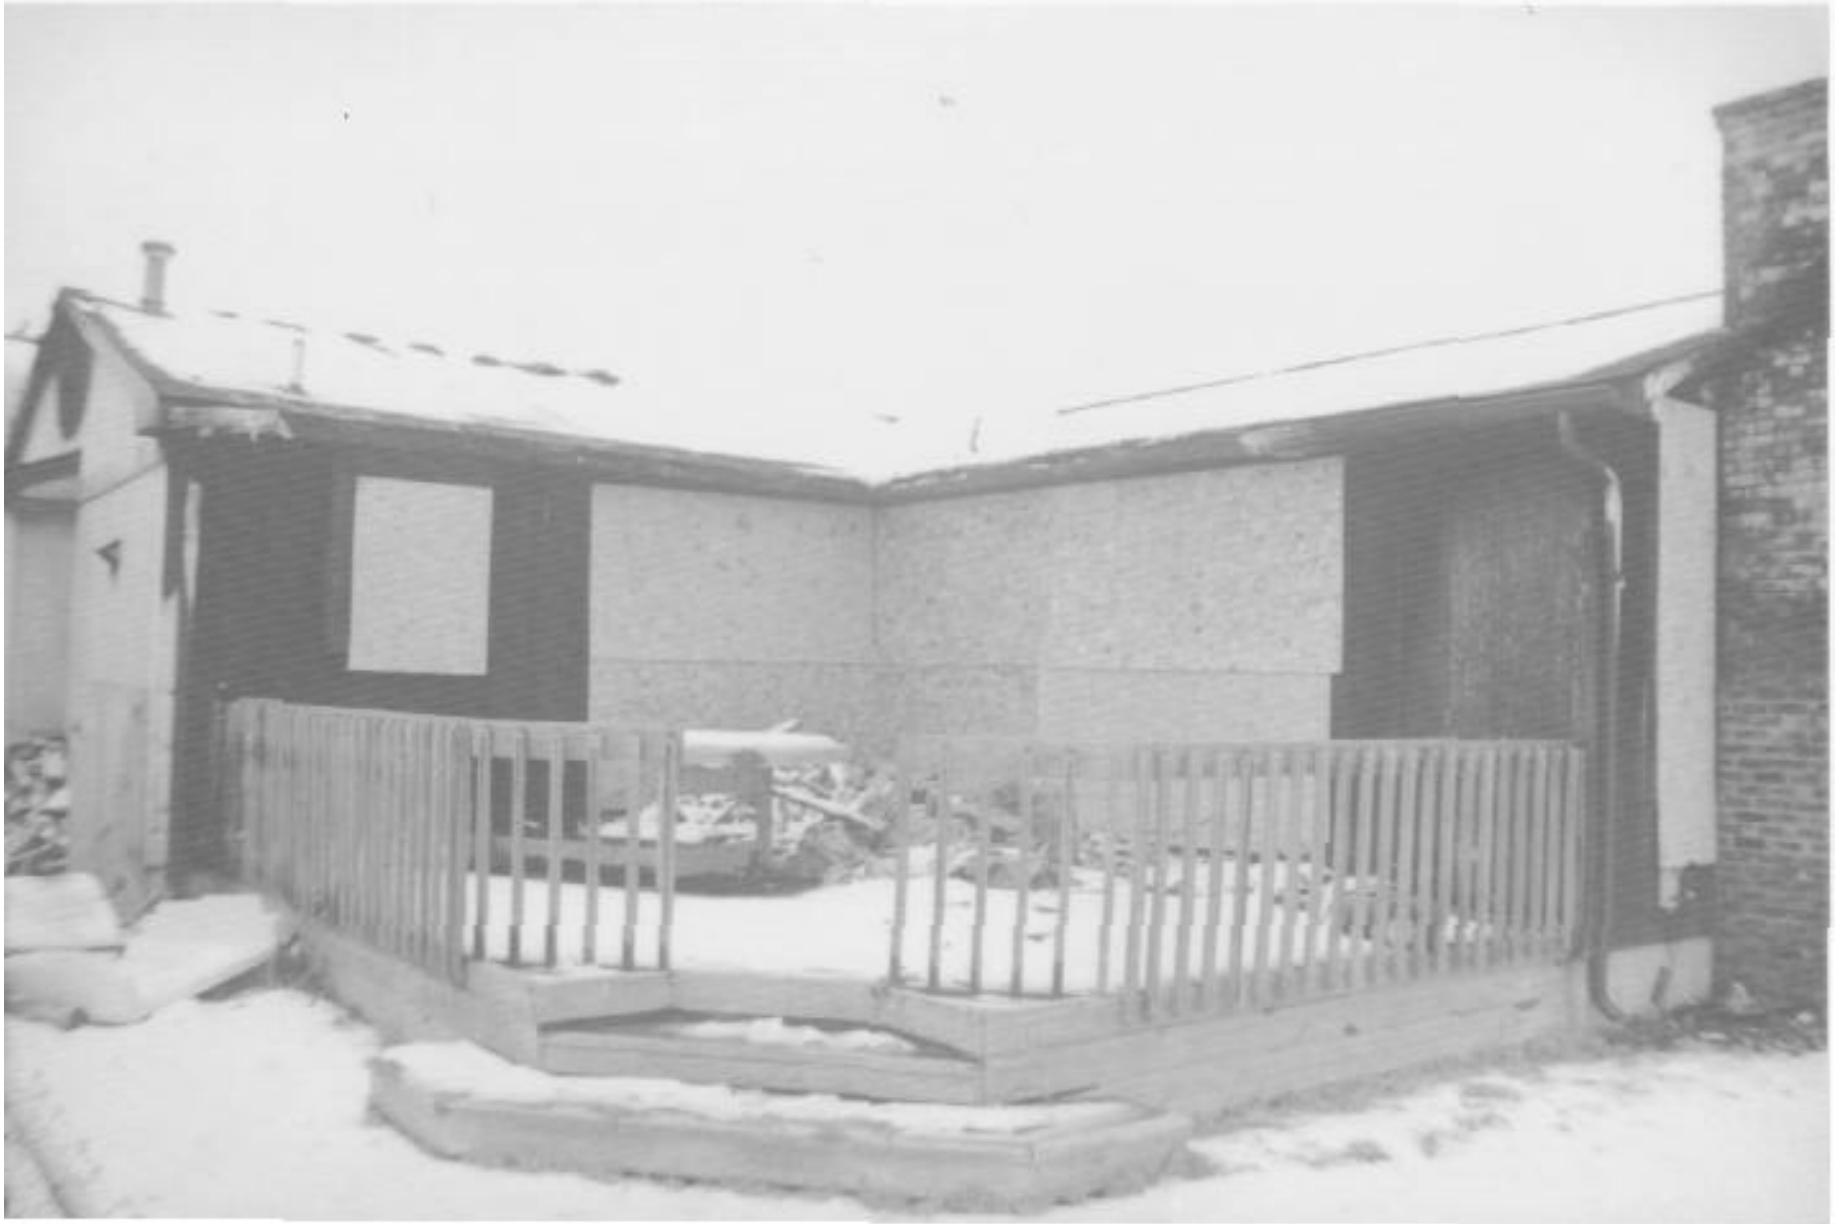
Rear deck. The French door opening to the family room is on the right, and the doorwall to the kitchen on the left,
