Technical Report Series

Fire Apparatus/Train Collision Catlett, Virginia

**Fire Apparatus/Train Collision
Catlett, Virginia
(September 28, 1989)**

September 28, 1989

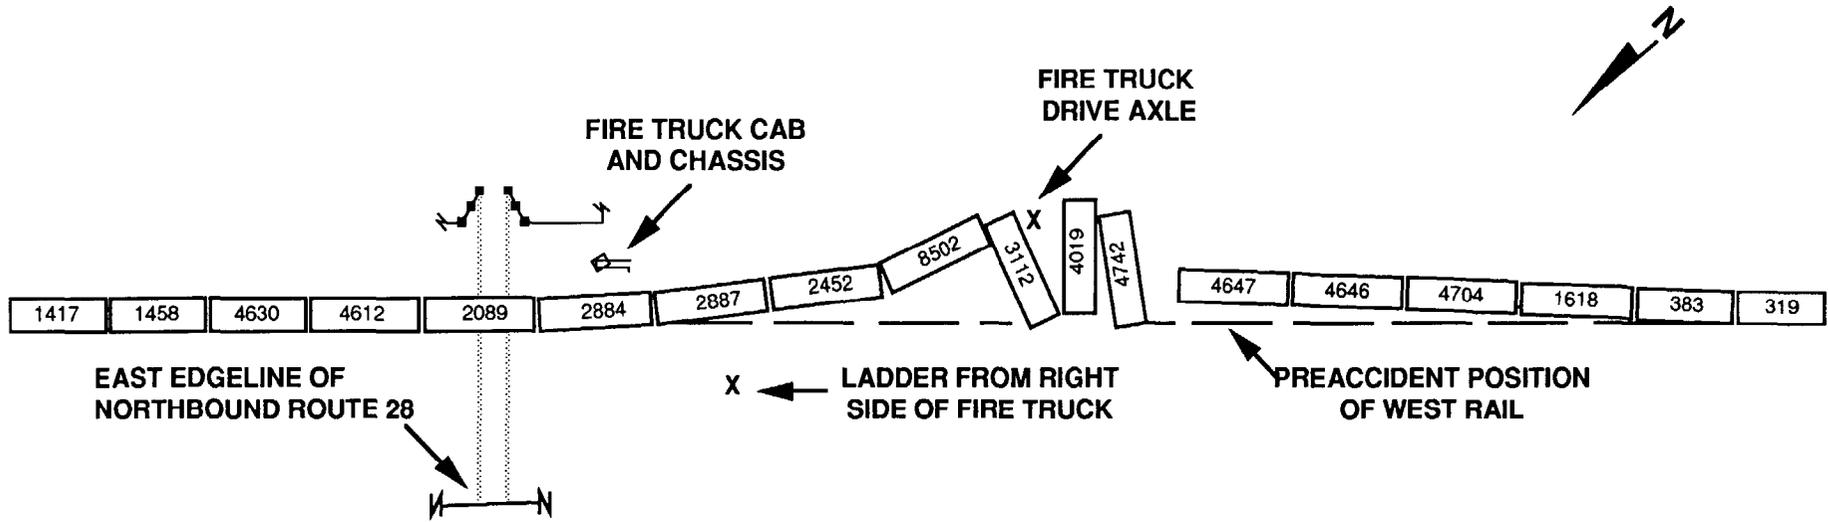
FINAL REST POSITIONS OF WAGON 7 AND RAILROAD CARS

The impact destroyed Wagon 7 and derailed much of the train. The gasoline tank on Wagon 7 ruptured and the gasoline ignited, forming a fireball and flame that travelled down the tracks as the train pushed the wreckage of Wagon 7 approximately 970 feet past the crossing. The driveway from Route 28 to the vehicle fire was blocked by derailed train cars. All but the last five cars of the 18-car train derailed. Several passenger cars came to rest in a tilted position as the train telescoped after the collision. None of the cars overturned, however.

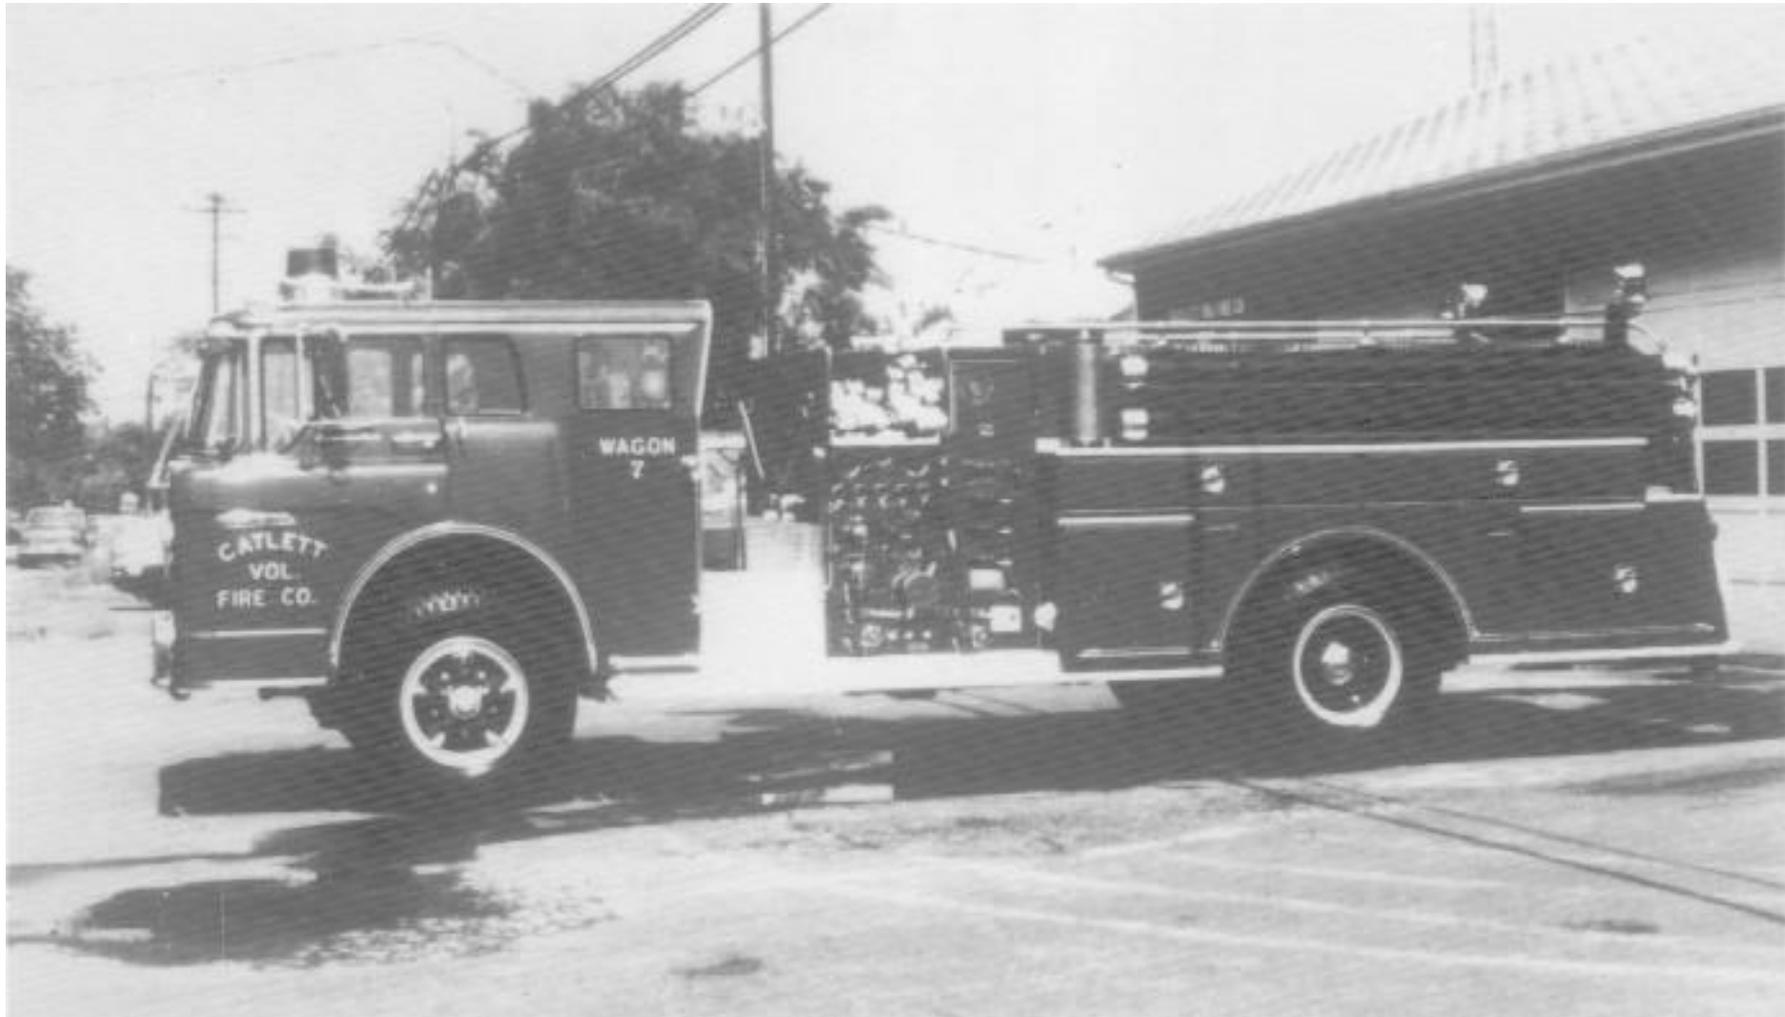
Left side of Wagon 7

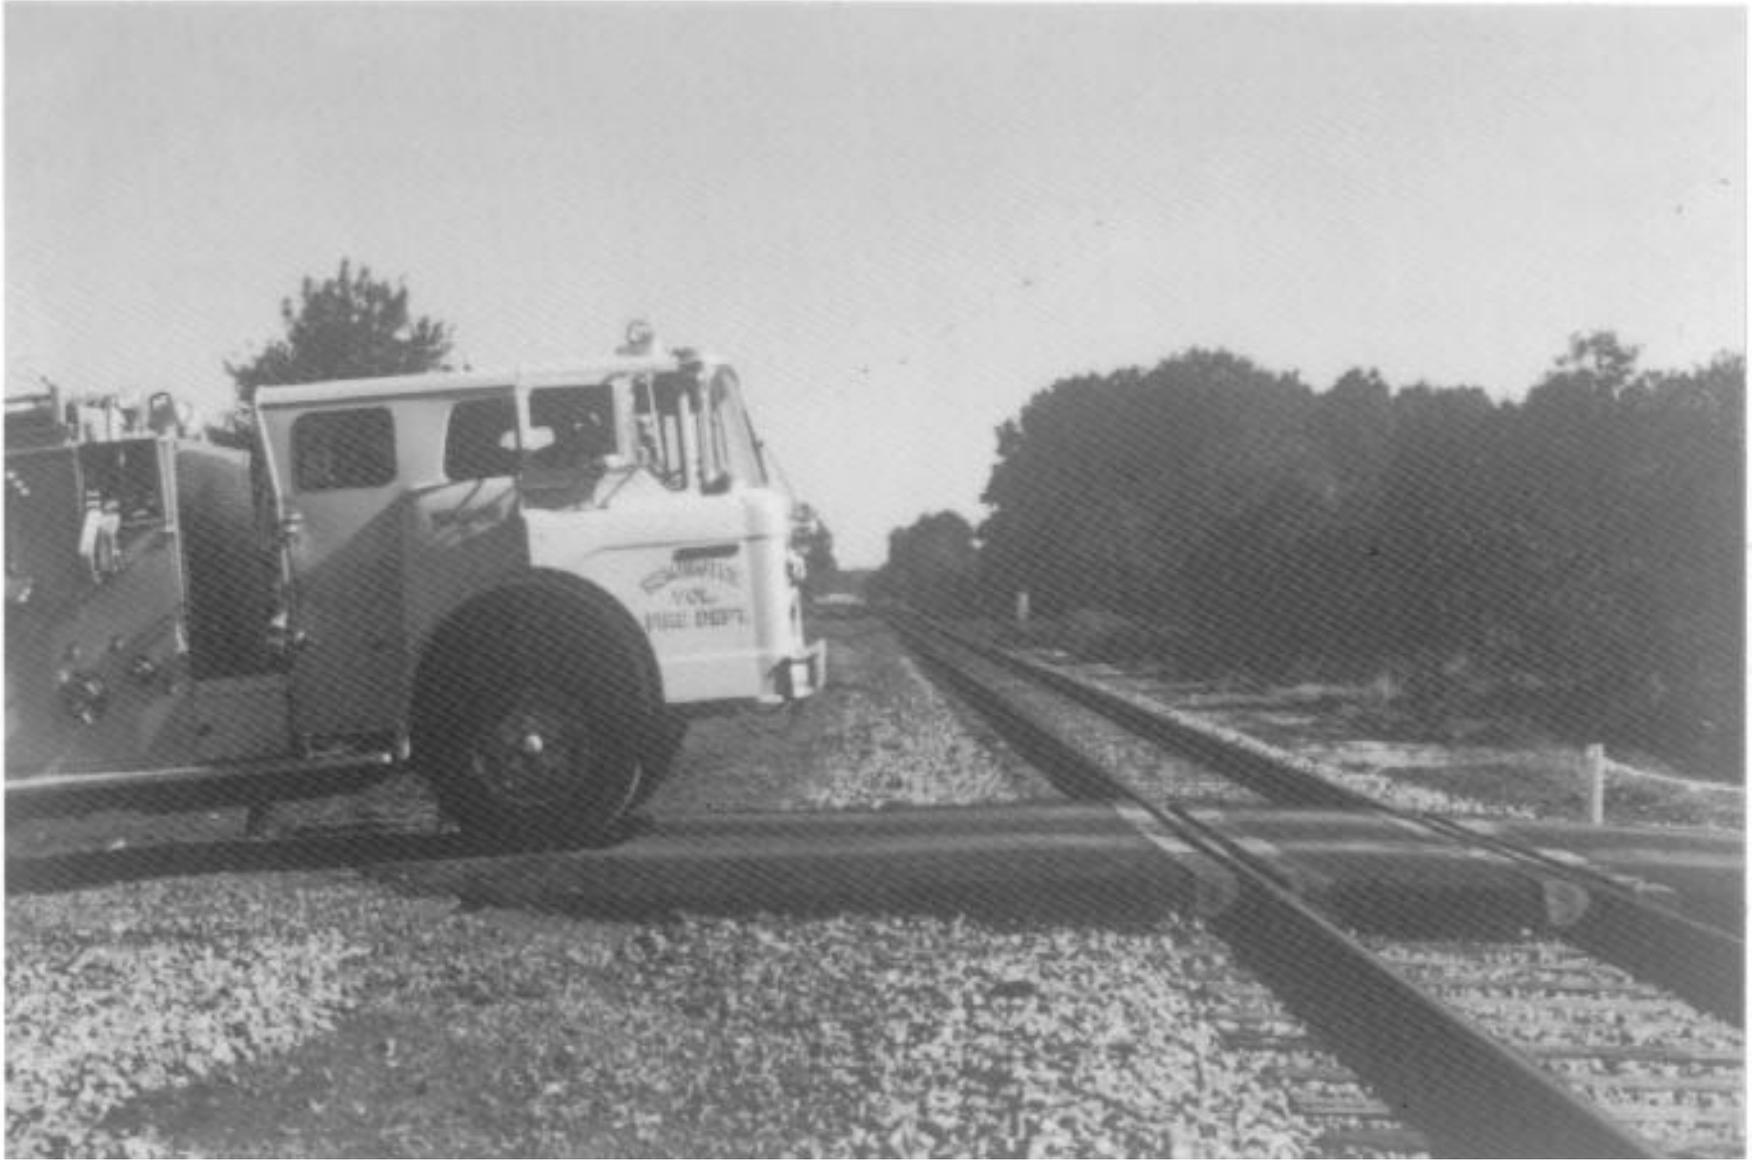
Even though it was dusk, the weather conditions at the time of the accident were clear. The 59-foot section of the driveway from the highway to the rail crossing had an 11.9 degree grade. But the tracks were straight and there were no visual obstructions that prevented the driver of Wagon 7 from seeing the approaching train. National Transportation Safety Board investigators estimate that the railroad tracks are visible for approximately 3,700 feet in the direction the train came from.

Wagon 2 at accident crossing - camera facing north

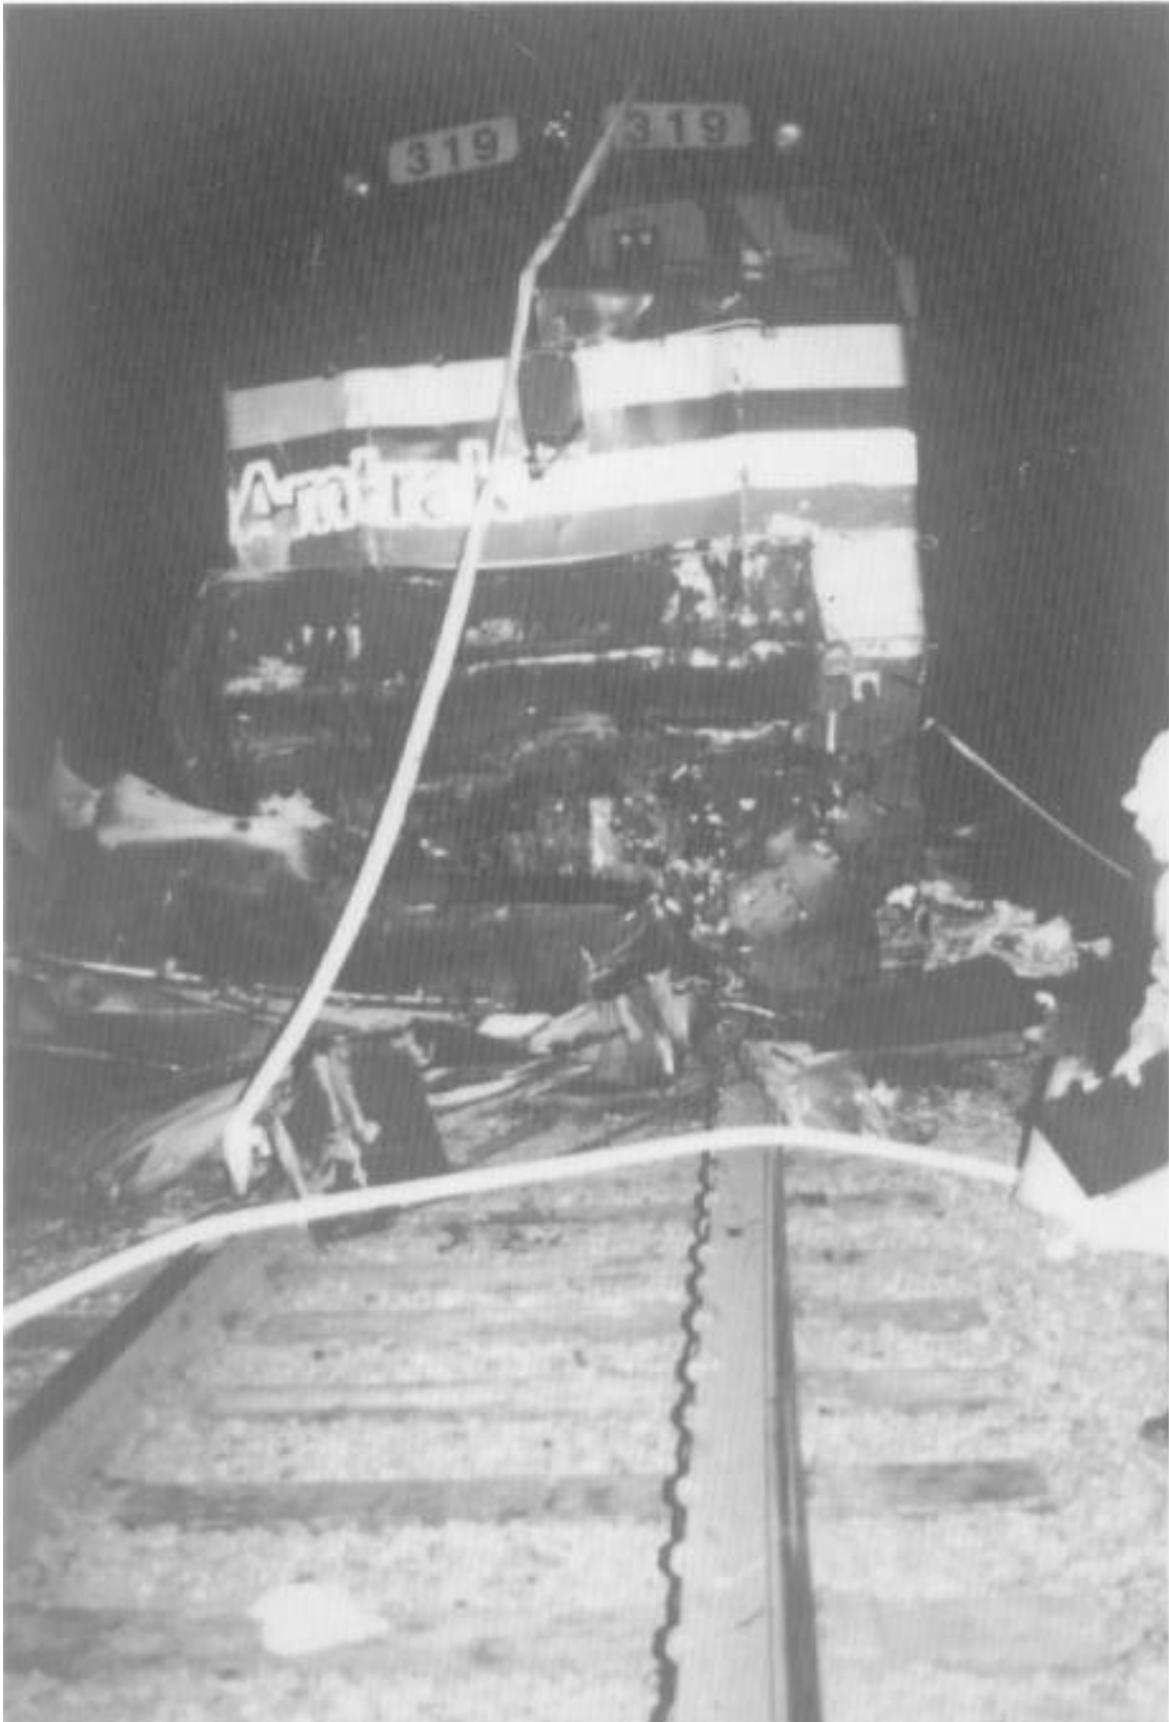
Front of locomotive 319

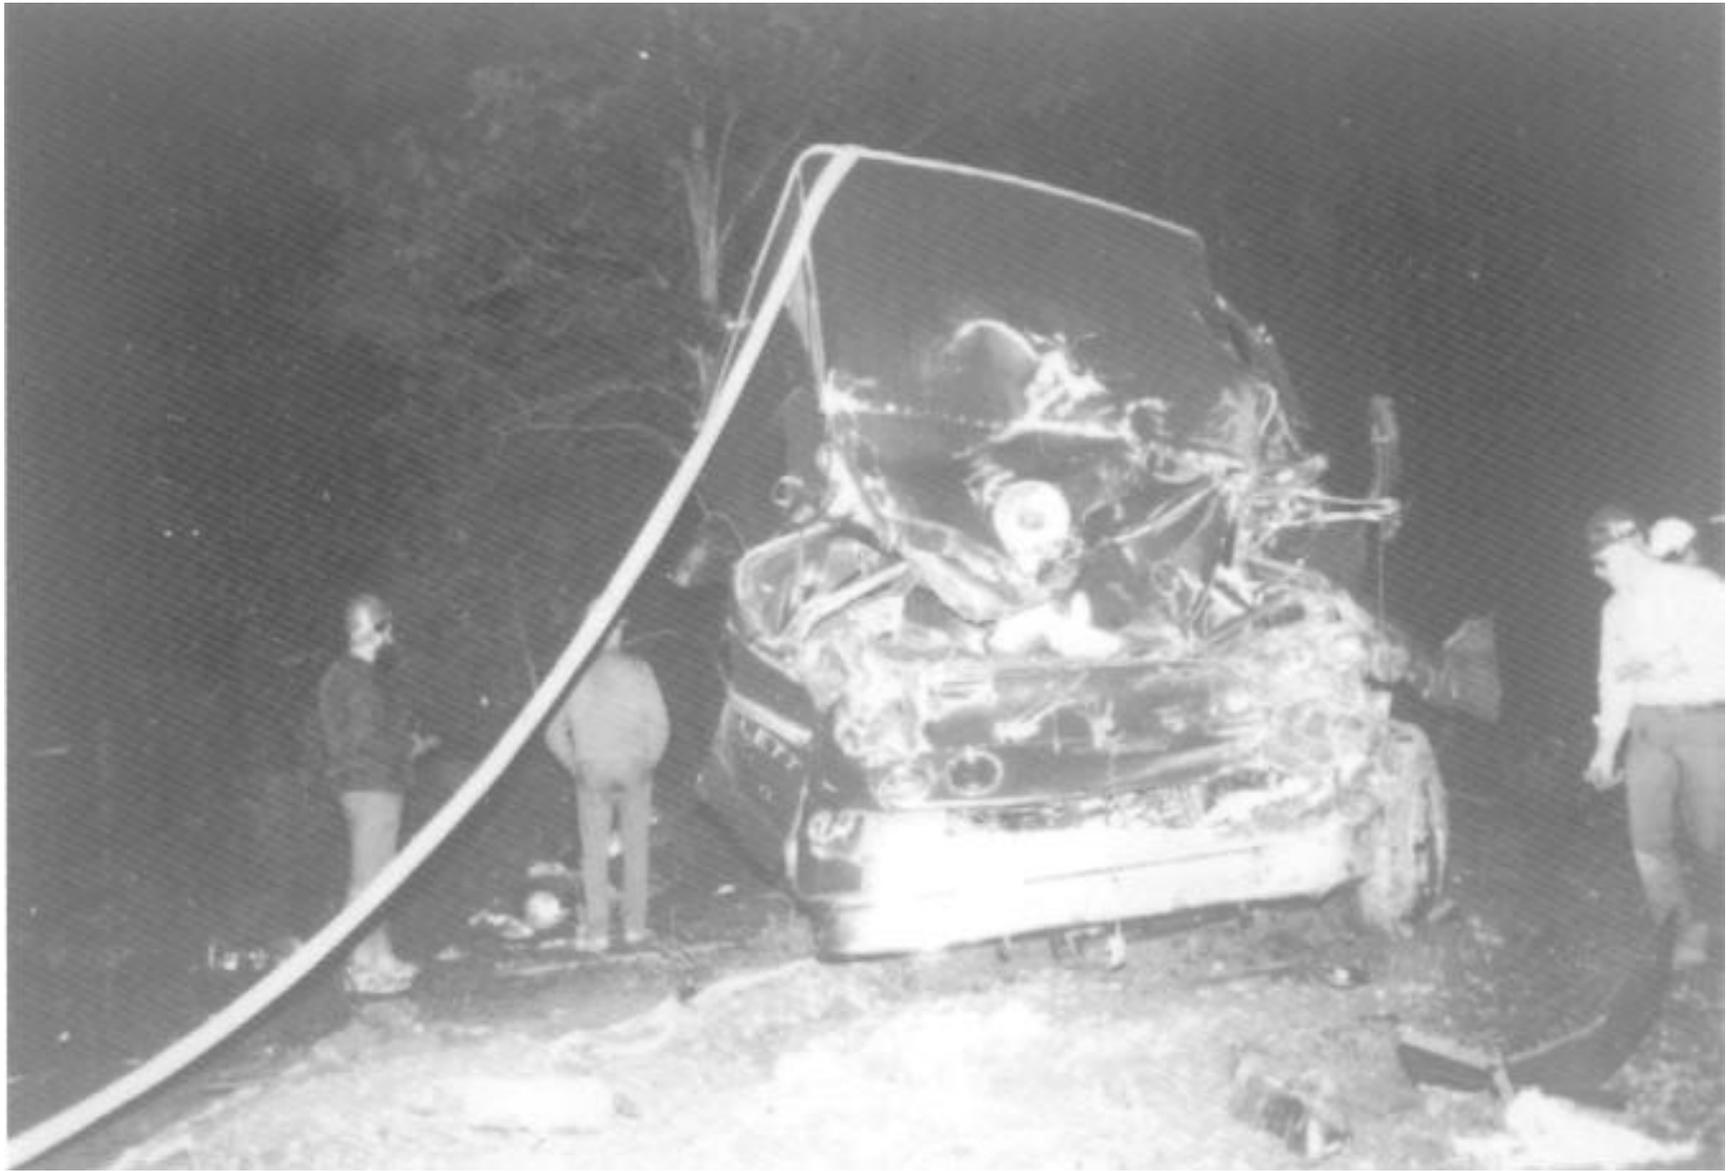
Cab of Wagon 7 - camera facing southeast

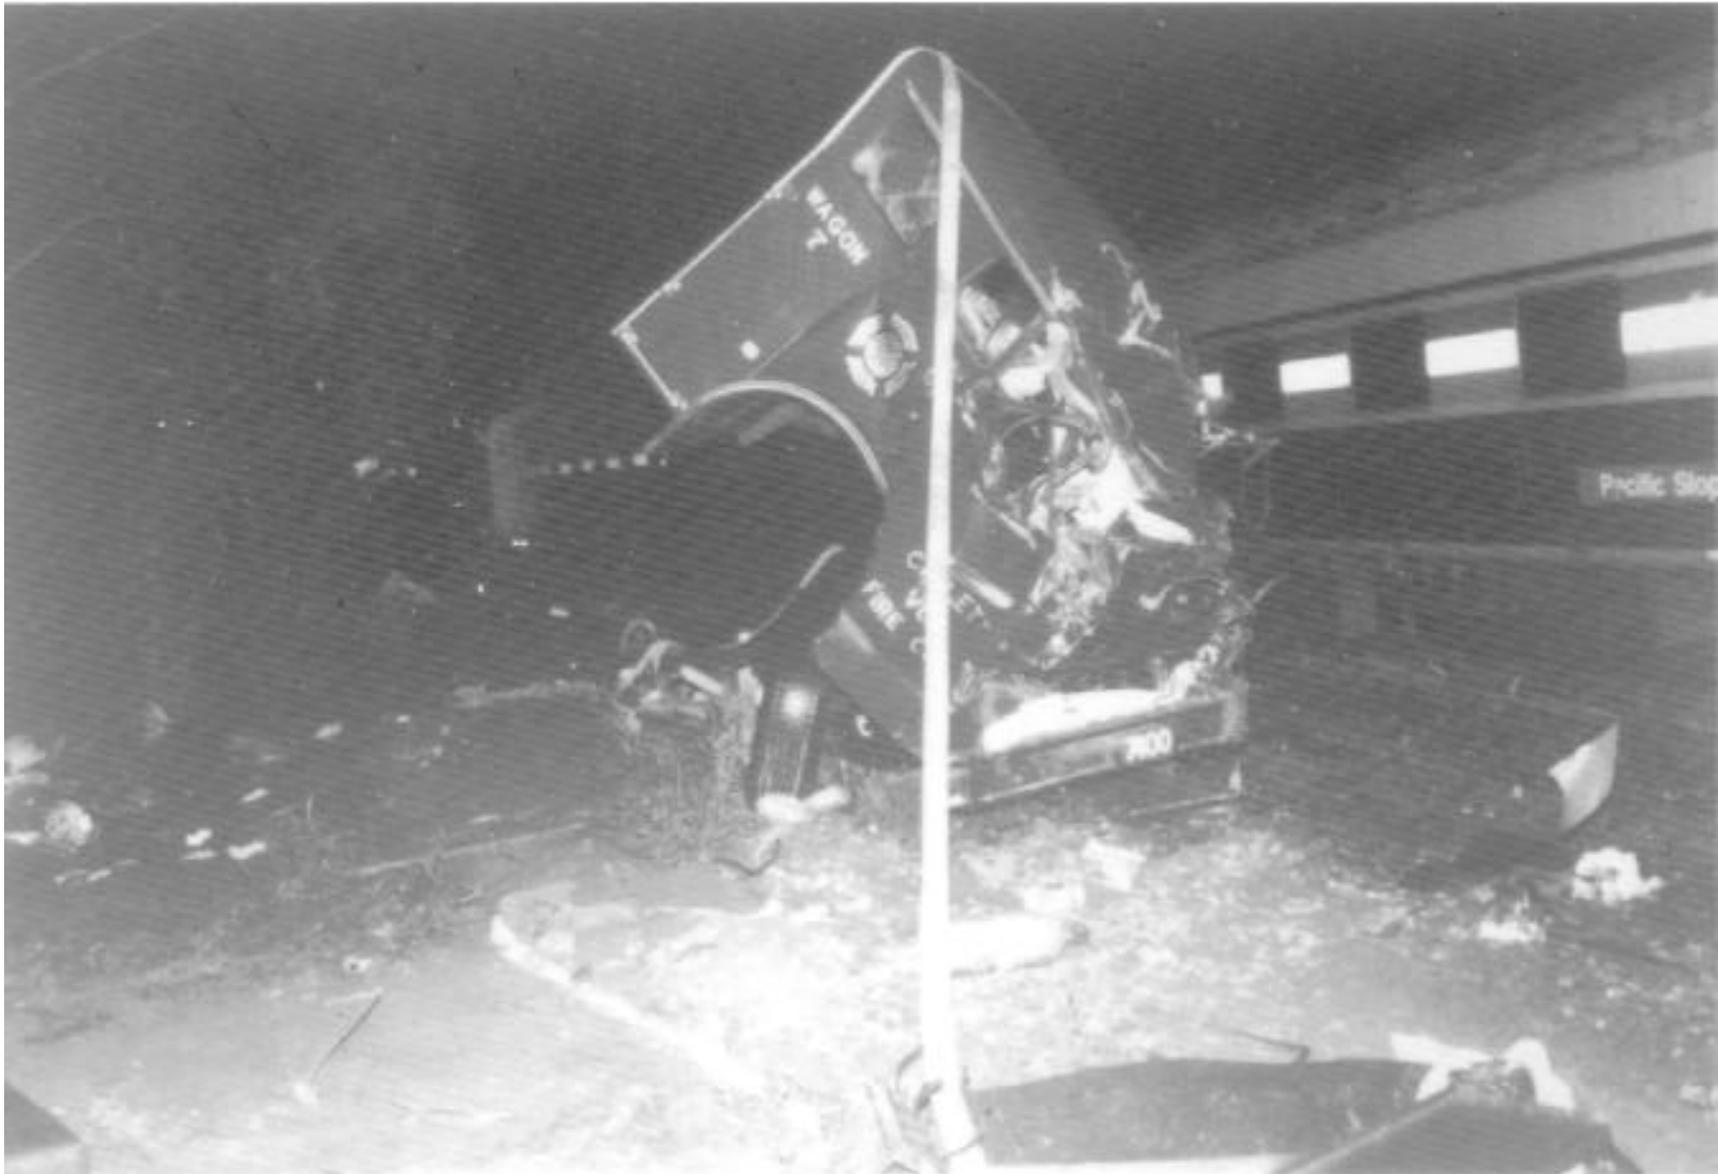
Cab of Wagon 7

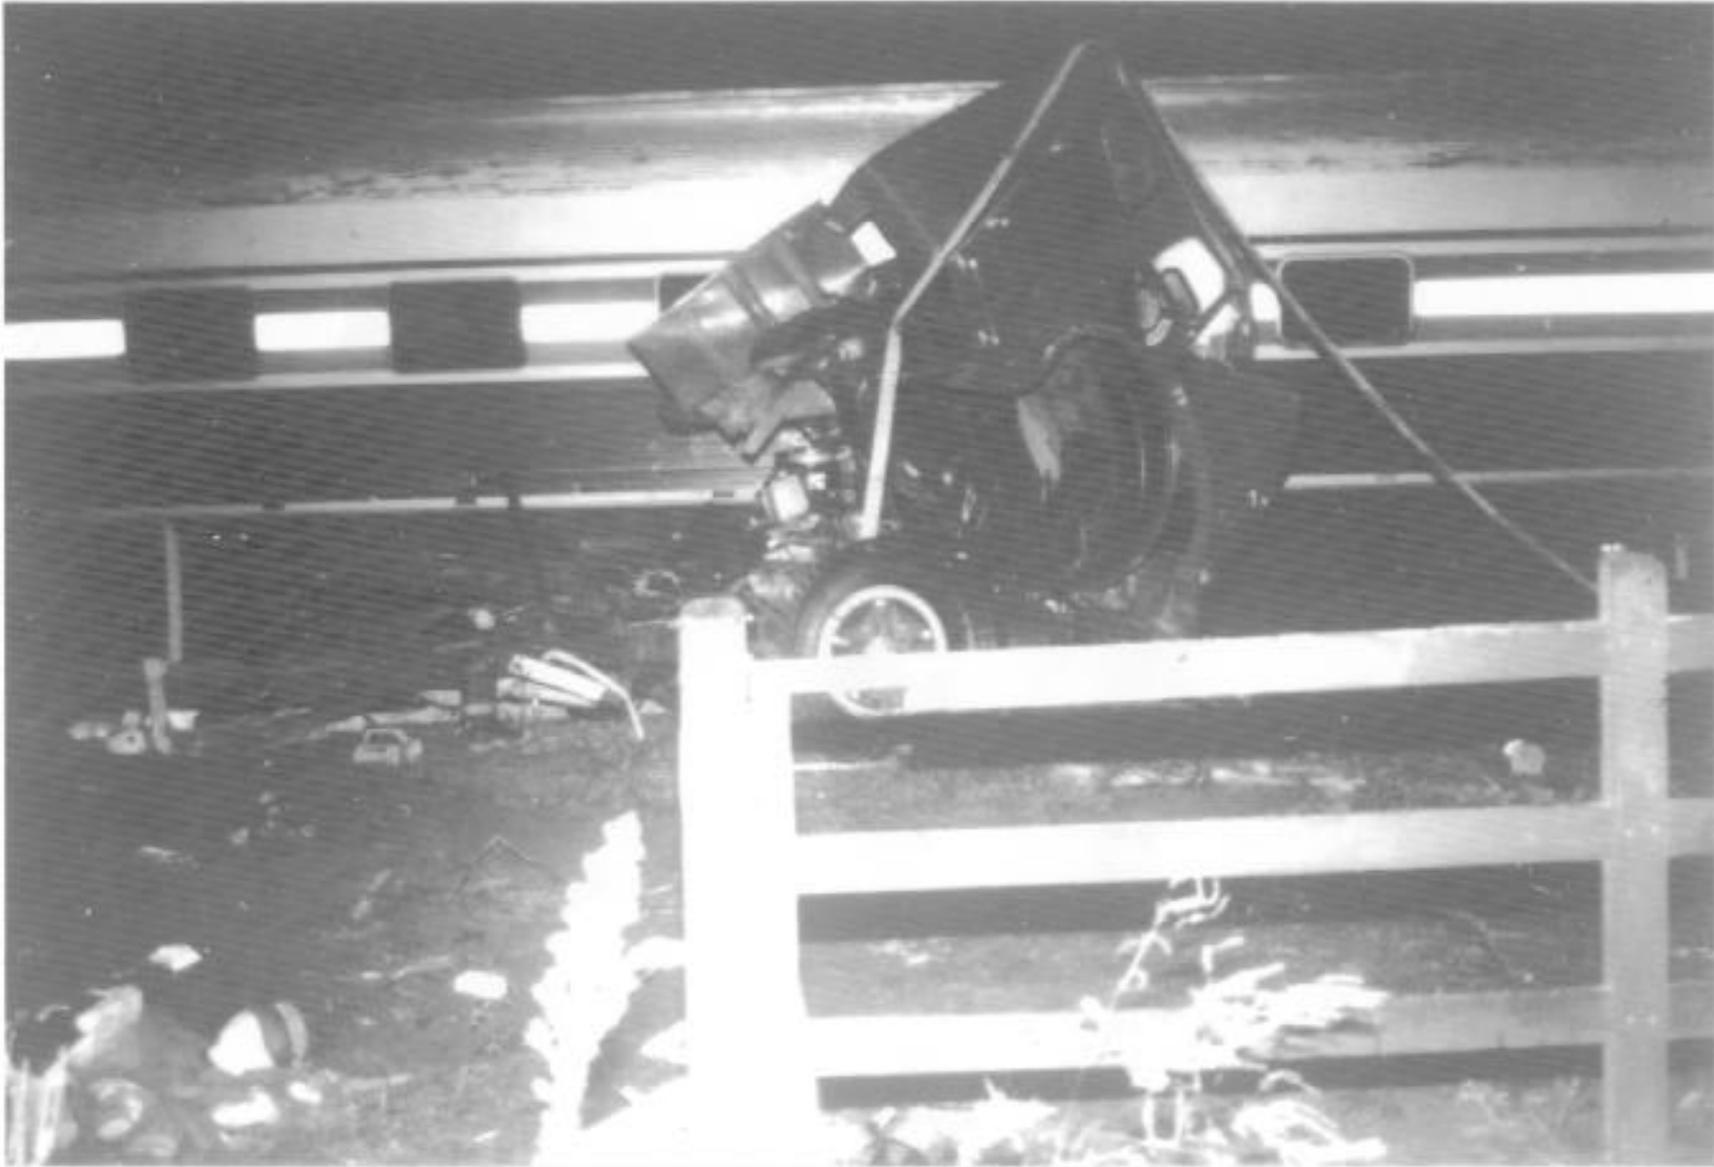
The brunt of the collision was directed at the rear of the vehicle, at about the rear axle. When the collision occurred, the cab and chassis of the Catlett pumper rotated counterclockwise 450 degrees and came to rest about 80 feet southeast of the crossing. The lead locomotive stopped about 965 feet past the crossing with the left side of Wagon 7's hose body wrapped around its front end. Most equipment and the rear bodywork were scattered along the collision area. Gasoline fires that broke out near the second locomotive and several derailed cars were extinguished by other firefighters responding to the emergency. The primary fuel for these fires was from the fuel tank aboard Wagon 7, which ruptured in the crash.

Cab and chassis of Wagon 7
Southwest corner of fence around private residence is in center foreground.
NOTE: Injured firefighters were found in the area at the bottom left of the photo.

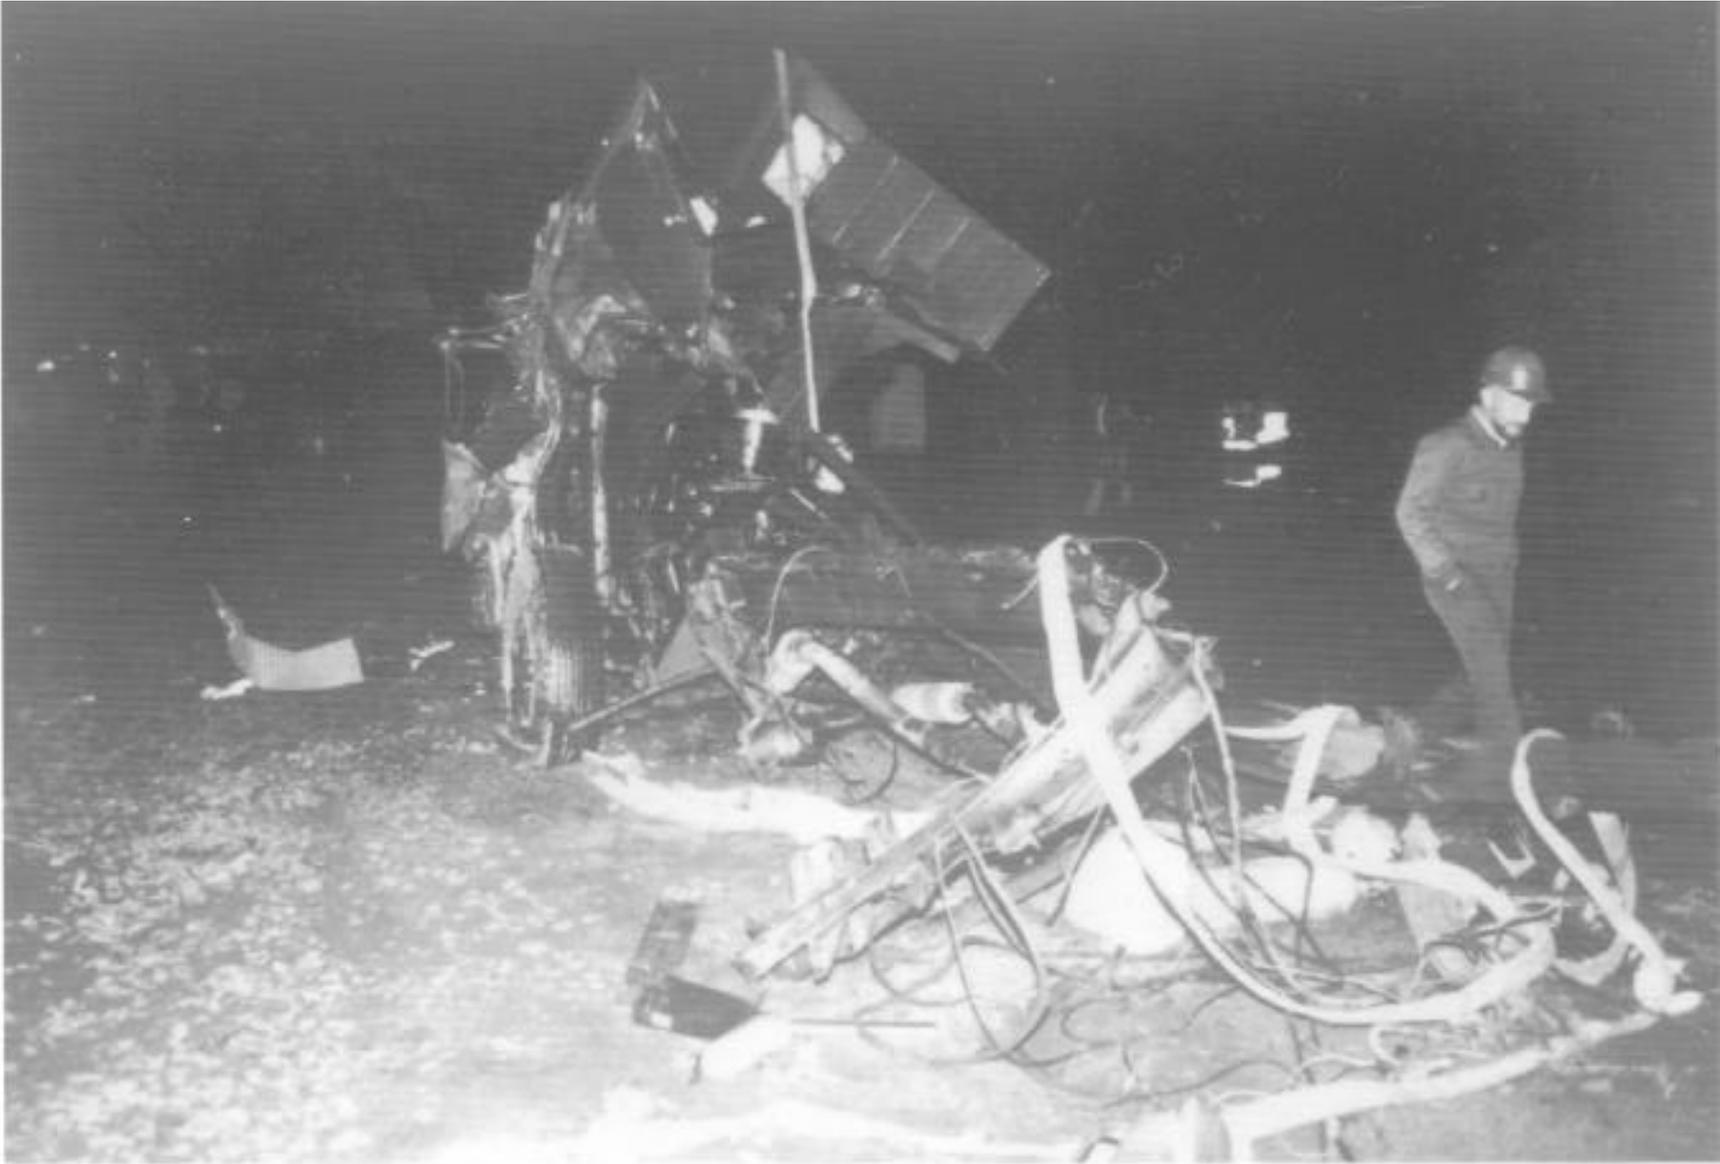
Chassis and cab of Wagon 7

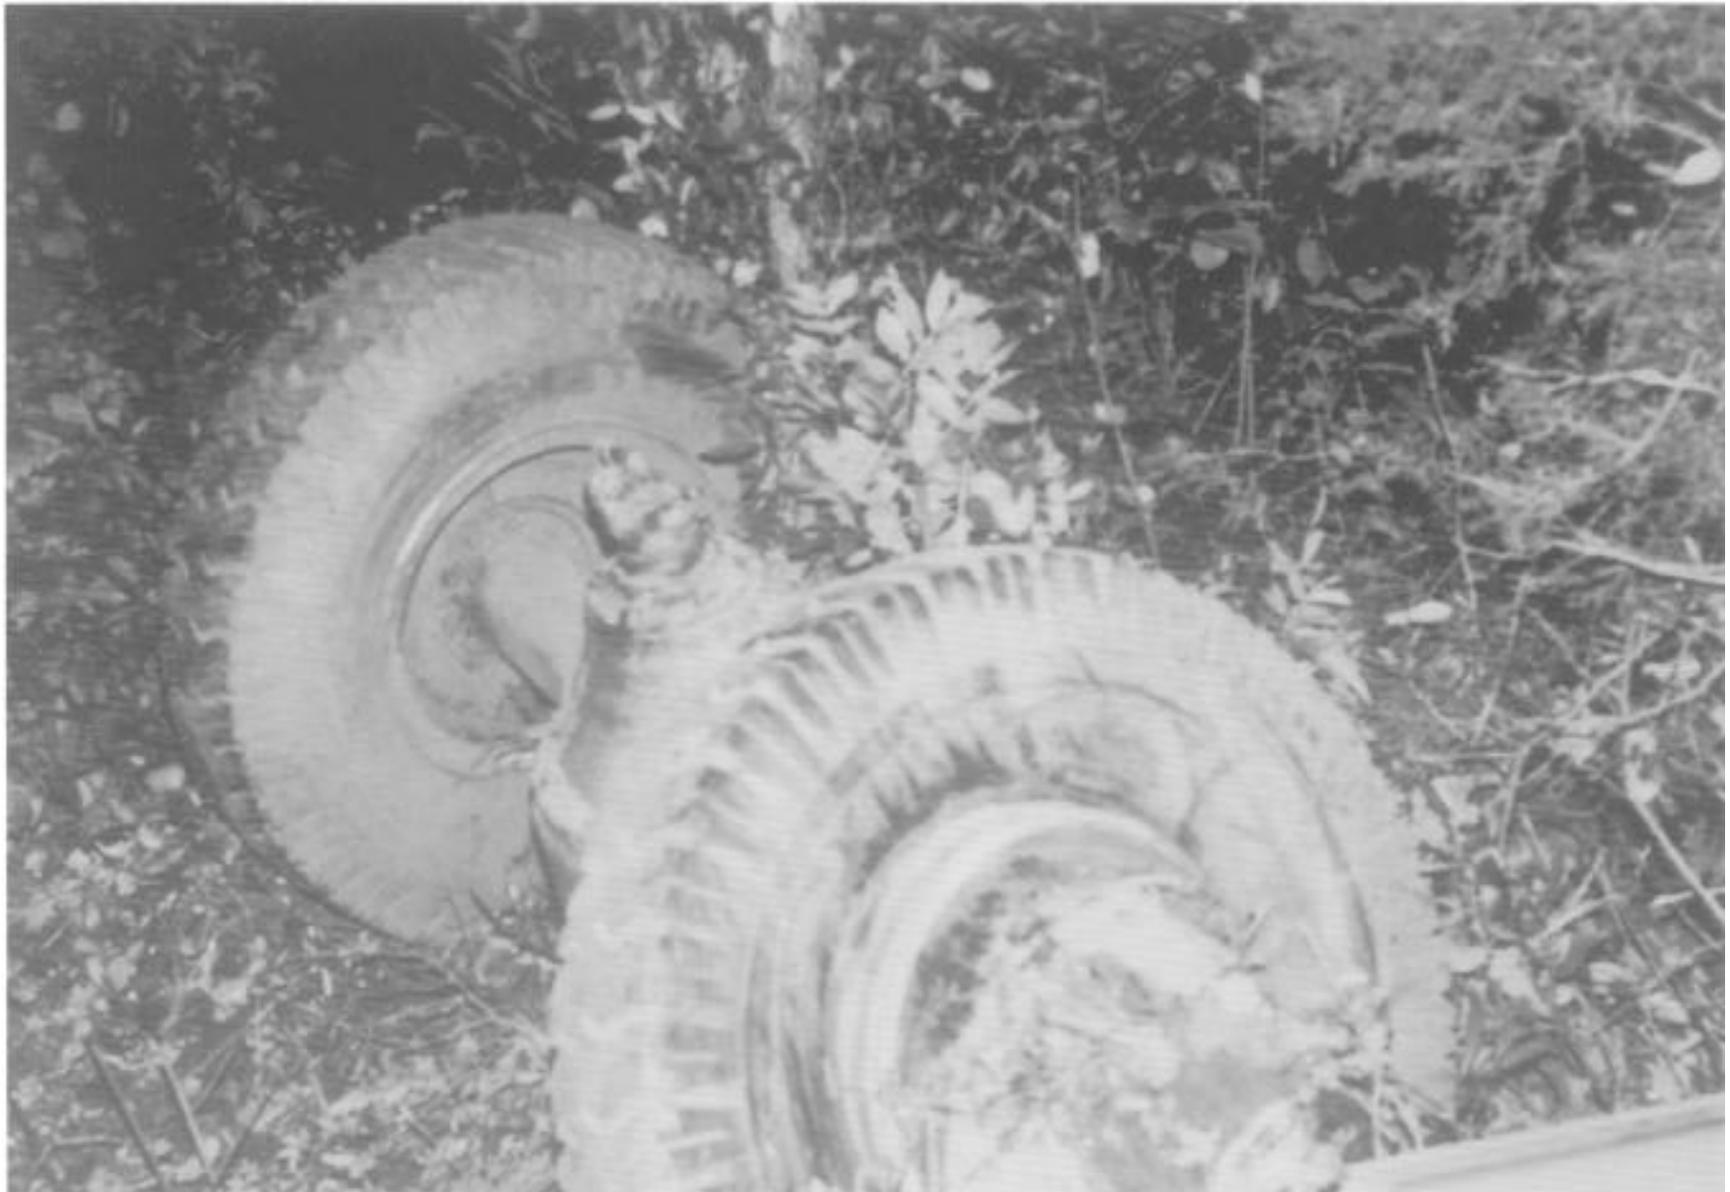
Closeup of fire truck drive axle

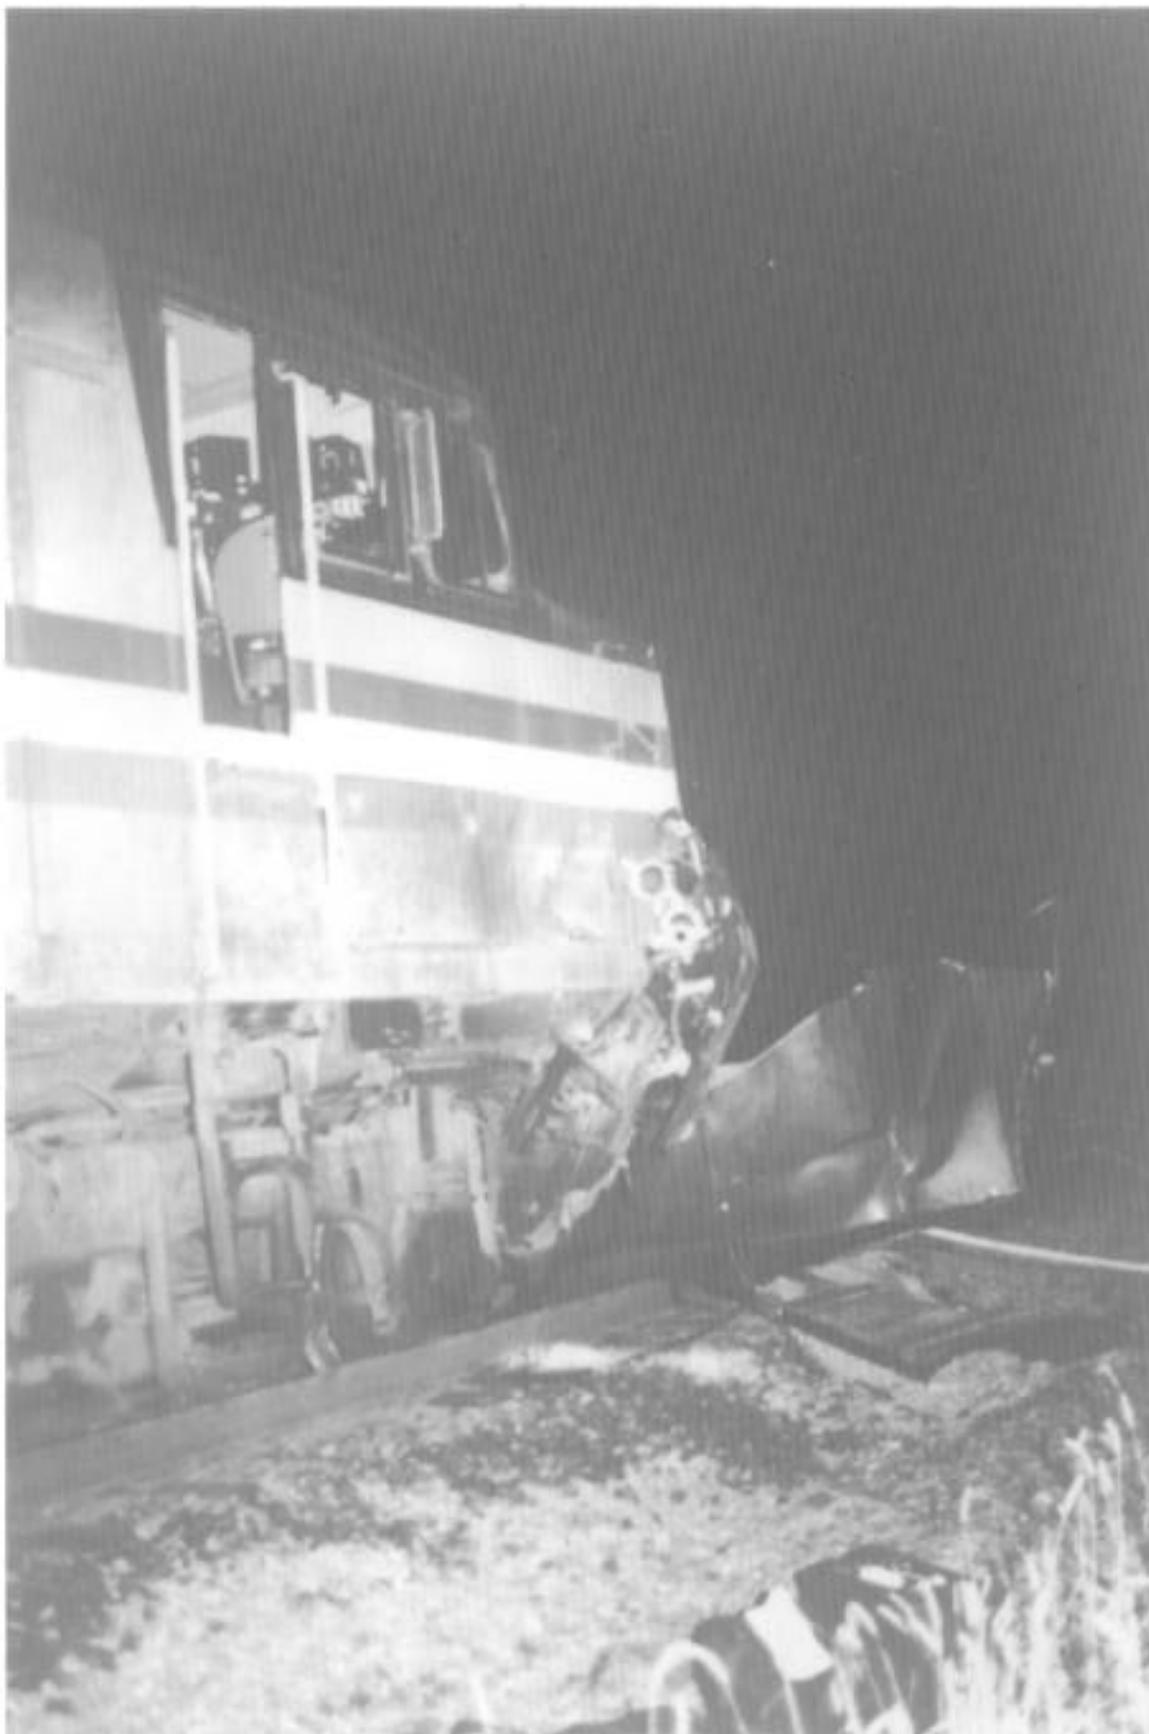
Right front of locomotive 319

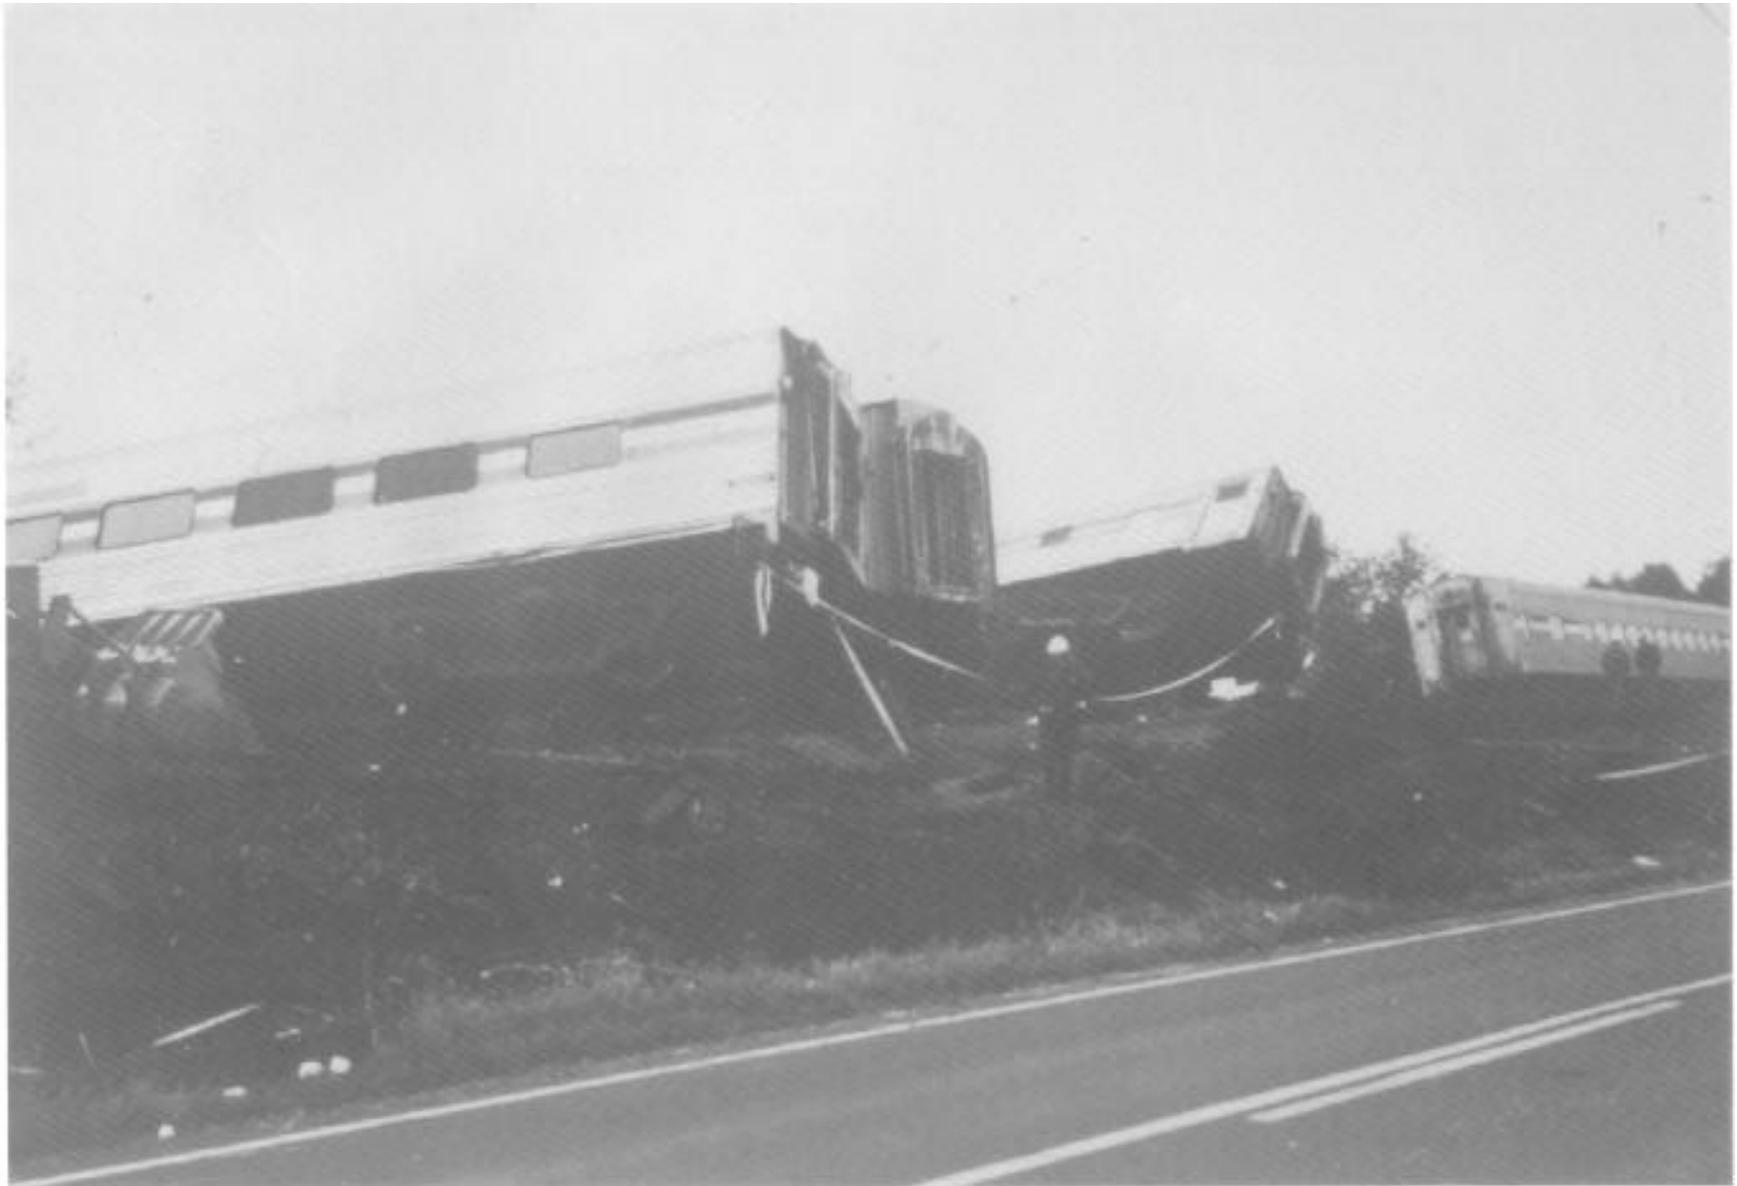
West ends of cars 3112, 4019, and 4742
