Technical Report Series

Fire Apparatus/Train Collision Catlett, Virginia

**Fire Apparatus/Train Collision
Catlett, Virginia
(September 28, 1989)**

September 28, 1989

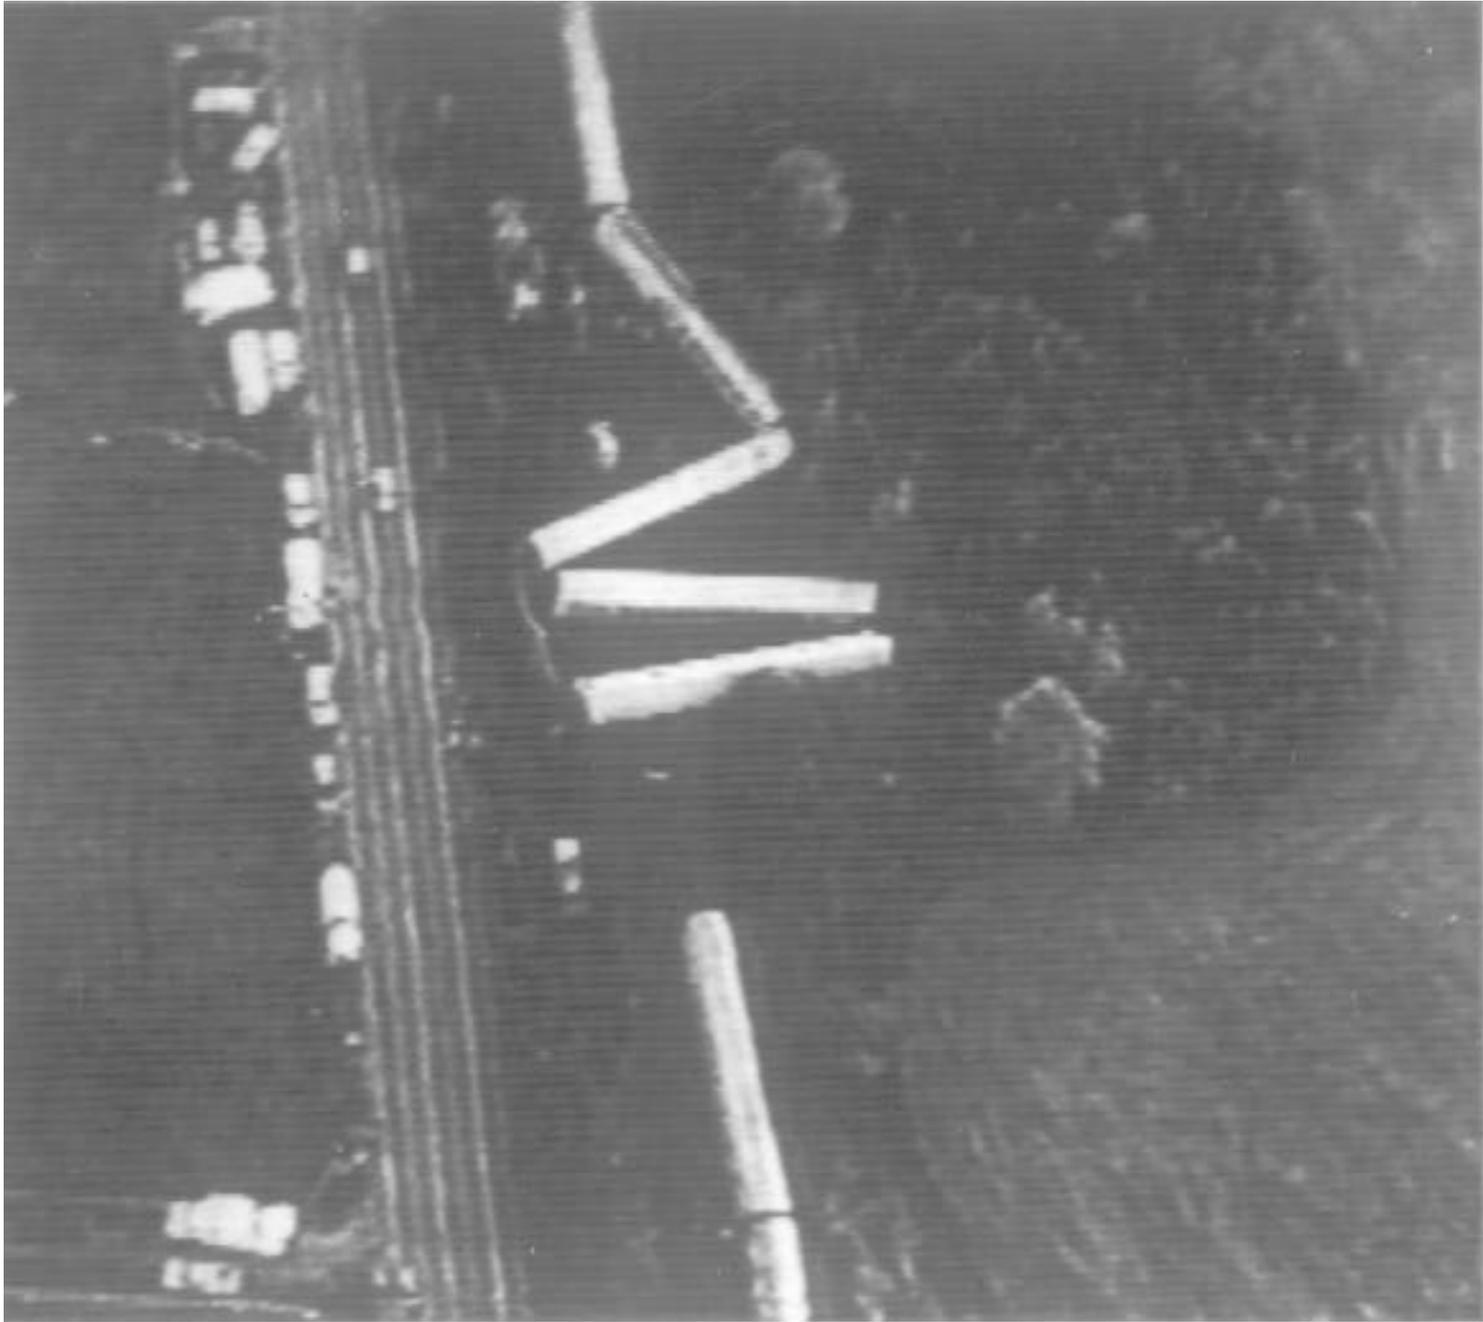
Aerial view of accident site

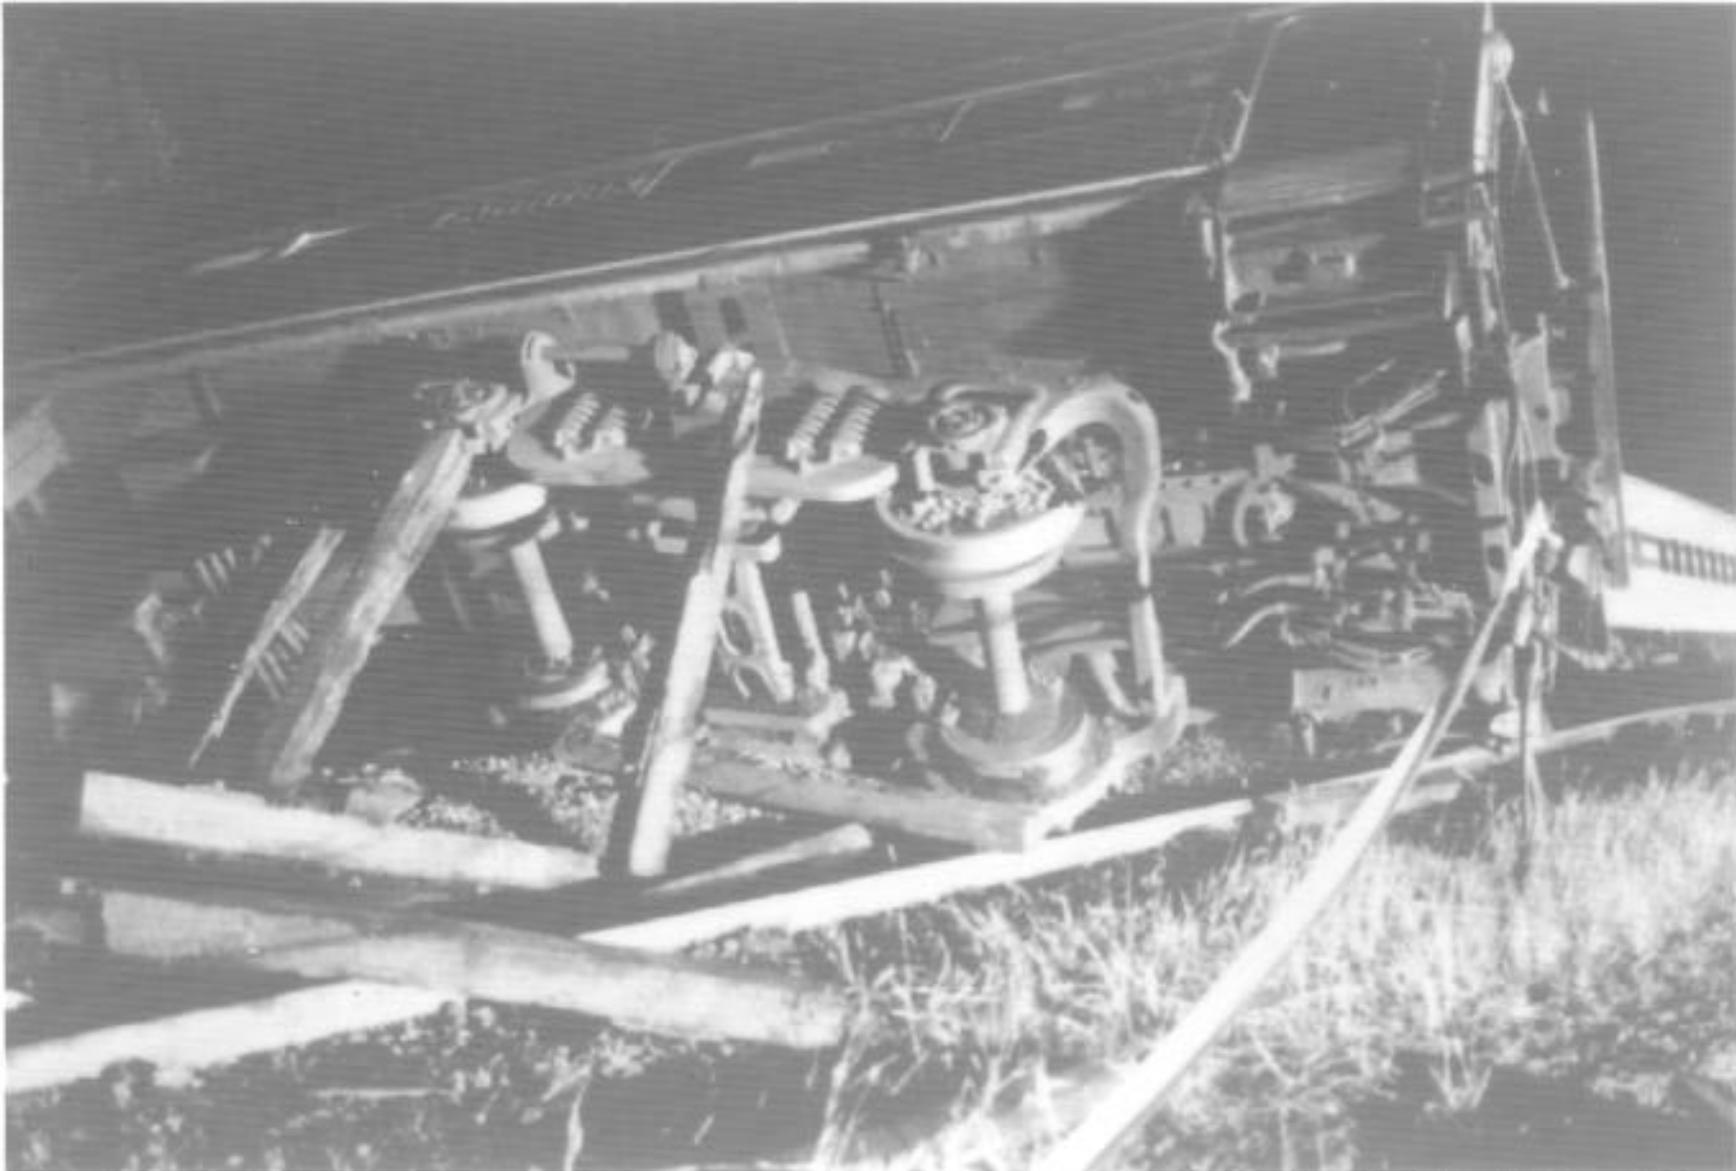
North side of car 4742

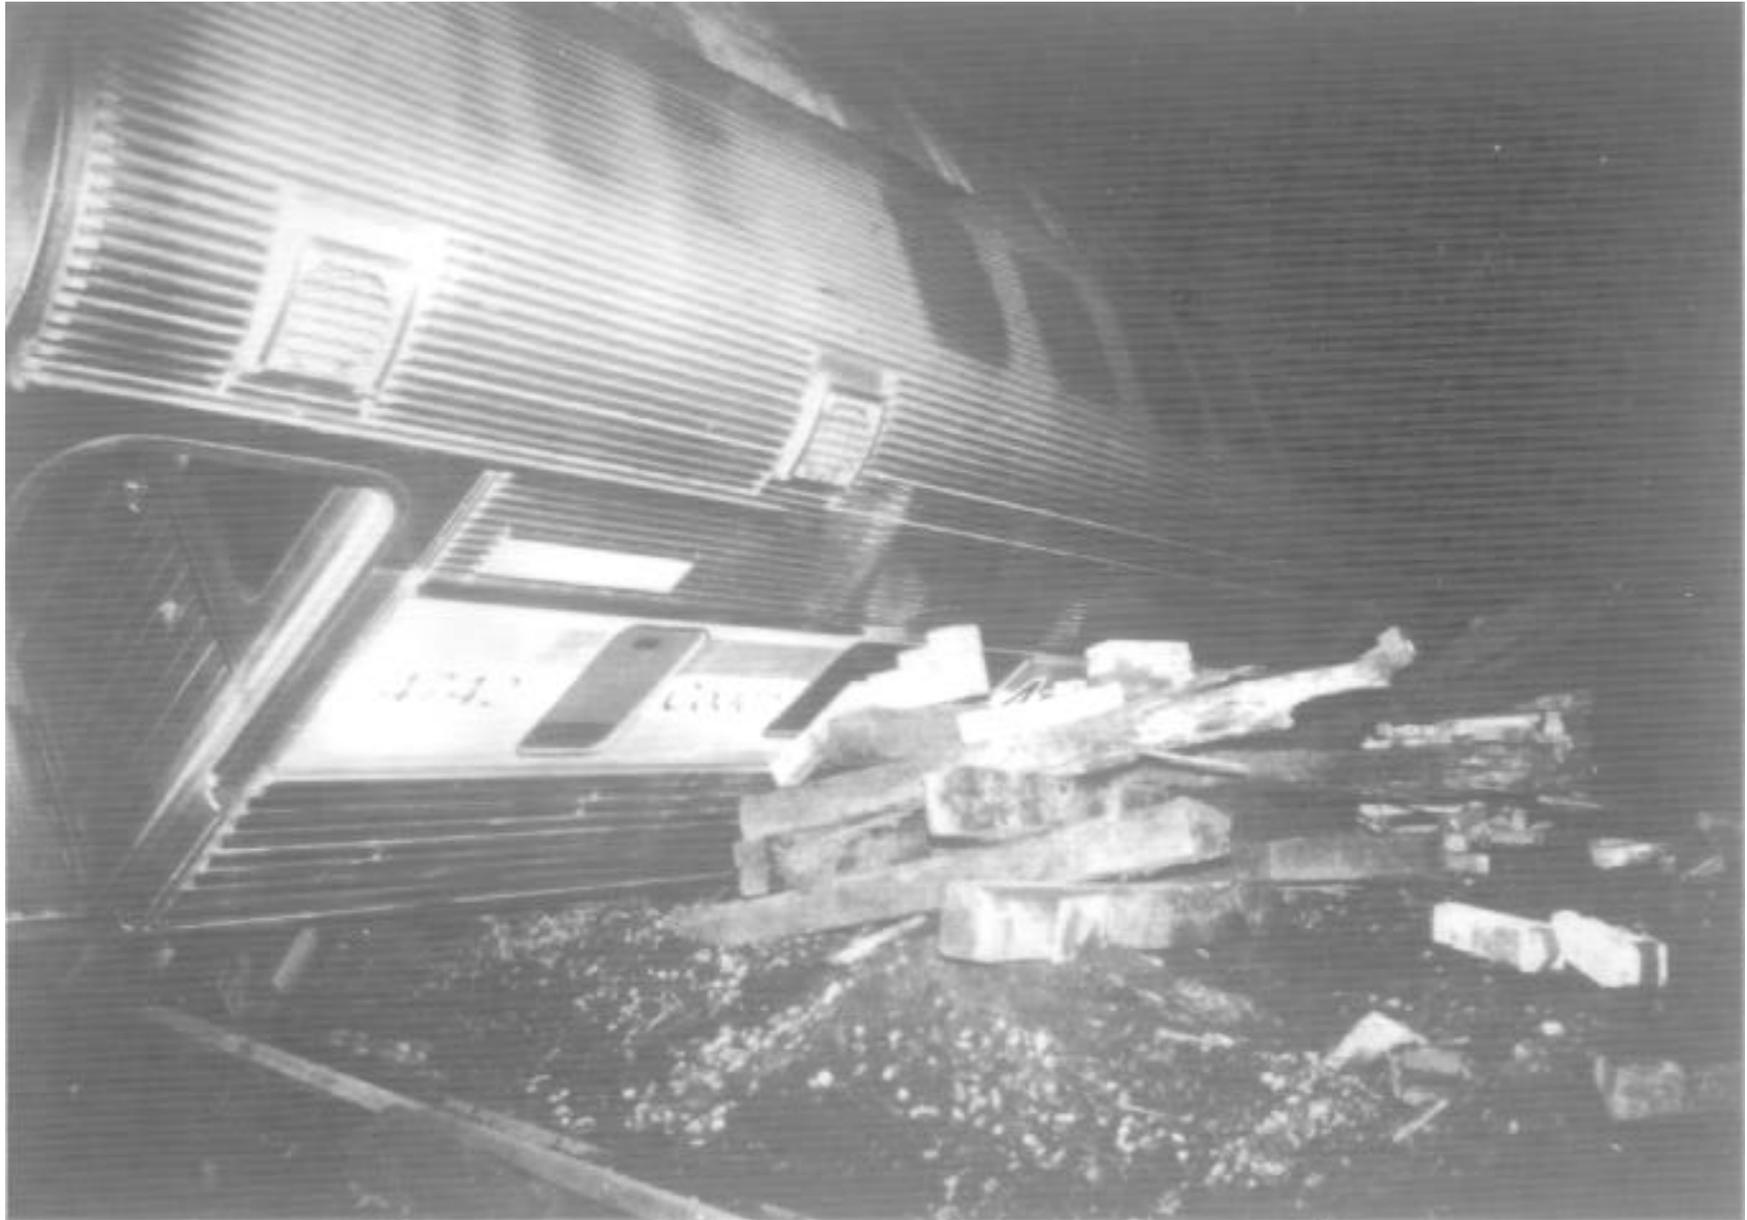
South side of car 4742

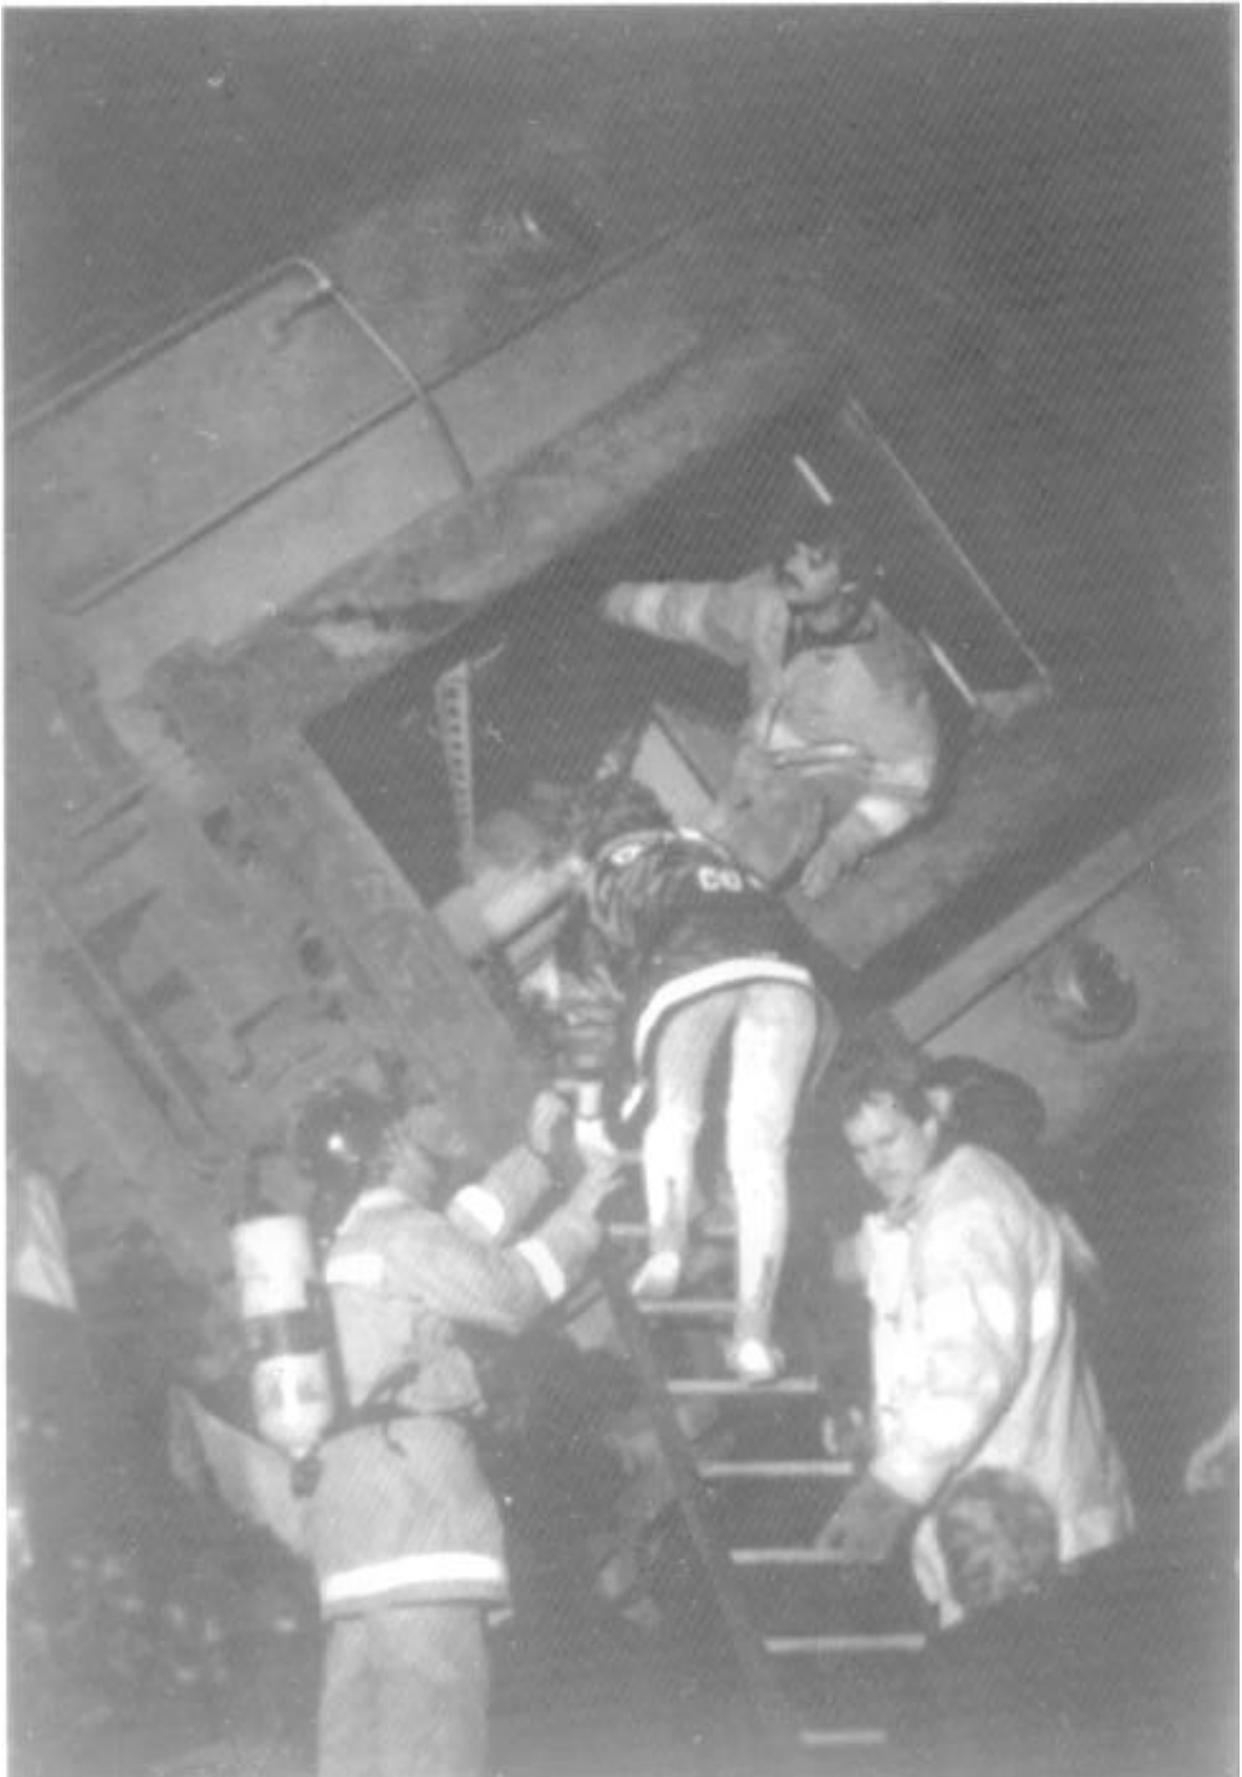
Evacuation operations from west end of car 4742

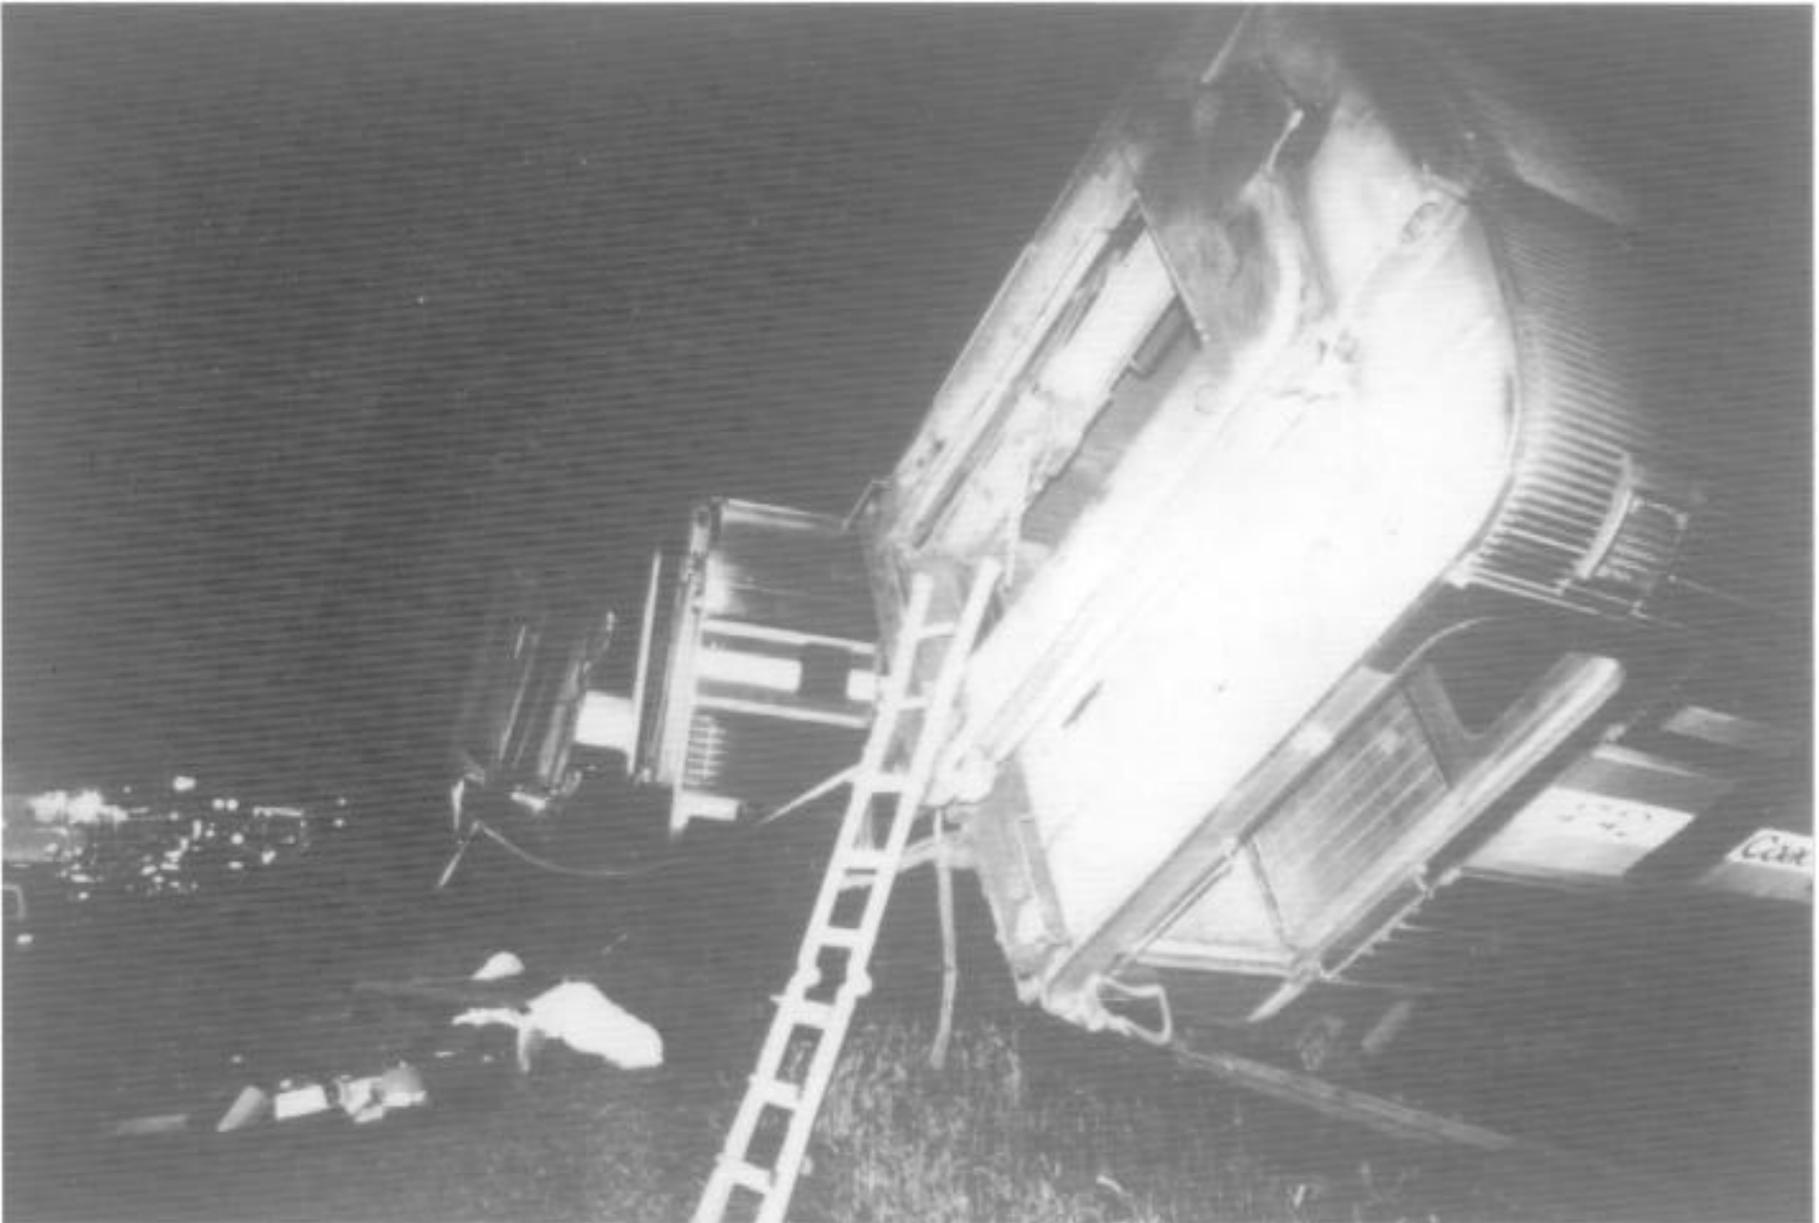
West end of car 4742

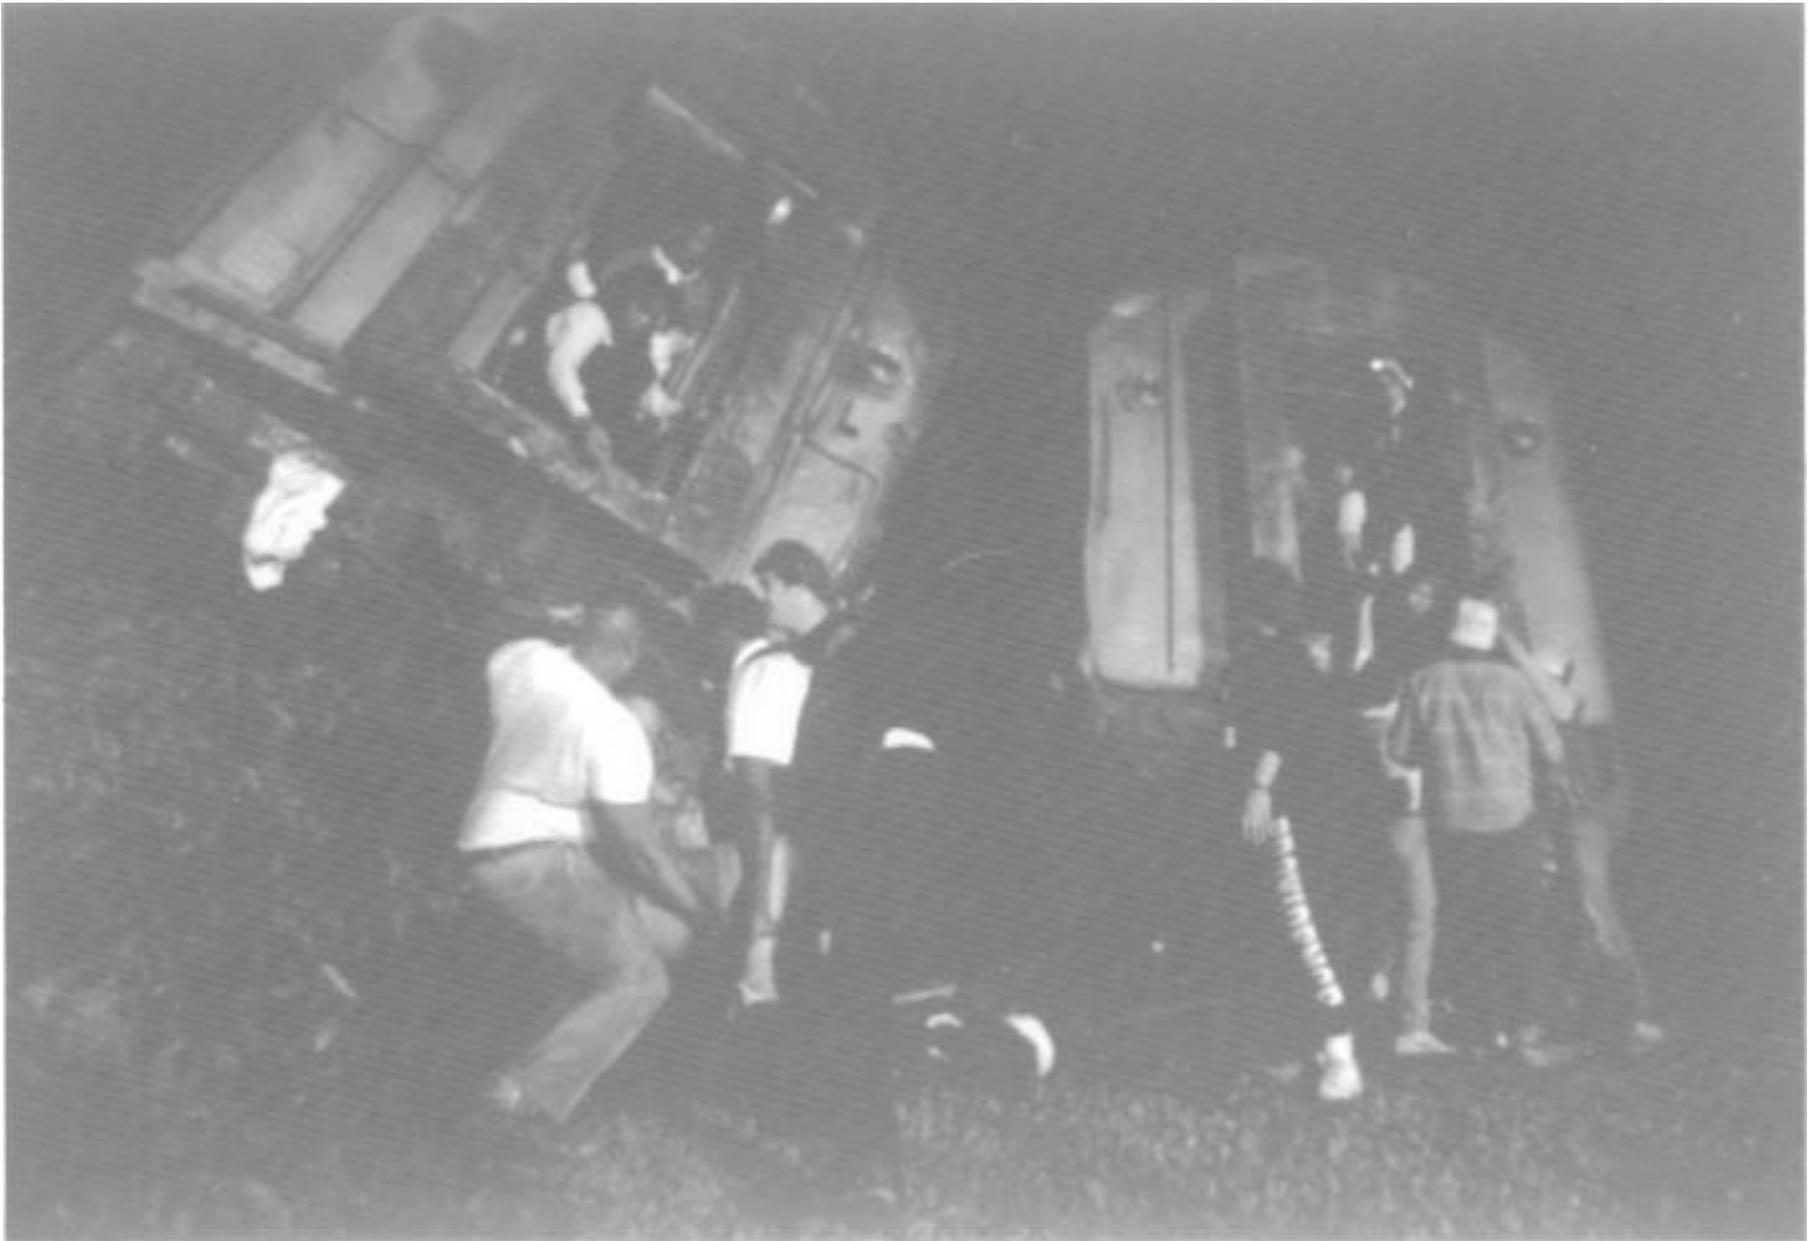
Evacuation of passengers from west ends of cars 4019 and 3112
