Chicken Processing Plant Fires Hamlet, North Carolina, and North Little Rock, Arkansas

**Chicken Processing Plant Fires
Hamlet, North Carolina
(September 3, 1991)
North Little Rock, Arkansas
(June 7, 1991)**

This is Report 057 of the Major Fires Investigation Project conducted by TriData Corporation under contract EMW-90-C-3338 to the United States Fire Administration, Federal Emergency Management Agency.

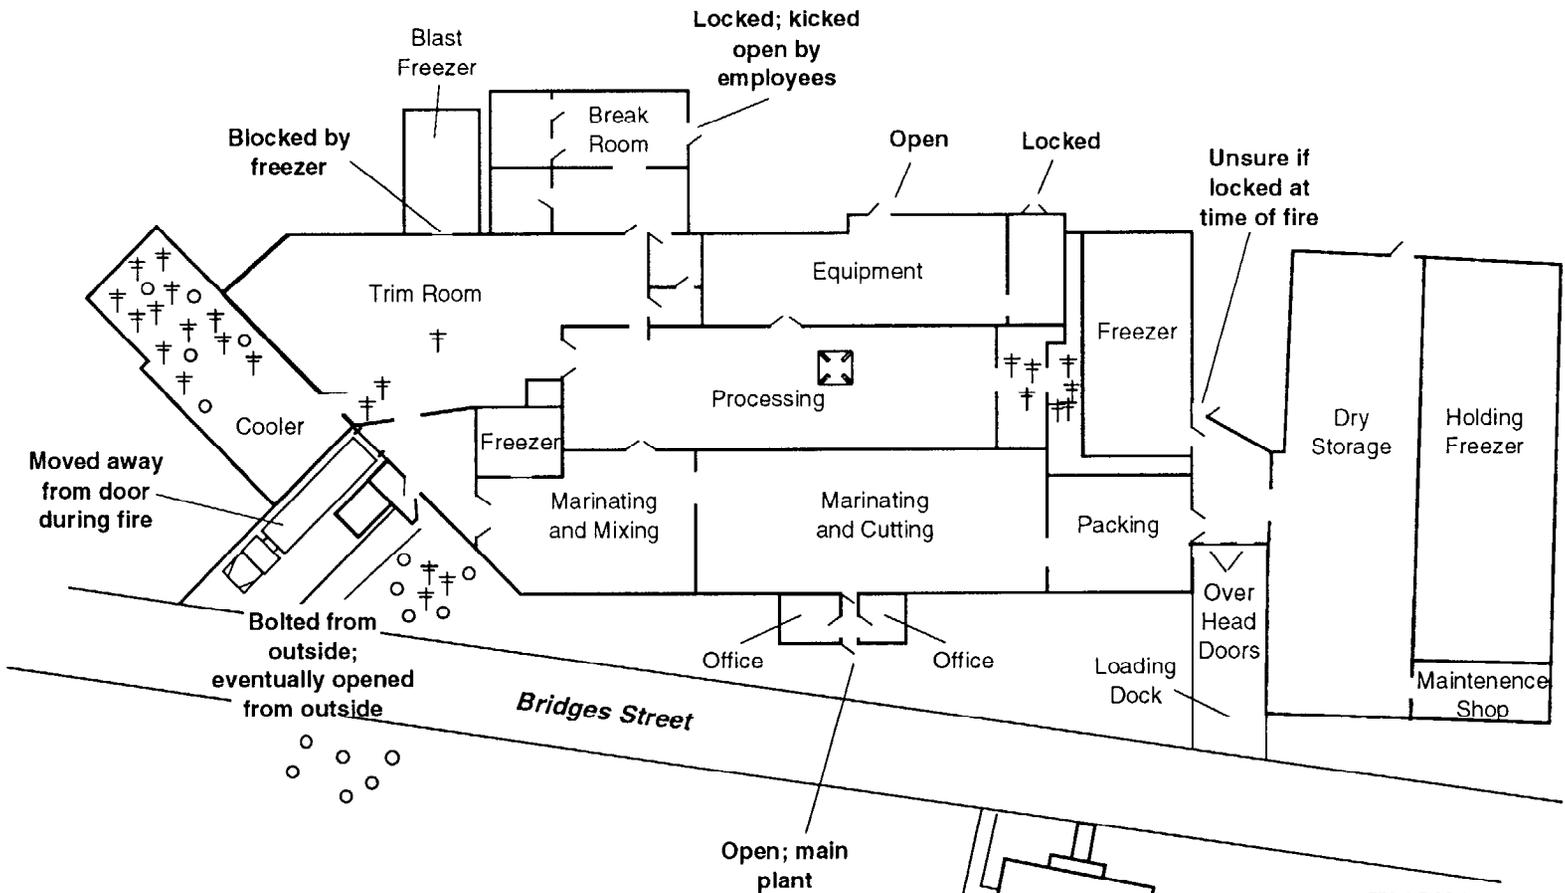
Appendix A
Imperial Foods Plant Floor Plan

Key	
†	= Deceased
○	= Injured
☒	= Point of Origin

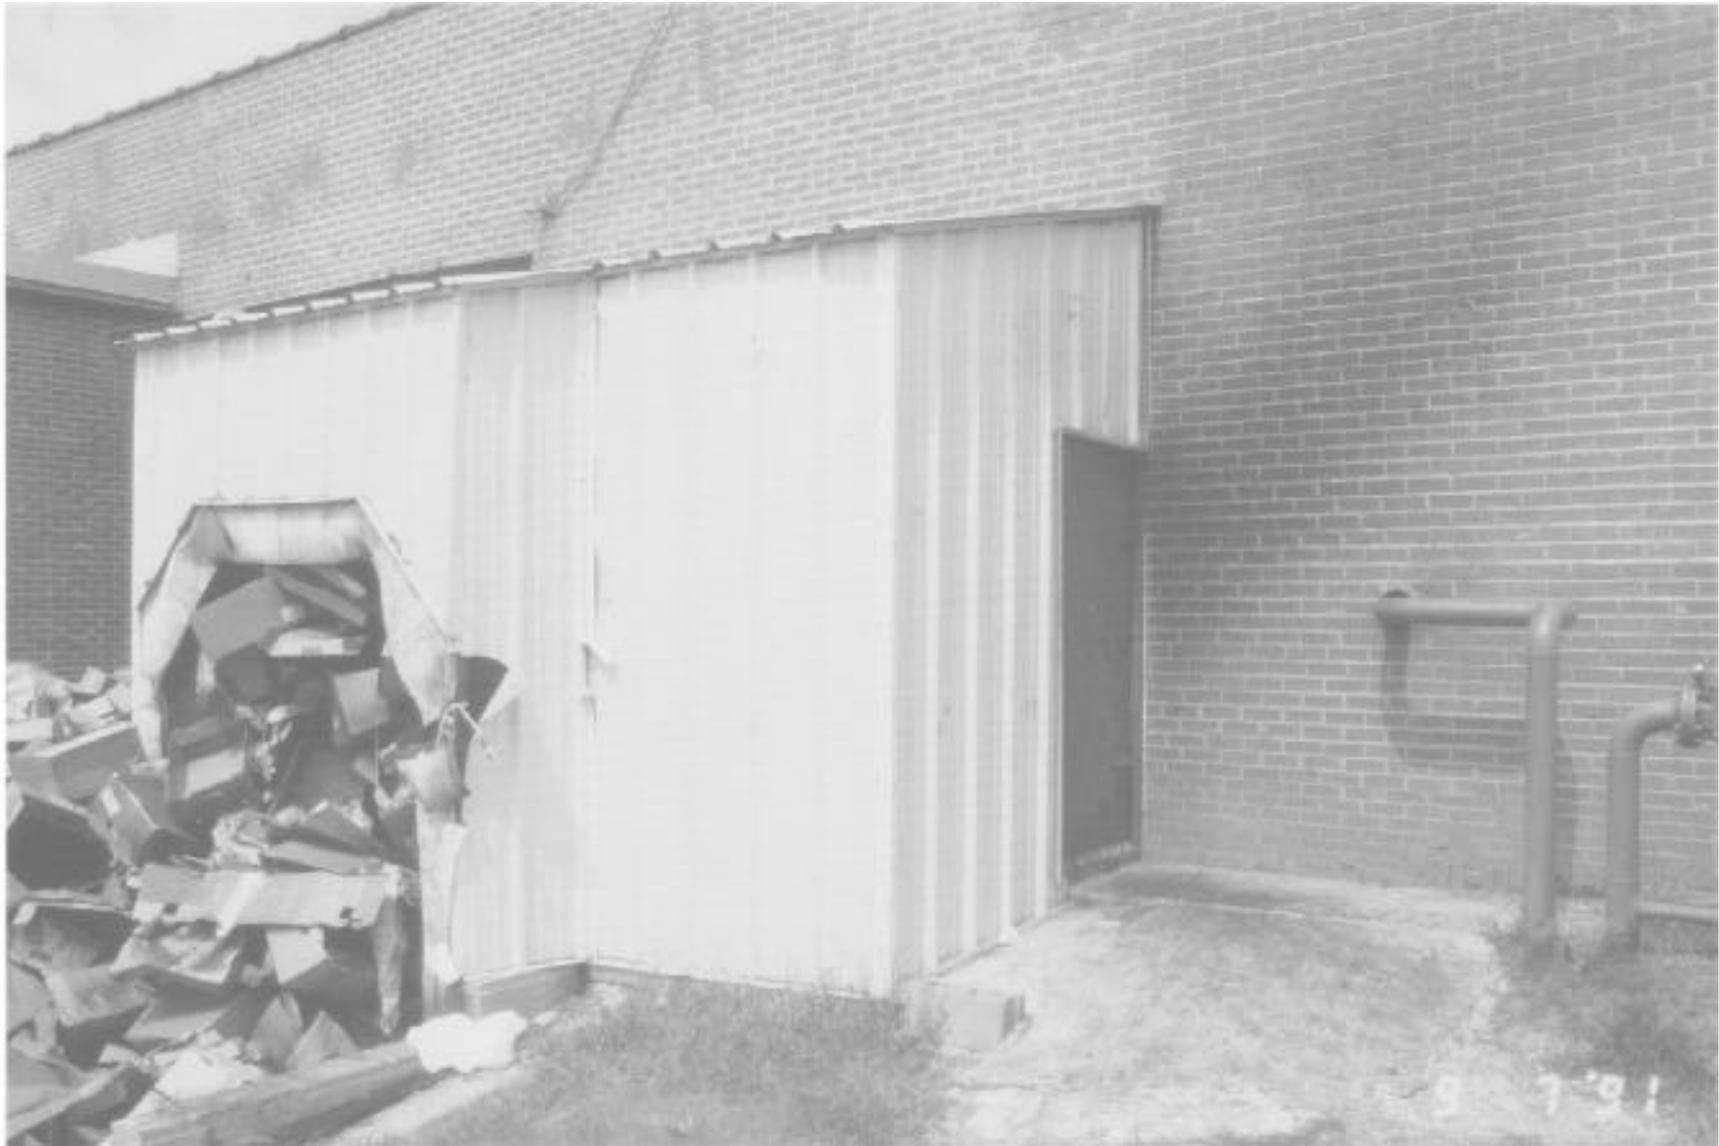
The compactor area and one of the exit doors that was locked.

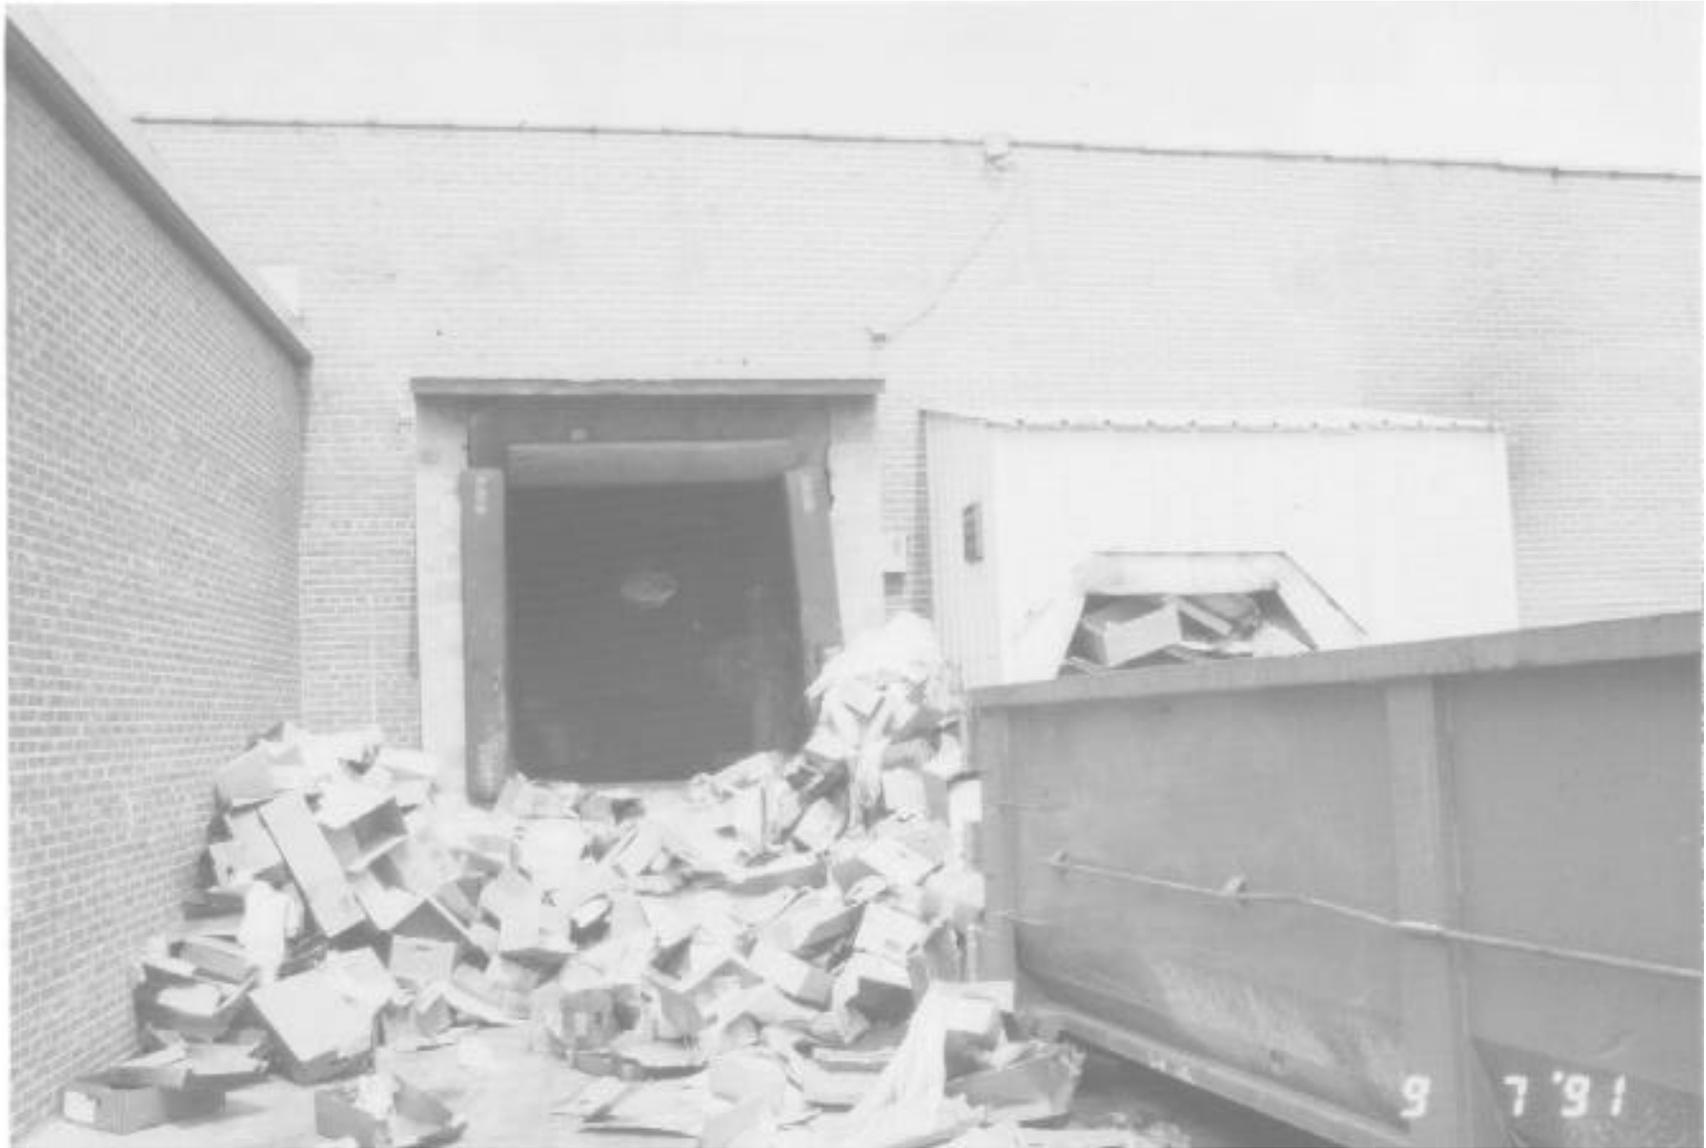
The loading dock area and sealed doors next to the compactor. The pads around the doors are designed to form a seal when the trailer backs into this dock.

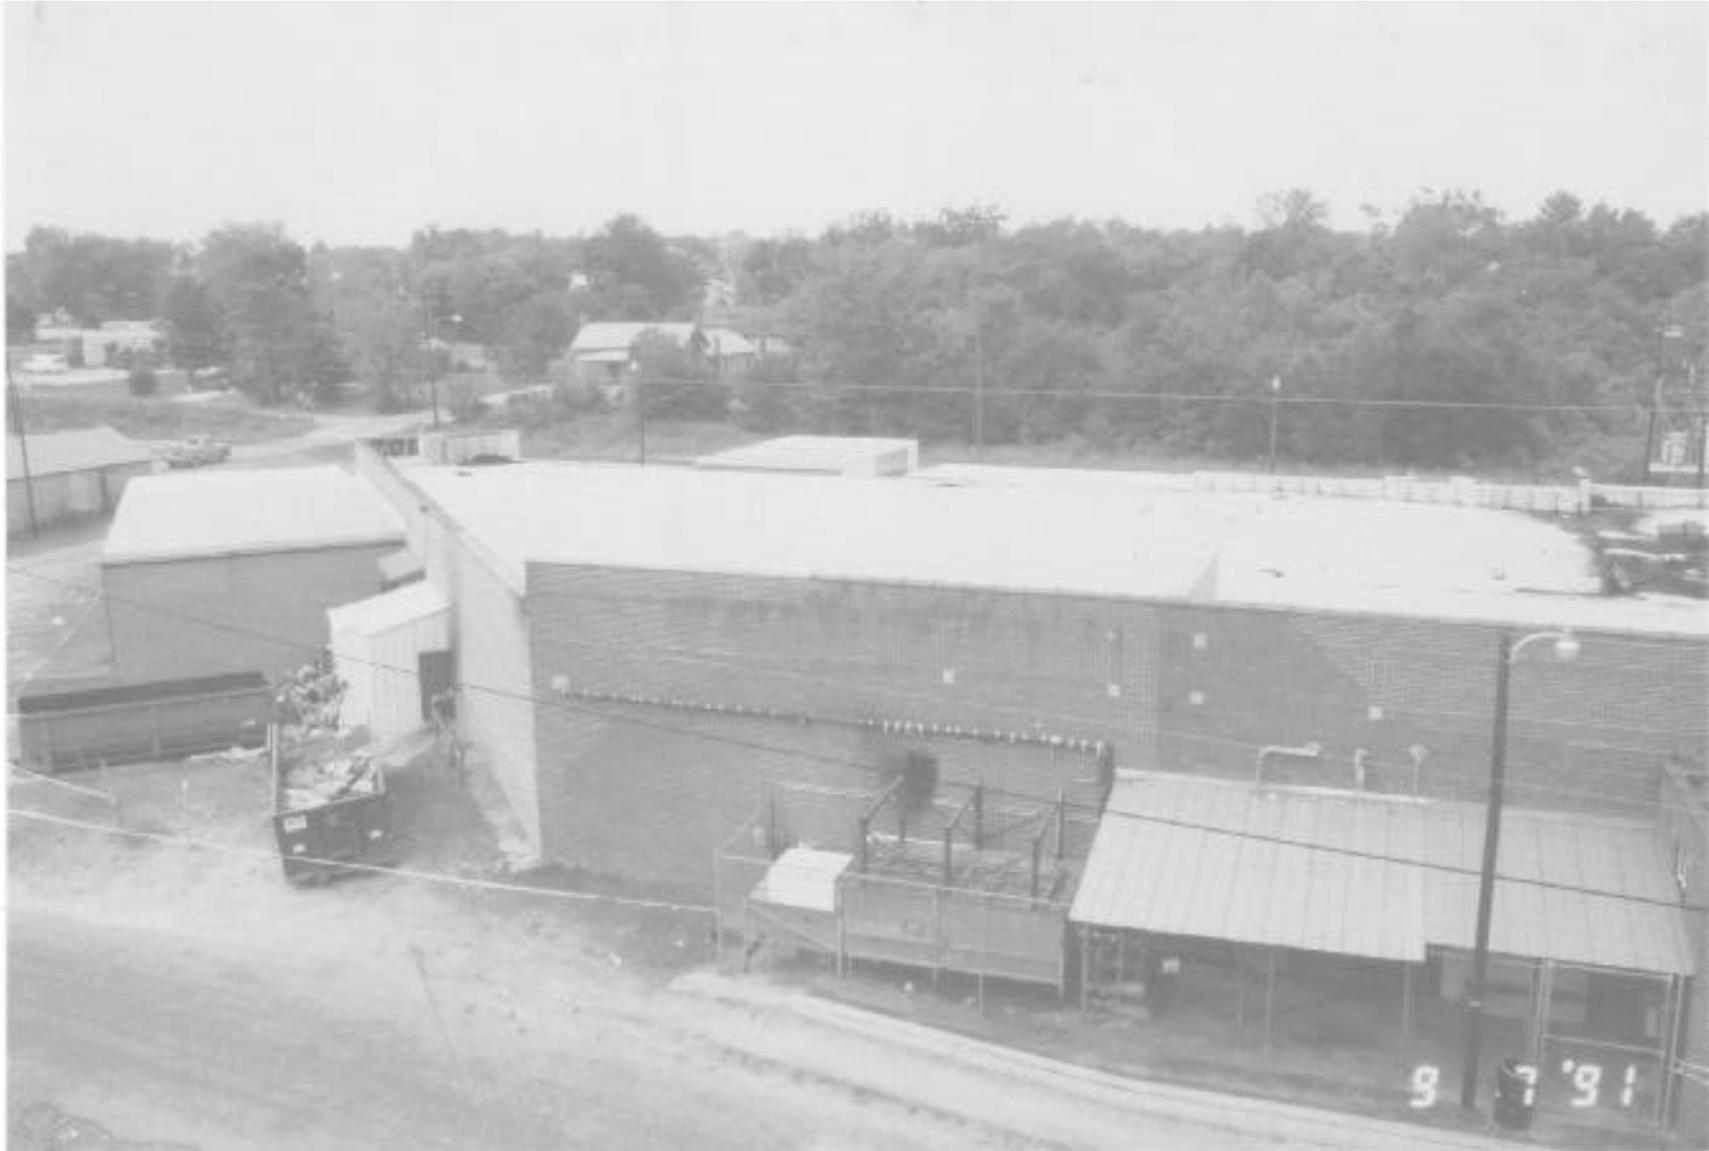
A view from an aerial ladder from the east looking southwest. Some roof damage is visible at the extreme right.

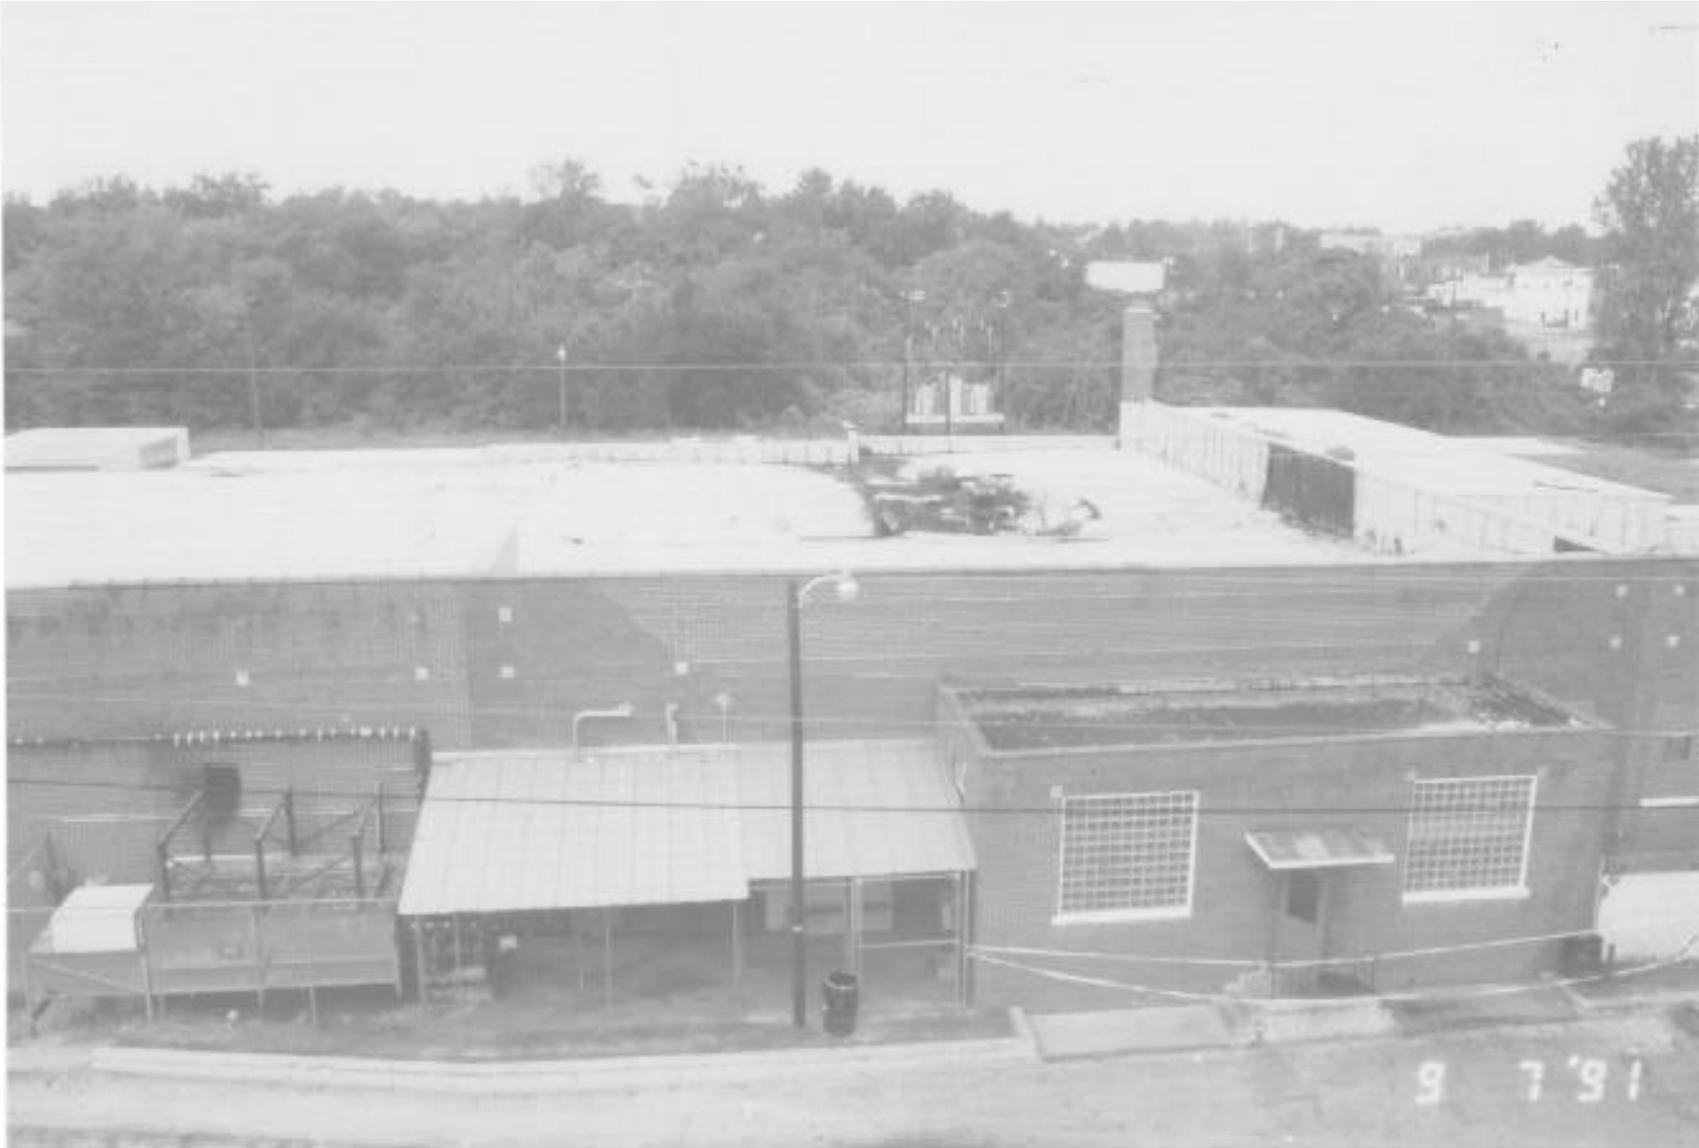
Another view from the aerial ladder from the east looking west, shows the portion of the roof collapsed over the area of origin.

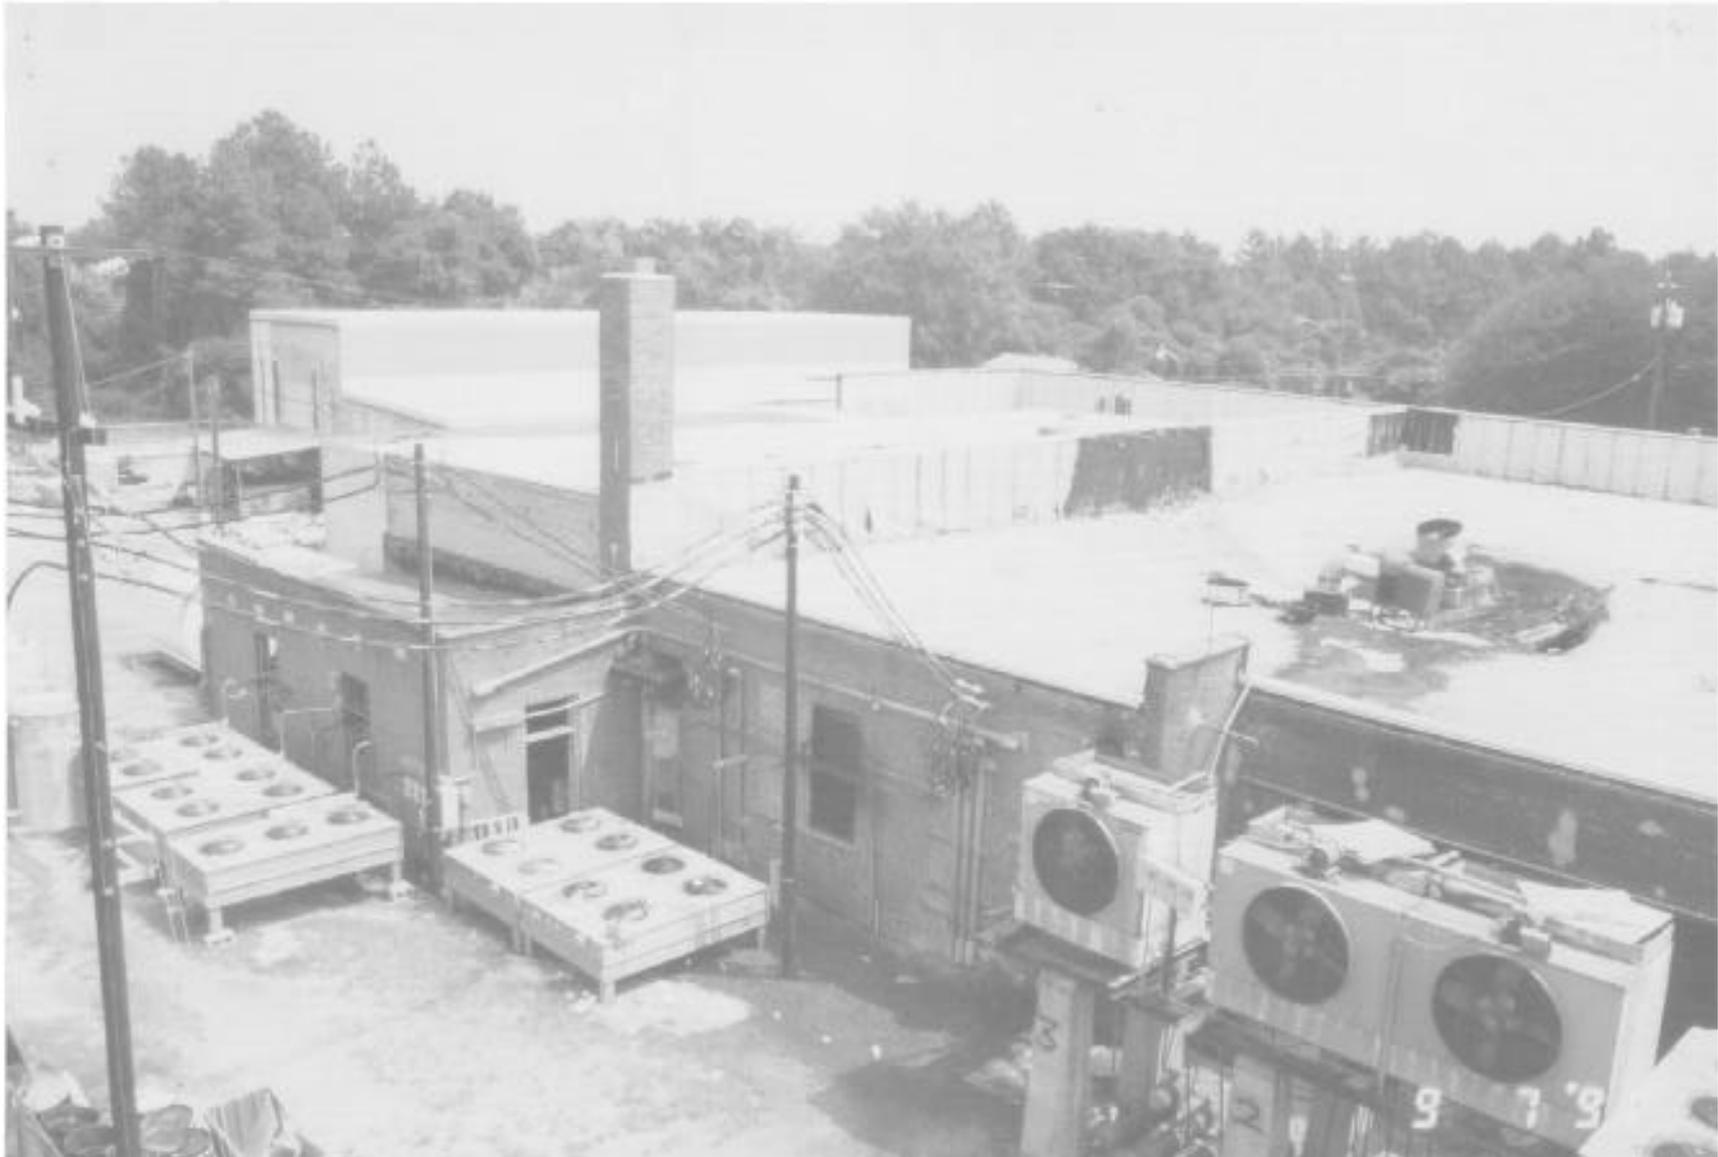
A view from the aerial ladder from the west side looking to the northeast. The roof collapse can be seen on the right, refrigeration compressor equipment is seen on the ground in the lower left.

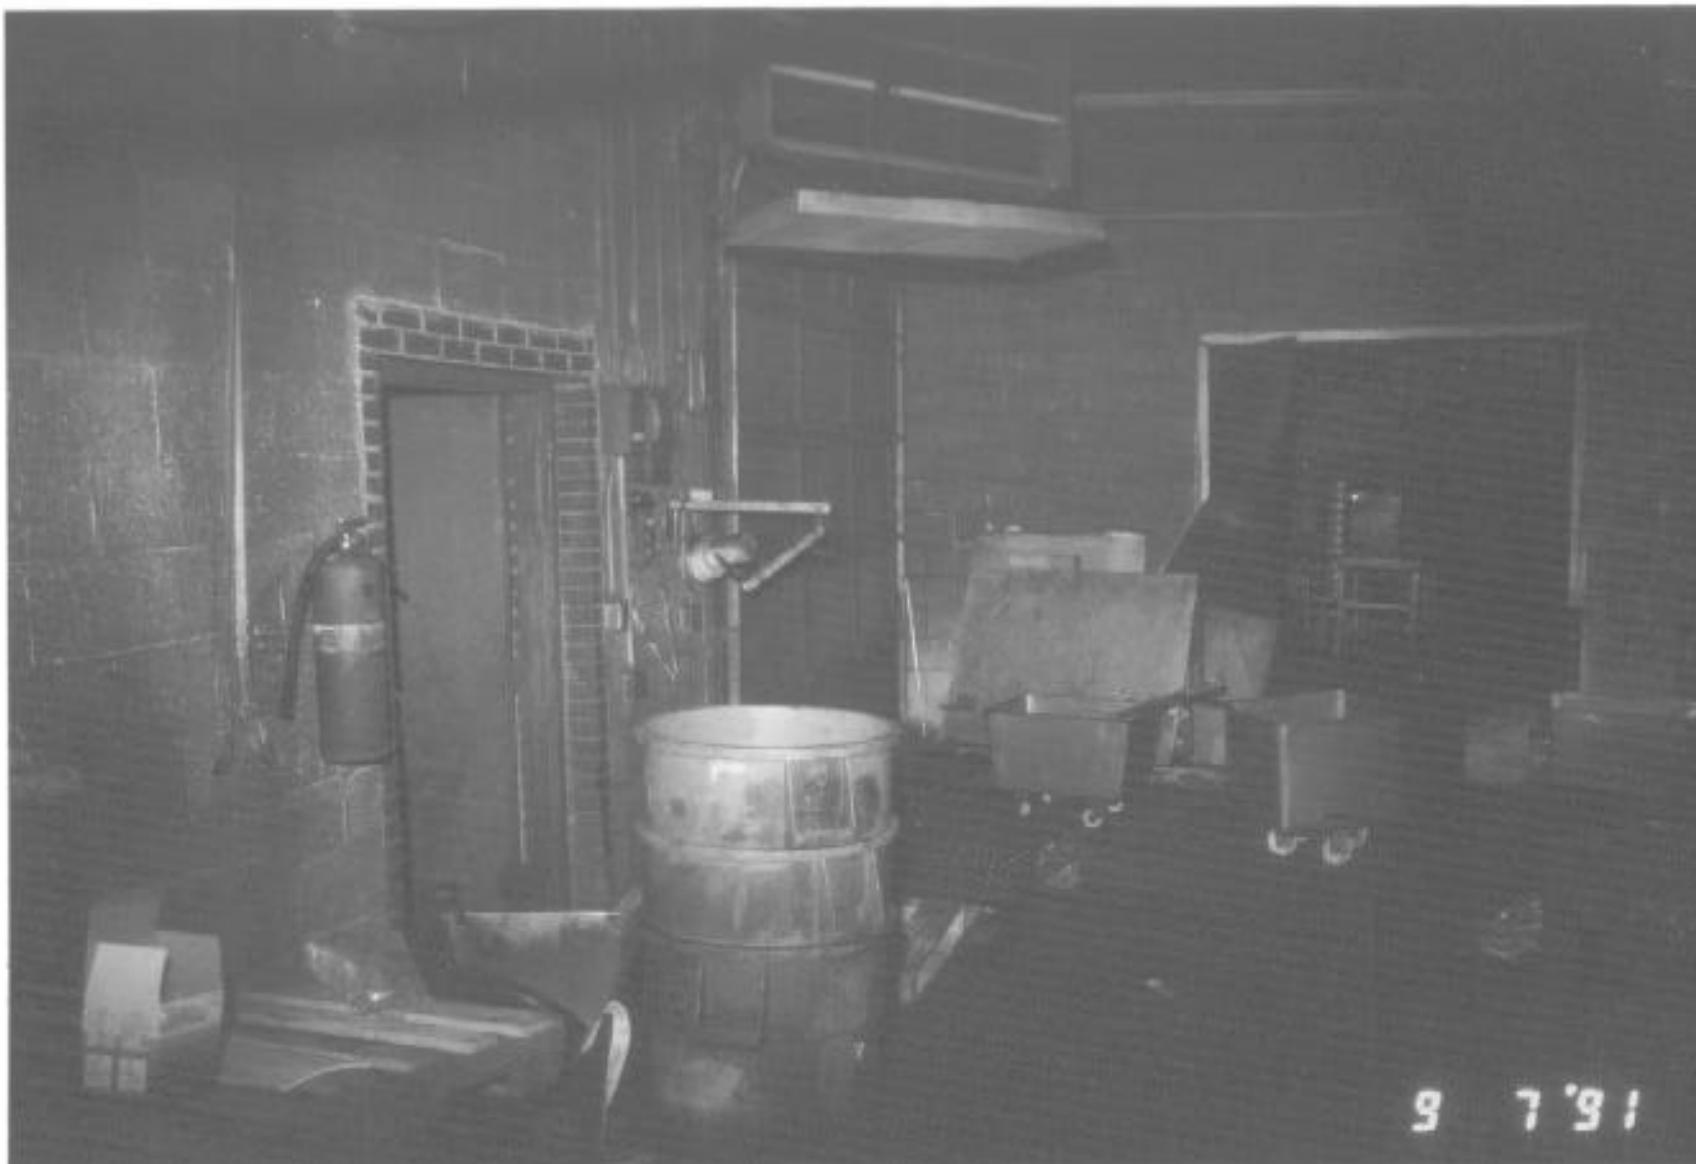
The trash and loading dock area. It was into this compactor area that several people tried to escape only to find the door to the outside locked. Upon coming back out of this area, they went through the large doors at the right which ultimately led to the large walk-in cooler where the largest fatality count was found. View is from the east toward the west southwest.

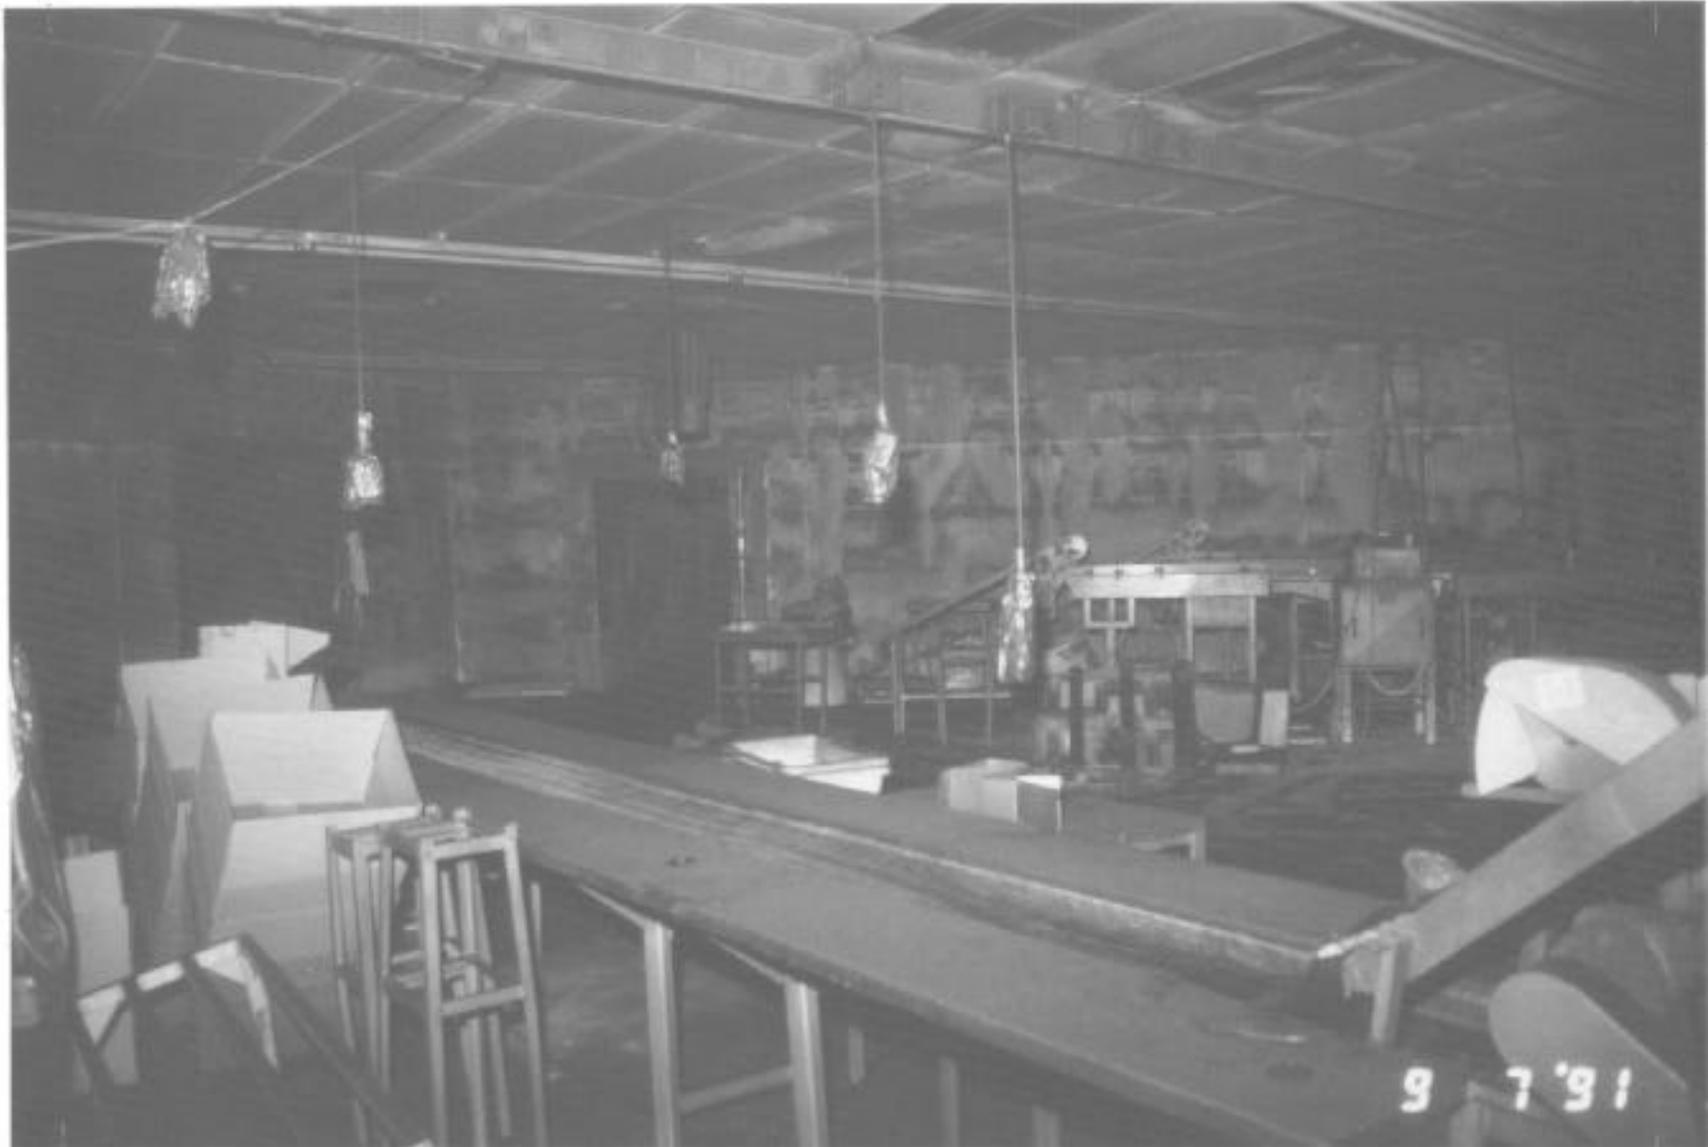
View showing the trim room as seen from the west center looking to the southeast. This view is looking toward the door to the cooler where the highest fatality count was located.

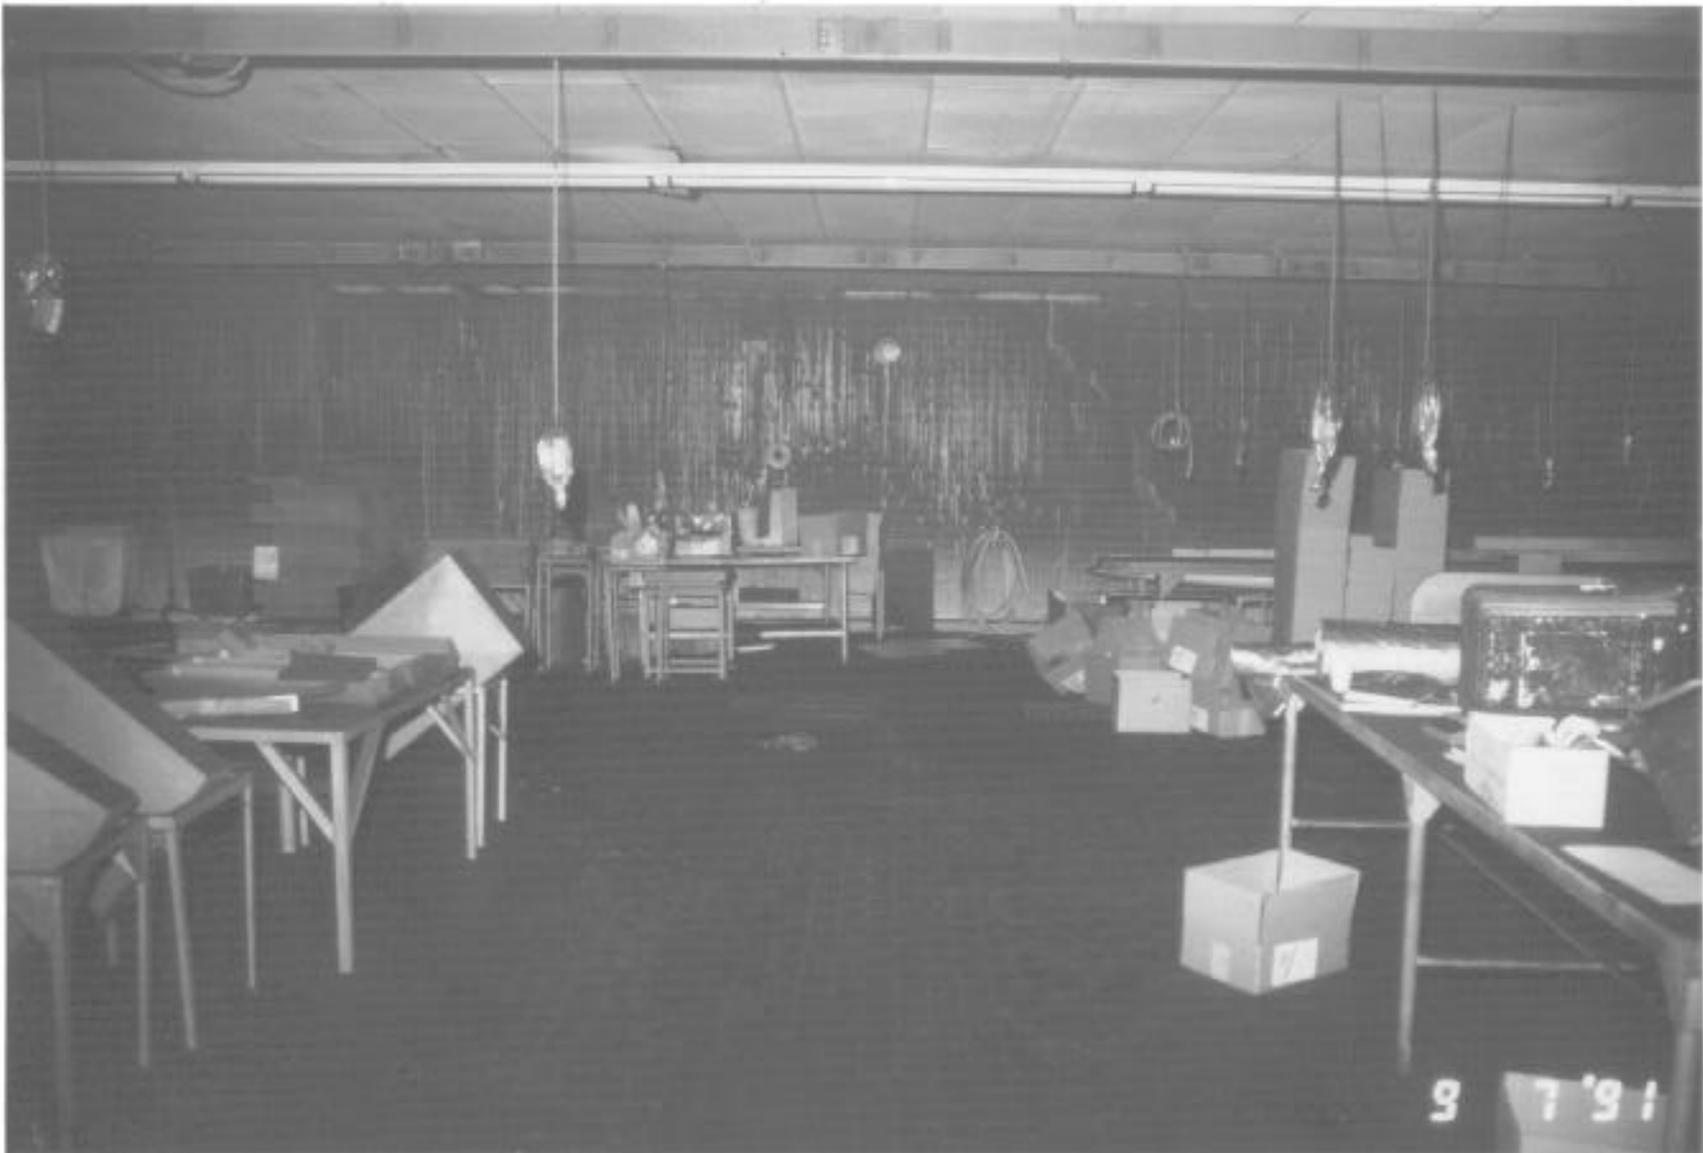
Inside the marinating and cutting room; no direct flame impingement actually entered into this area. View is from the east to the west.

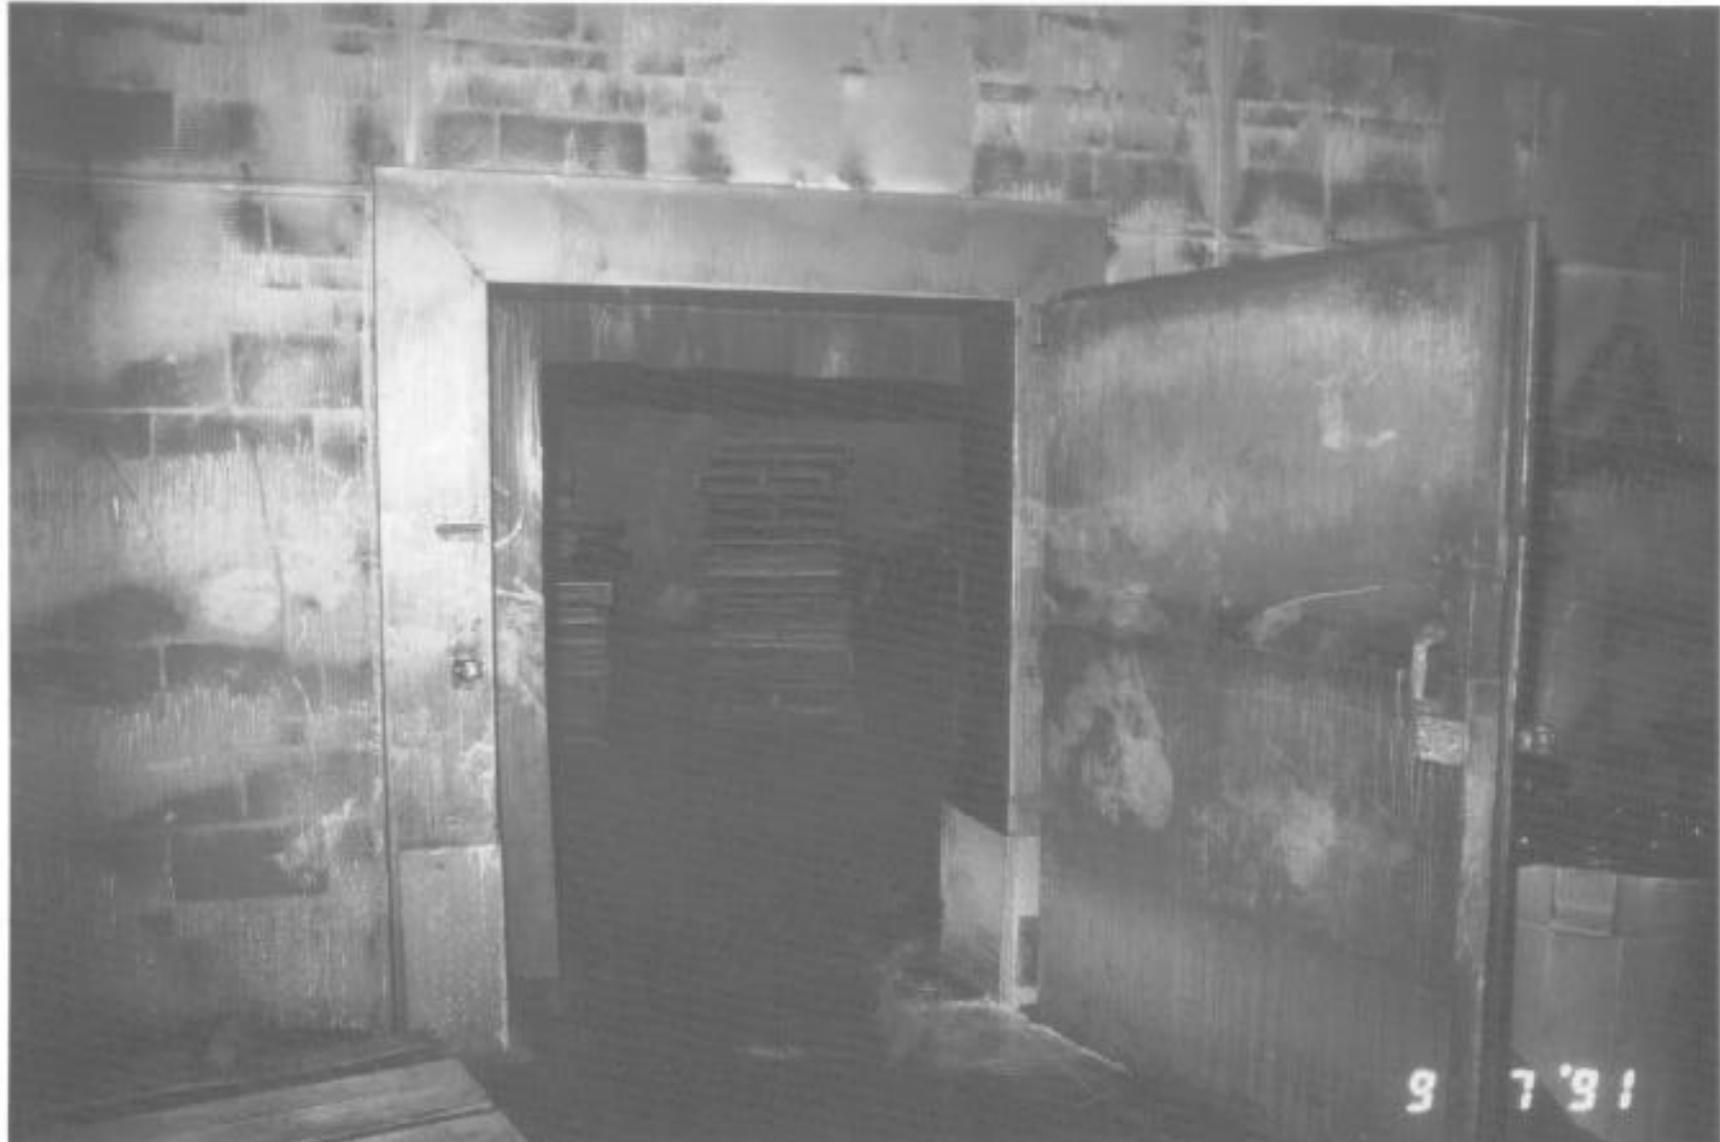
The cooler door, which was at the south end of the building, where the highest fatality count was found.

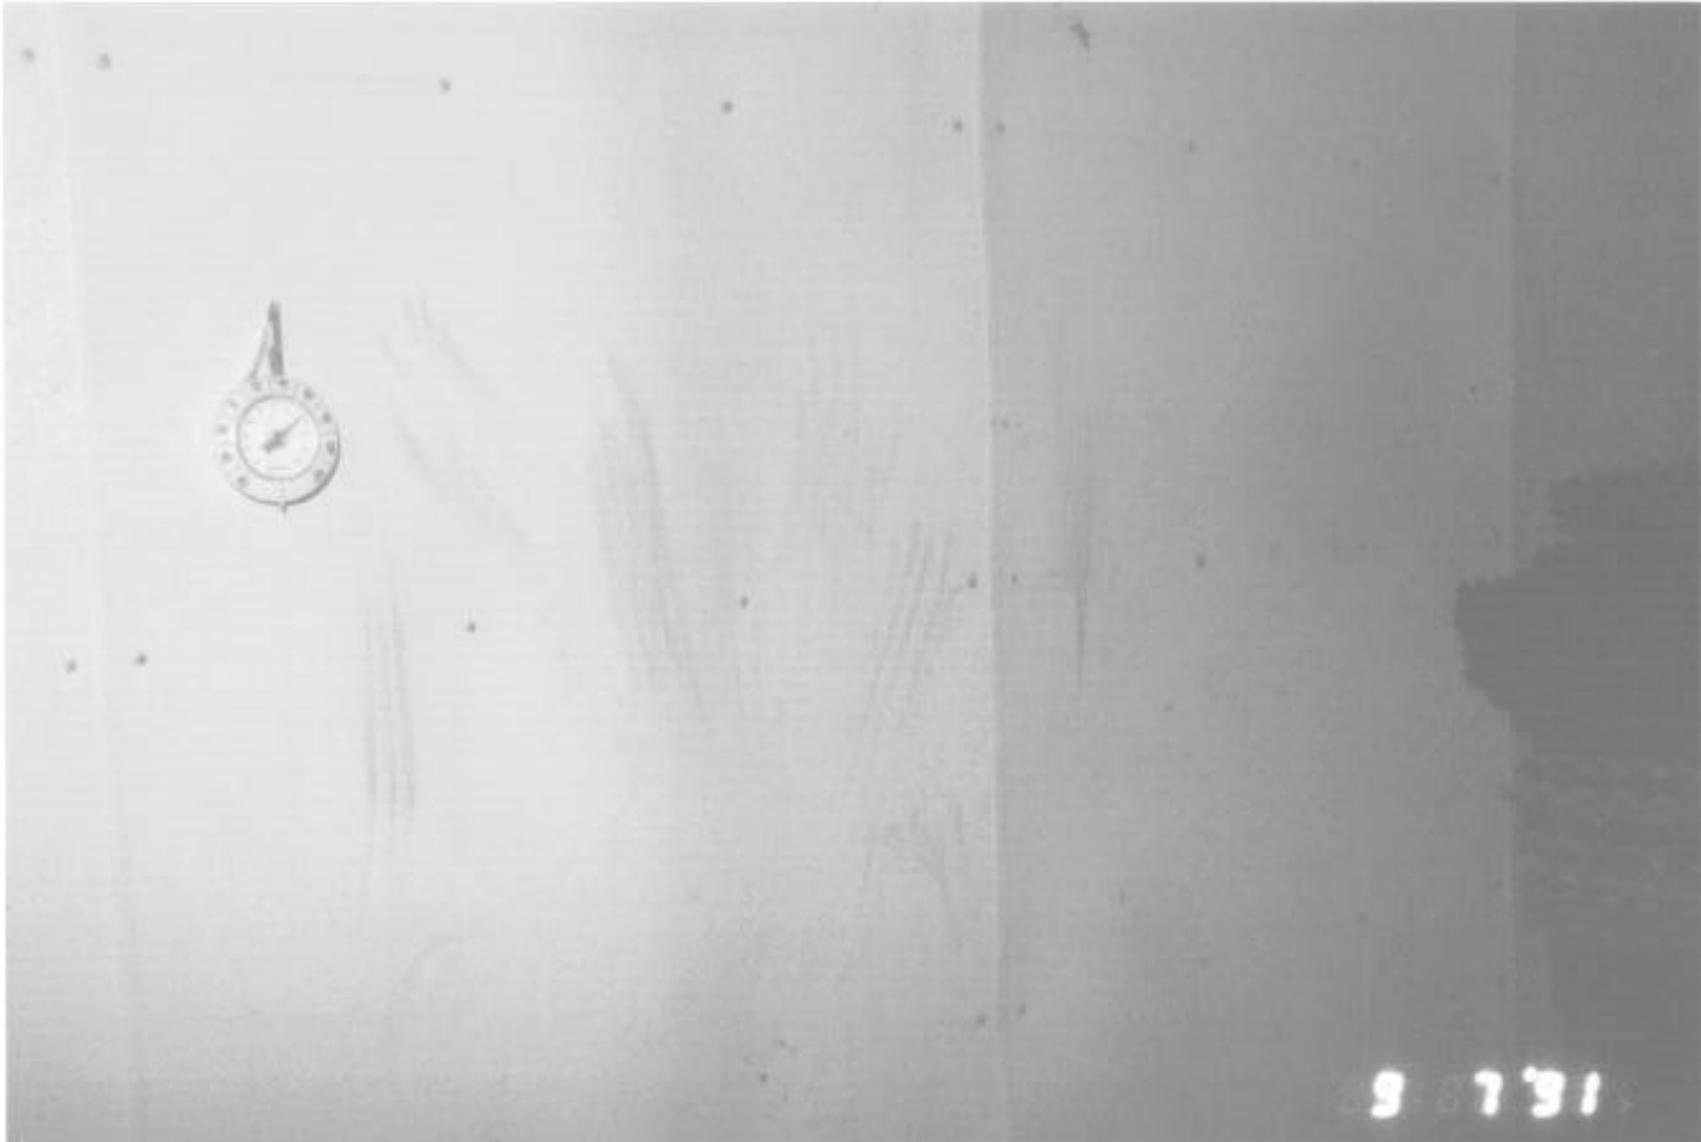
The west wall in the west portion of the cooler. Numerous handprints were found where people were trying to find escape routes.
