Chicken Processing Plant Fires Hamlet, North Carolina, and North Little Rock, Arkansas

**Chicken Processing Plant Fires
Hamlet, North Carolina
(September 3, 1991)
North Little Rock, Arkansas
(June 7, 1991)**

This is Report 057 of the Major Fires Investigation Project conducted by TriData Corporation under contract EMW-90-C-3338 to the United States Fire Administration, Federal Emergency Management Agency.

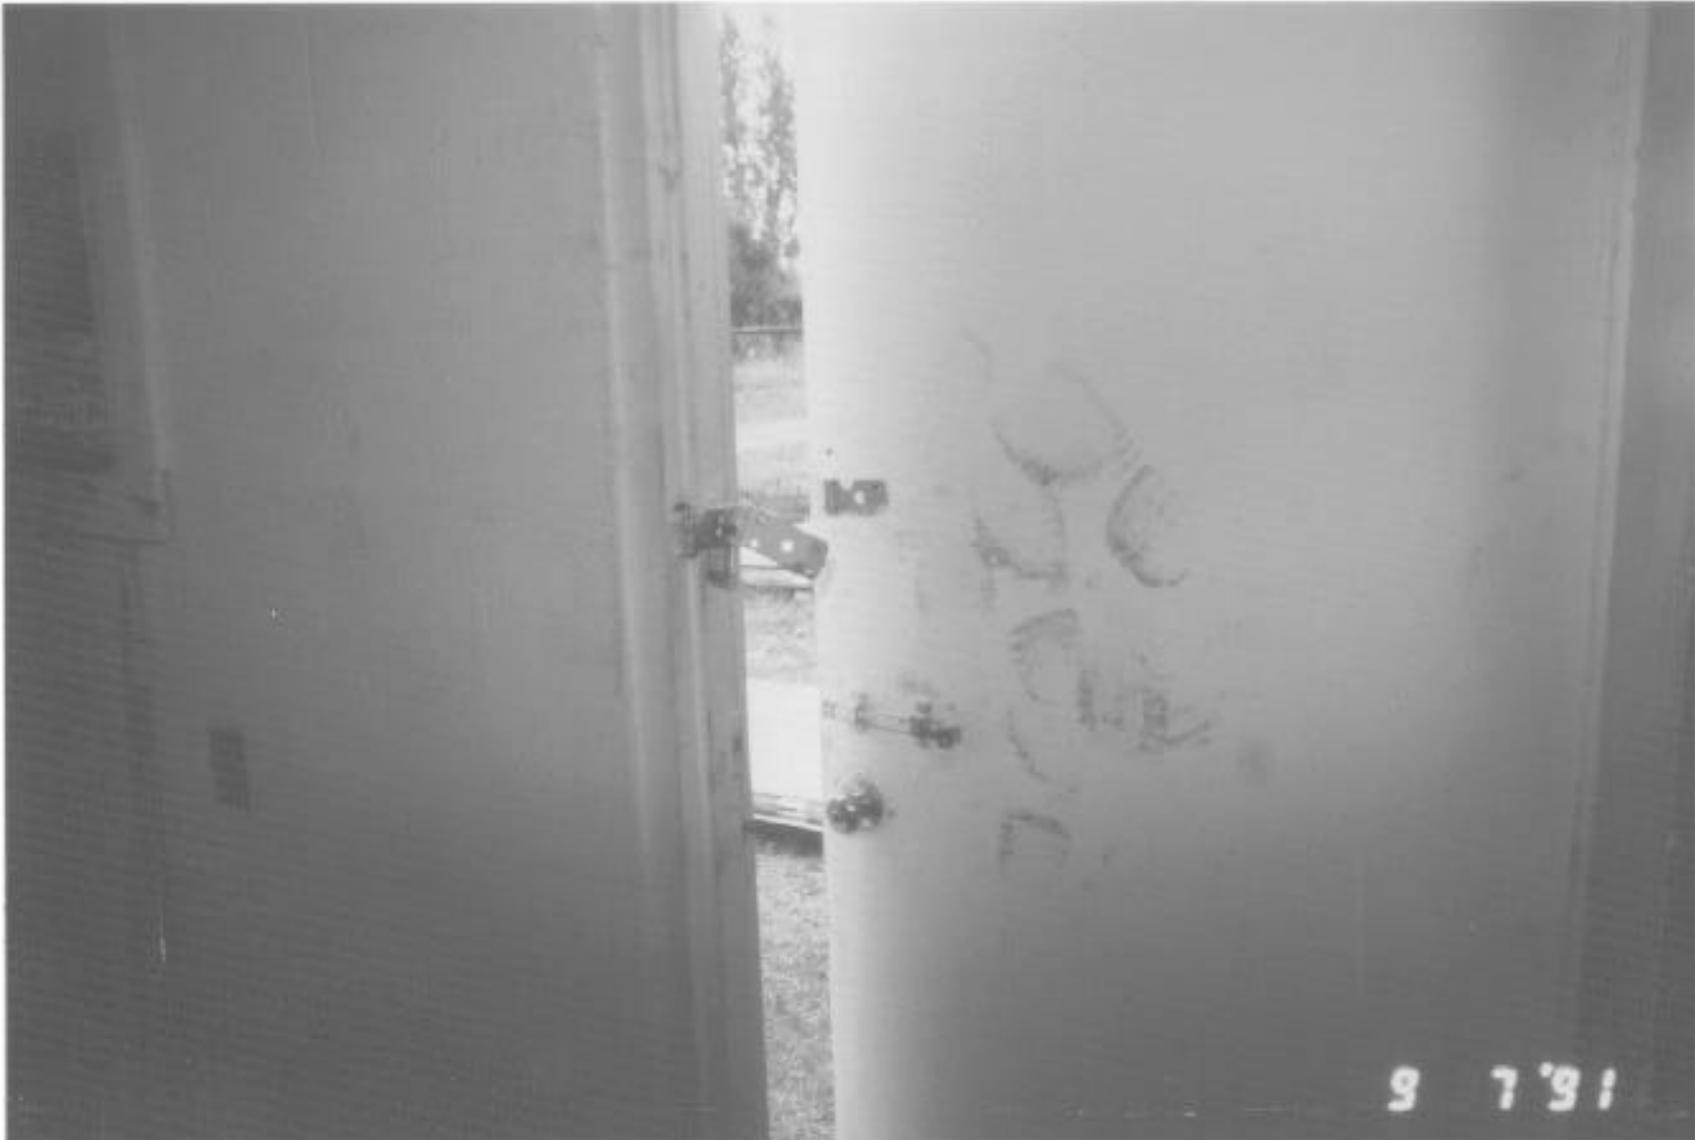
A close-up view of the north door to the break room. Note the footprints and padlock in place where the door was kicked; it was eventually opened for the escape of some personnel.

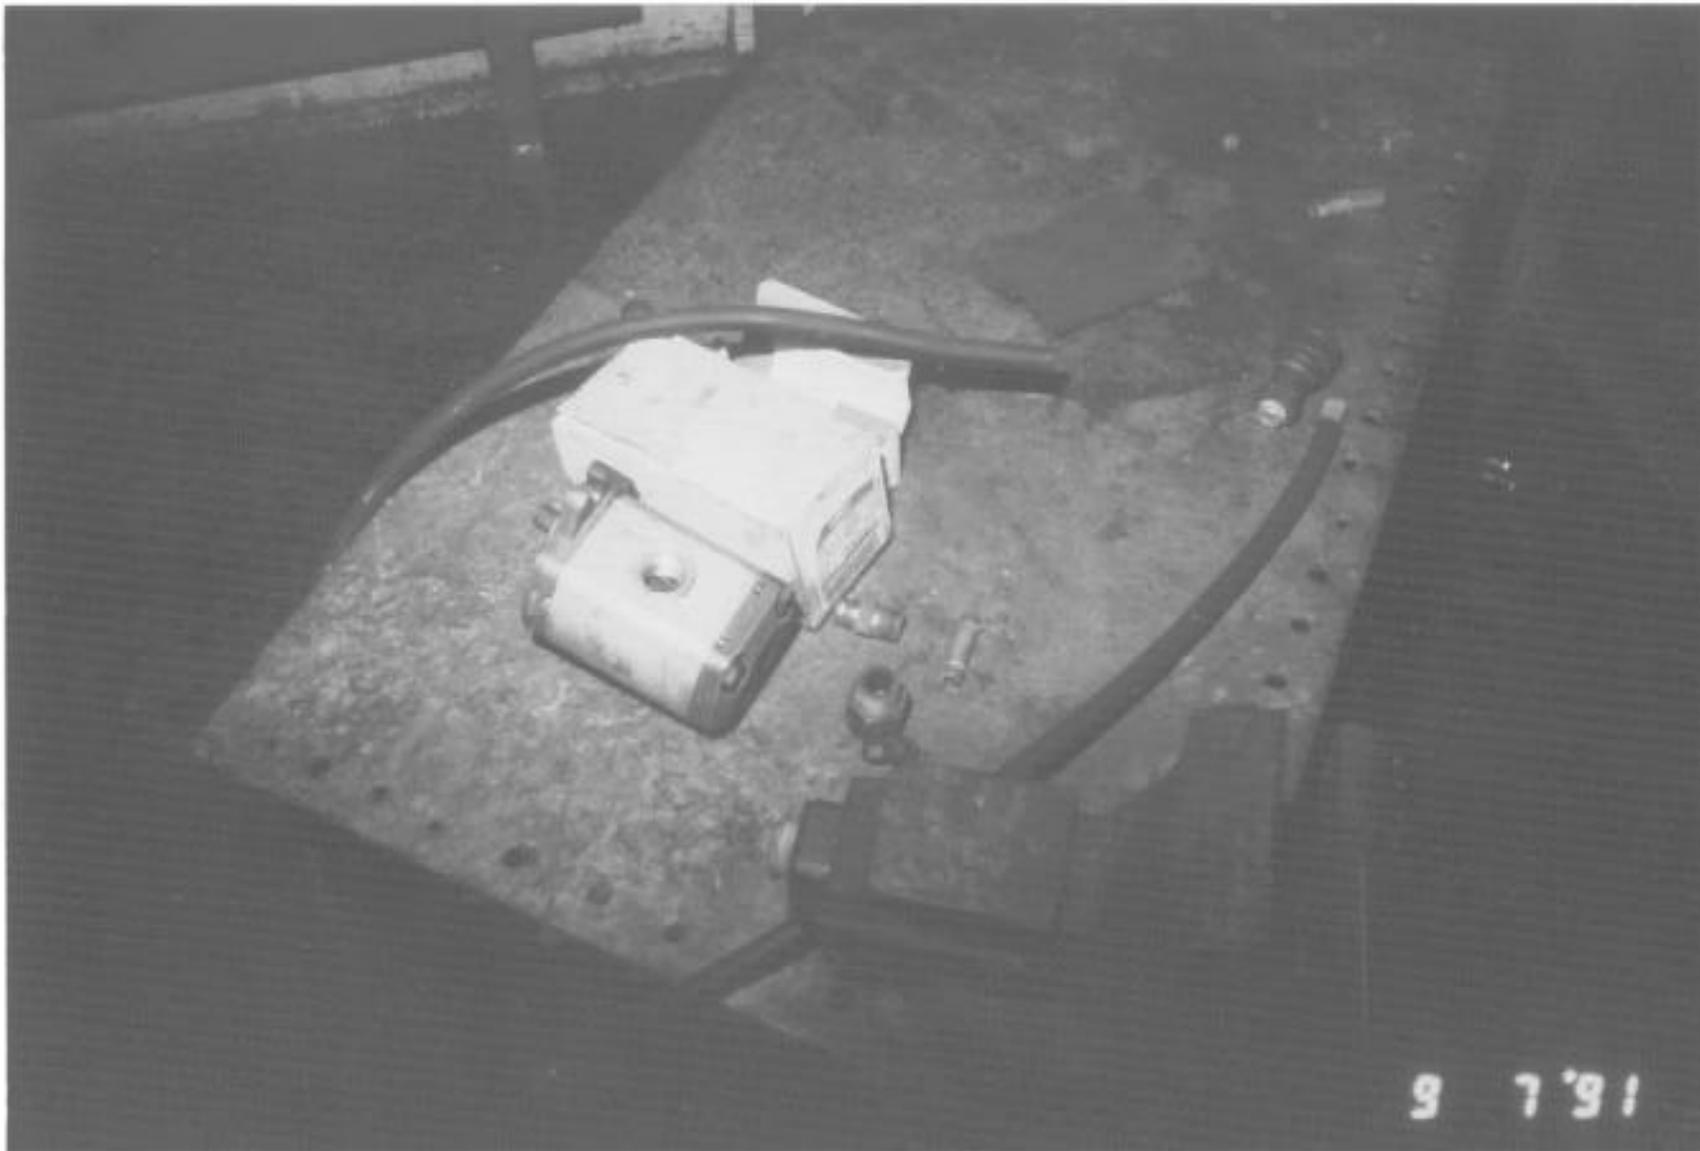
A maintenance worker who survived the fire indicated that the hydraulic line that drove the conveyor had developed a leak. The hydraulic line was turned off and drained of fluid. Then the maintenance worker disconnected the leaking line and replaced it with a factory prepared line.

The factory prepared line, however, was found to be too long and would have dragged on the floor, possibly causing people working in the area to trip. So the maintenance worker reportedly asked for and gained permission to cut the factory prepared hydraulic line to an appropriate length, replaced the end connector with their own connector, and put the line back in place. This line has been described as a 3/4-inch flex line rated to carry 3,000 psi. Information from plant personnel indicated normal pressure was kept at approximately 800 psi, but it would at times fluctuate as high as 1,200 to 1,500 psi.

The hydraulic line was brought back to operating pressure. Shortly afterward it separated at the repaired connector point. The connector was some four to six feet above floor level with hydraulic fluid being expelled at a pressure of 800 to 1,500 psi. It obviously began to splatter off the concrete floor. Droplets were bouncing back onto the gas heating plumbs for the cooking vat, which turned them into vapor. The vapors then were going directly into the flame. The vapors had a much lower flashpoint than the liquid hydraulic fluid and therefore rapidly ignited.

The remains of the hydraulic line that had been cut by the maintenance worker for the repair process **that** took place just preceding the fire.

4. High pressure equipment maintenance and repairs must be limited to factory trained personnel and specifications.

Operations such as these plants have extensive hydraulic systems. They operate at considerable pressures and, as in these two cases, are integral parts of cooking processes. Moving parts and high pressures will naturally increase the likelihood of failure. Maintenance must be a constant ongoing process. For maximum safety, maintenance personnel must be trained by the factory representatives. If any parts are replaced, they must conform to factory specifications or not be used. If a maintenance division alters any part of the high pressure system, their alterations must meet or exceed factory specifications.

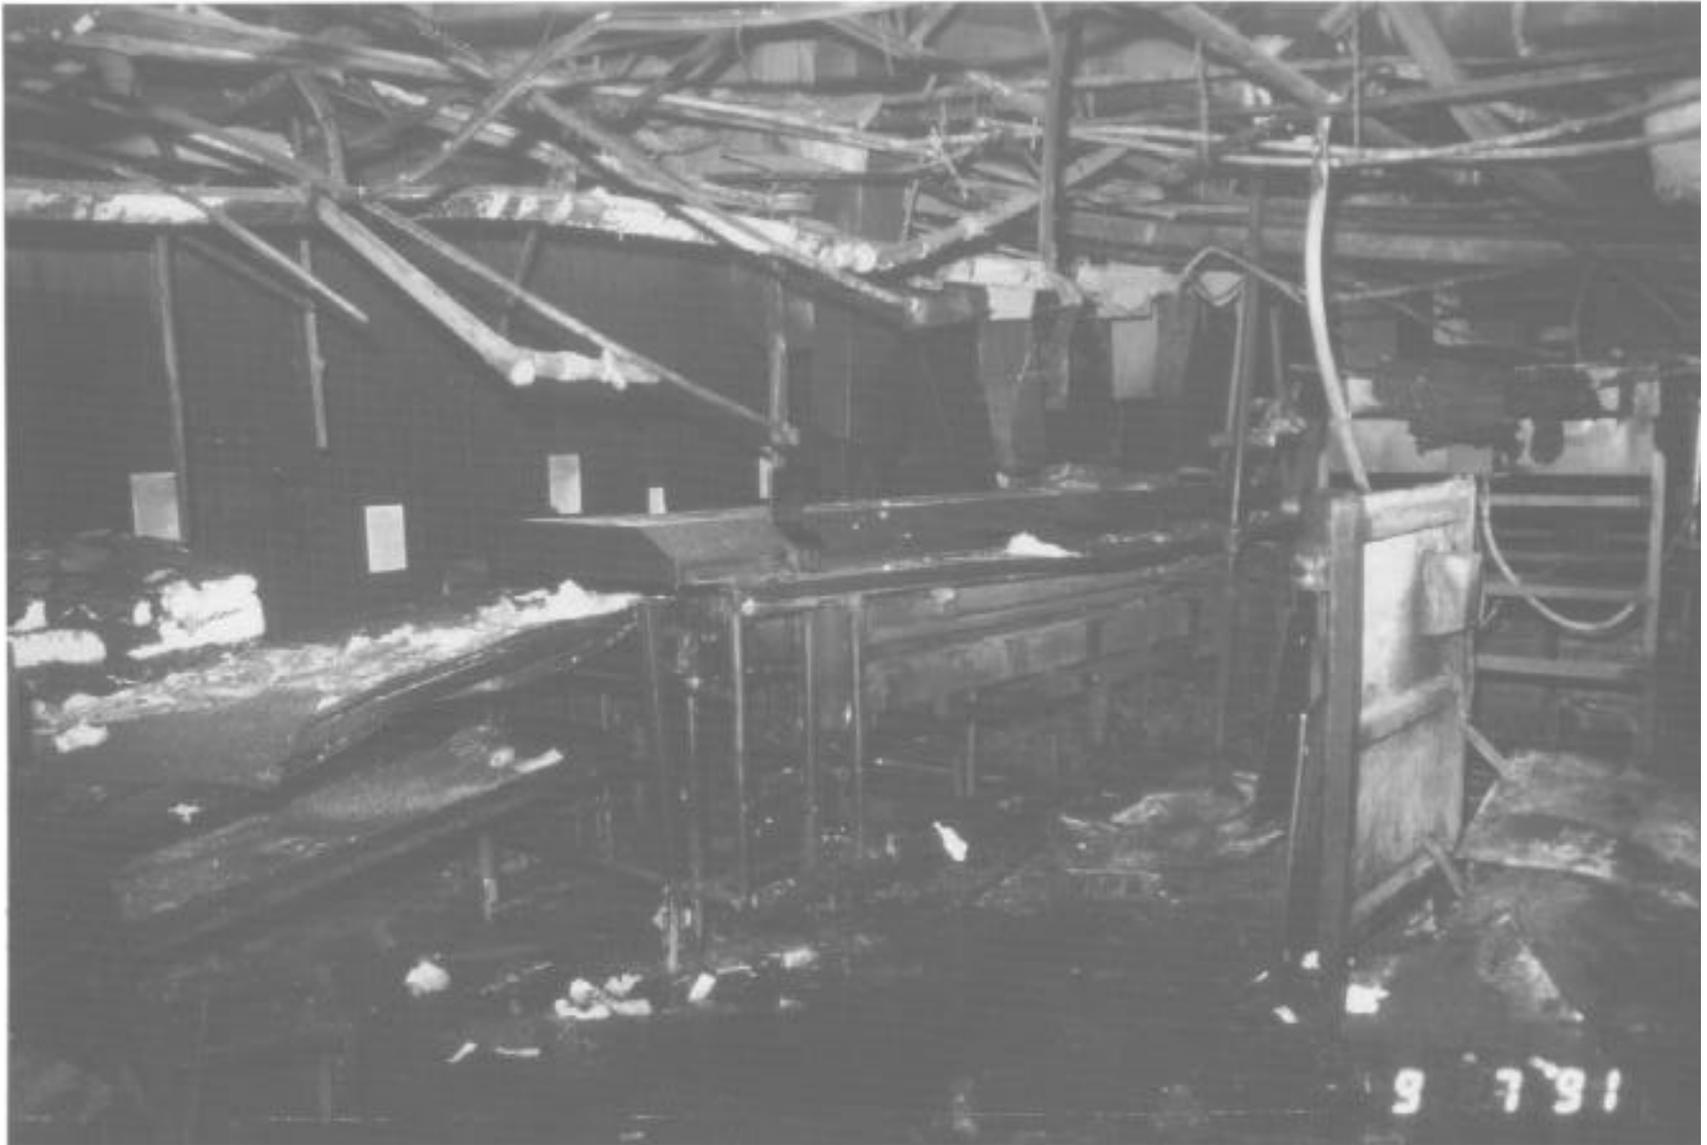
The area of origin viewed from the southeast to the northwest.

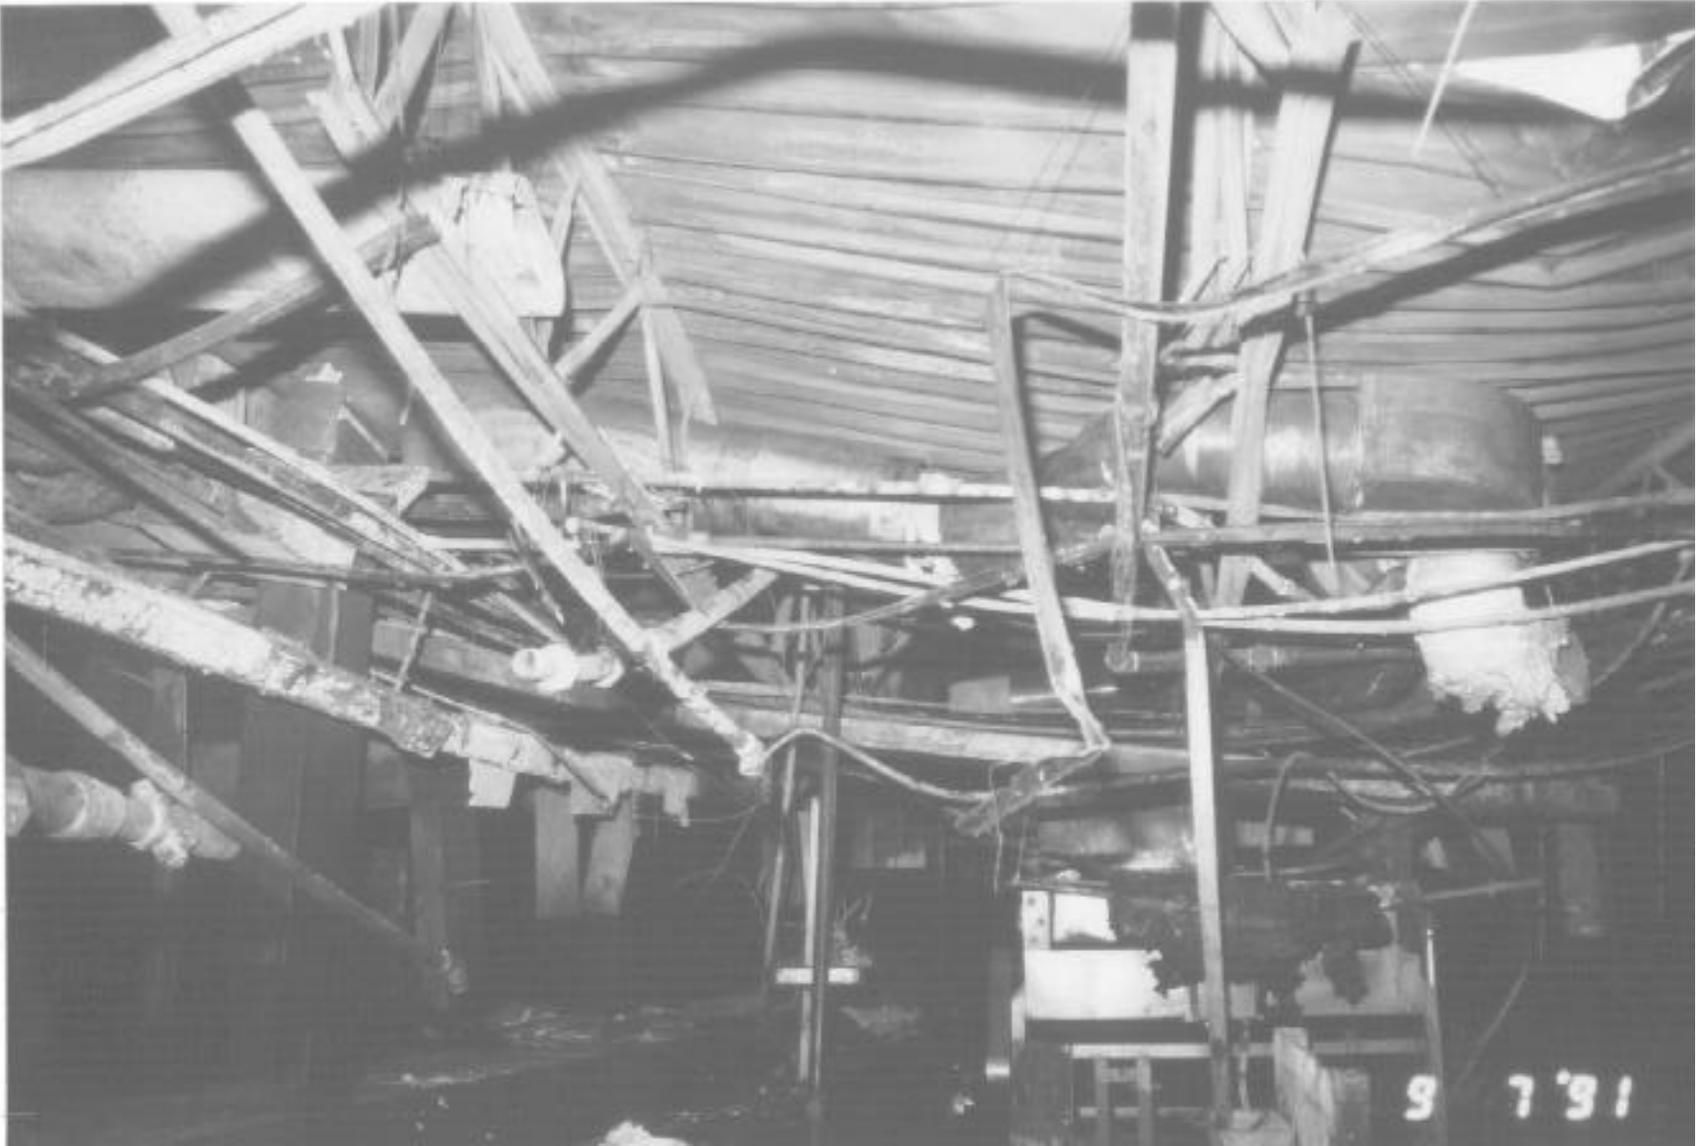
Damage to the steel girders and roof supports over the area of origin.
