Floor Collapse Claims Two Firefighters Pittston, Pennsylvania

Floor Collapse Claims Two Firefighters Pittston, Pennsylvania (March 15,1993)

Investigated by: J. Gordon Routley

This is Report 073 of the Major Fires Investigation Project conducted by TriData Corporation under contract EMW-90-C-3338 to the United States Fire Administration, Federal Emergency Management Agency.

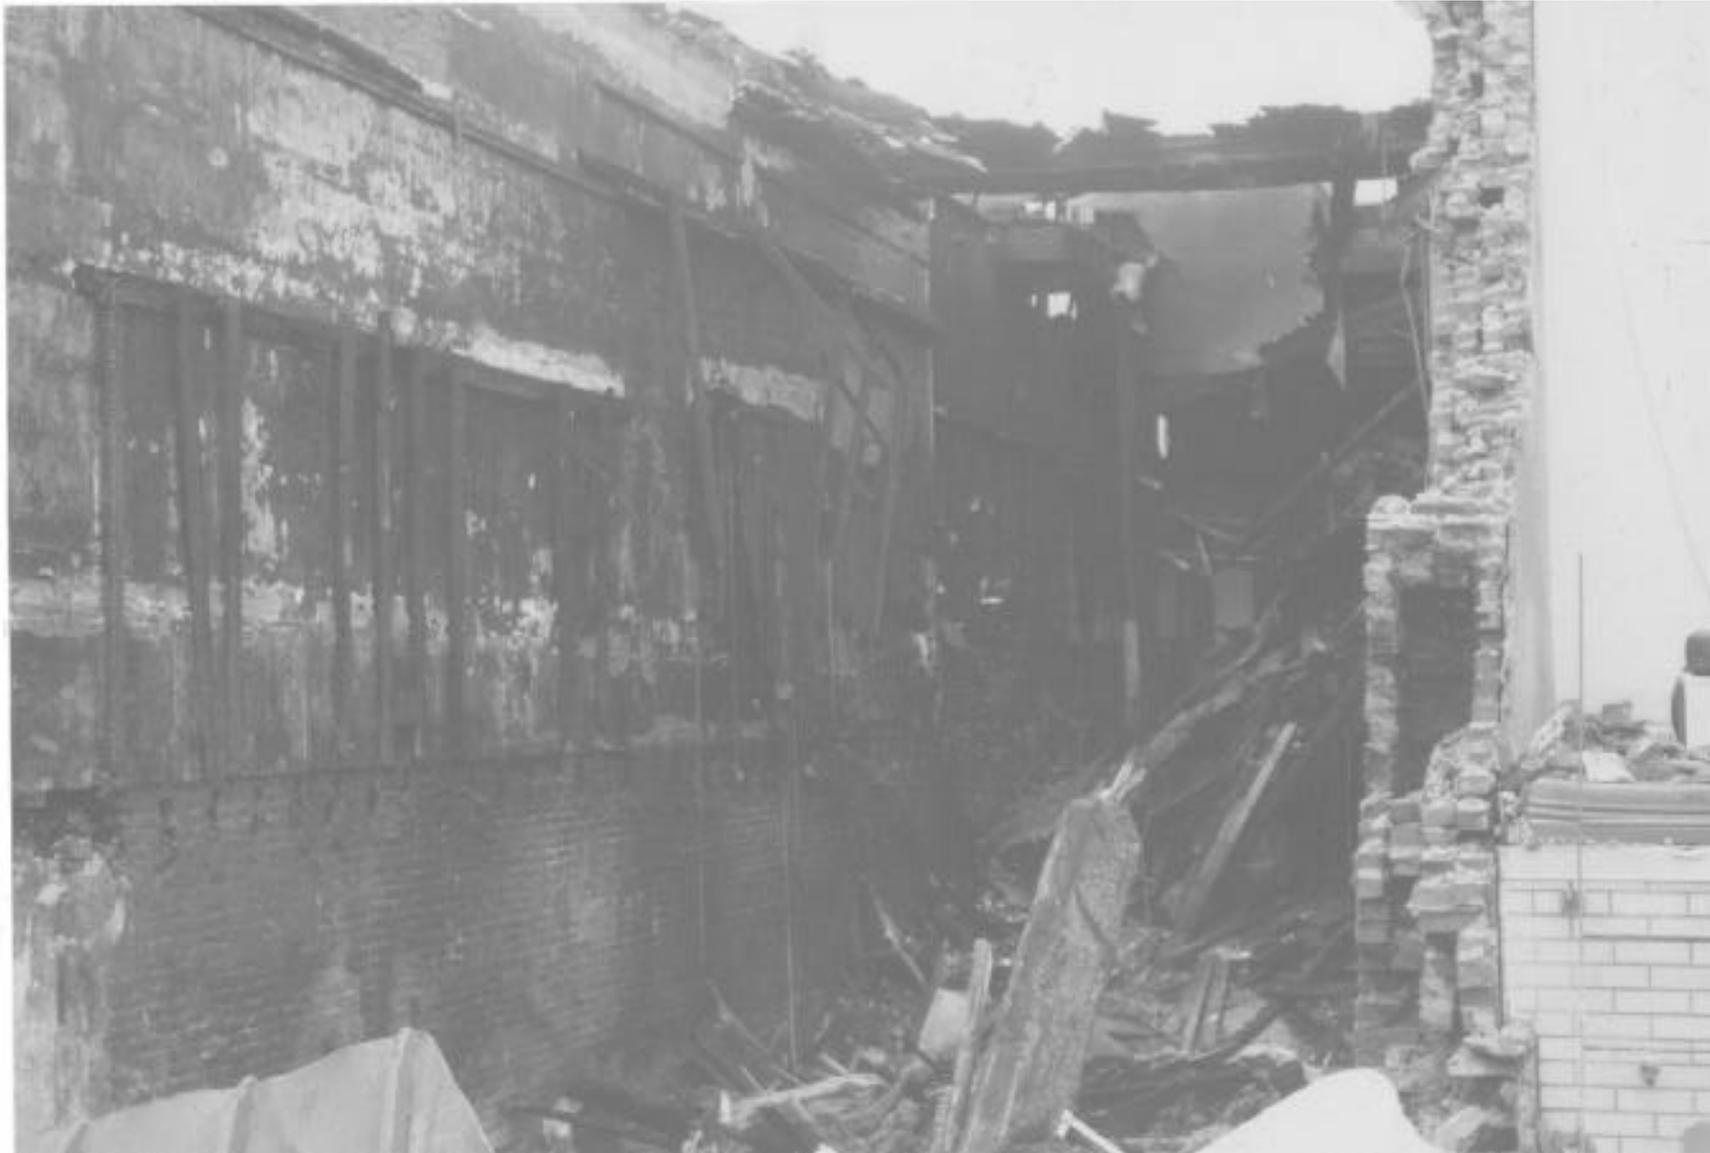
The fire may have smoldered undetected for hours. The vacant area had an opening to an old chimney flue or vent stack in the exterior wall, which may have allowed the smoke to escape during the early stages of the fire. The downtown area was sparsely populated due to the snowfall that had started on the previous day, and even if someone had seen smoke coming from the stack it would have looked like smoke coming from a chimney.

Void in brick wall (foreground) was a flue from a heating unit (previously removed) that may have allowed smoke from the basement to vent to the outside in the early stages of the fire.

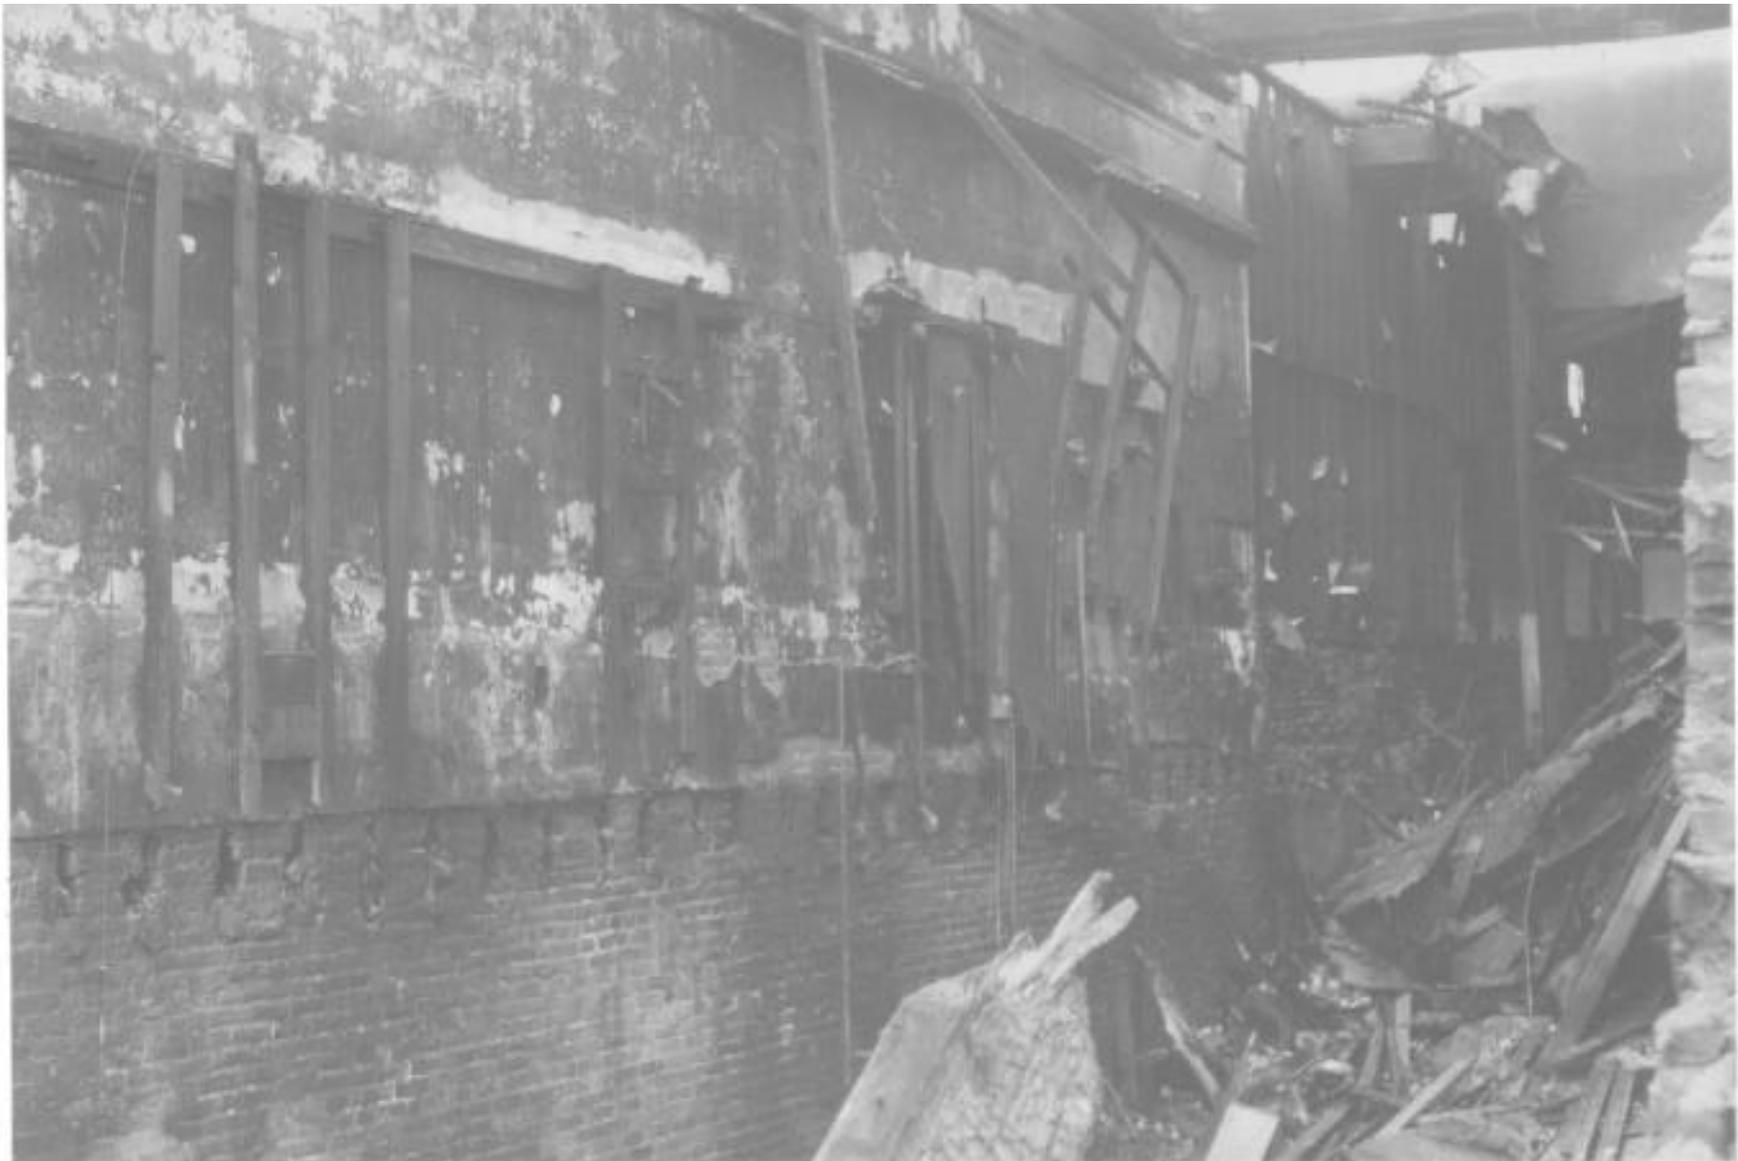
The wall of the front portion of the stationery store remains standing, although the interior is destroyed and the roof has collapsed.

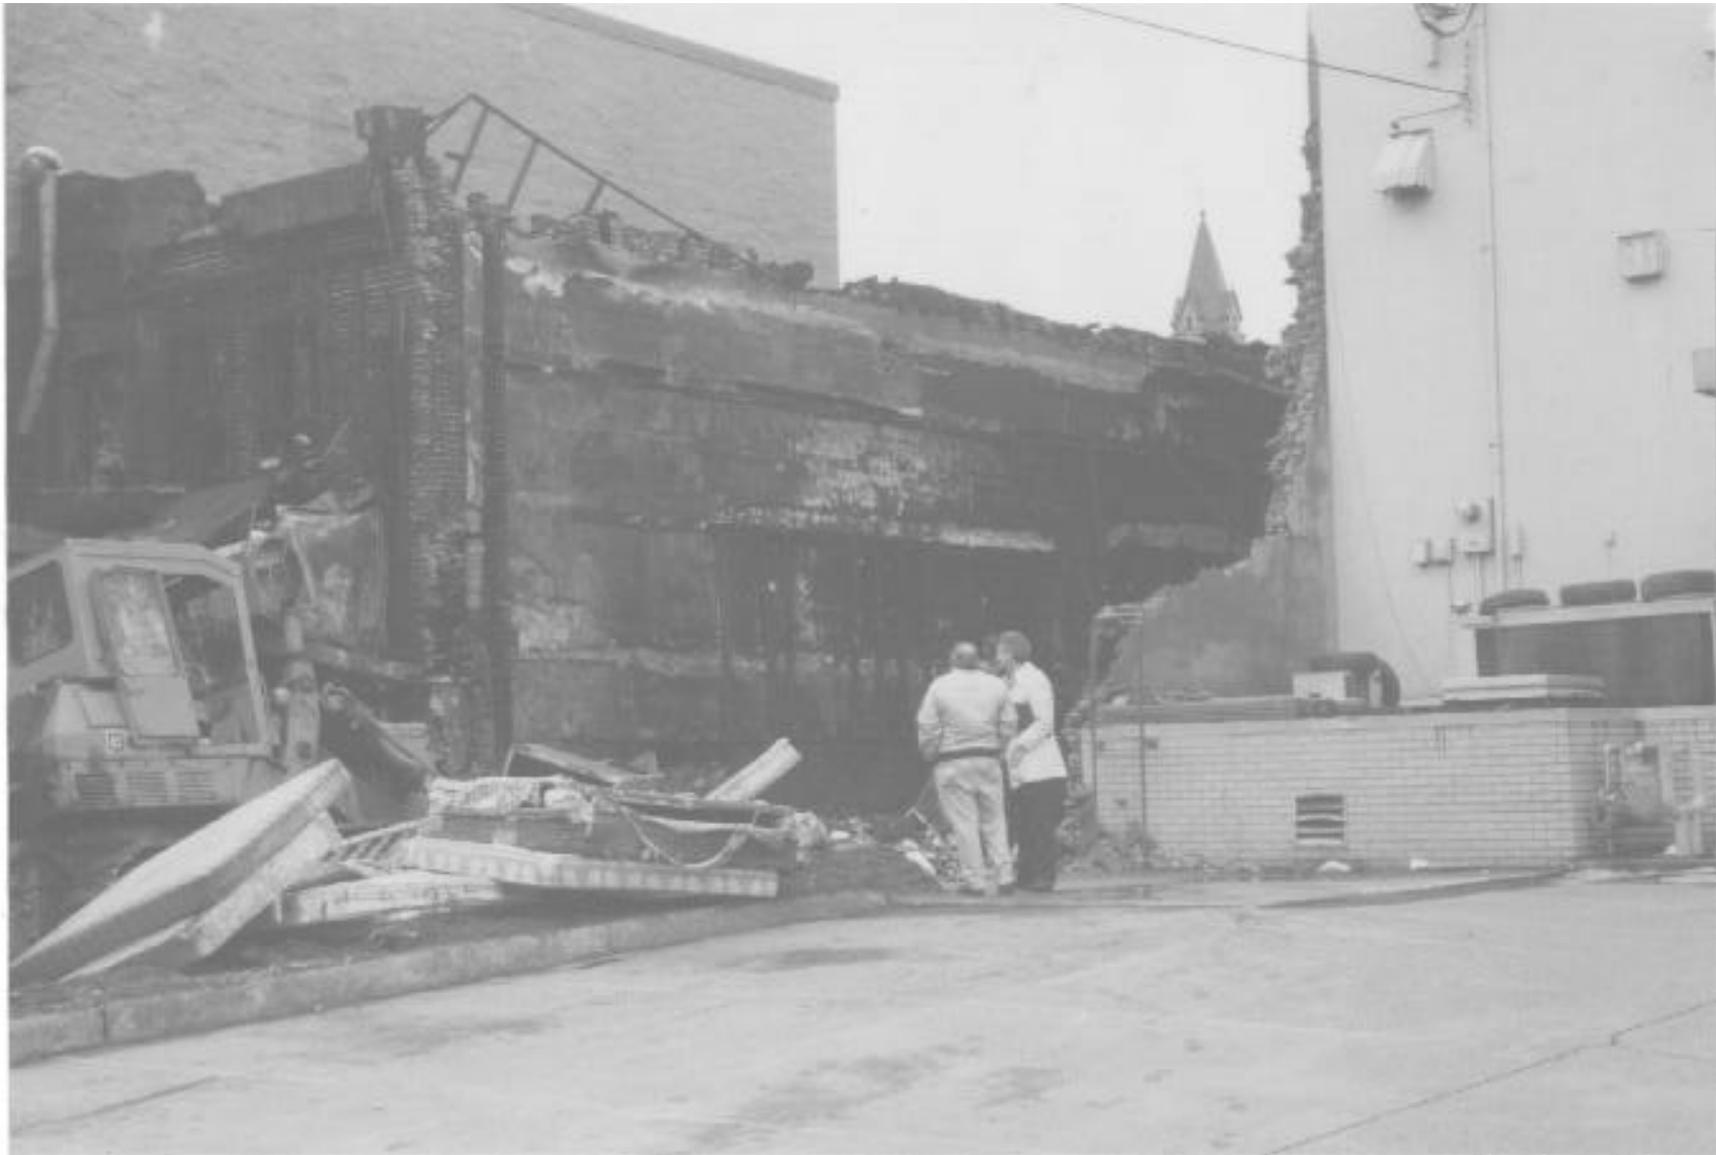
It appeared from the positions of the bodies and the furniture that had fallen on top of them that most of a room had dropped into the basement without warning. The other firefighters who had seen the fire reported that Lombardo and Insalaco appeared to be fighting a fire that was coming up around the baseboards of a room, well back inside the vision center, when they were last seen. Further investigation of the fire cause found that the probable point of ignition was in the same area where the collapse occurred, under the floor where the two firefighters were working.

The fire probably ignited one of the 3 x 10 wood floor joists and may have smoldered for hours before it was discovered. Large beams of this type have been known to burn for more than 24 hours before open flaming was observed. The electrical short could have ignited more than one joist or the fire may have spread at a slow rate in the very old wood.

View of the area of fire origin and the area where the floor collapse occurred, after most of the debris has been removed. Indentations in the brick wall indicate where floor joists were supported.

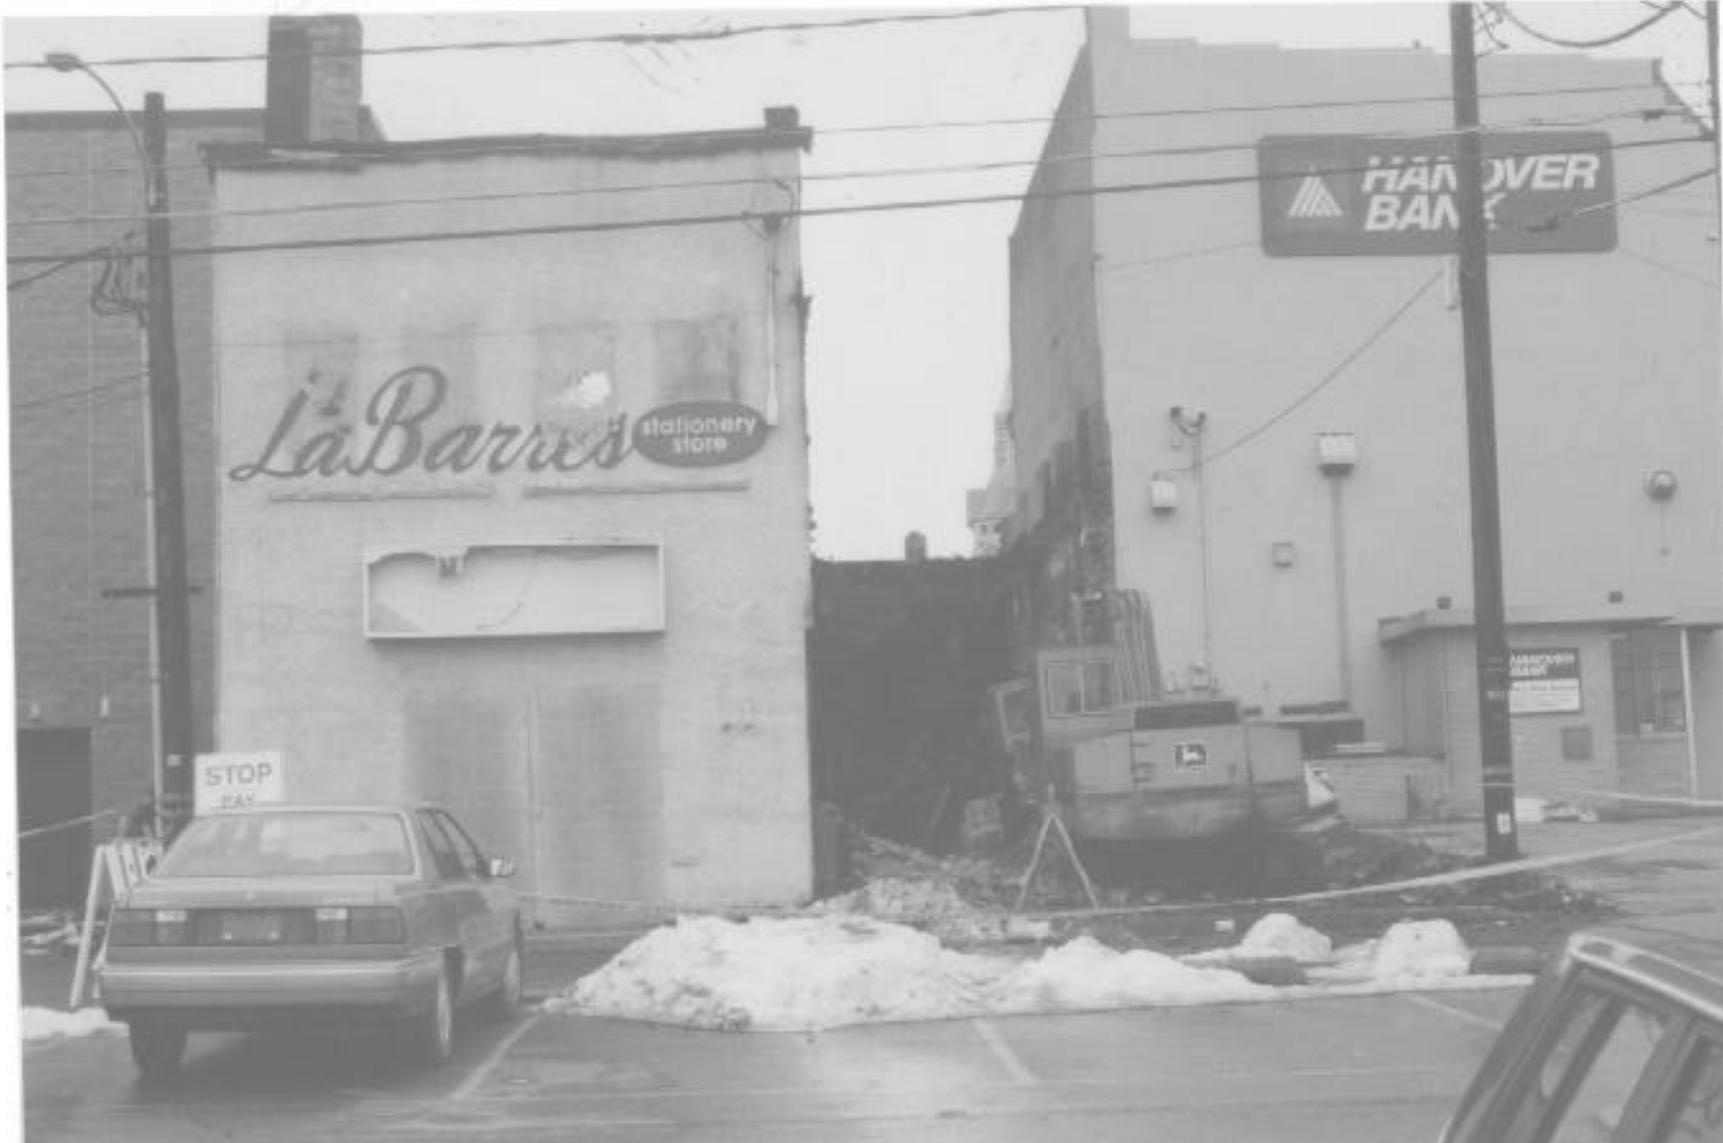
After demolition of the rear part of the fire occupancy, the narrow width of the fire buildings is evident. The demolition was necessary to allow investigators to access the area of fire origin. The boarded-up doorway was the entrance to the pizza restaurant.

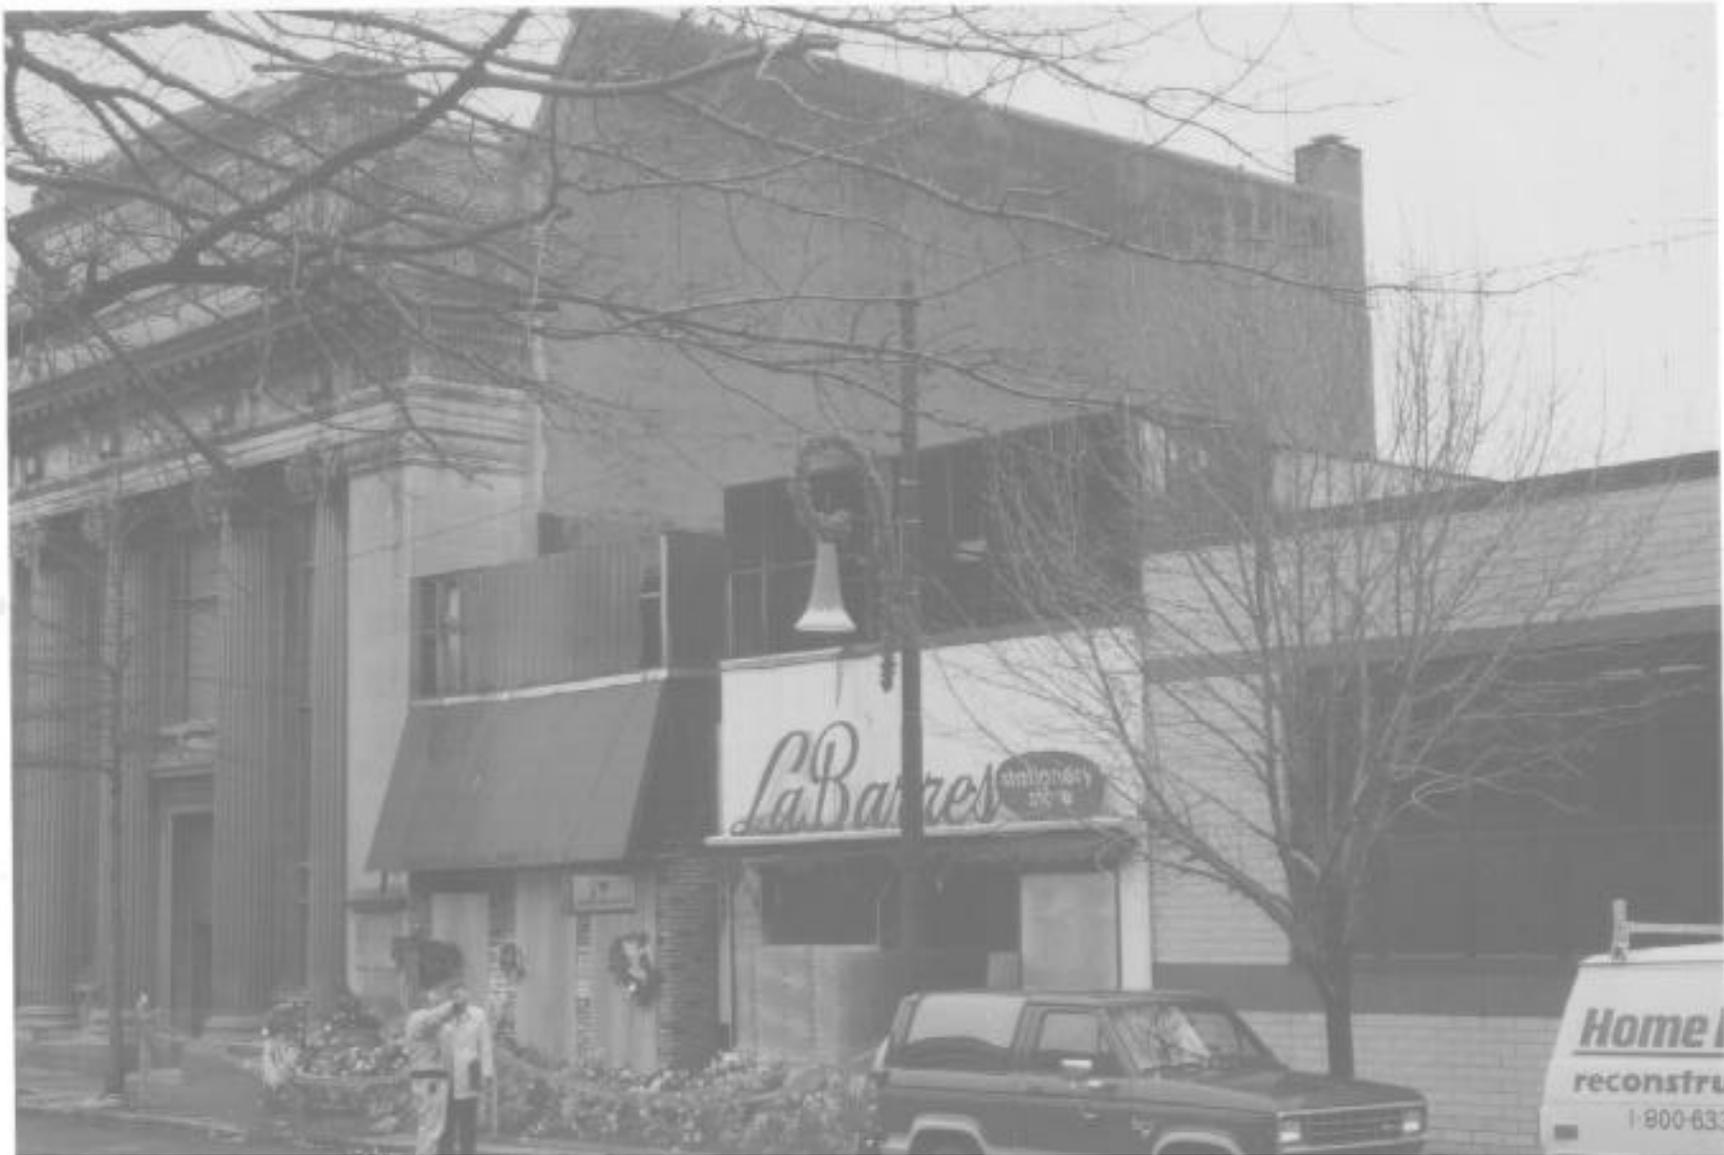
The outline of the upper floors of the original structures is visible in the wall separating the fire buildings from the exposed bank building (background). The void space above the entrances to the two buildings is also visible. The condition on arrival was smoke coming from this space.

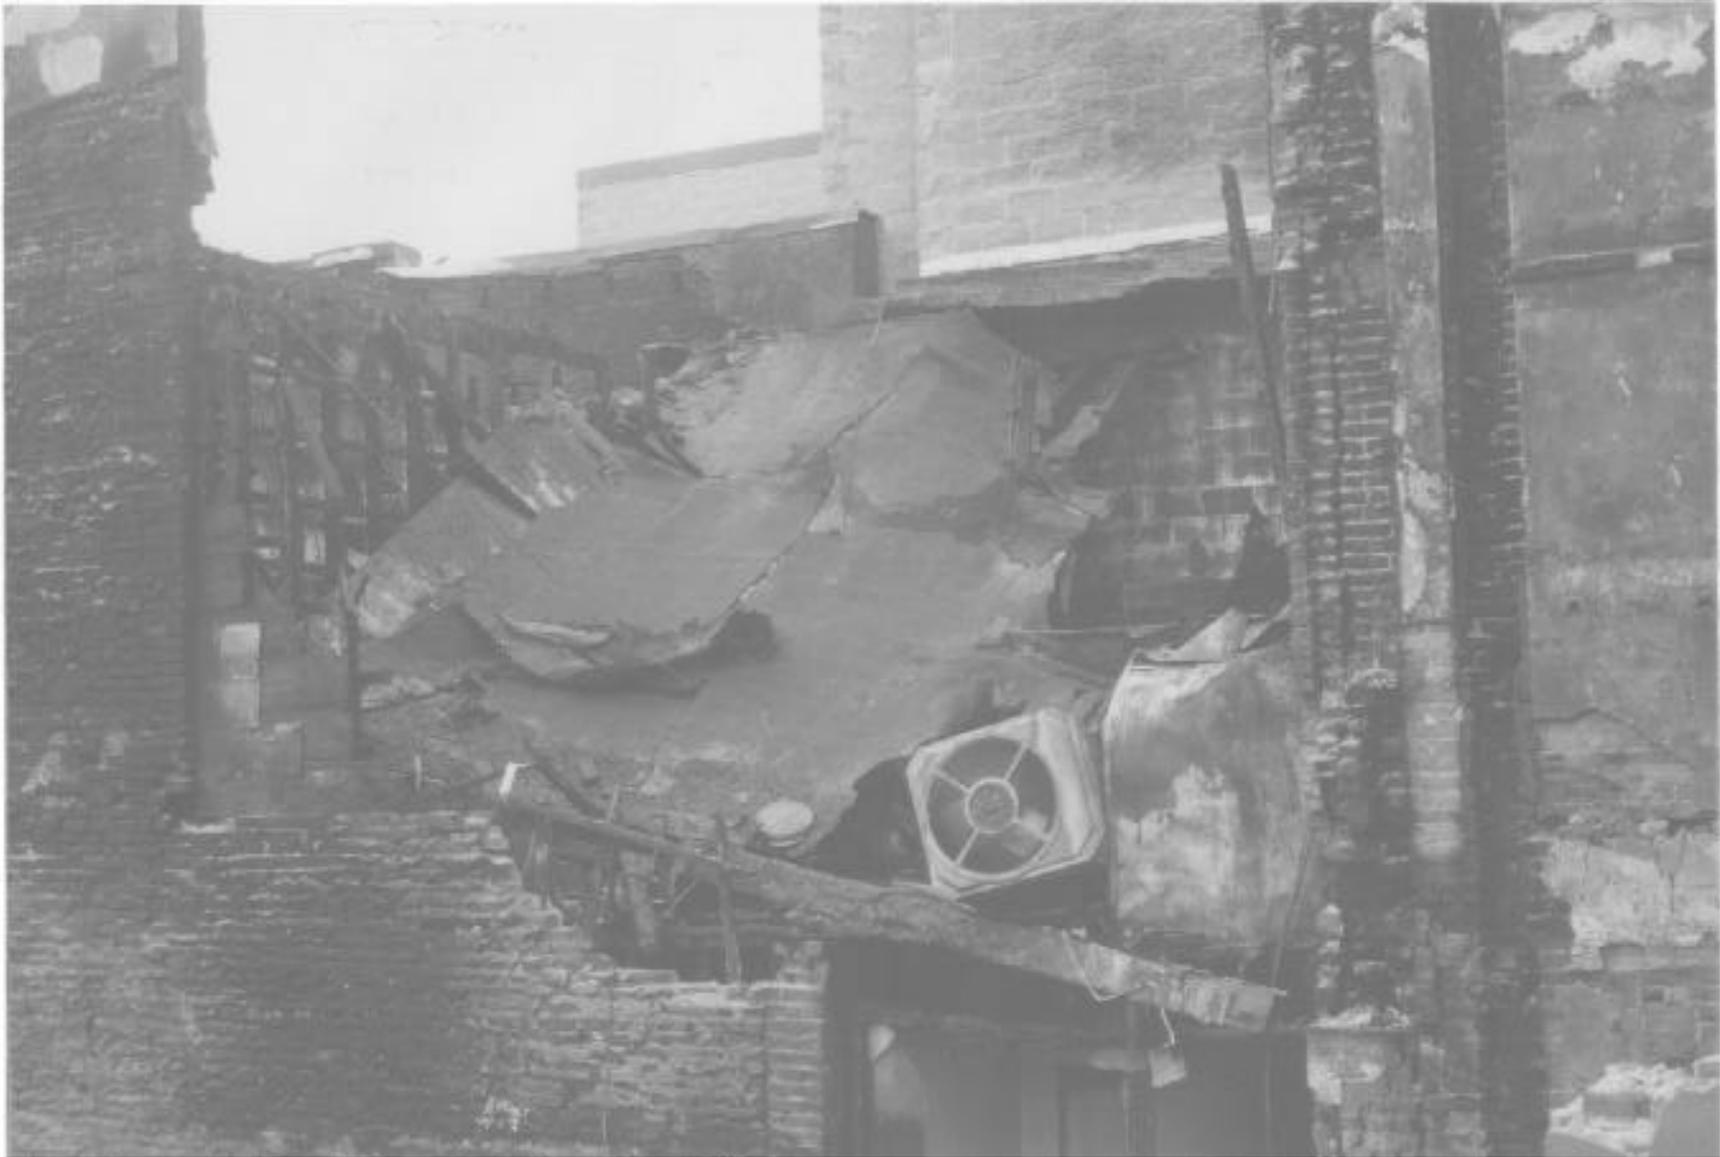
Collapsed roof section from the mid-section of the stationery store. The original walls of the front and rear buildings can be seen in this photo. The opening at the lower level is the original alley, which was filled in by construction joining the front and rear buildings. This opening provided an open path for fire extension between occupancies.

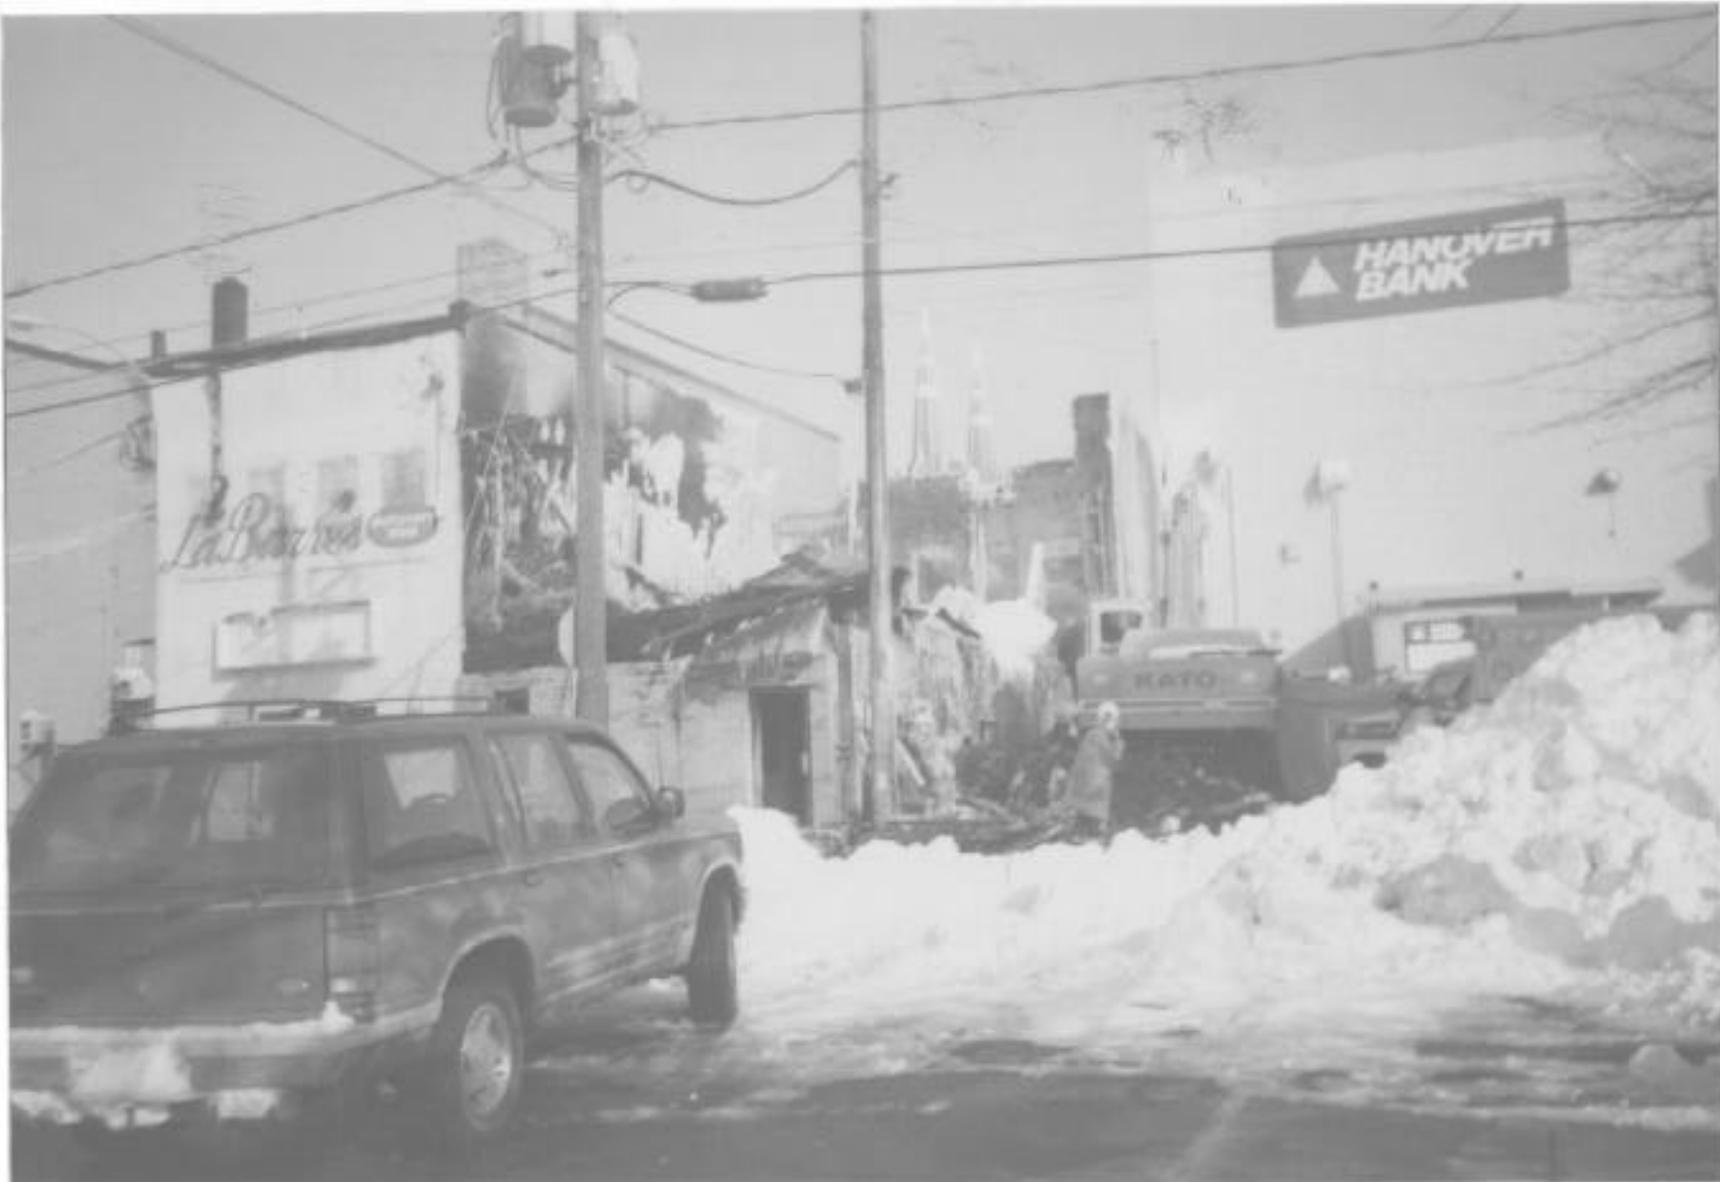
Approximately 16 hours after the fire the upper floor of the rear portion of the vision center building has collapsed and heavy equipment has been moved into the bank parking lot to begin debris removal. The door in the single story section that remains standing was the access to the vacant office occupancy. The rear wall of the front section of the building is also visible.

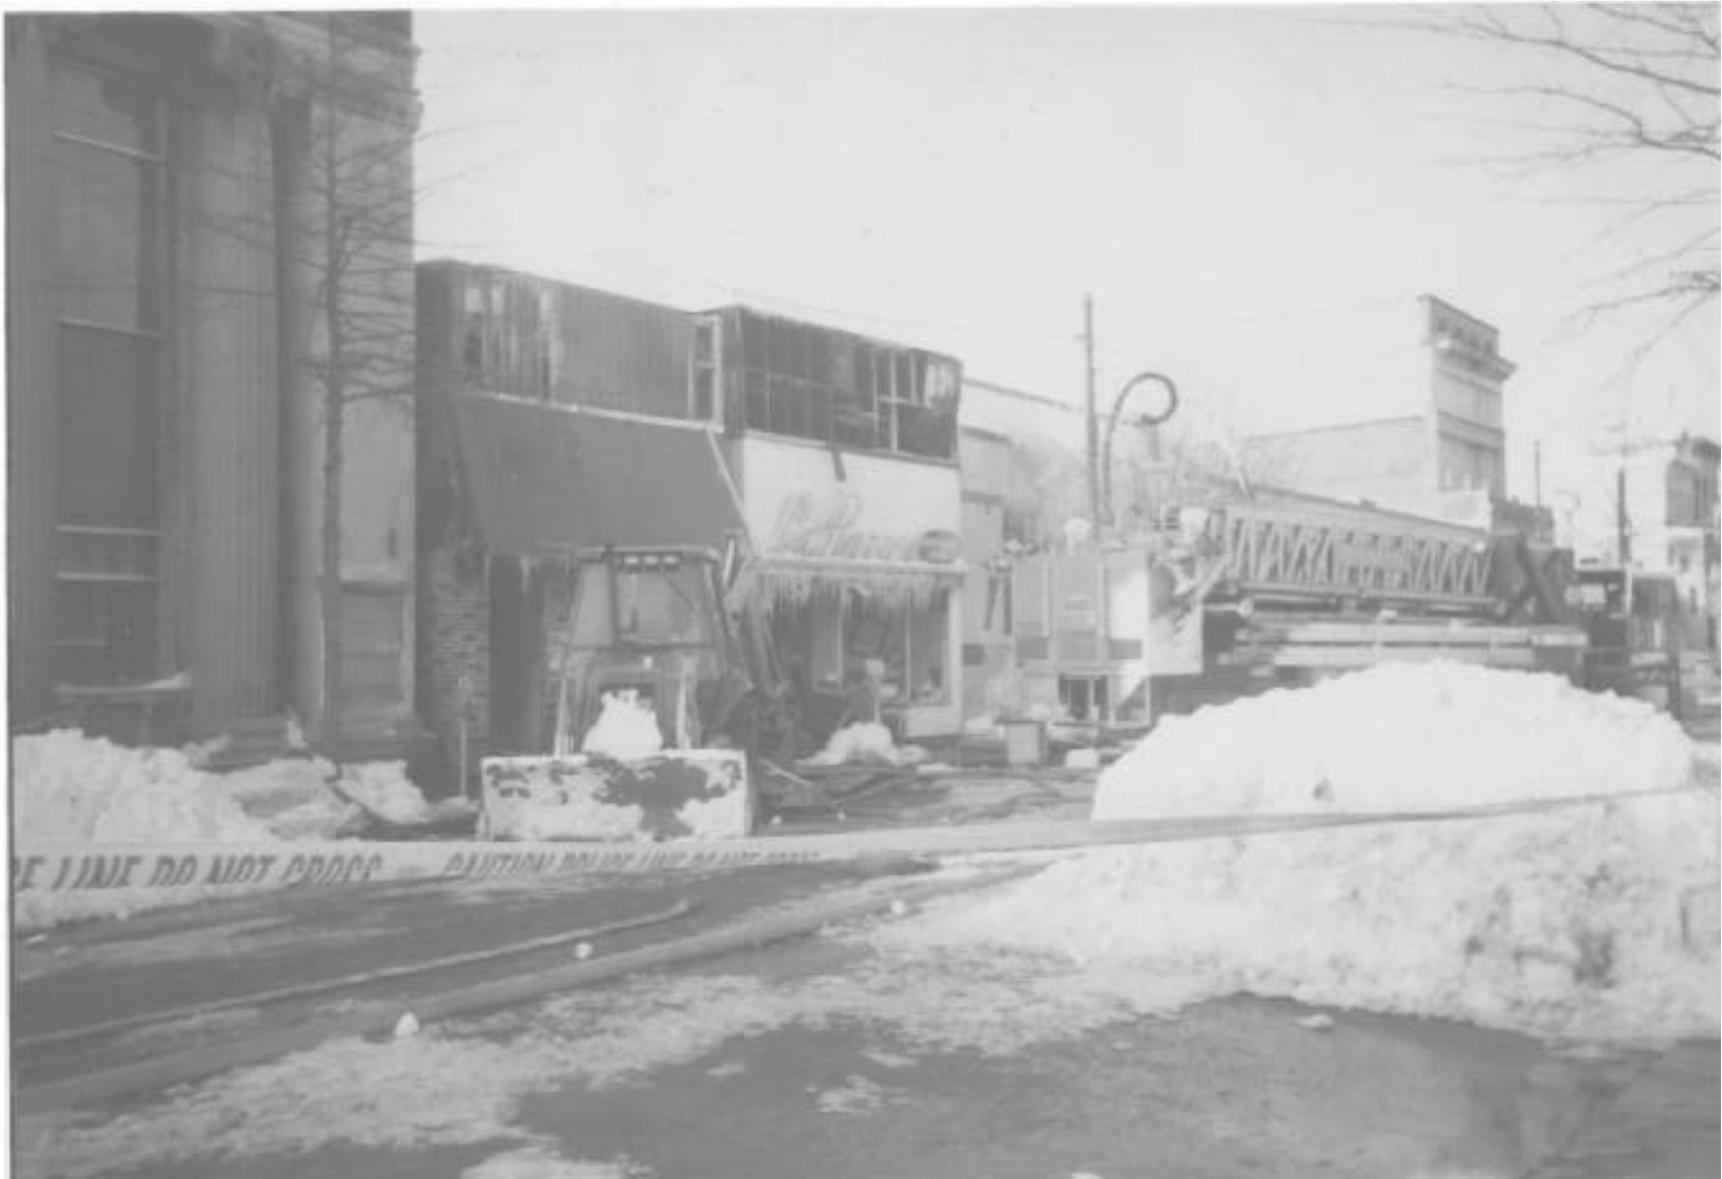
Approximately 16 hours after the fire, a backhoe is in front of the occupancy of fire origin to open an access to the coal bin under the sidewalk and provide access to the basement.
