## **Three Firefighters Die in Pittsburgh House Fire Pittsburgh, Pennsylvania**

## **United States Fire Administration Major Fire Investigations Program**

# EAST SIDE OF DWELLING - 8361 Bricelyn Street

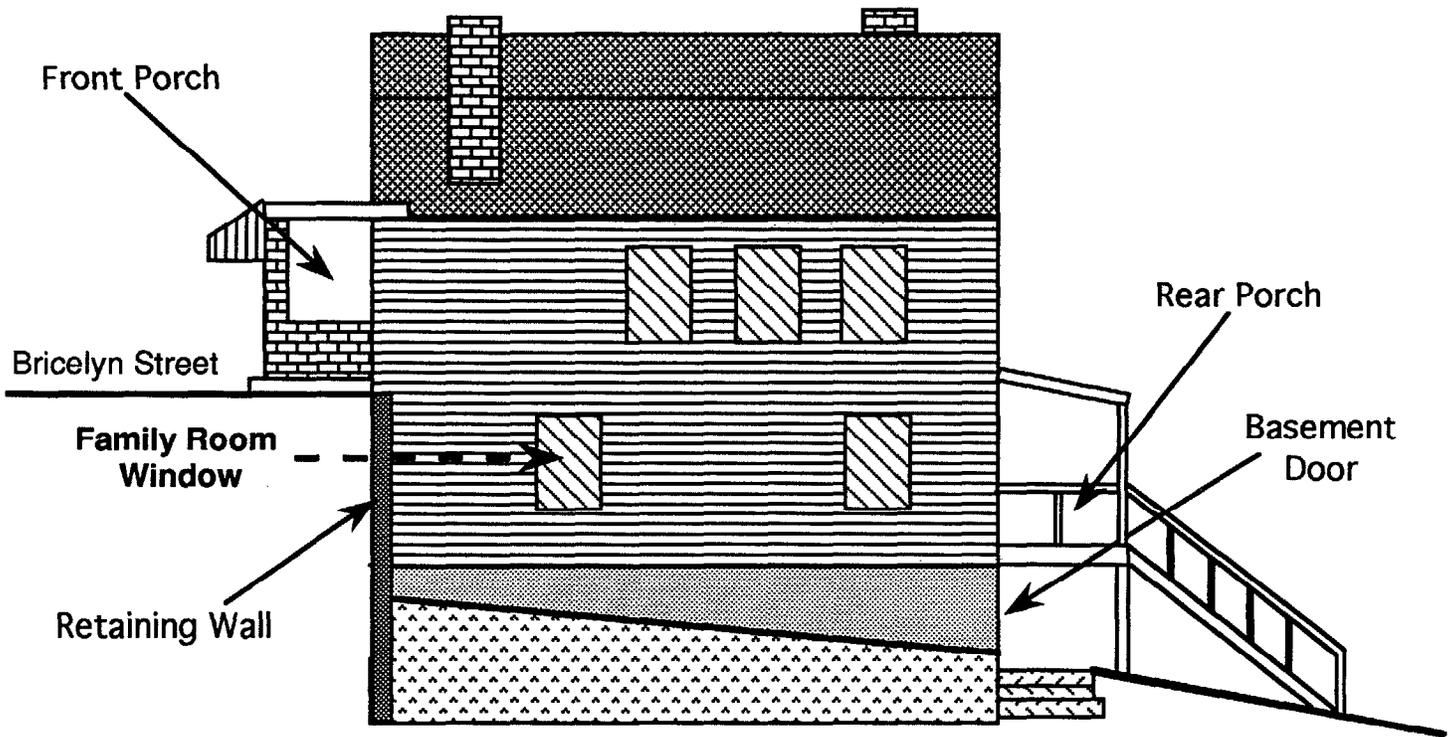
The kitchen and family room were located on the first floor, the living room and one bedroom were on the second floor, and two additional bedrooms were on the third floor. The heating equipment, a washer and

drier, and storage areas were located in the basement. The furnace, water heater and clothes drier were all fueled by natural gas.

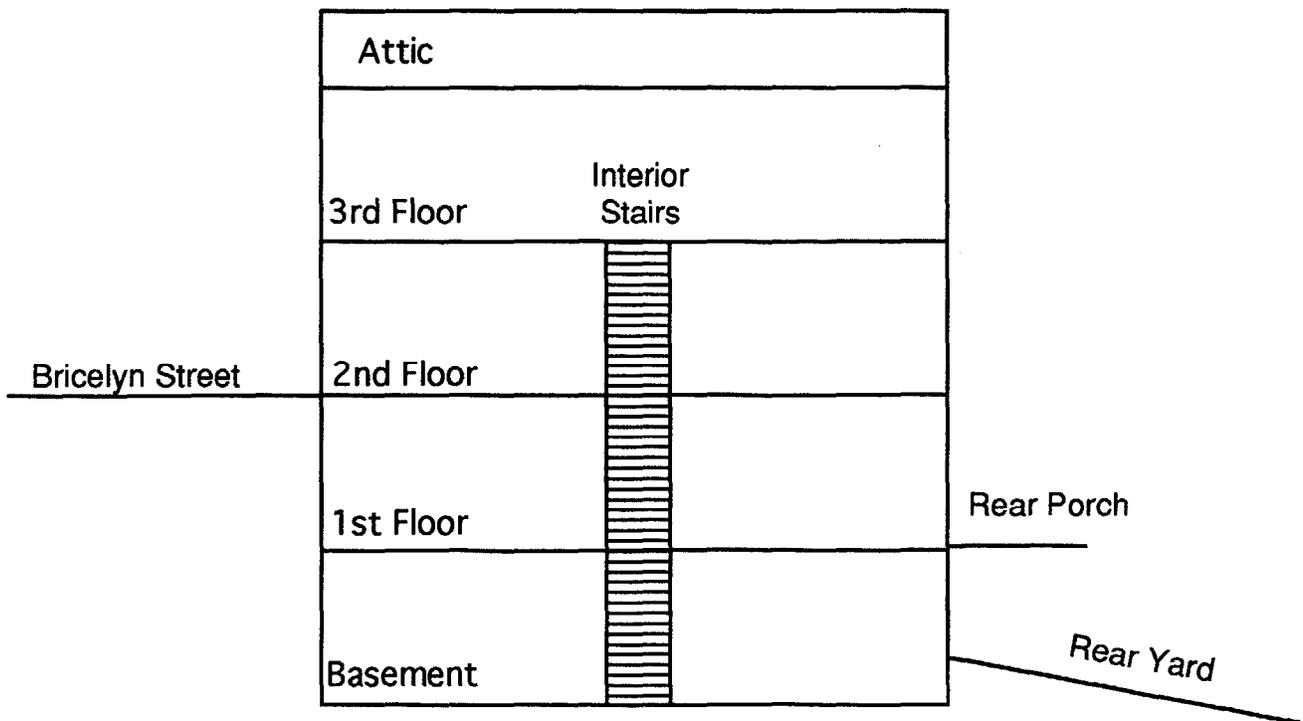
## INTERIOR CROSS SECTION

The three stair sections were stacked, one directly above another, and divided each floor into front and rear sections. A wood door at the top of the basement stairs opened into a narrow vestibule on the first floor; when this door was open it blocked the opening between the kitchen at the rear and the family room at the front. There were no doors in the stairways between the first and second or the second and third floors.

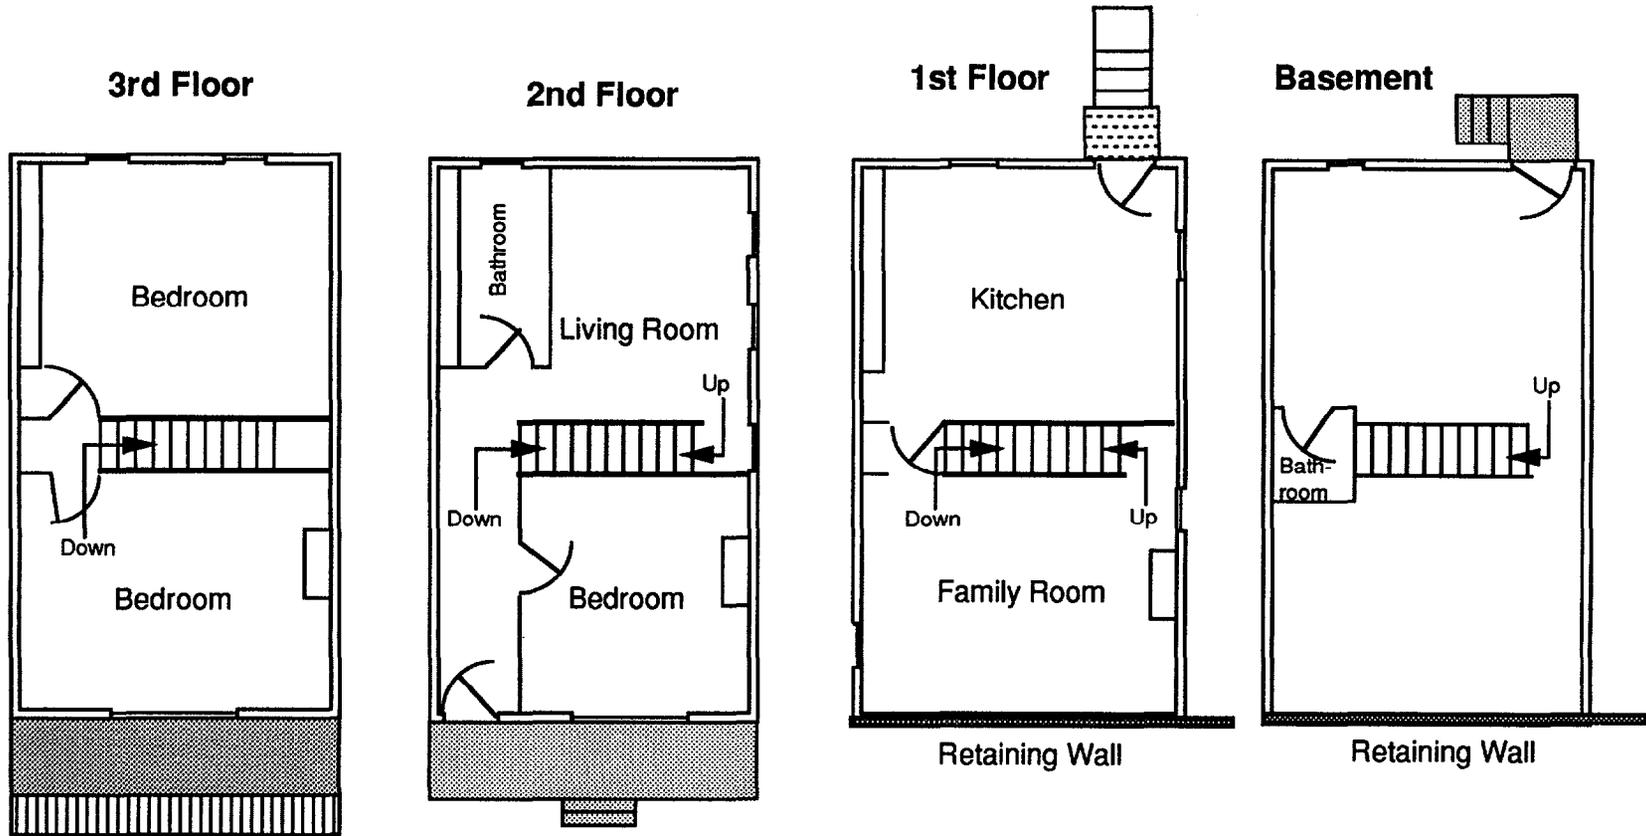
# FLOOR PLANS 8361 Bricelyn Street

The fire was determined to have been caused by arson and originated in the basement, directly under the kitchen. This would place the point of origin close to the gas-fired appliances. The fire first involved contents in the basement, then extended upward through void spaces in the exterior walls and around the stairway. The void spaces allowed the fire to extend directly to the attic. It later broke through the walls and/or ceiling and involved the bedrooms on the third floor.

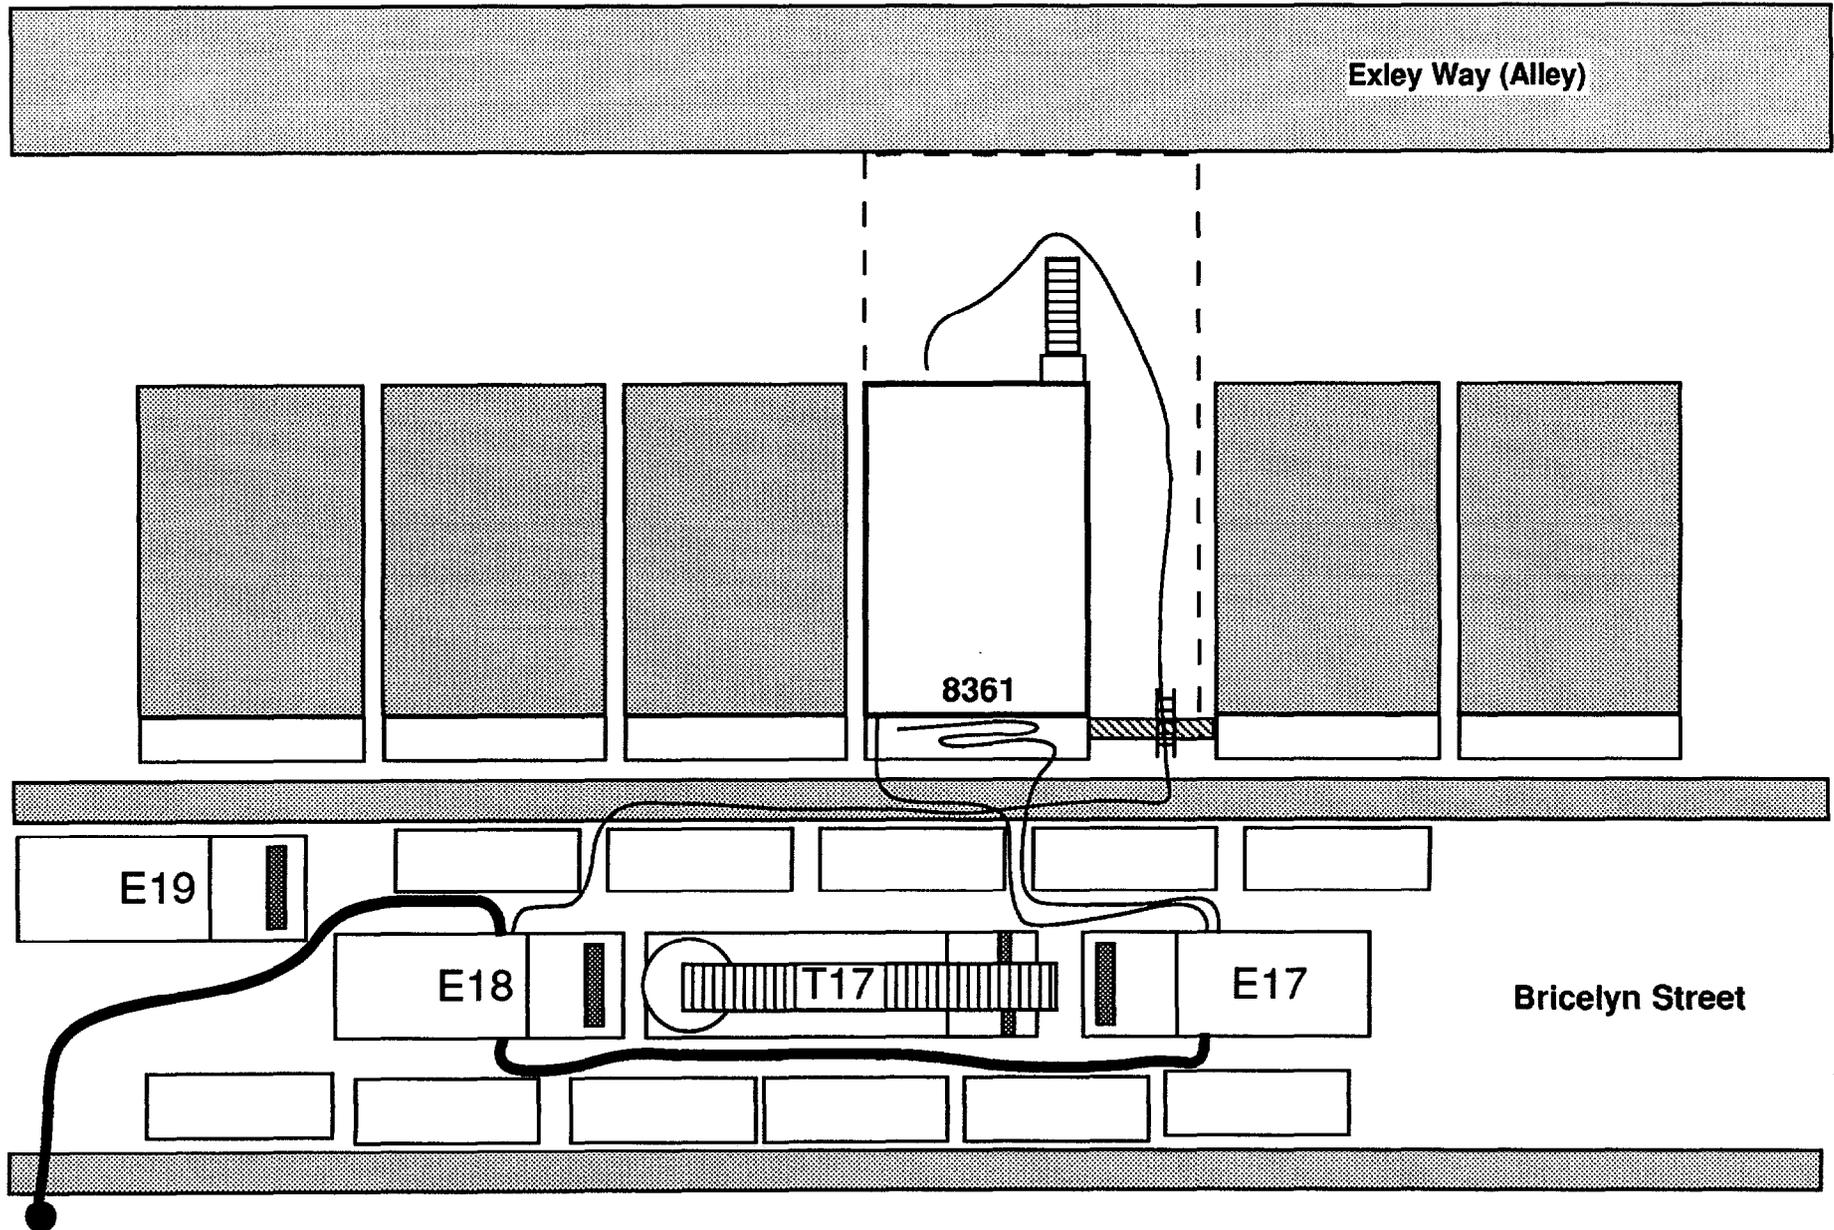
# LOCATIONS OF FIRST ALARM COMPANIES

The initial response consisted of Engines 17, 18, and 19, Truck 17, and Battalion Chief 2 (Unit 4042). Engine 19 was dispatched in place of Engine 15, which was on another call, and Battalion Chief 2 was responding in place of Battalion Chief 3. Battalion Chief 3 (Unit 4043) became available after the call was dispatched and replaced Battalion Chief 2 on the assignment. The Emergency Medical Services Division dispatched Medic 11 and Rescue 1 on the first alarm, each with two paramedics on board. (Pittsburgh EMS is a separate division of the Department of Public Safety.)

Engine 18 had arrived at 0032 hours. The crew stretched a 5 inch supply line from a hydrant and connected it into their pump, and then stretched another 5 inch line from Engine 18 to Engine 17. After positioning the ground ladder, they advanced a 1-3/4 inch attack line from their apparatus down the ladder to the side yard and around to the rear of the involved house. They observed the fire in the basement and operated the hose line through the rear basement window. The captain went to the roof to assist Truck 17, leaving the two firefighters to operate the line.

The crew of Truck 17 was on the roof and could see the increasing smoke and heat conditions in the attic. The captain who was working as a firefighter on Truck 17 advised the acting lieutenant that the fire was in the walls and was coming up through the void spaces. He said that he would go inside to check on fire conditions on the lower floors and advise Engine 17 of the vertical extension.

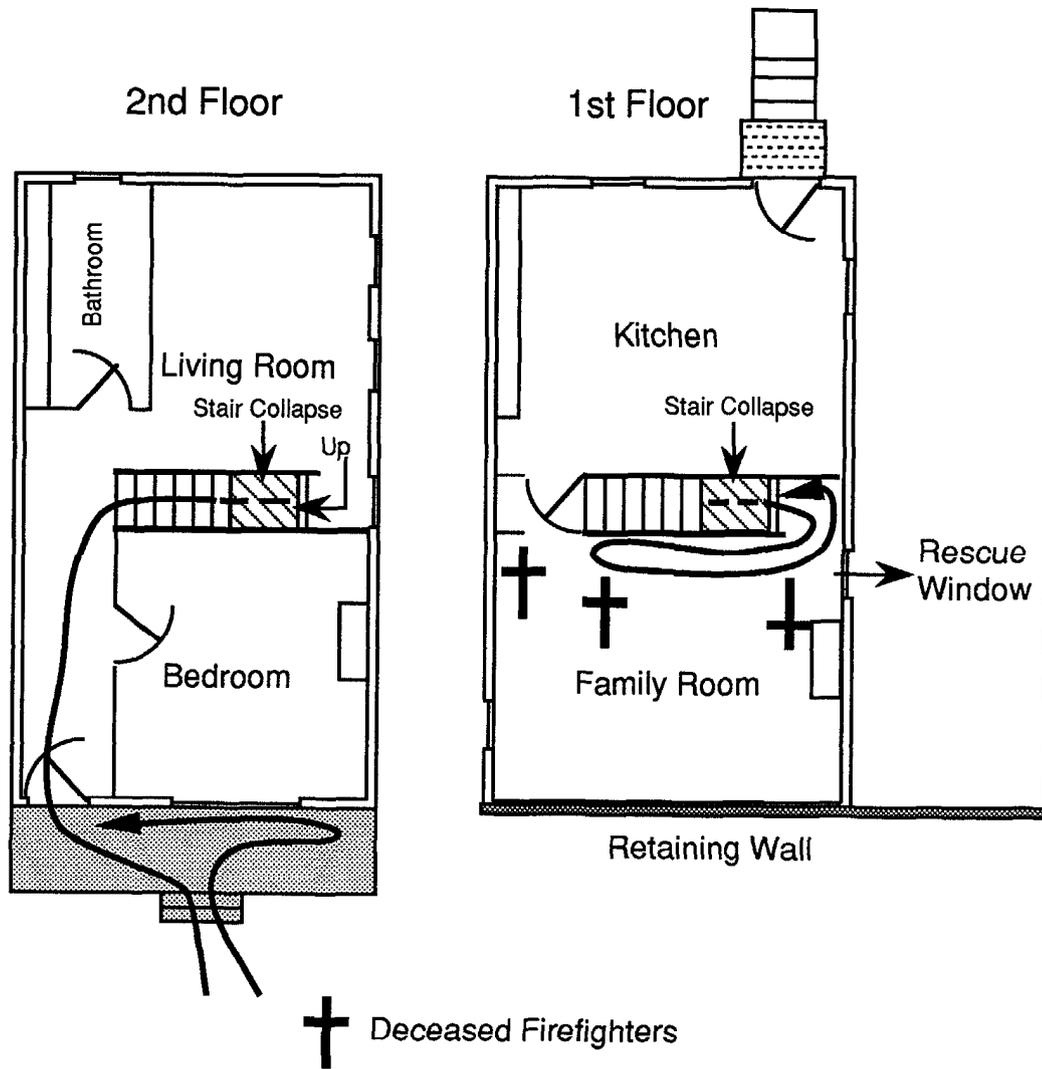
# INTERIOR DETAILS - 8361 Bricelyn Street

Advancing into the family room, the crew from Engine 7 found the three unconscious personnel from Engine 17. (See diagram on the following page.) At 0139 hours the Incident Commander was informed that three additional firefighters had been found and were being removed from the building. Additional personnel responded to the urgent requests for assistance and the three firefighters were removed to the rear yard.

Their return path back up the stairs was blocked by the fire coming up through the collapsed section. Their hose line, which was suspended over the collapsed stair section, eventually burned through and ruptured. The hose line was found with the nozzle open at the bottom of the stairs, which suggest that they were trying to control the fire that was coming up through the opening when the hose ruptured. It appears that the firefighters could have escaped through the kitchen or through the windows in the family room. With the door to the basement stairs in the open position their path into the kitchen would have been blocked and the smoke and heat coming up the stairs would have presented an additional obstacle. If they had closed the door at the top of the stairs they might have been able to walk or crawl out through the kitchen, if they had known about the kitchen door and windows.

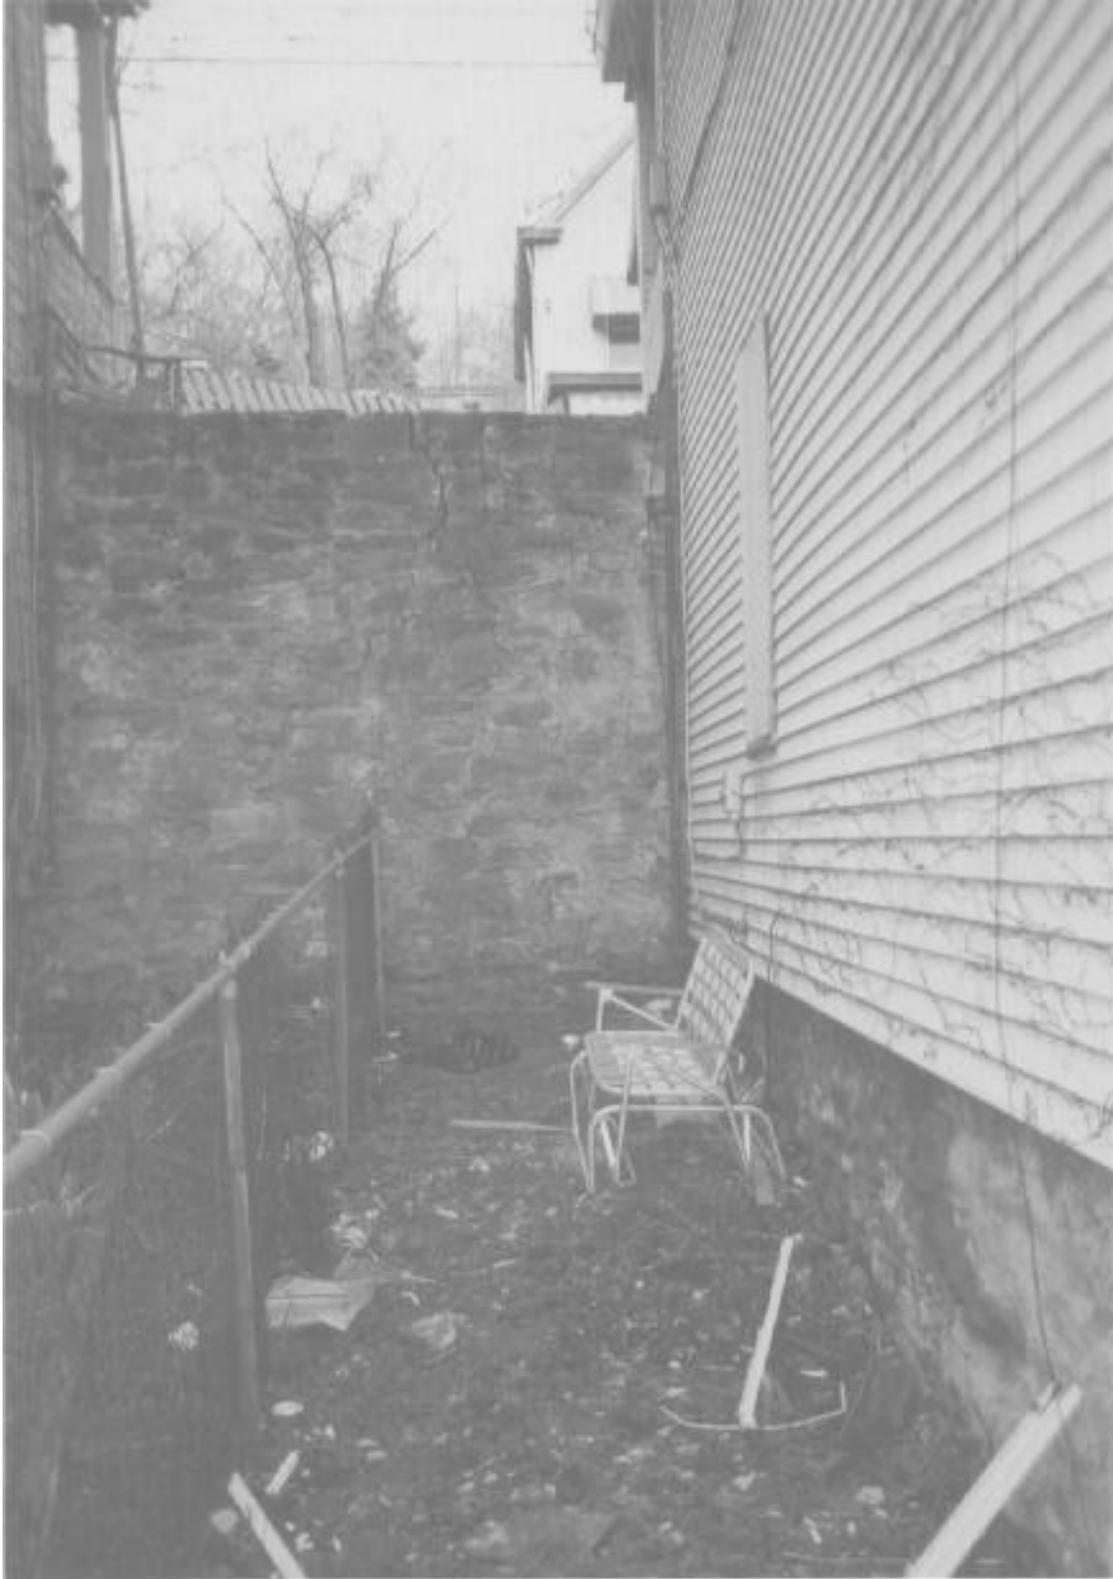
Side yard showing retaining wall and window where firefighters were rescued  
(above lawn chair.)

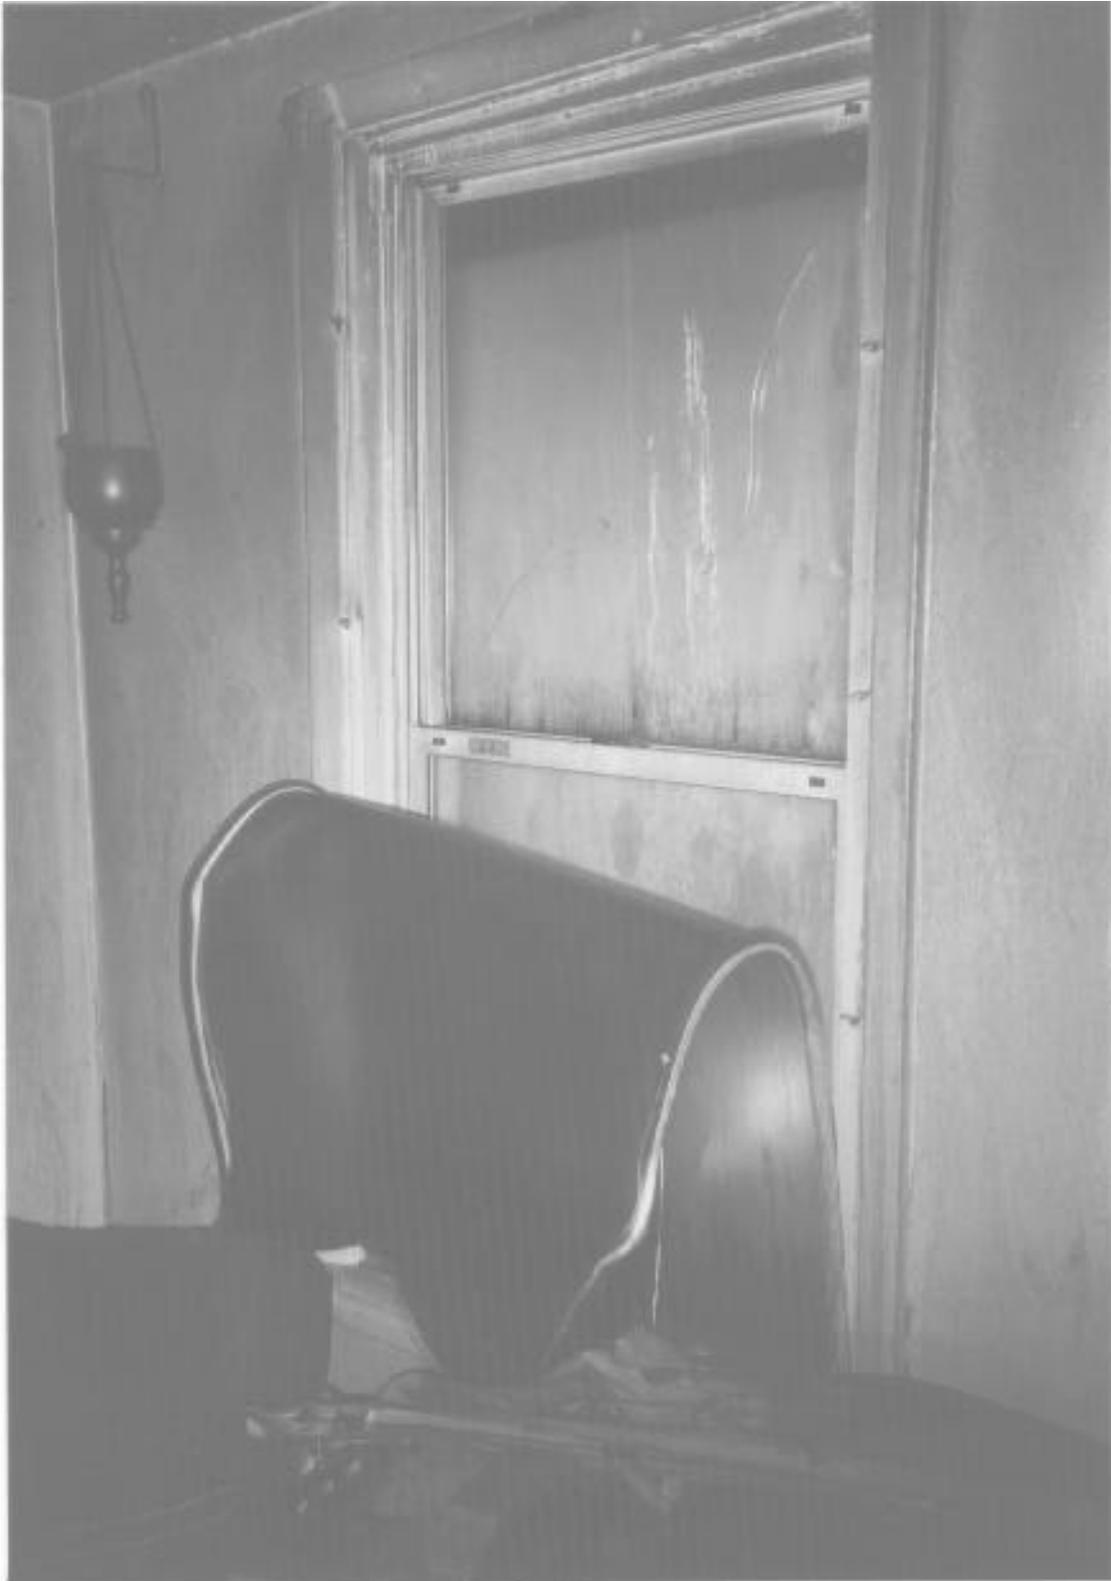
Window in corner of family room showing plastic panel which has partially melted and bent-over due to heat.

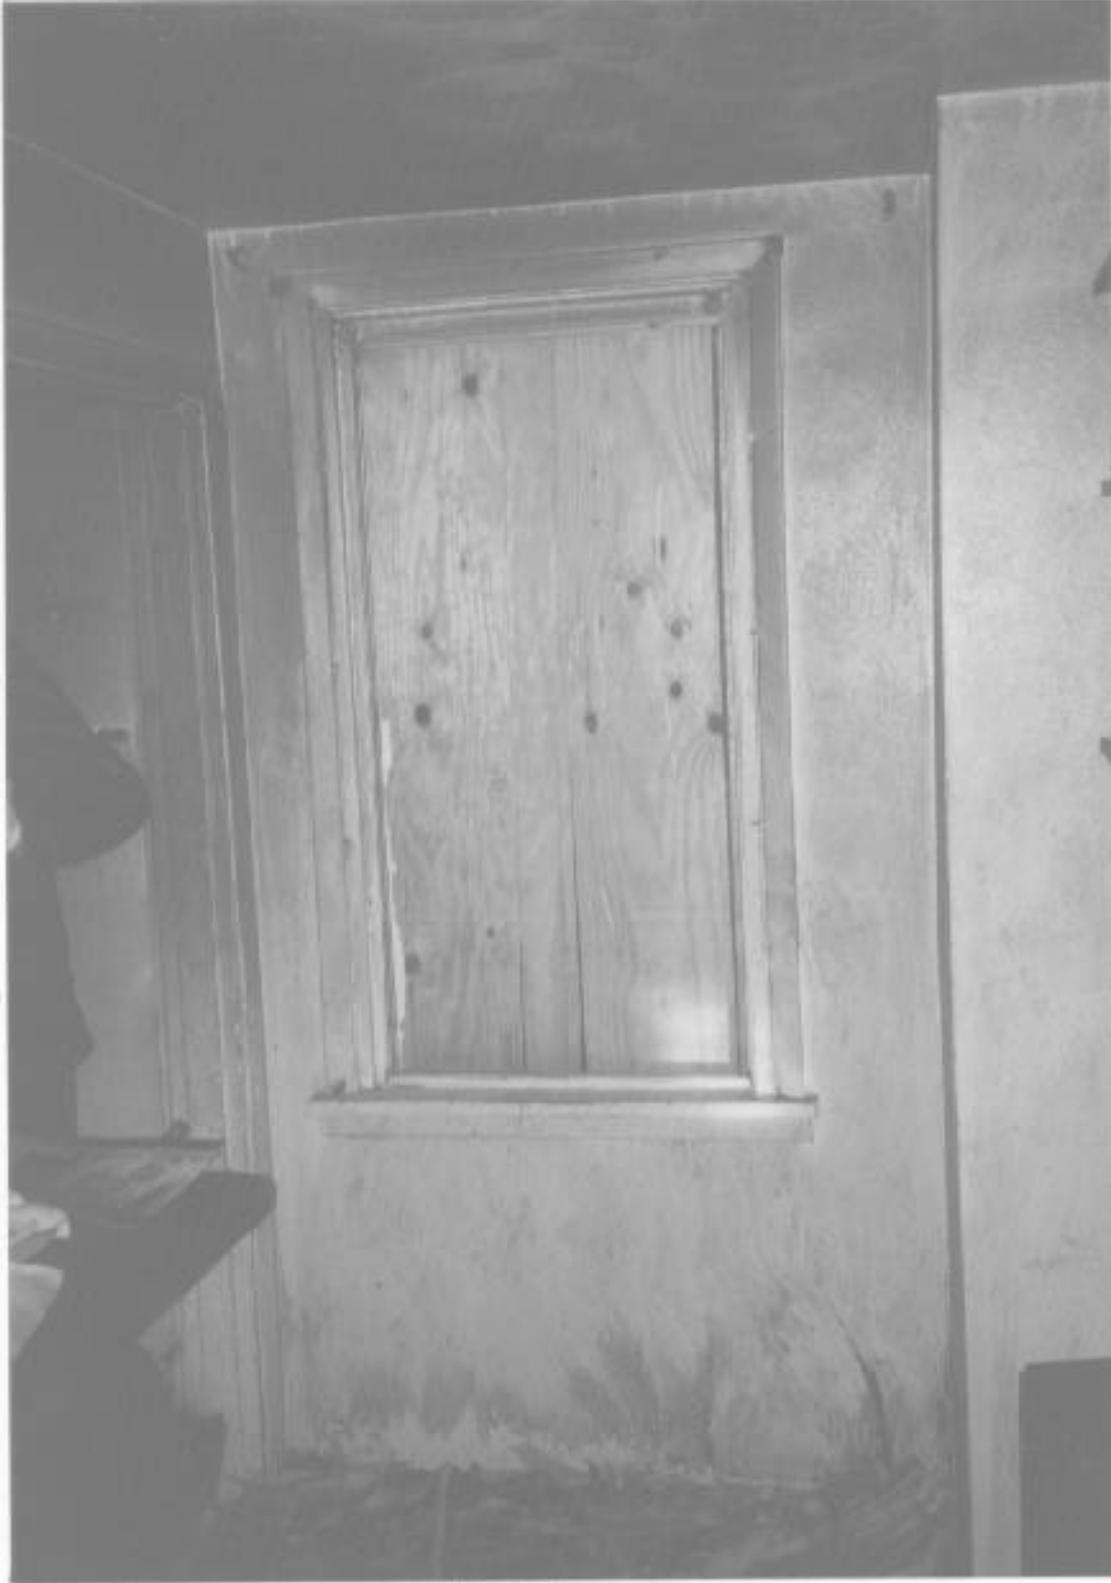
Inside view of window where firefighters were rescued.

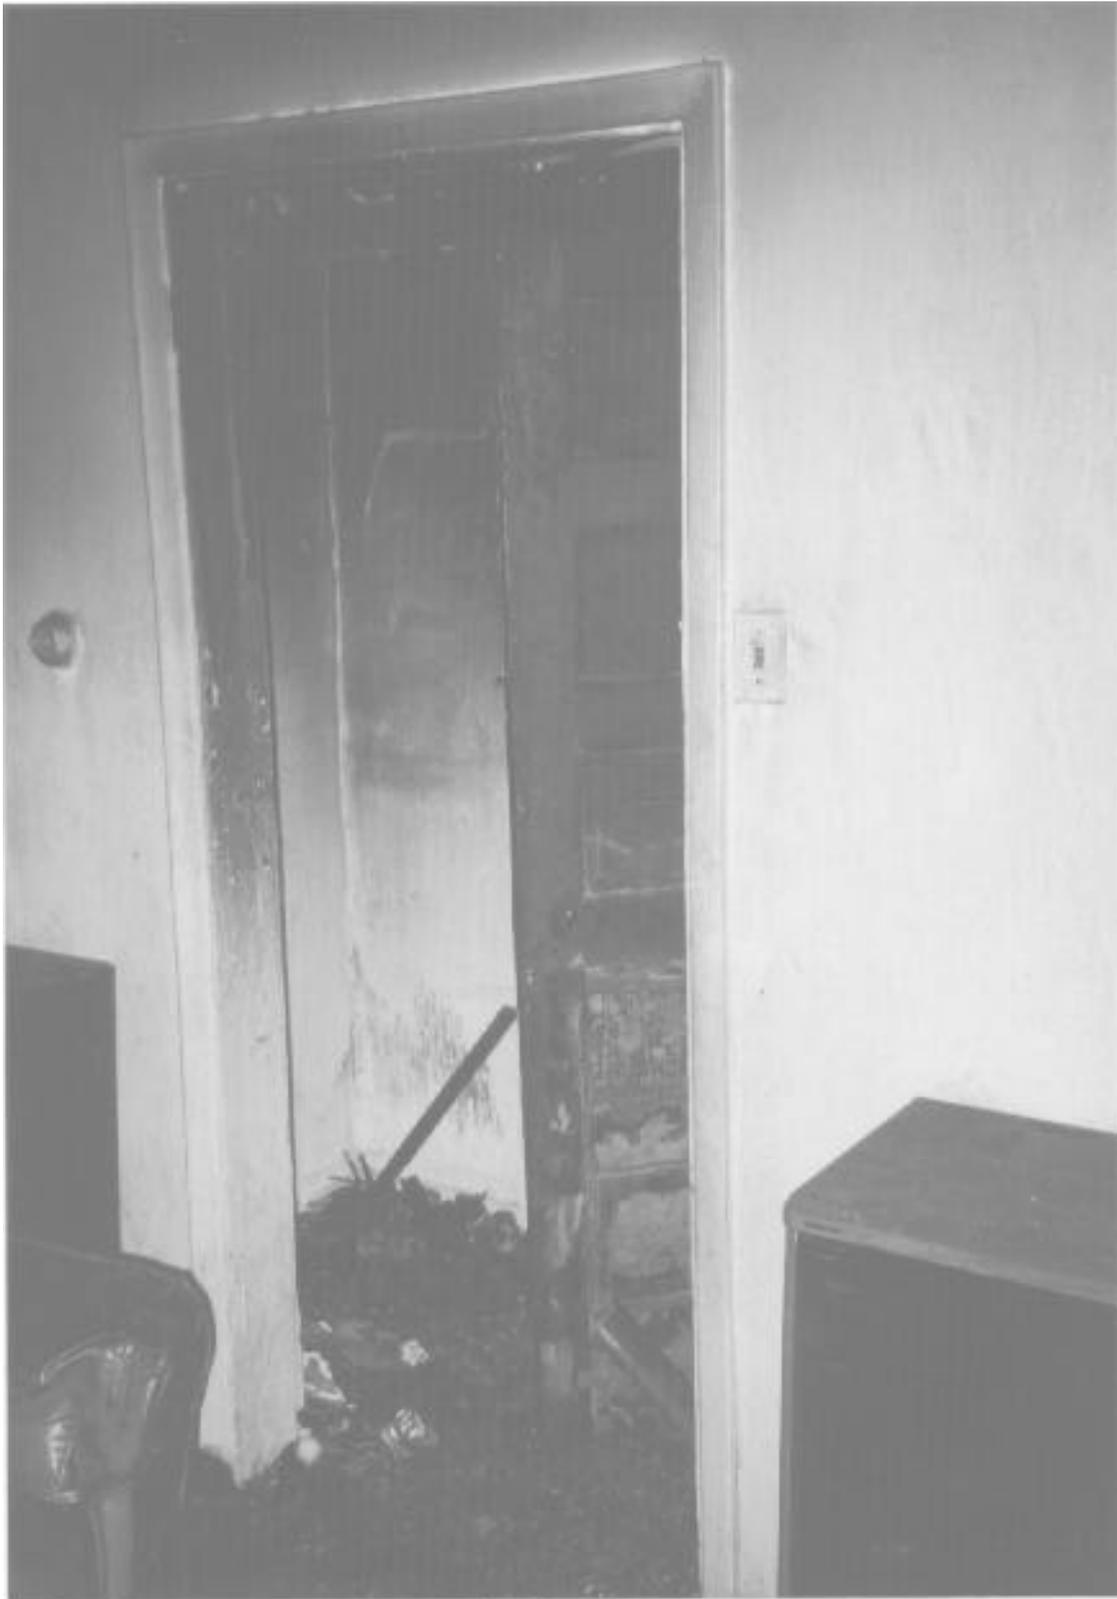
View from family room looking toward kitchen. Partially open door is at the top of the basement stairs.

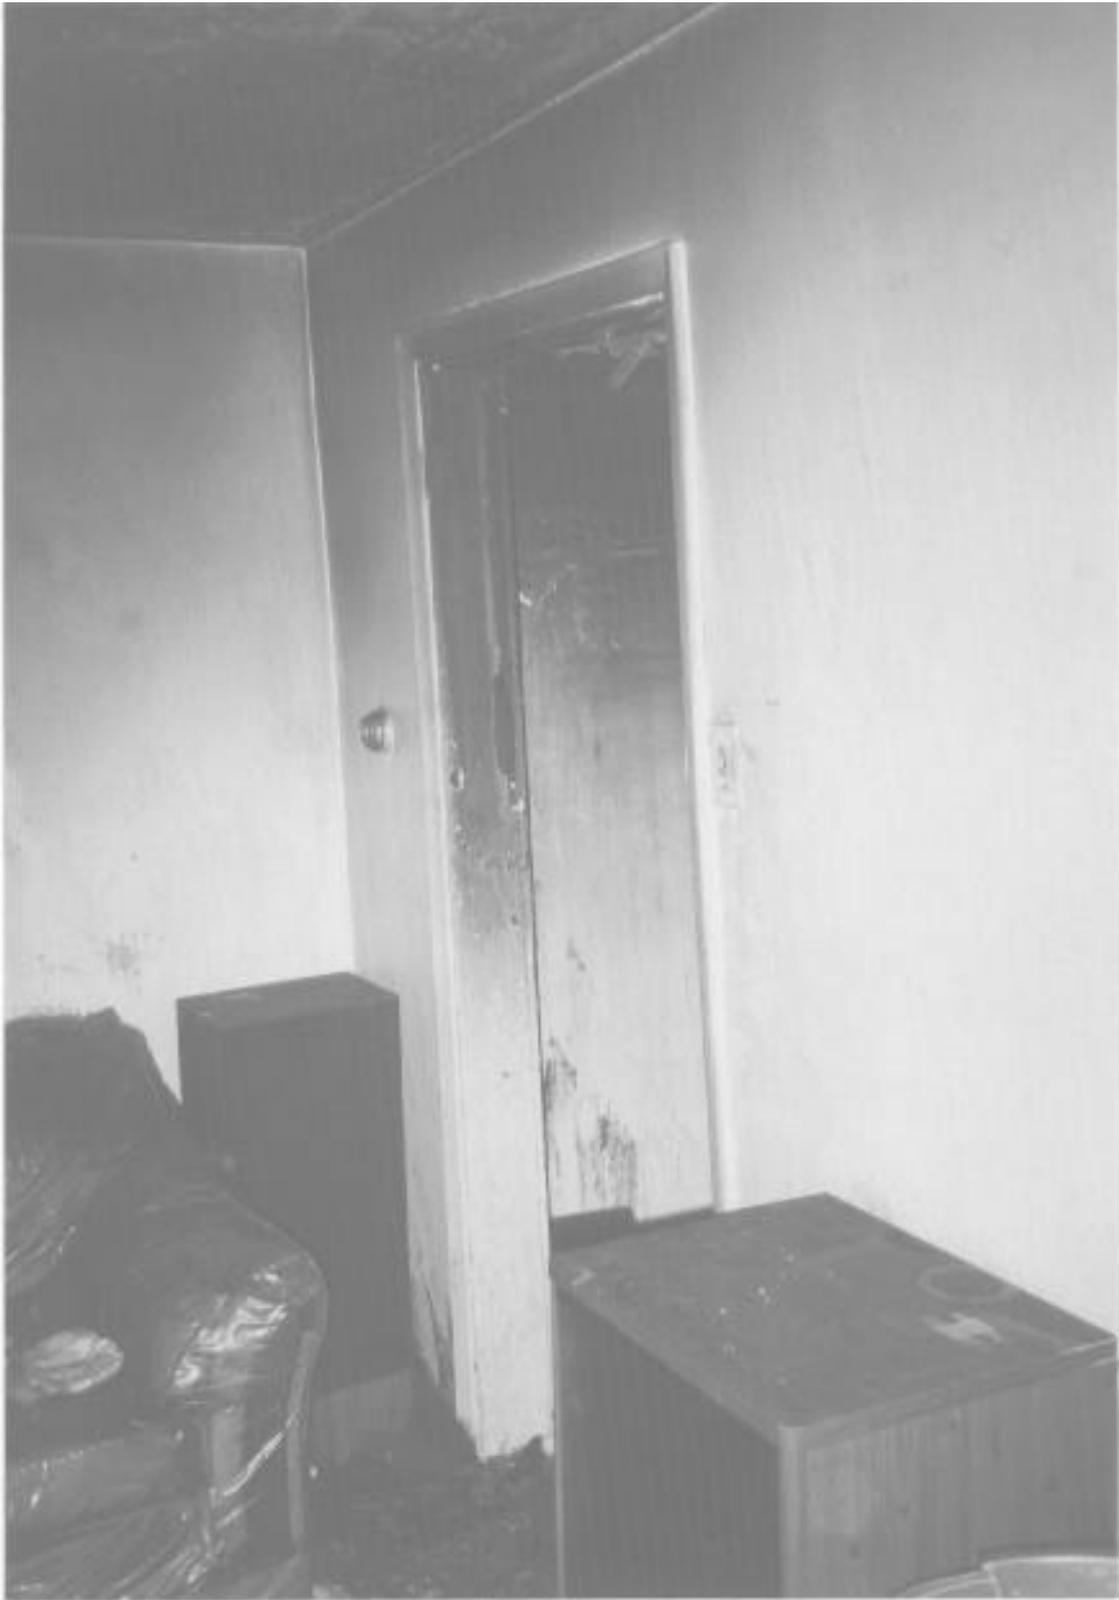
View of corner of the family room at top of basement stairs.
