Hospital Fire Kills Four Patients Southside Regional Medical Center Petersburg, Virginia

**Hospital Fire Kills Four Patients
Southside Regional Medical Center
Petersburg, Virginia
(December 31, 1994)**

This is Report 080 of the Major Fires Investigation Project conducted by Varley-Campbell and Associates, Inc./TriData Corporation under contract EMW-94-C-4423 to the United States Fire Administration, Federal Emergency Management Agency.

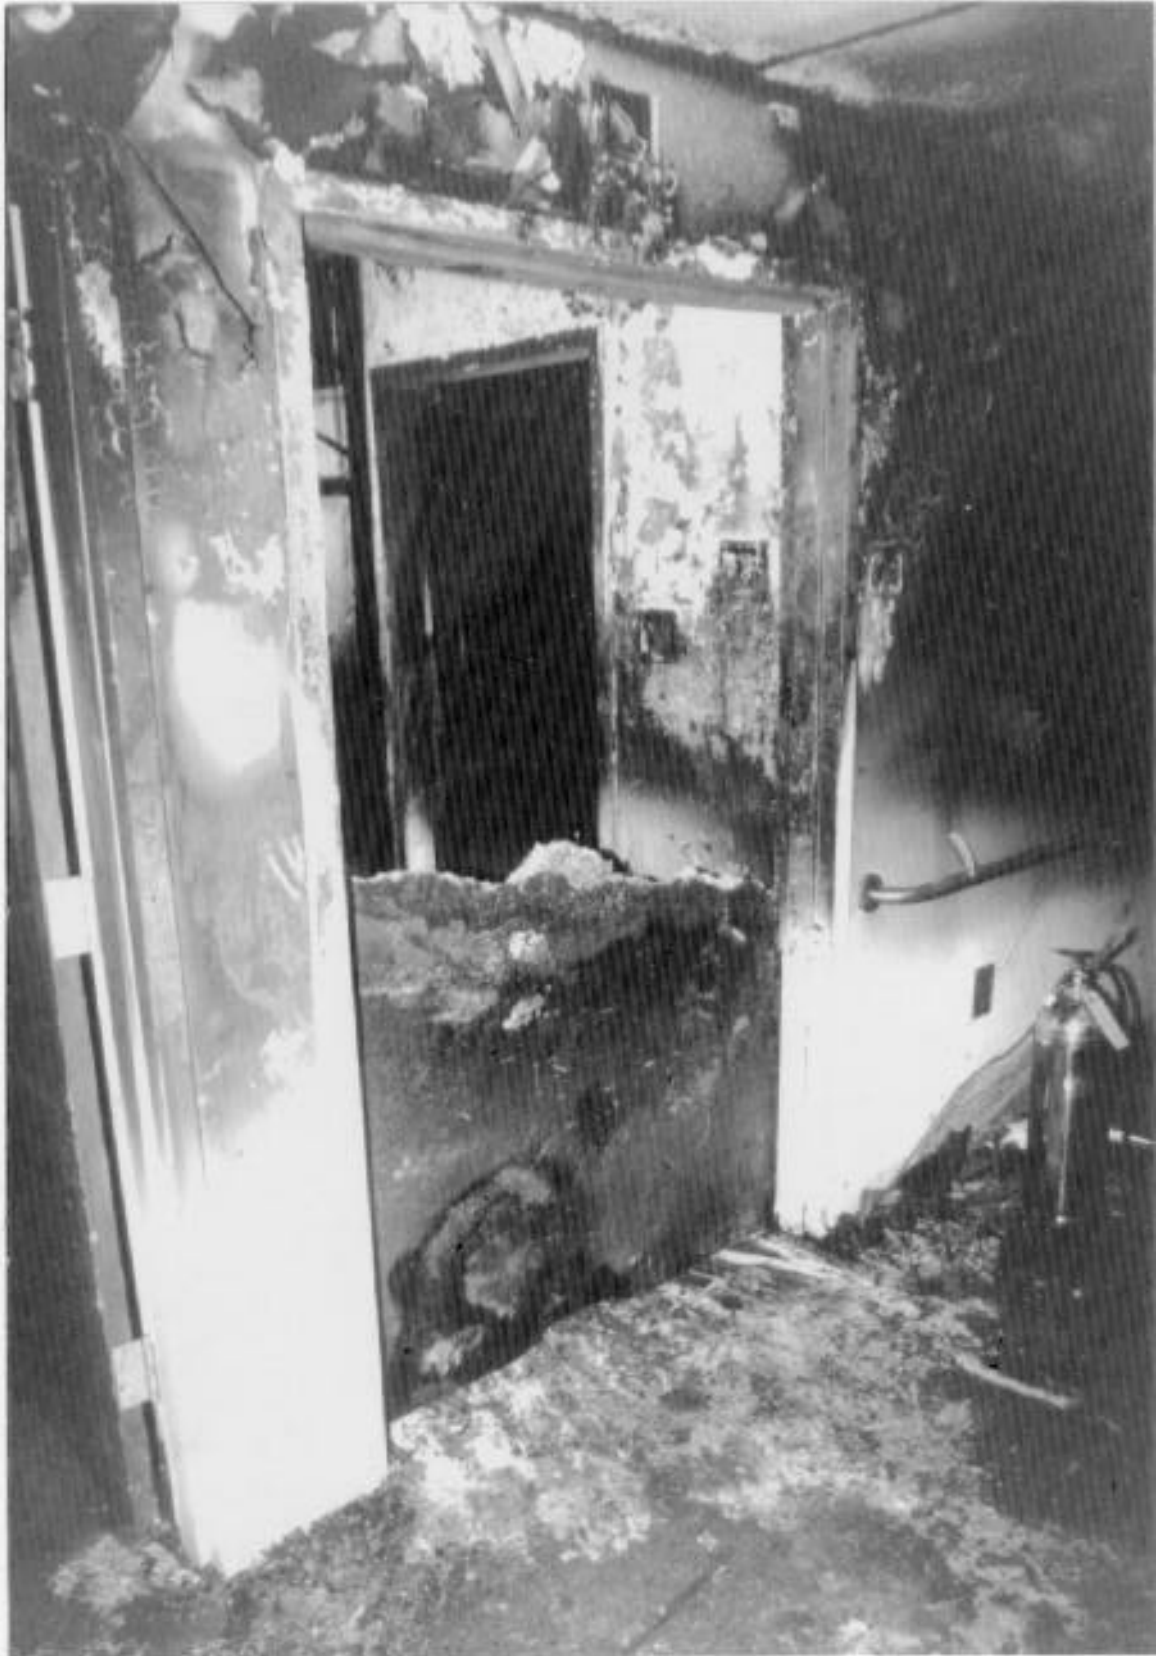
There was heavy smoke and heat damage around the door to the room of origin. The top portion of the door burned away in the fire.

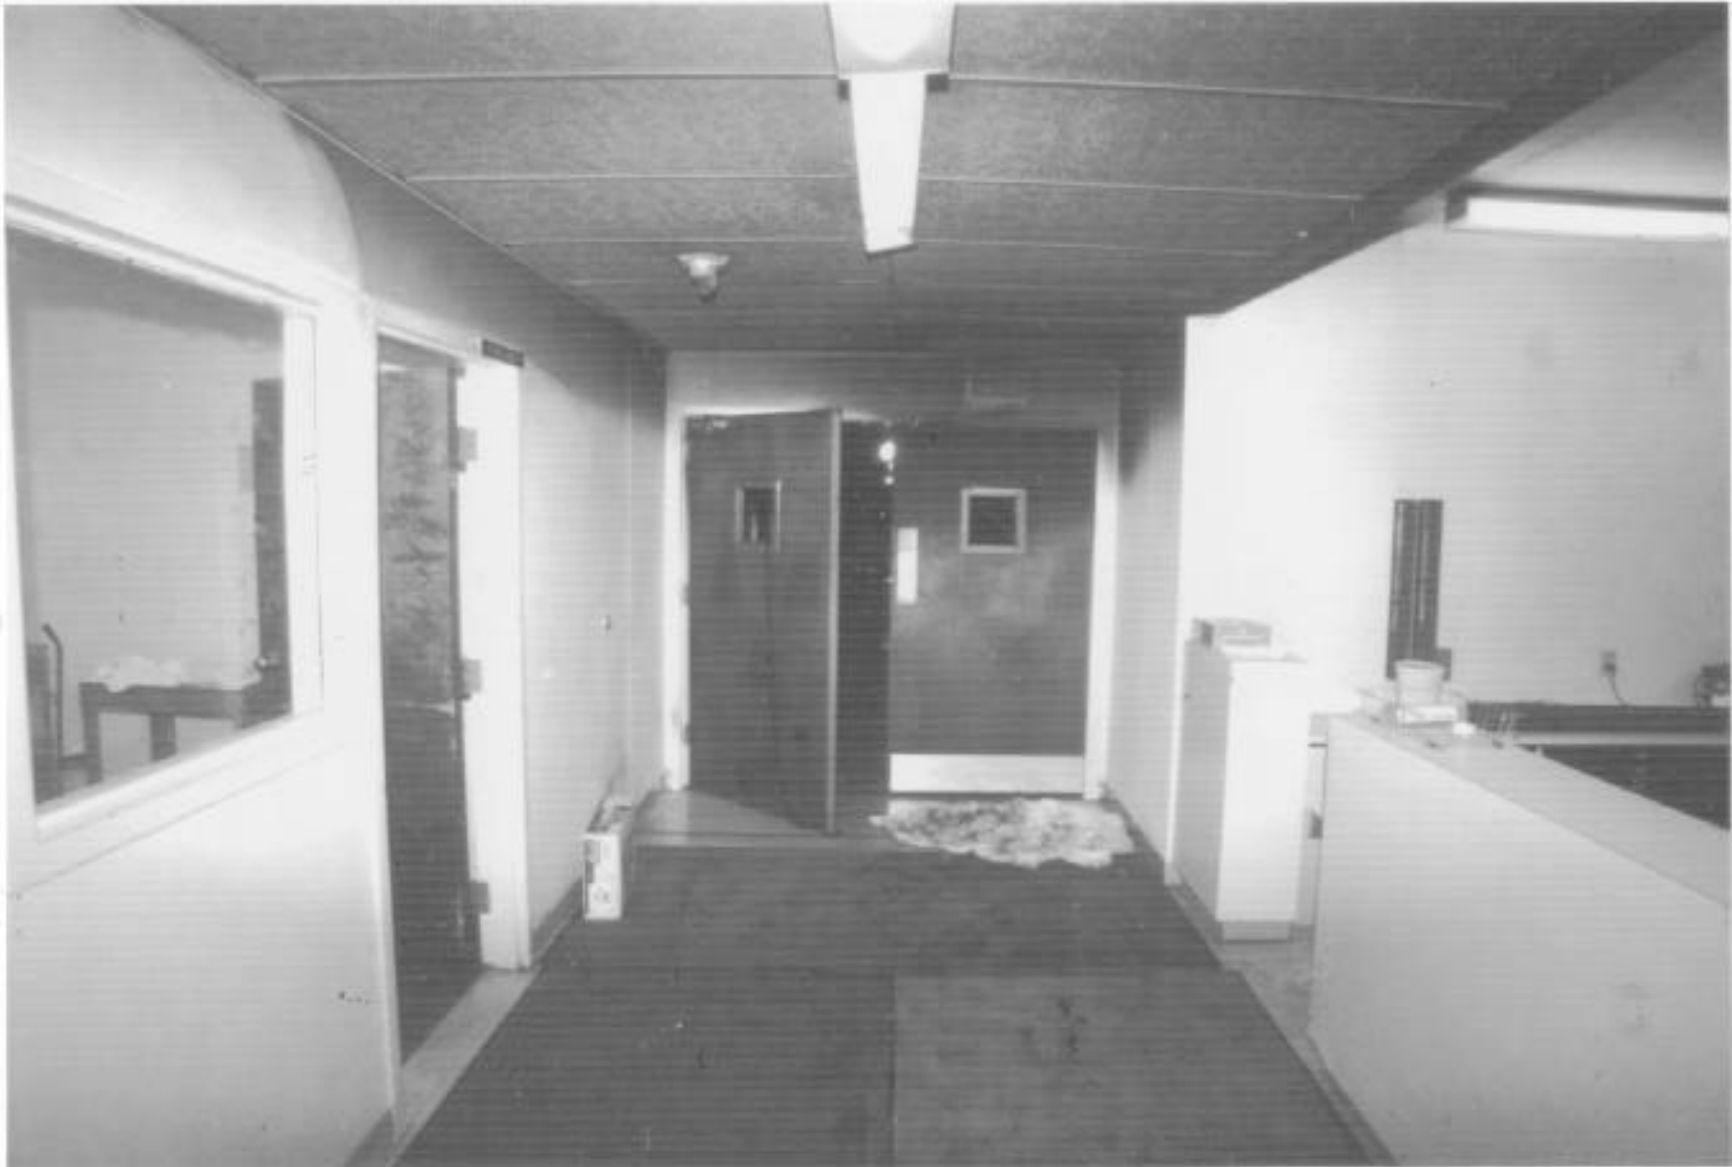
This fire demonstrated that smoke spread can be effectively controlled by smoke control doors and closed doors. Smoke spread via the corridor into other rooms on the corridor was controlled effectively by hospital personnel closing doors to patient rooms. The self-closing smoke control doors at one end of the corridor contained the heavy smoke damage to only one corridor on 4-South wing.

This photo looks down toward the south corridor with the nurses station on the right. The self-closing smoke control doors contained the bulk of the smoke and heat conditions to the corridor of origin, but some smoke escaped into the nurses station area as victims were evacuated through the doors.
