**Logan Valley Mall Fire
Altoona, Pennsylvania**

**Logan Valley Mall
Altoona, Pennsylvania
December 16, 1994**

This is Report 085 of the Major Fires Investigation Project conducted by Varley-Campbell and Associates, Inc./JTriData Corporation under contract EMW-94-4423 to the United States Fire Administration, Federal Emergency Management Agency.

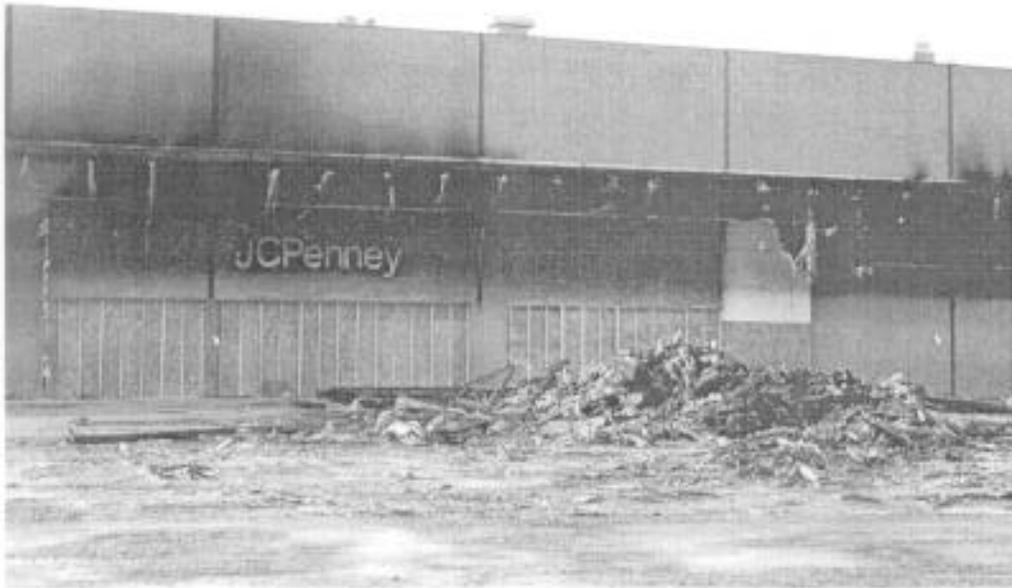
Photograph 1.

East wall of the J.C Penney Store where the westerly fire travel was stopped. Roof line of covered mall is identified by the dark black horizontal line. Glass entrance and show windows are behind the chipboard and wood studs.

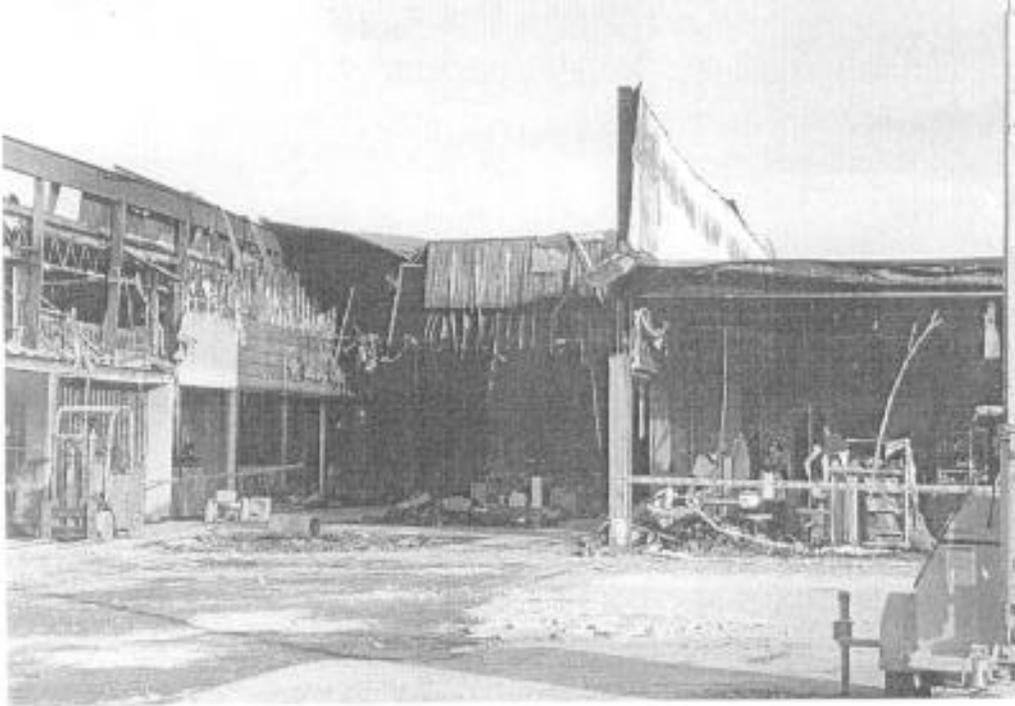
Photograph 2.

Covered mall to the east of the Murphy store and some of the stores adjacent to the covered mall. The three different roof heights and construction features are illustrated. The tenant separation wall for the right hand store has been removed.

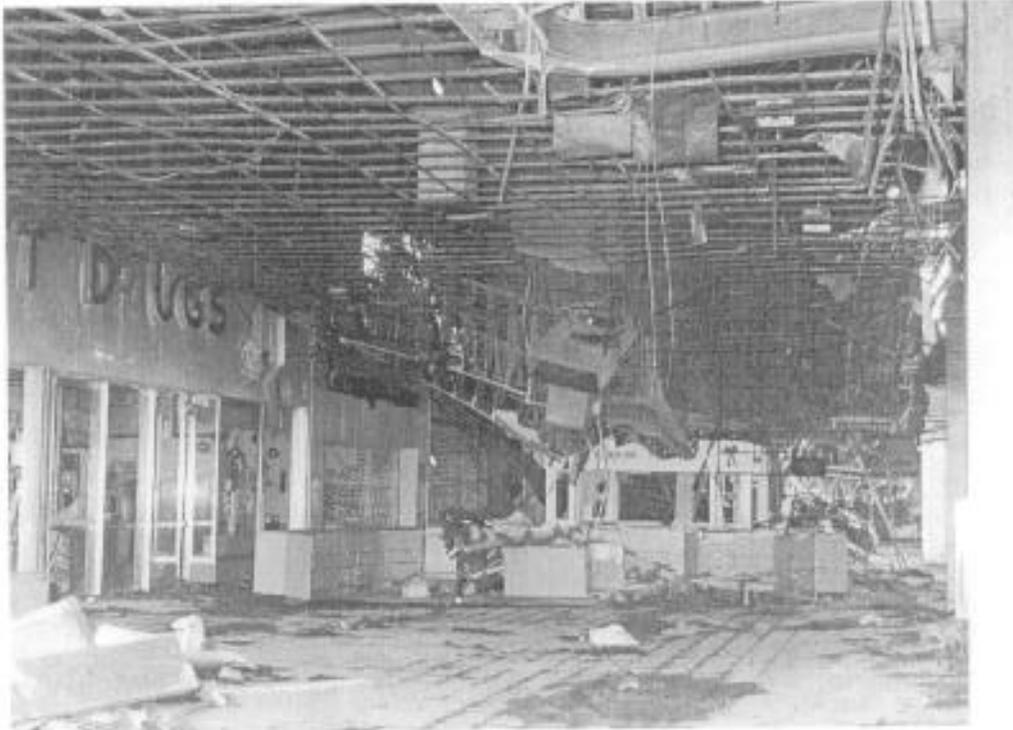
Photograph 3.

Looking east into the covered mall from about where the forklift is located in Photograph 2. The ceiling tiles were removed during the fire and the floor debris was removed before the photograph was taken. Note the partial roof collapse in the background

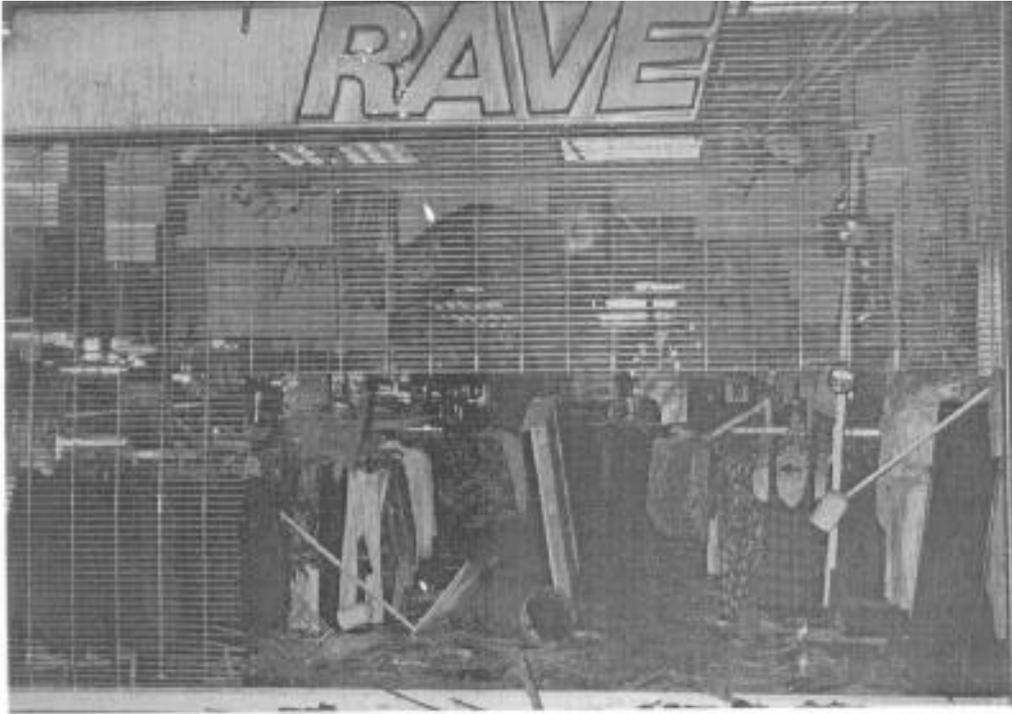
Photograph 4.

Open grill security separations allowed the free passage of smoke and heat into stores from the common, covered mall. This contributed to smoke and water damage to the stores' contents. Additionally, the forcible entry through these separations was more difficult and time consuming than for stores with solid separations. Smoke damage in a retail store is often as costly as direct fire damage. Controlling smoke travel is an important element in limiting damage. Rated fire resistance in the separation is not as important as a solid separation with minimal unprotected penetrations. NFPA 101, *Life Safety Code*, does not require separation between the covered mall and the tenant stores, but does require automatic sprinklers and a "smoke control system" within the covered mall. These systems were not present in this incident.

Store on the south side of the covered mall. Typical of the forcible entry work performed on the security grill and the damage to goods. This store had automatic sprinklers and the sprinkler heads at the front entrance operated.

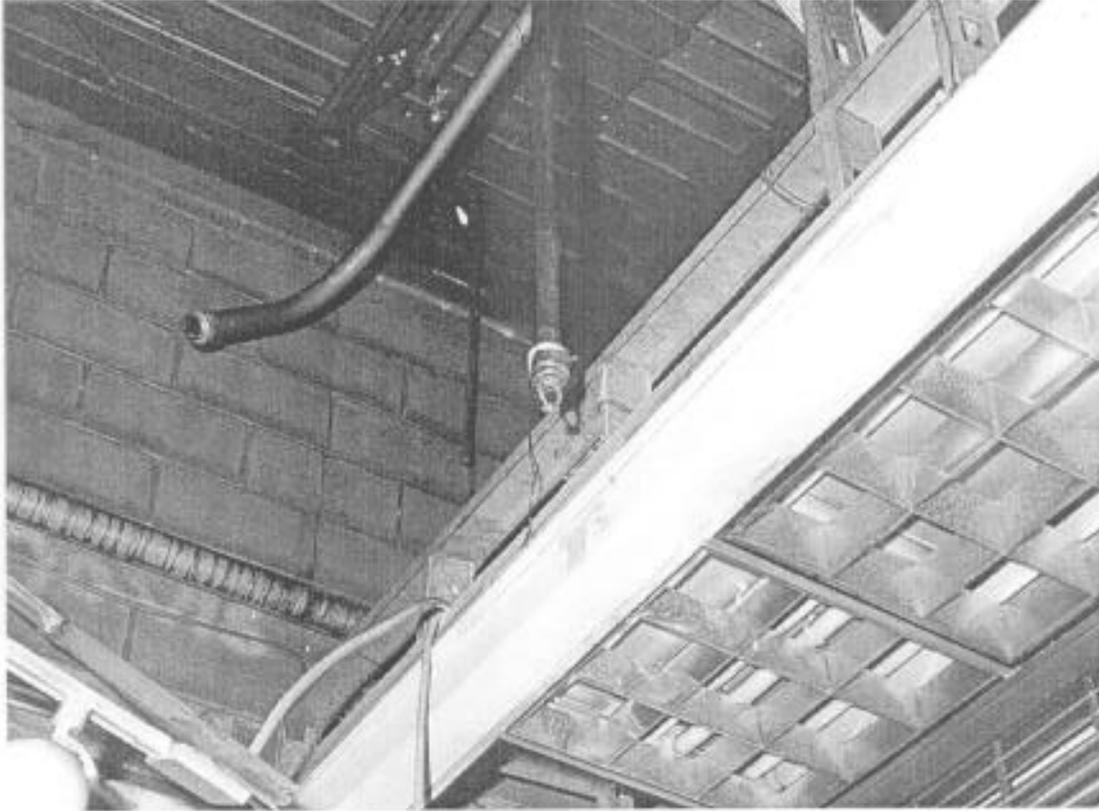
Photograph 5.

Open sprinkler head inside the store in Photograph 4. The ceiling tiles and grid around the head were removed before the picture. Typical concrete block tenant separation wall and metal deck roof construction in the older section. Interior tenant construction has used wood studs for the metal ones.

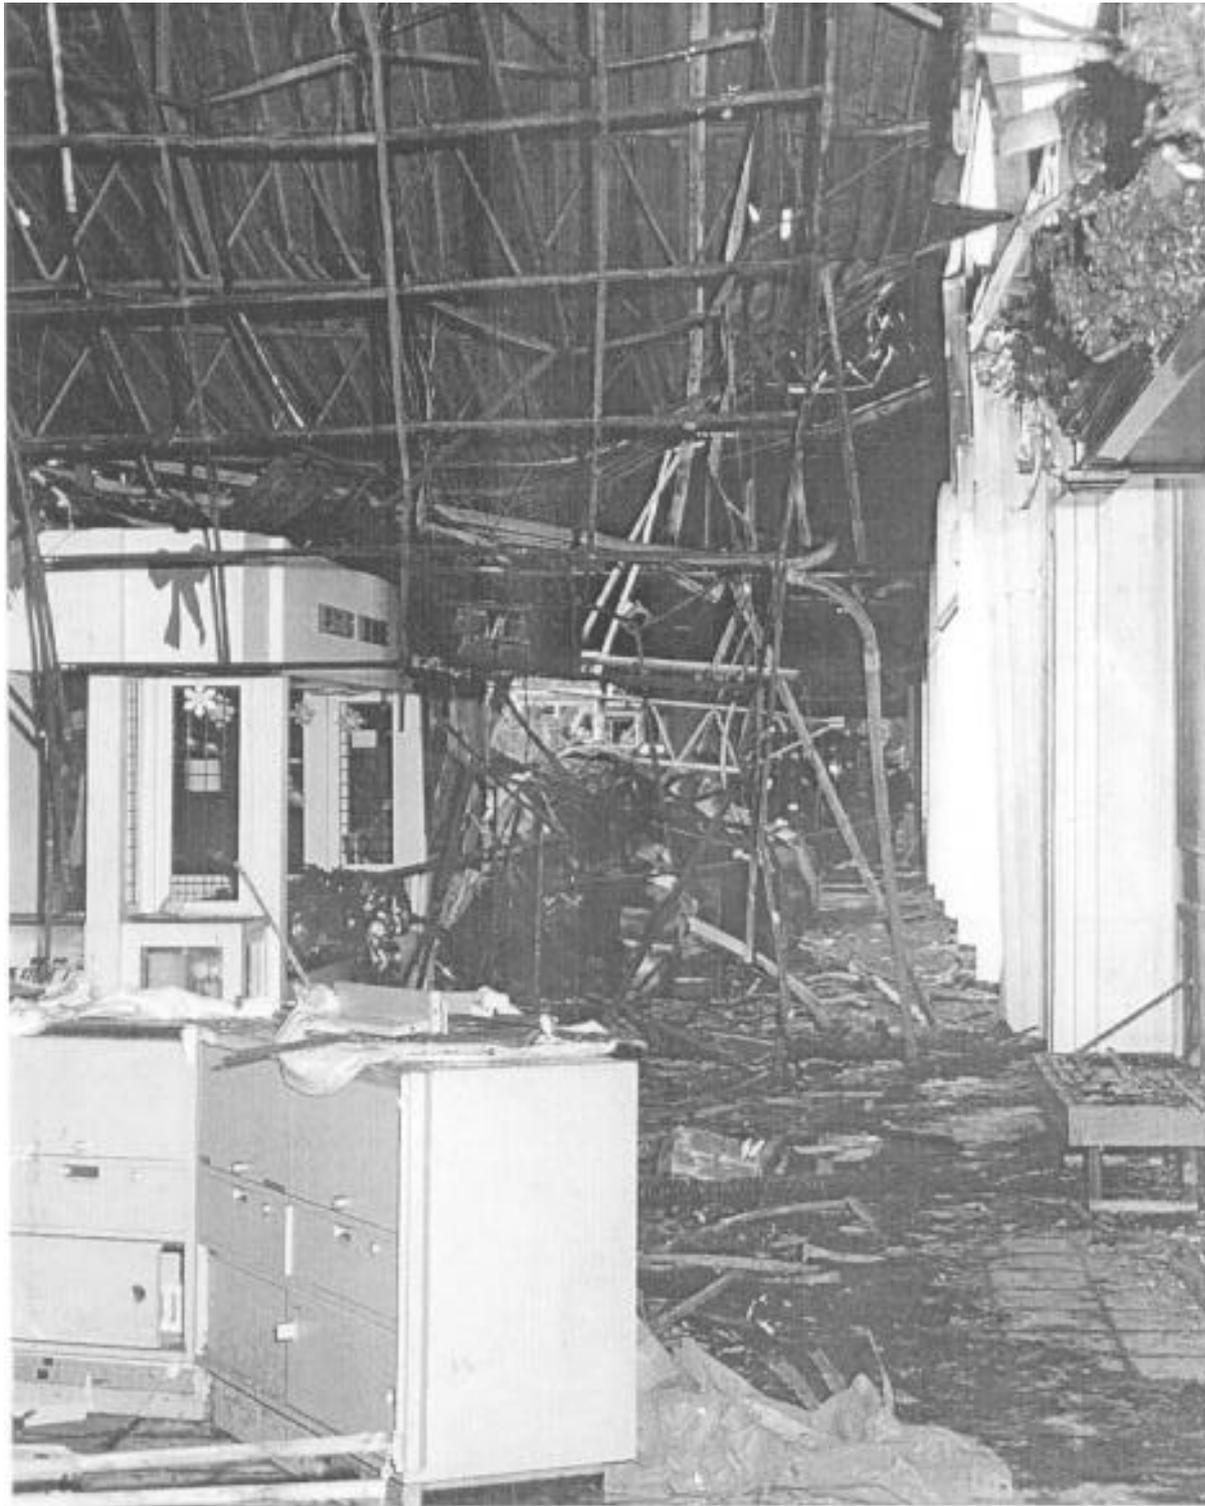
The fire damage and collapse of the covered mall roof was attributed to fire spreading under the metal deck roof. The fuel for this fire was the melted and vaporized asphalt from the adhesive and vapor barrier above the metal deck and under the roof insulation. This flammable vapor leaked into the building through the seams in the metal deck where it ignited. This combustion melted and vaporized more asphalt, creating a self-sustaining fire under the roof deck. The undamaged combustible kiosks at floor level further support this observation and also document the effectiveness of firefighter tactics and operations in this area.

Photograph 6. Moving further east in the covered mall, the counters in the foreground are also in Photograph 3. This area is where the metal roof began a partial collapse. The goods in the kiosks were either stored before the fire or removed prior to the picture.

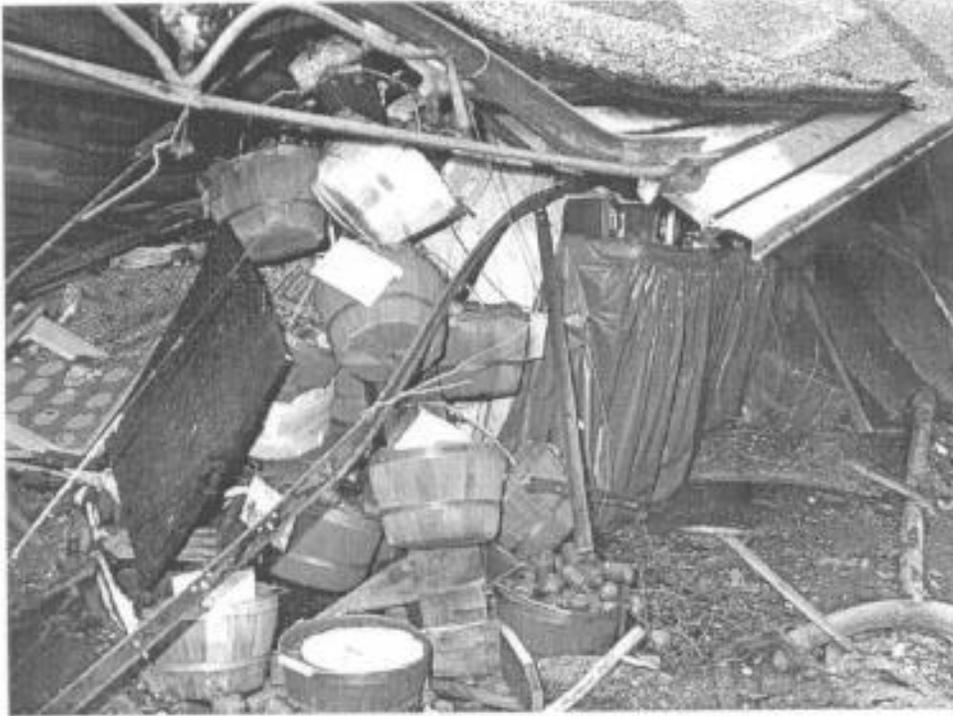
Photograph 7.

The fire and heat spread for a considerable distance in the covered mall area from in front of the G. C. Murphy store east to the food court. The covered mall's roof collapsed for about 60 feet to the east of the G. C. Murphy store. Further to the east, a roof section approximately 80 feet long was left standing but showed signs of burning on the underside of the deck. A kiosk below this section suffered only smoke and water damage. East of the standing section, another part of the roof collapsed in a lean-to fashion for a distance of approximately 60 feet. This collapse was due to the roof support beam on the south side rolling over. A candle kiosk under this collapse was not burned and the visible candles were not melted. One basket of candles was covered with melted tar, likely from the roof. (See Appendix F)

A candle kiosk under the roof collapse area shown in Photograph 6. Note that the candles, wicker baskets and table skirting are not melted or burned. Yet, the metal bar joist is severely deformed.

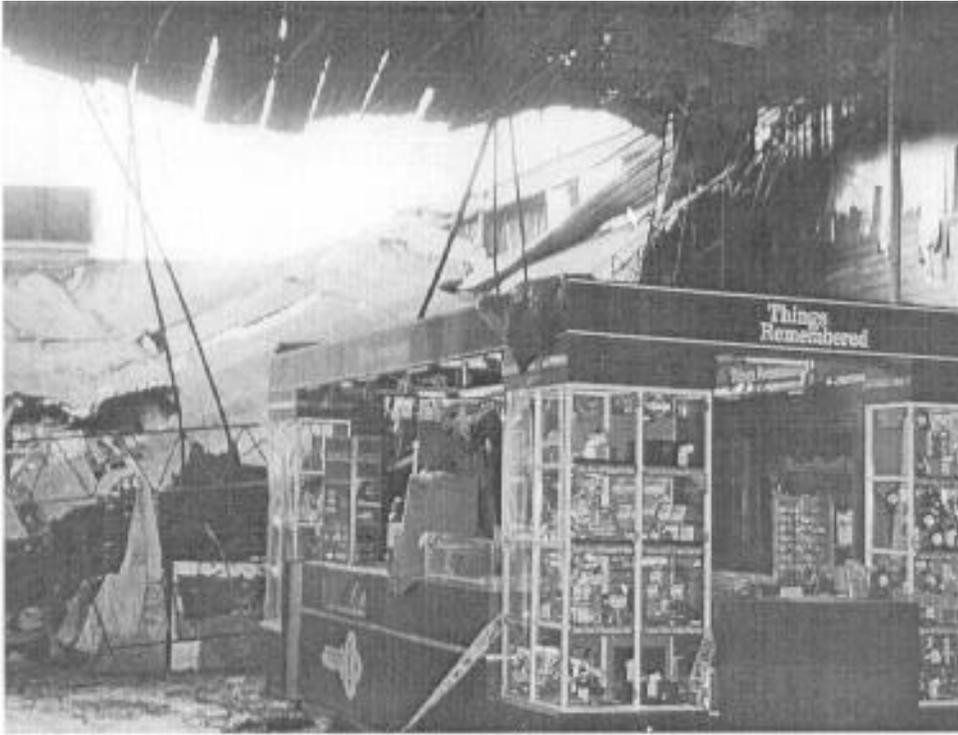
Photograph 8.

A front view of the partial roof collapse over the Things Remembered kiosk.

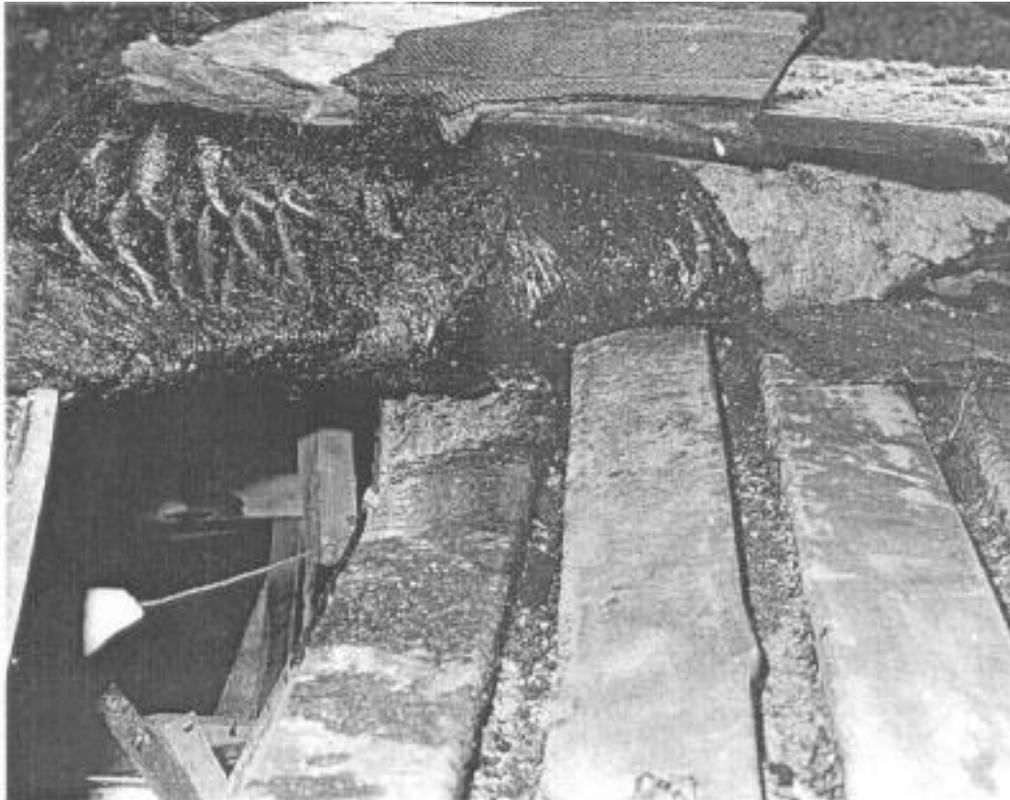
Photograph 9.

This hazard was first published following the 1953 fire in Livonia, Michigan and has reoccurred several times since. An exposure fire heating the corrugated metal roof deck melts and vaporizes the asphalt material commonly used as both the adhesive and part of the vapor barrier. The insulation board, laid into and on top of these layers, and the layers of felt and additional asphalt on top of the insulation do not allow the vapors to escape upwards. As a result, these flammable vapors are forced through the seams in the metal deck panels into the building. The fire inside the building ignites these vapors which continue the process of generating fuel and fire under the metal deck. The heavy black smoke produced often obscures the flames in such a fire. Large caliber hose streams are needed to cool the metal roof deck and supporting structures. Water must reach the deck; steam does not provide the required cooling. Where ceilings are installed, they need to be removed to provide access for cooling hose streams.

The top of the metal deck roof illustrating the insulation board, the vapor barrier under the board, the seam in the deck and the deformed condition of the metal. This section is in the partial roof collapse area shown in previous photographs.

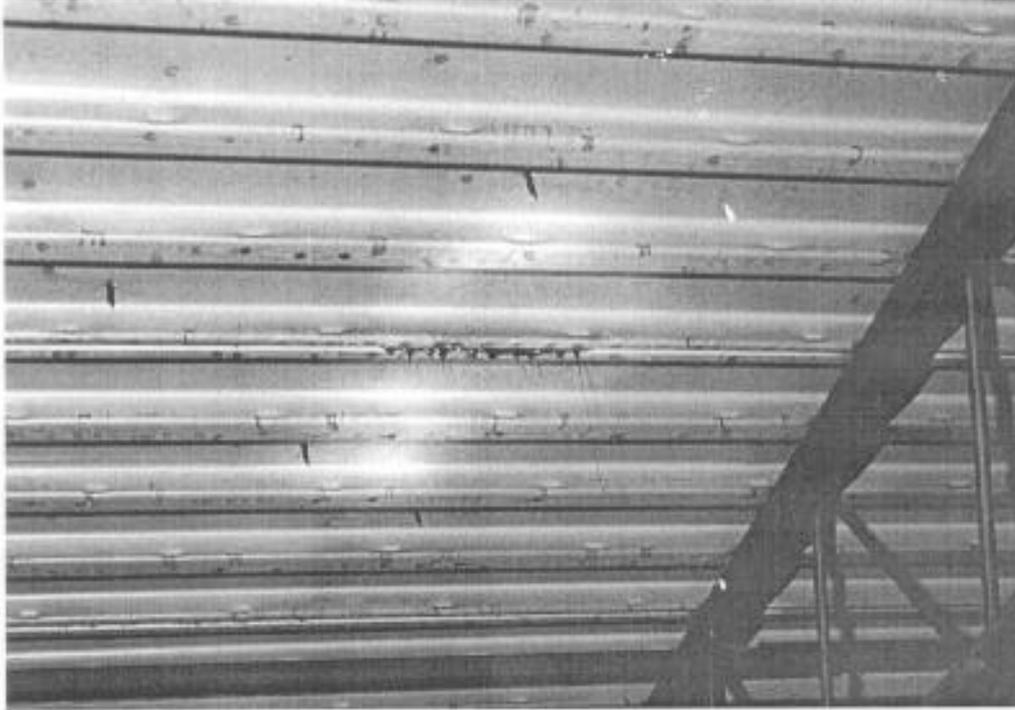
Photograph 10.

Recent reroofings involved tearing off the combustible roof materials and replacing them with a Class I roofing system¹ with mechanical fasteners for the insulation board. However, the complete removal of the combustible asphalt from the metal deck is difficult to accomplish.

Therefore, even where a Class I roofing system had been installed, fuel supplies for a fire immediately under the metal deck remained. (See Lessons Learned for more on this type of fire.)

The underside of the metal deck roof above one of the stores adjacent to the covered mall. Note the tar dripping through the seam in the valley between metal deck sections. You can also see three mechanical fasteners poking through ridges in the deck. Such fasteners are usually found when less combustible roofing methods are employed.
