Five Fatality Residential Motel Fire Thornton, Colorado

**Five Fatality Residential Motel Fire
Thornton, Colorado
January 27, 1997**

This is Report 104 of the Major Fires Investigation Project conducted by Varley-Campbell and Associates, Inc./TriData Corporation under contract EMW-94-4423 to the United States Fire Administration, Federal Emergency Management Agency.

**11 EAST 84TH AVENUE
THORNTON, COLORADO**

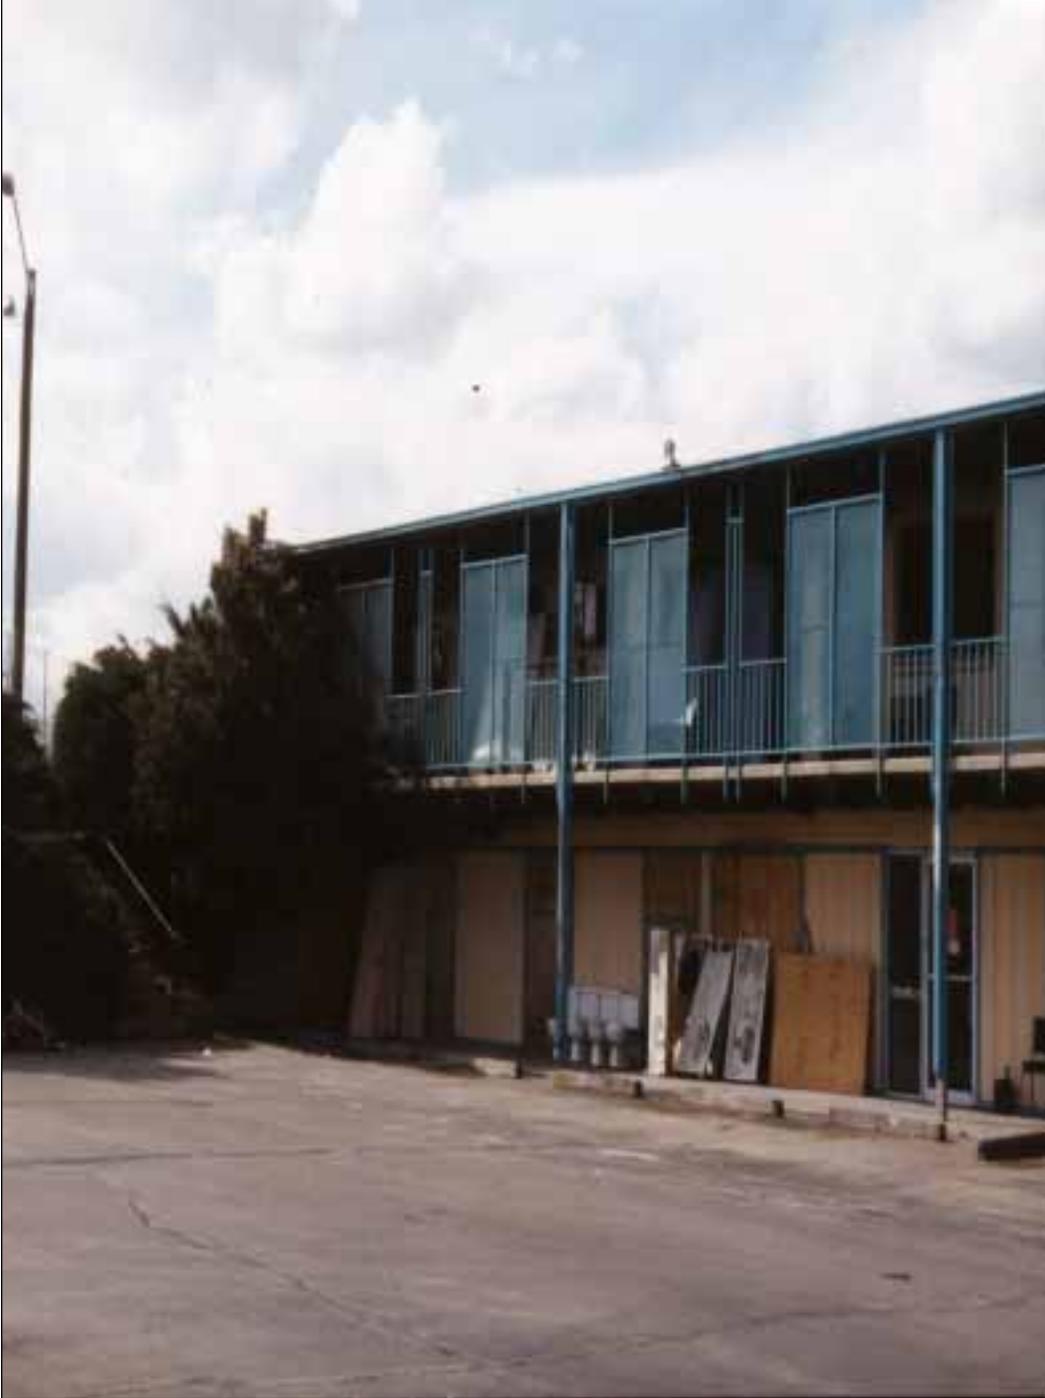
1. Southwest corner of the front wing looking northwest. The 100 level commercial and offices and the 200 level guest rooms are shown. The pine tree shields the entrance to the stairway and storage closet which was the point of origin.

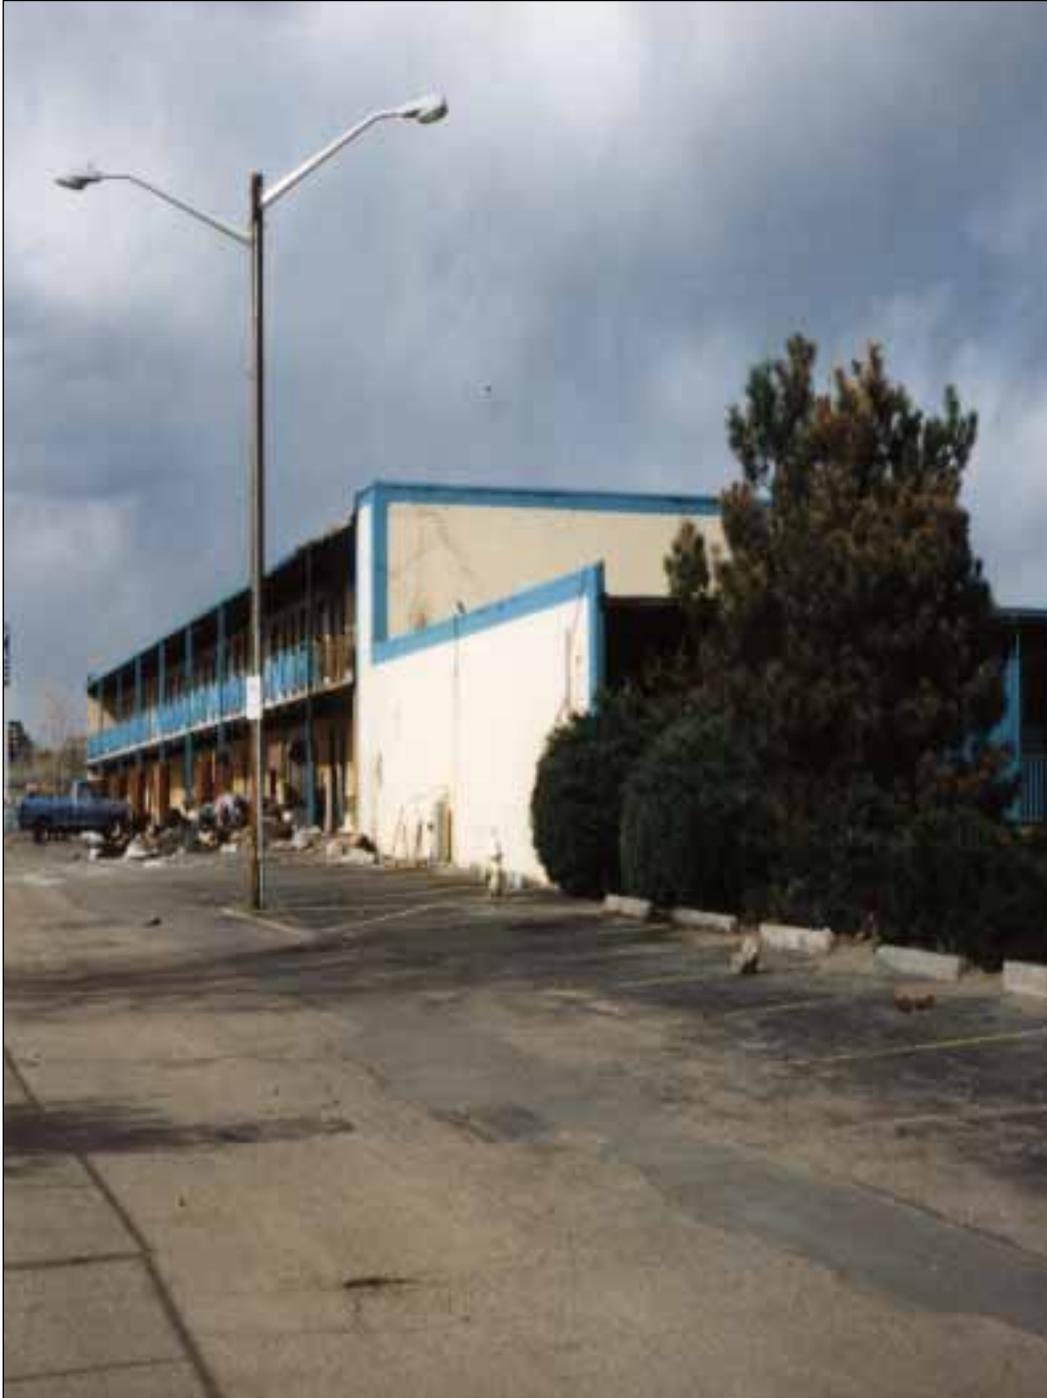
2. The west side of the property looking north. This is the 200 and 300 level guest rooms of the west wing and the end of the front wing. Engine 67 used the fire hydrant to the right of the light pole.

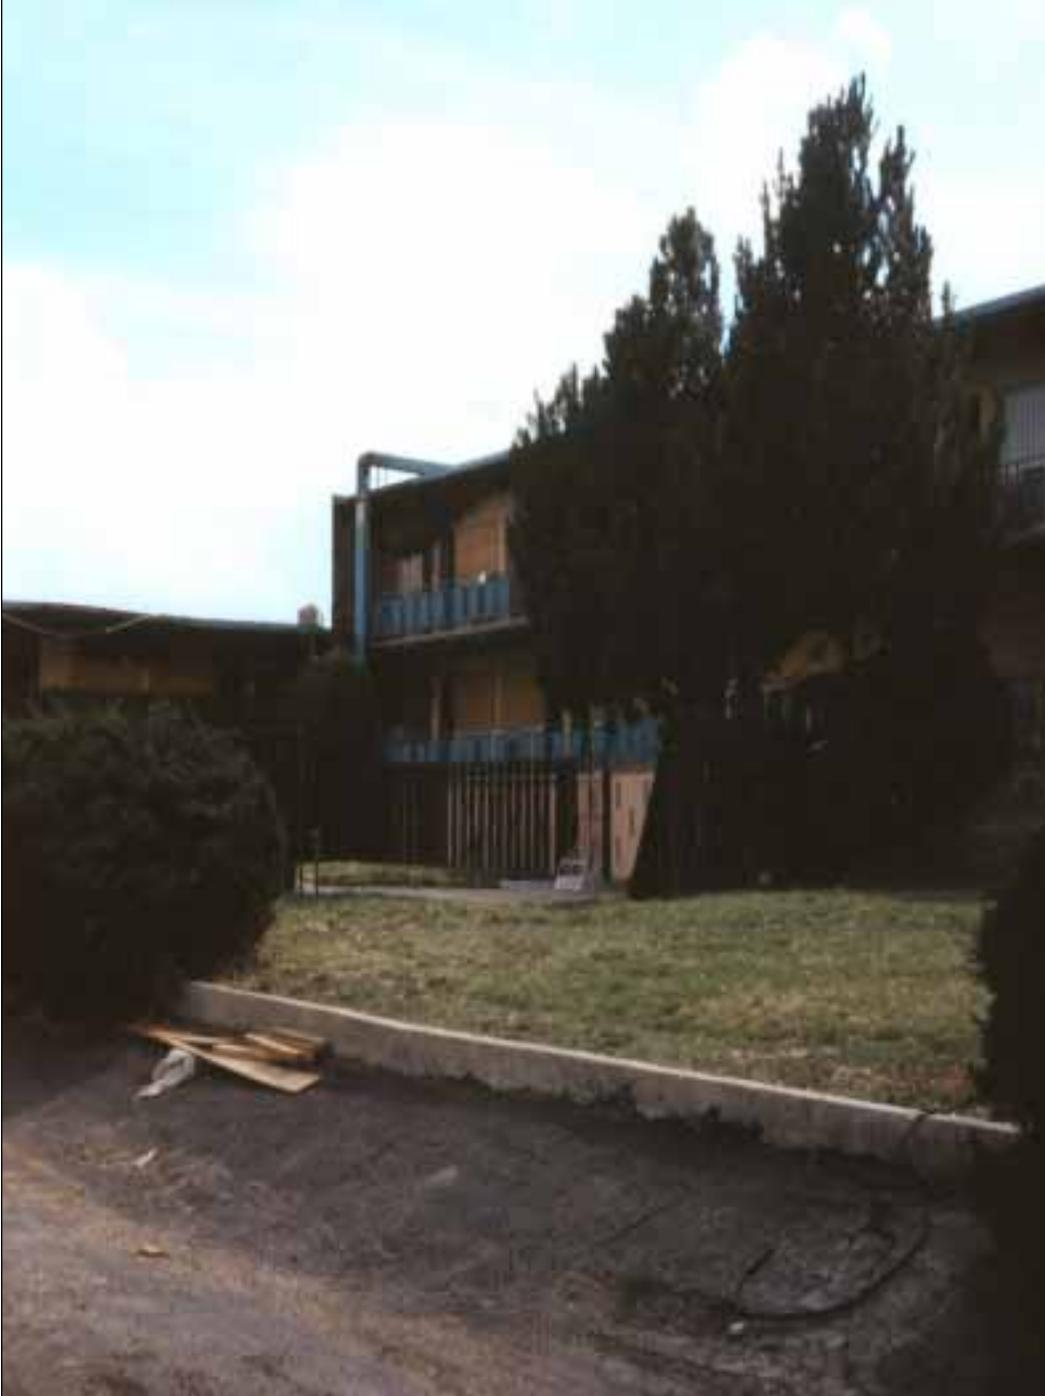
3. The inside corner of the junction between the front and west wings; part of the U shape. This illustrates all three levels of the property and the grade change.

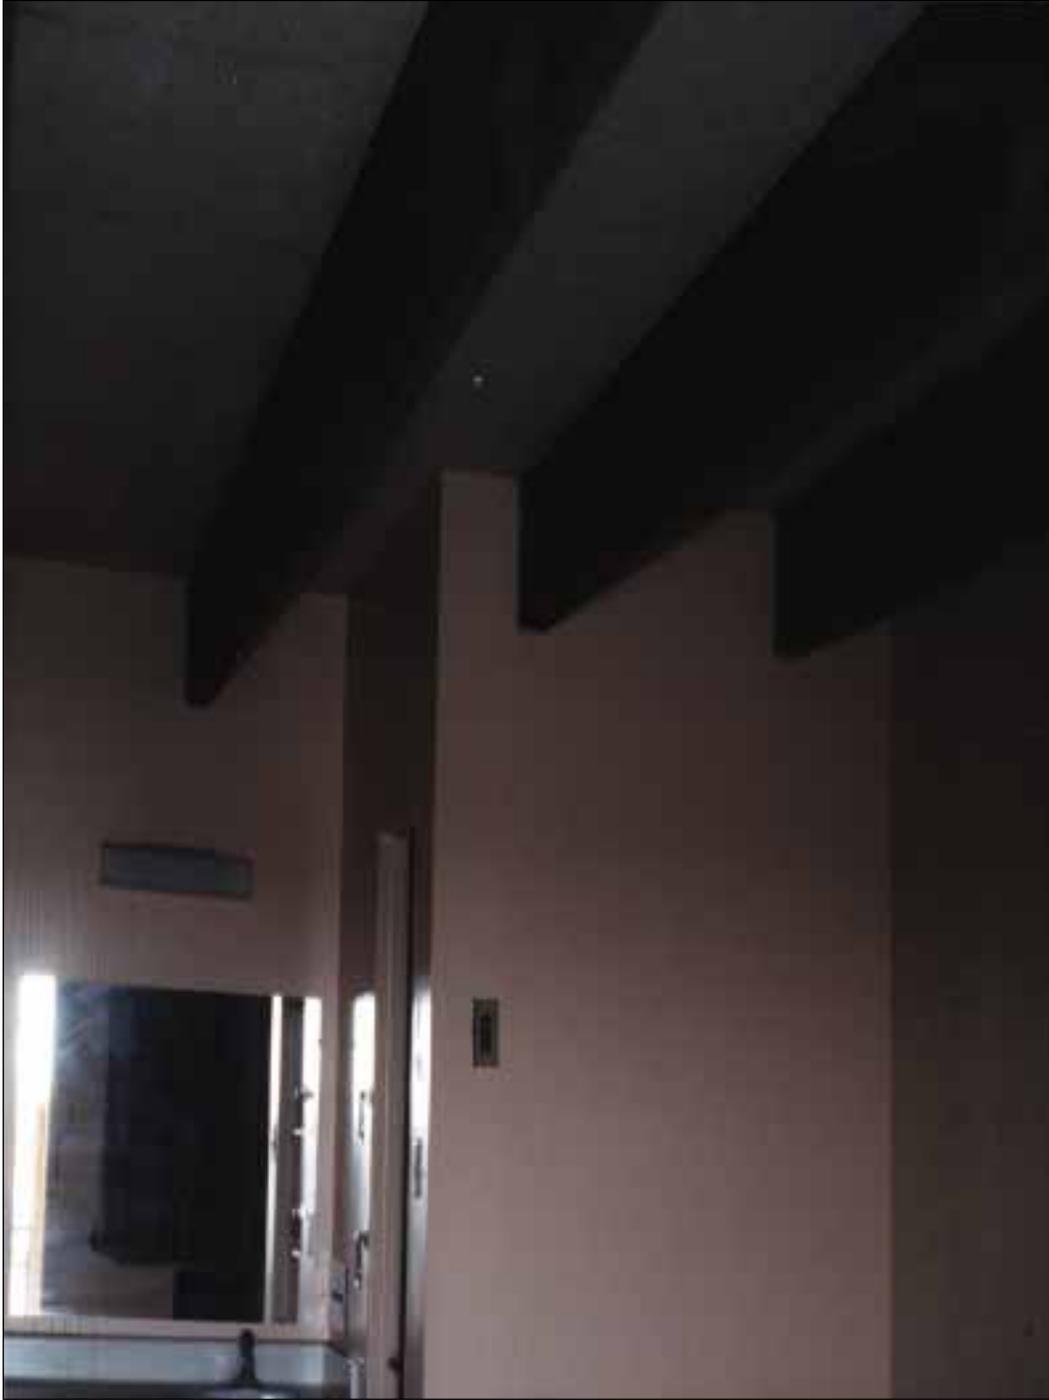
4. Typical guest room ceiling, bathroom, and sink on the utility chase wall.

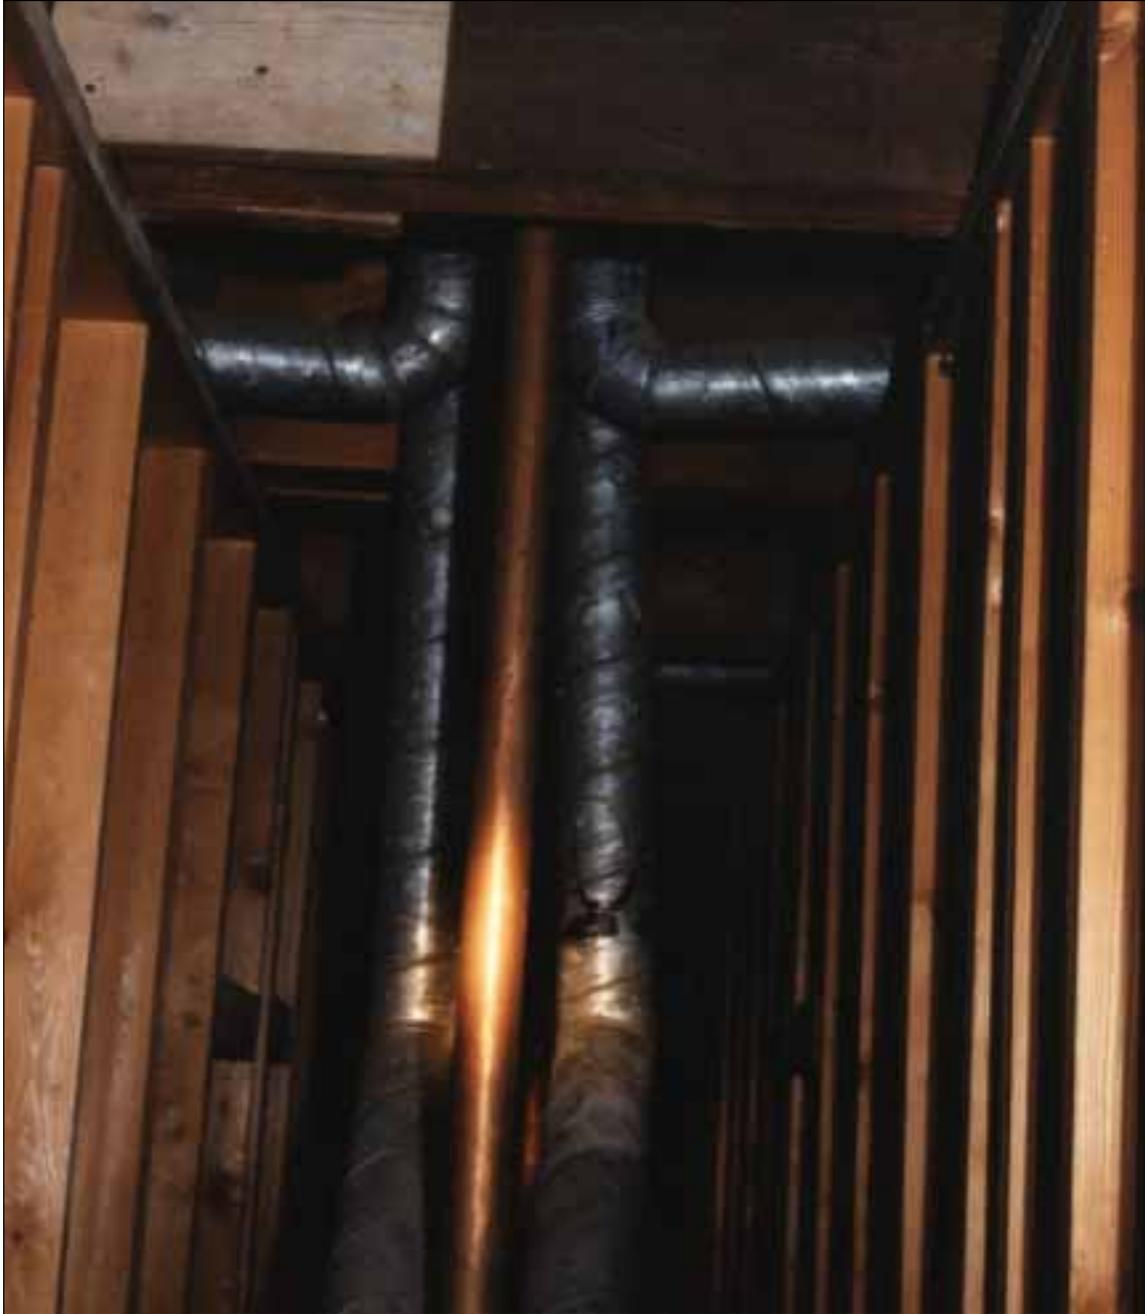
On the second floor, the utility chase was constructed of parallel 2" x 4" wood stud walls covered only on the guest room side only with drywall. (See photograph 5). The chase walls formed the center support for the 4" x 12" wood roof beams which were spaced about 34-inches on center. The beams held up a light weight roof consisting of Tectum board¹ covered with a hot mopped asphalt built-up gravel topped roof covering. (See photograph 6.)

5. The interior of the utility chase between rooms showing the second floor wall construction and the wood beams supporting the roof.

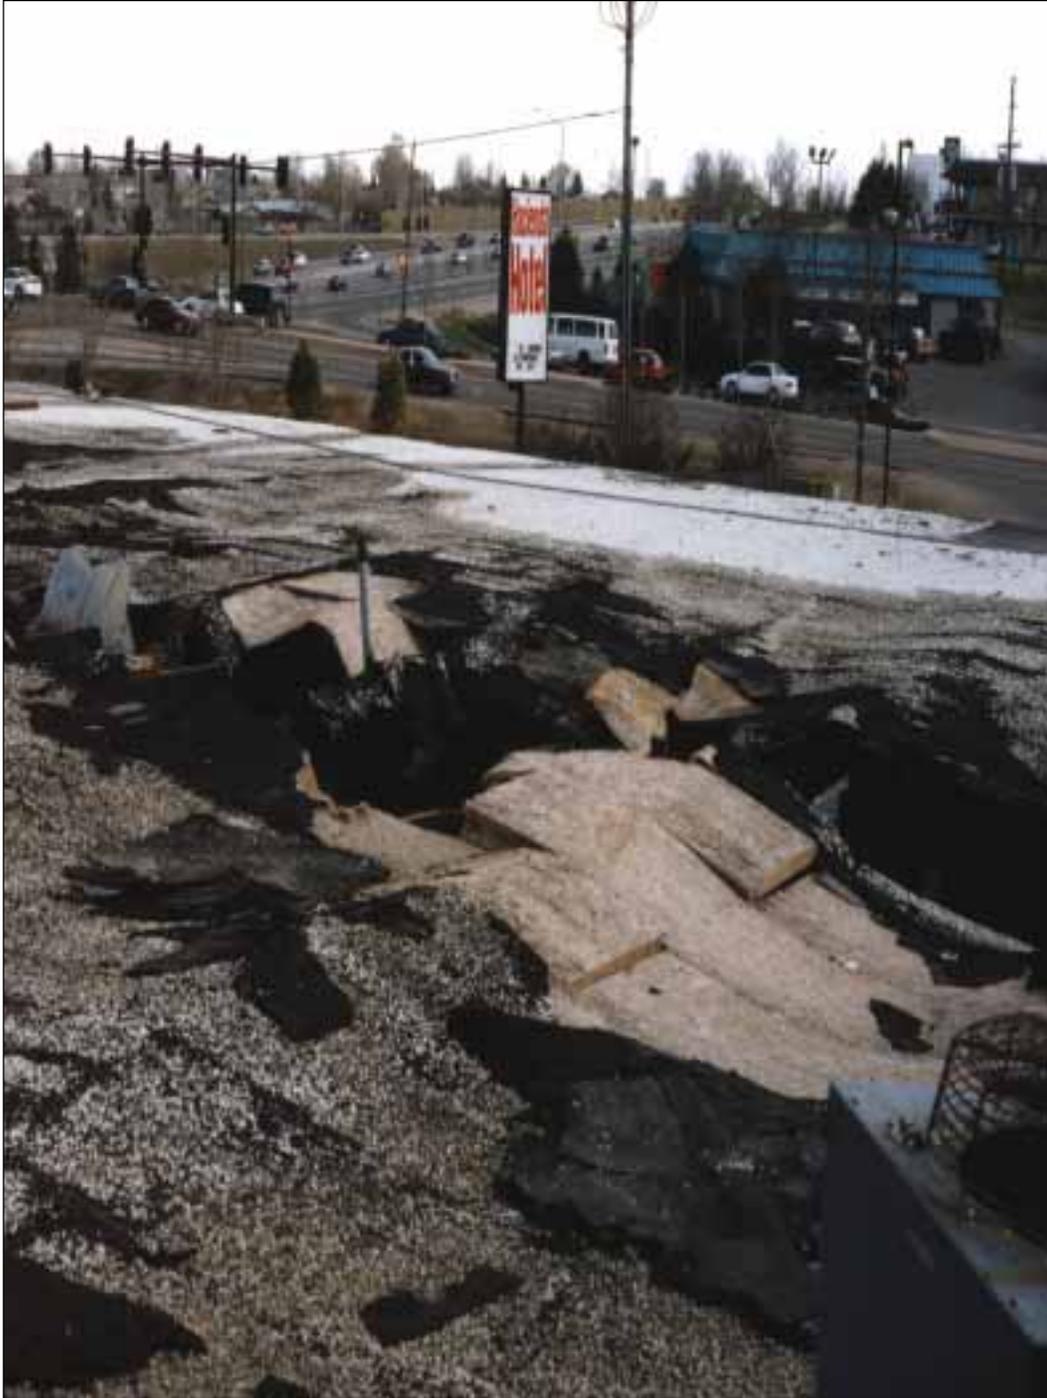
6. Roof over the front wing. The collapsed area is above the utility chase. The roof construction of Tectum board, built-up roofing, and gravel topping is illustrated.

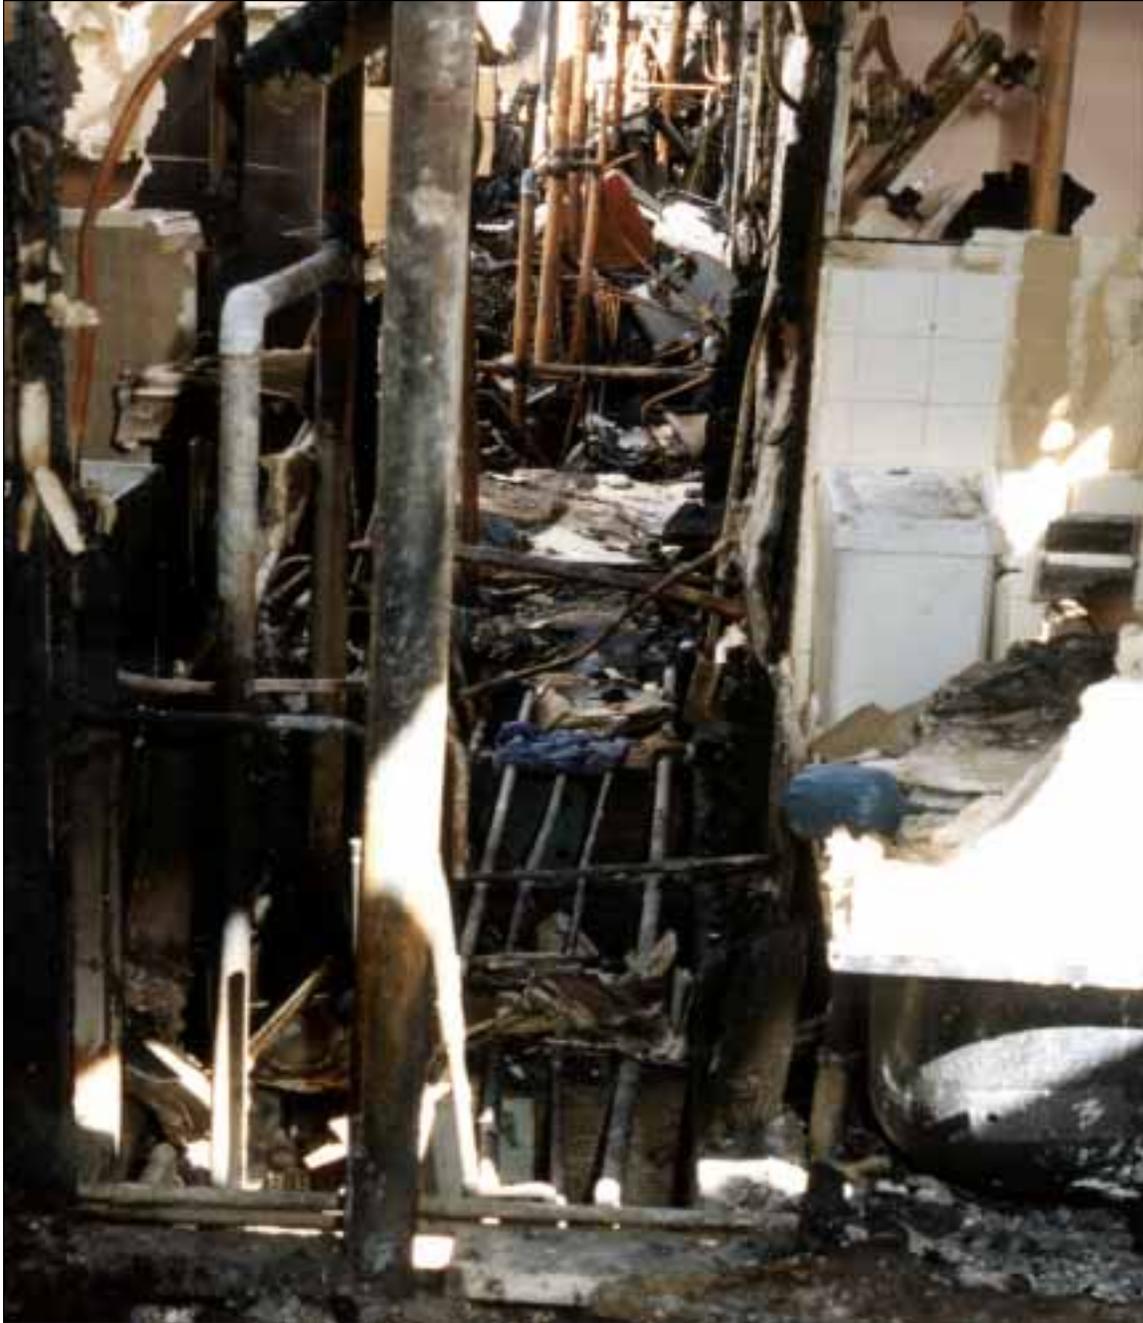
While the fire was essentially contained to the front wing, it was burning within the entire length of the utility chase. The fire broke out of the chase at several locations on the first and second floors. Inside the utility chase, the exposed 2 x 4 wood studs were heavily damaged the entire length and the studs near the westend were totally consumed by the fire. This resulted in the roof collapsing over almost the entire length of the chase. Partial roof collapse also occurred over Rooms 219 to 222 and at the rear (by the utility chase) of Rooms 208 to 211. The fire entered several rooms on the second floor, consuming most of the rooms' contents. Yet adjacent rooms were not heavily damaged. On the first floor north side, the fire followed along the wood construction in the separator walls between rooms, consuming the 2 x 4 wood studs from the inside out.

The utility chase was not smoke or fire stopped either vertically or horizontally within the chase. In addition, the chase was not separated by fire resistance rated construction from the guest rooms. Even the first floor hollow concrete block walls were not completely separated from combustibles concealed spaces in the guest rooms. On the second floor, the wood studs were exposed in the utility chase providing a fuel source for the fire to move horizontally inside. As the wood studs failed, or the fire found openings in the gypsum board wall, the fire was able to enter the guest rooms, especially where fuel was available in the room near the utility chase wall. Several guest rooms were gutted by fire in this manner. The recognition of combustibles concealed spaces is an important part of the pre-incident plan process. Fire companies or fire protection staff need to carefully investigate the building's construction and physical arrangement to identify potential concealed spaces. The more difficult task is developing and implementing actions to mitigate construction deficiencies such as lack of smoke and fire stopping, exposed combustibles materials or lack of fire resistance rated separations.

7. The west end of the utility chase in the front wing. Room 222 is to the left and Room 211 to the right. The second floor utility chase walls were burned away.

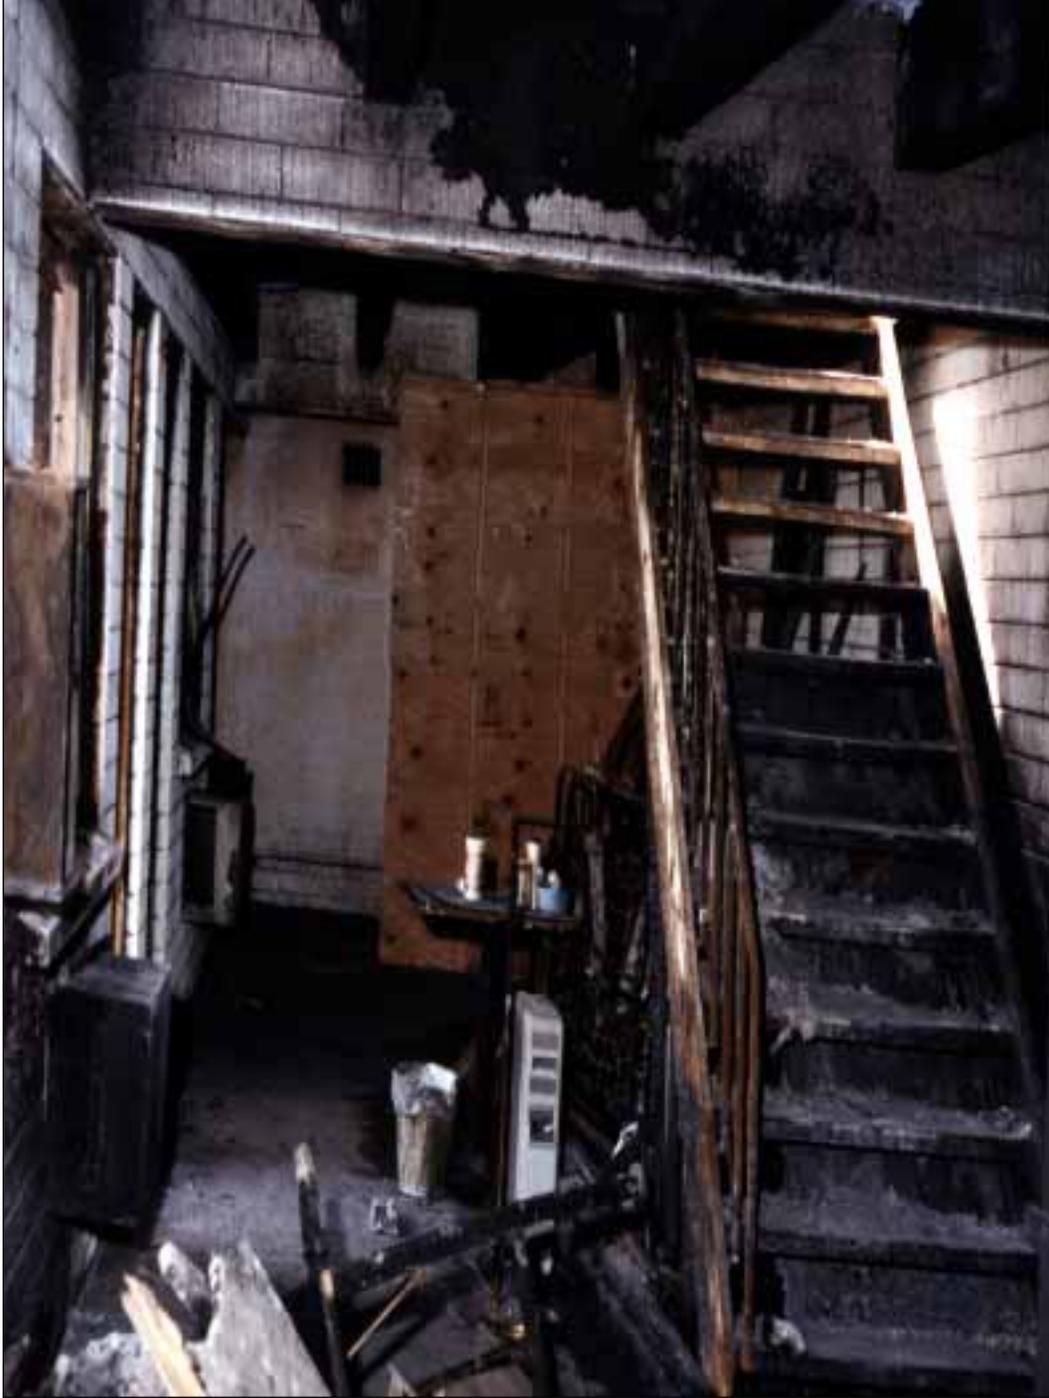
8. The 200 level breezeway area outside of Rooms 220 to 222 looking west. The open stairway to the 300 level is on the right. Under the stairs is another storage room whose wood stud and gypsum board walls were destroyed by the fire.

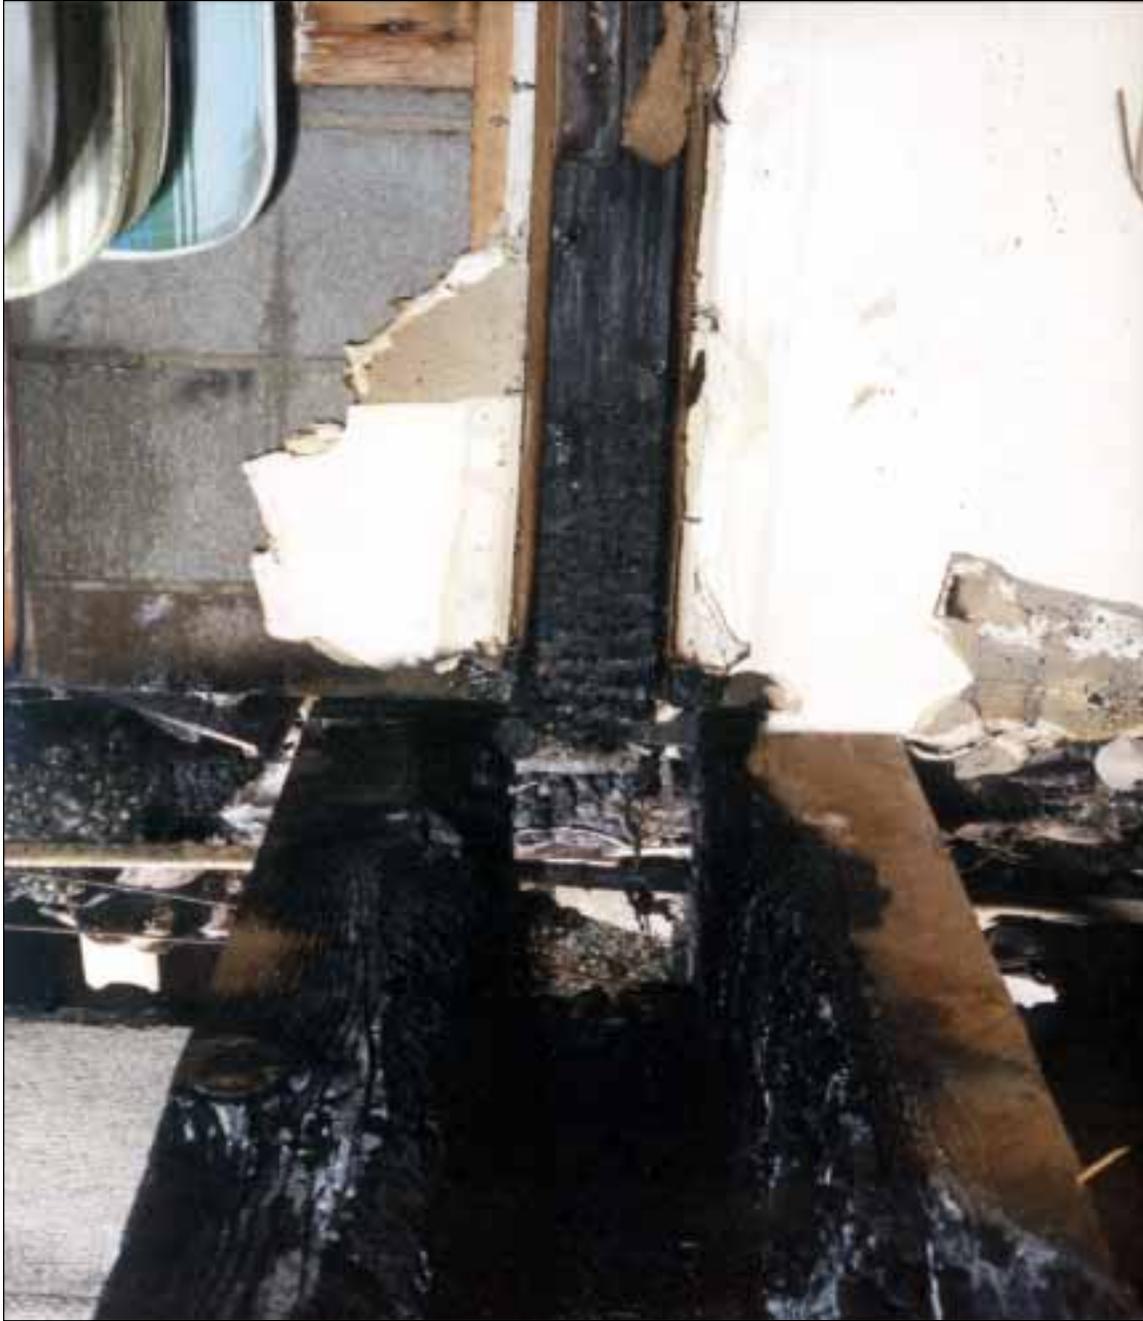
9. A separation wall between 100 level guest rooms that was burned from the inside out. The parallel wood beams formed the top of the wall and the communication to the utility chase is at the back.

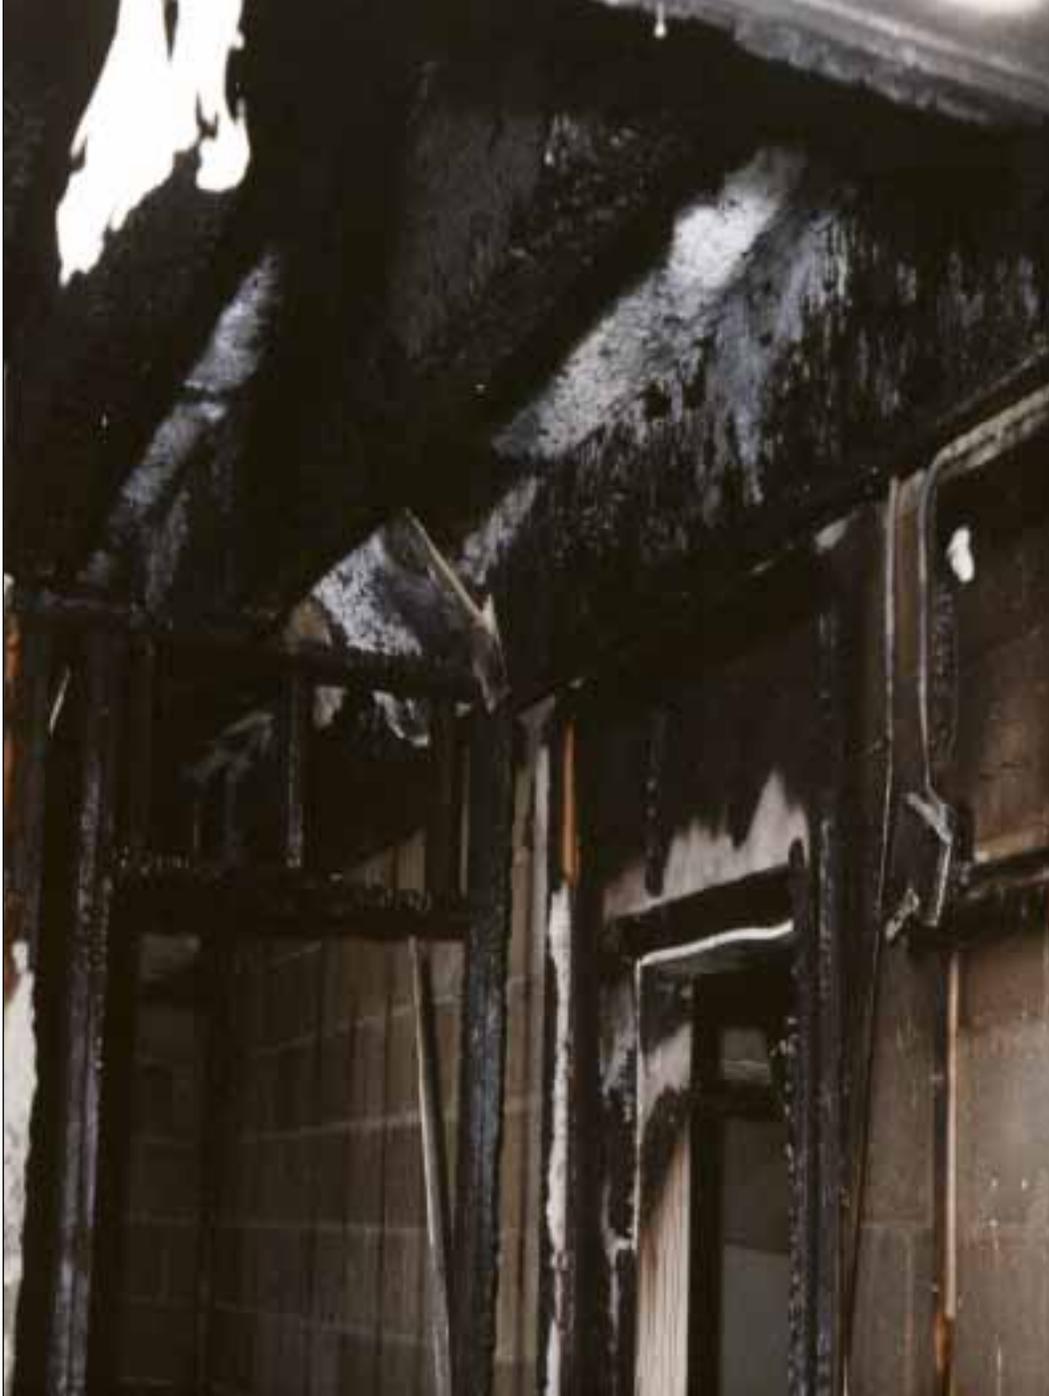
The point of origin is believed to be a first floor storage closet at the stairway located at the west end of the front wing. The closet was formed using the space under and adjacent to the stairway. The metal stairway with concrete filled steps and landing was enclosed on the underside with 5/8 inch drywall. The hollow concrete block stairway walls were also covered with furred out drywall. Where walls were needed to complete the closet enclosure, 2 x 4 wood studs were erected and covered with 5/8 inch drywall on each side.

The closet was nearly filled with rolls of carpet and foam padding at the time of the fire. The wood door of the closet at the beginning of the fire is believed to have been partially open. This allowed combustion air into the closet and the heat, smoke, and flames to quickly rise up the adjacent stair opening to the second floor corridor and breezeway. The storage closet was also adjacent to the utility chase which allowed smoke, and eventually fire, to enter the chase and then extend to the guest rooms.

10. The top of the door frame for the 100 level closet determined to be the point of origin. The open stairway to the 200 level is to the top left off the photograph.

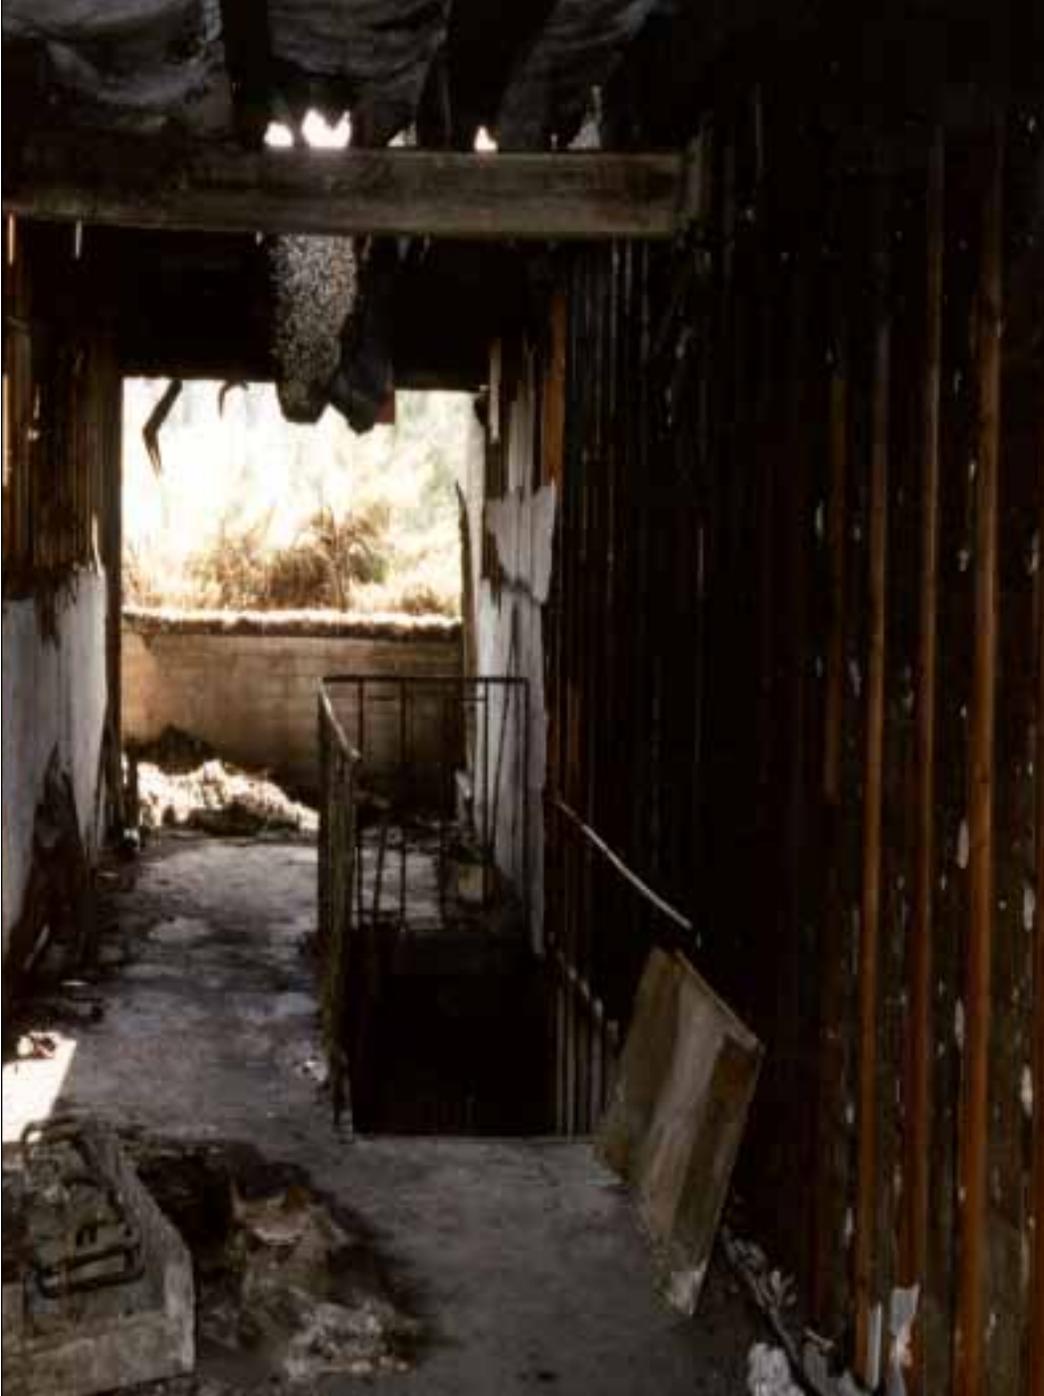
11. The top of the open stairway from the 100 level looking south. A glass in aluminum frame wall enclosed this area just before the partial height brick wall in the background. Room 222 is to the left.
