Wood Truss Roof Collapse Claims Two Firefighters Memphis, Tennessee

Wood Truss Roof Collapse Claims Two Firefighters (December 26, 1992)

Investigated by: J. Gordon Routley

This is Report 069 of the Major Fires Investigation Project conducted by TriData Corporation under contract EMW-90-C-3338 to the United States Fire Administration, Federal Emergency Management Agency.

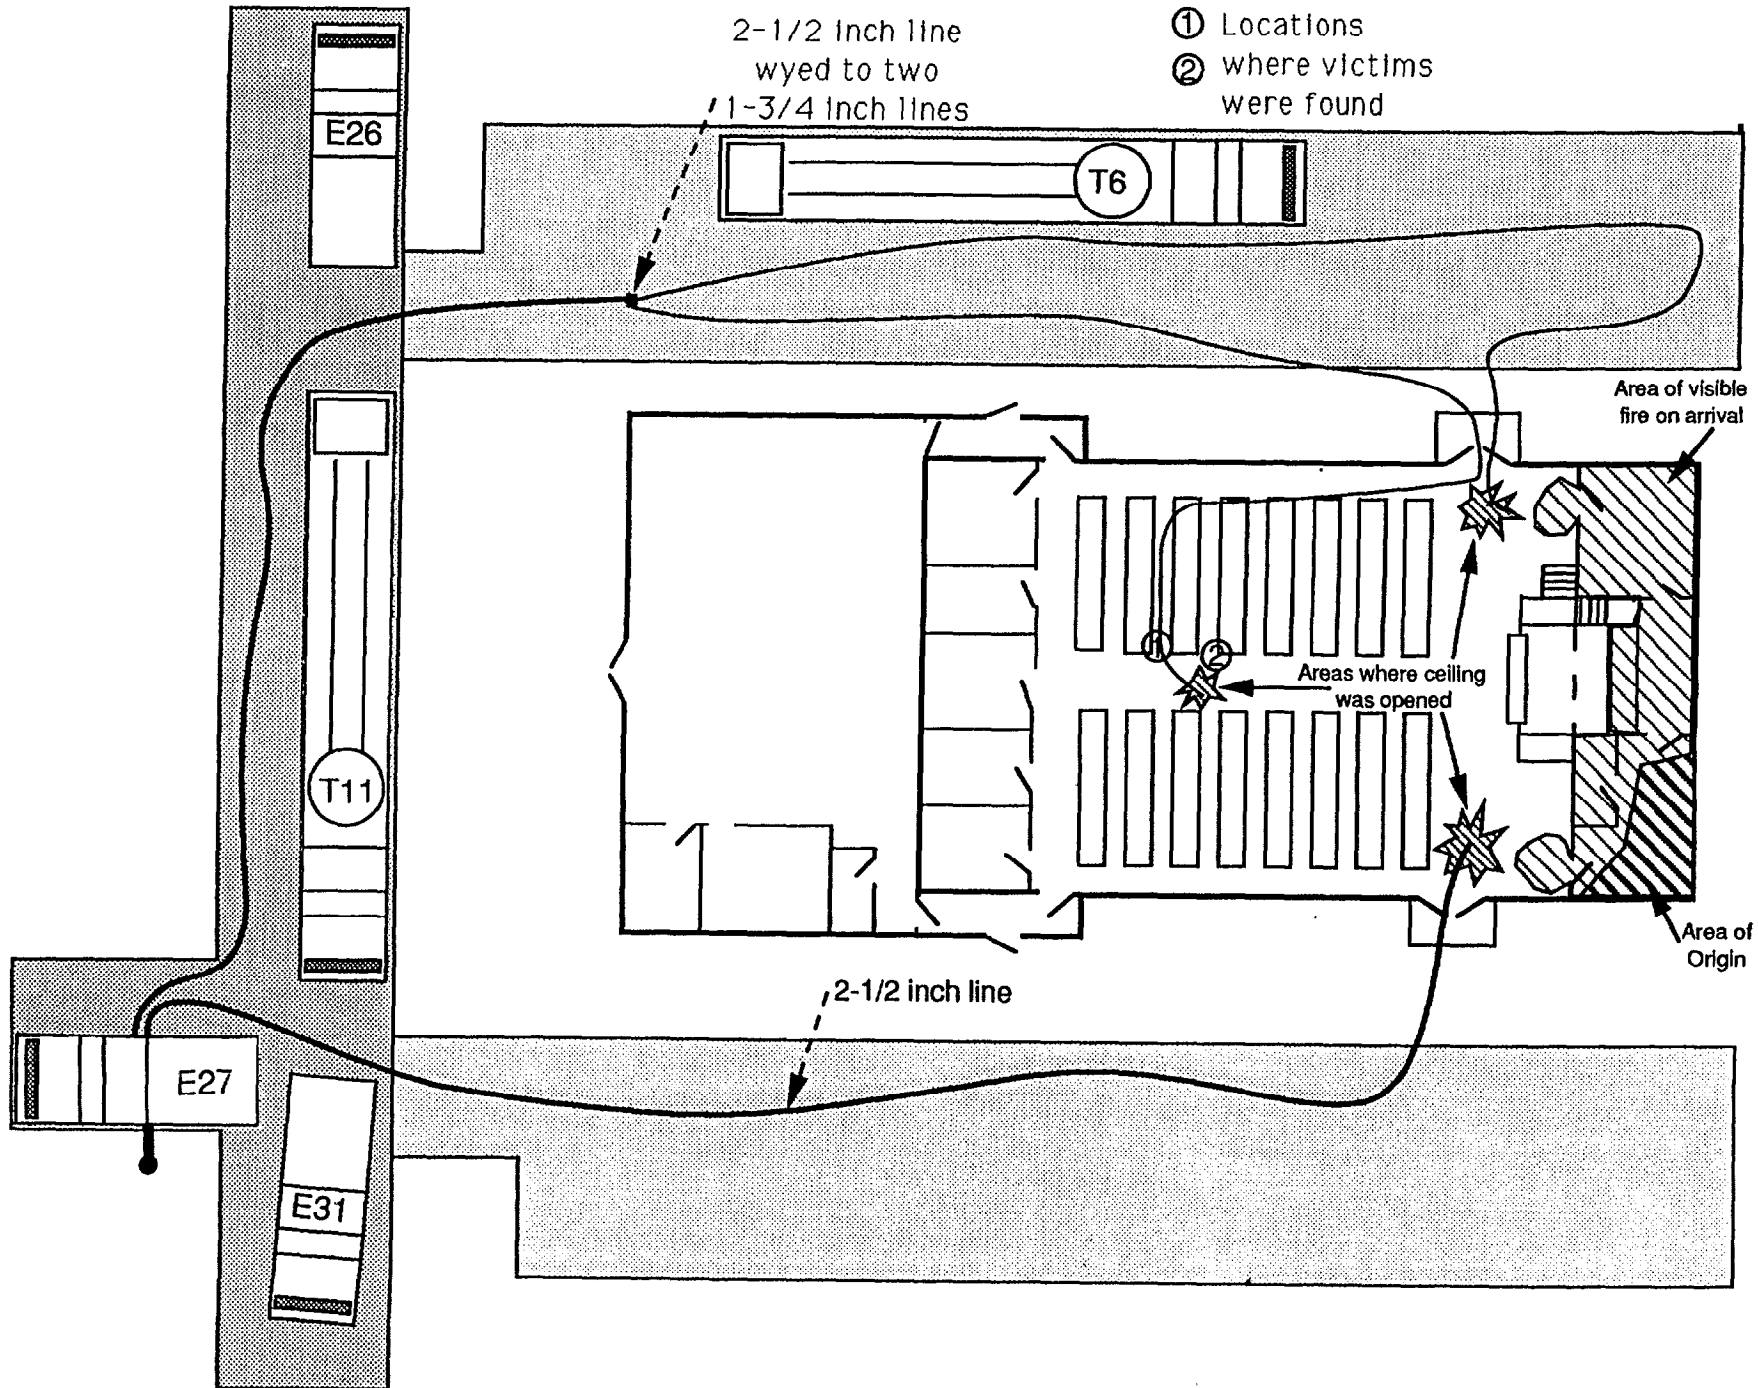
AREA OF FIRE INVOLVEMENT

A larger body of fire could be seen extending into the sanctuary at the opposite (south) side, near the south entry doors. The area where the fire was through the roof was entirely to the east of the sanctuary wall. The fire had melted connections in two of three gas lines, which supplied unit heaters located behind the wall, resulting in a particularly intense fire at the point of burn-through.
