Live Oak/Milstar Complex and Carpet Service Center

LaGrange, Georgia

UNITED STATES FIRE ADMINISTRATION FIRE INVESTIGATIONS PROGRAM

This is Report 086 of the Major Fires Investigation Project conducted by Varley-Campbell & Associates, Inc. under contract EMW-94-C-4423 to the United States Fire Administration, Federal Emergency Management Agency.

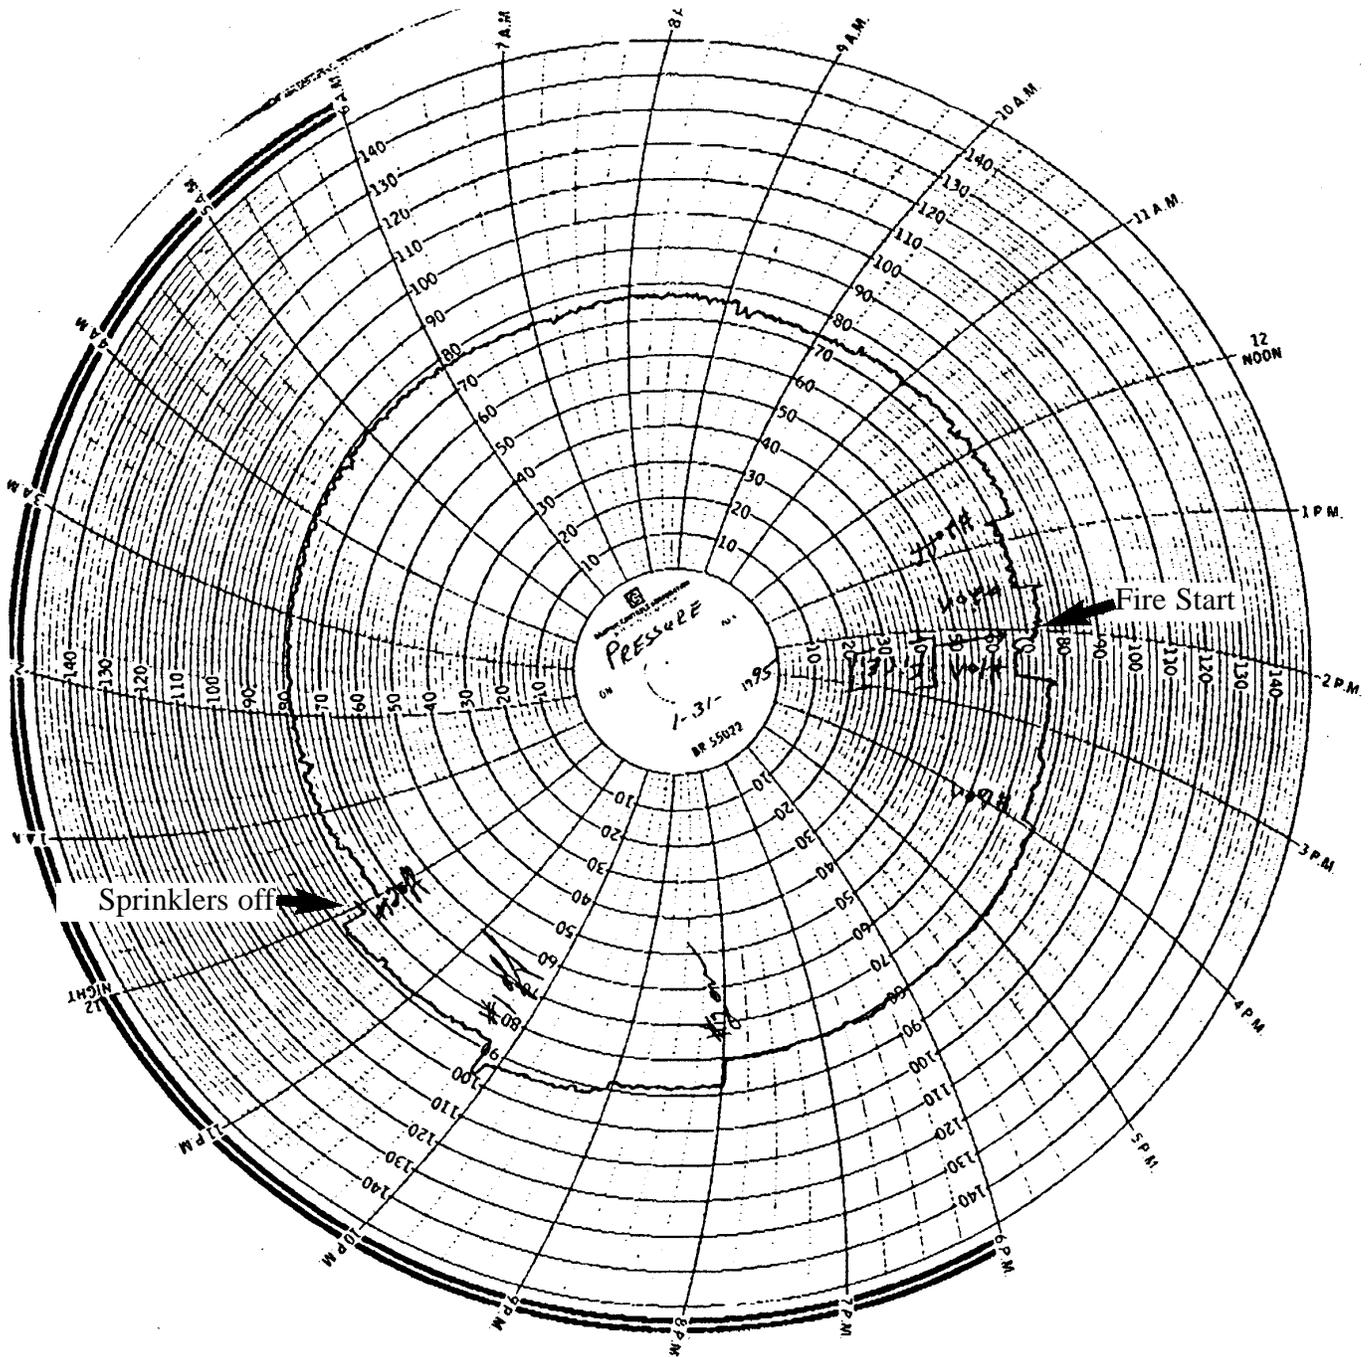
LaGrange Water Department Delivery Pressure Chart

Records indicate that during the afternoon and evening of January 31, 1995 four of the five pumps were placed into service and that nearly 10 million gallons of water was delivered that day. This figure was significantly above the normal daily consumption for the time of year. The delivery pressure chart recording at the treatment plant documents the pressure drop at the start of the fire and a spike when the city water connections to the Milliken plant were closed. During the period between these events, the treatment plant delivery pressure remained within the normal operating pressure range of 72 to 96 psi. This indicates that the water mains in the area of the fire were delivering water at their maximum rate.
