Old Buckingham Station Chesterfield, Virginia

Old Buckingham Station

58 Unit Apartment Building

May 19, 1995

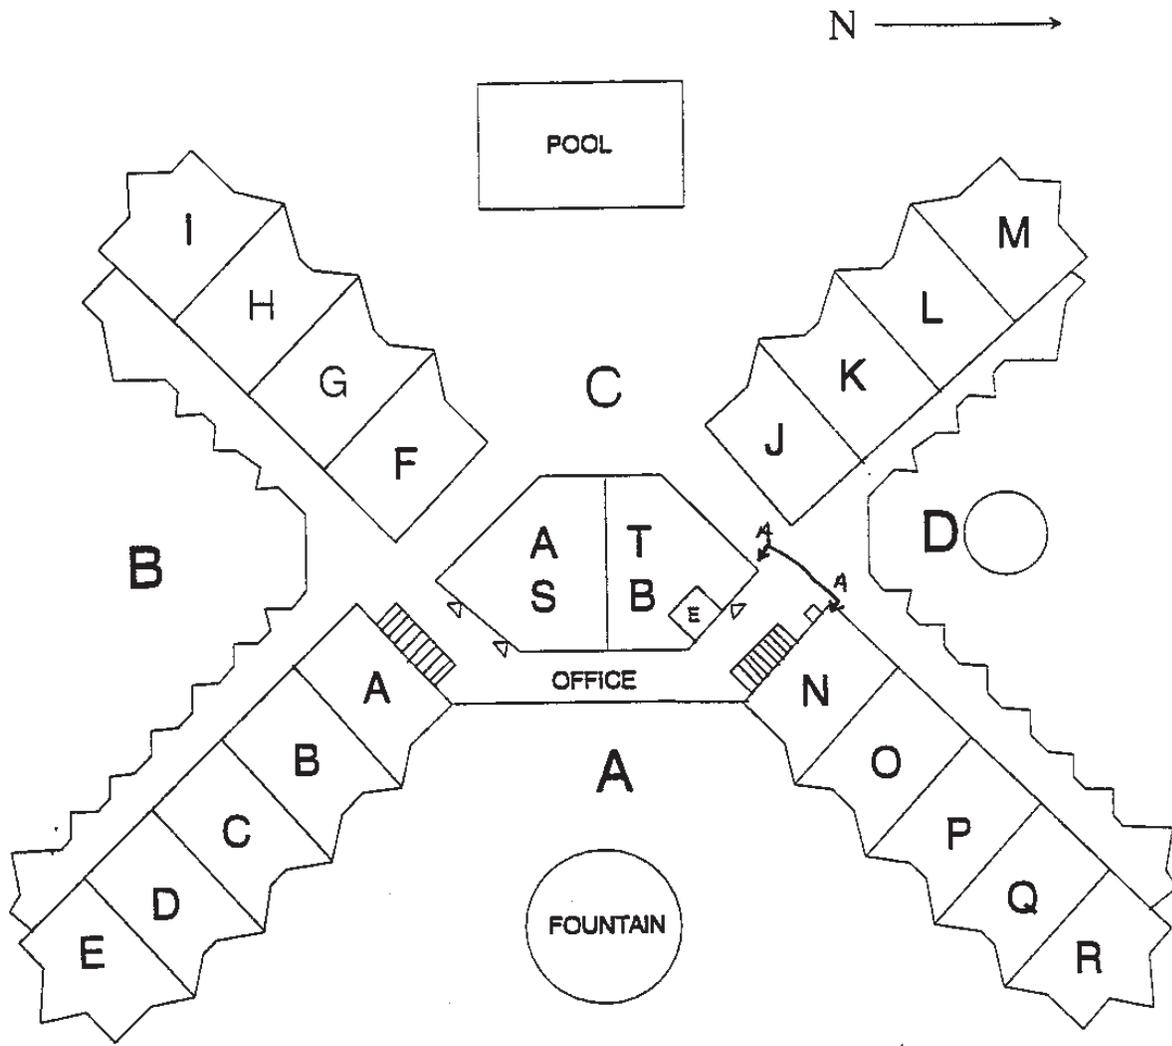
Fire investigators determined that the fire began on the second floor in a covered walkway between the northeast wing and the center core, just outside of apartment 2J. (See Appendix B for location) The cause was identified as an exterior light fixture that had been inverted from its usual operating position by one of the occupants and then wrapped with a flannel shirt to reduce the light intensity into their bedroom. The fixture's incandescent bulb was enclosed by a clear plastic globe. By inverting the fixture, the vent holes, which were intended to remove heat from the 60 watt bulb, were out of position and the plastic globe in combination with the flannel shirt held in the heat. This eventually resulted in the ignition of the shirt and the light fixture's plastic globe. The fire spread to the vinyl plastic siding and to the wooden stairway.

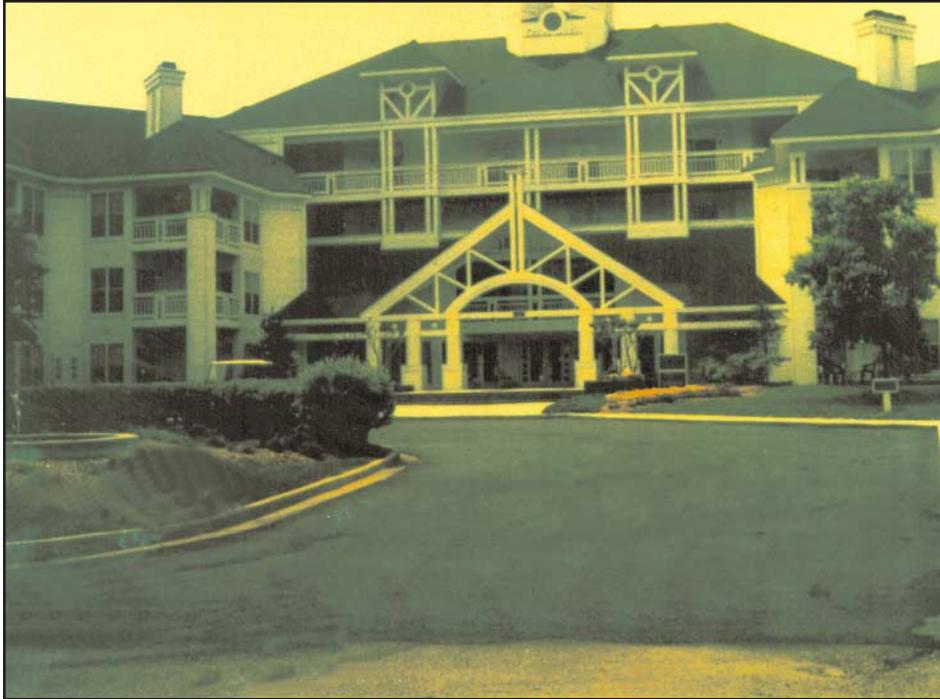
3. The main entrance to the building and the four story core building before the fire. North is to the right.

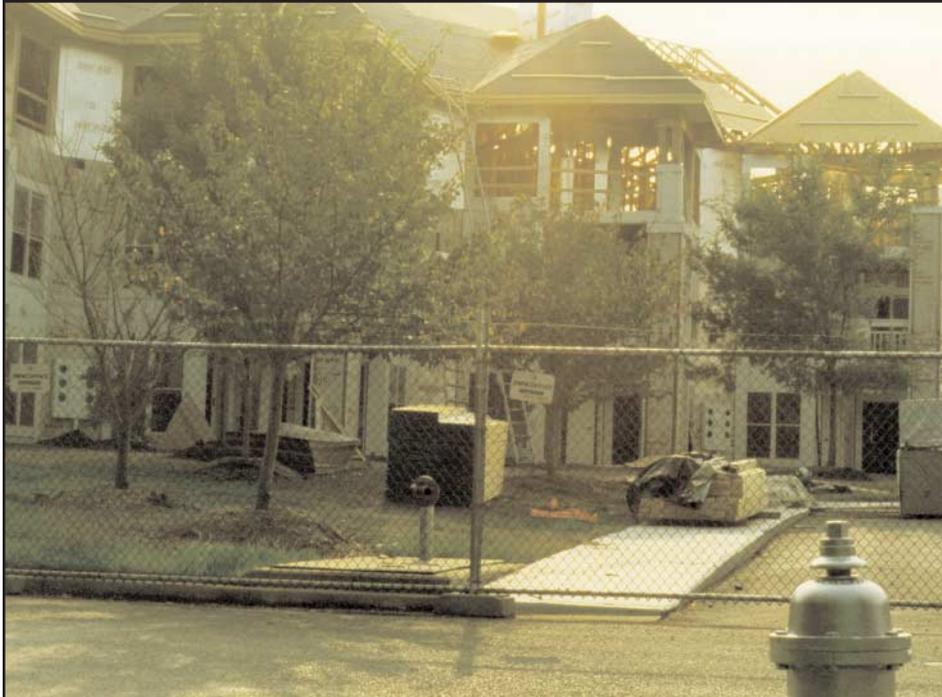
6. Fire hydrant and core siamese connection used by Engine 54 on arrival. Repairs and reconstruction are being made to the front wing; this side is the patio/balcony for each apartment.

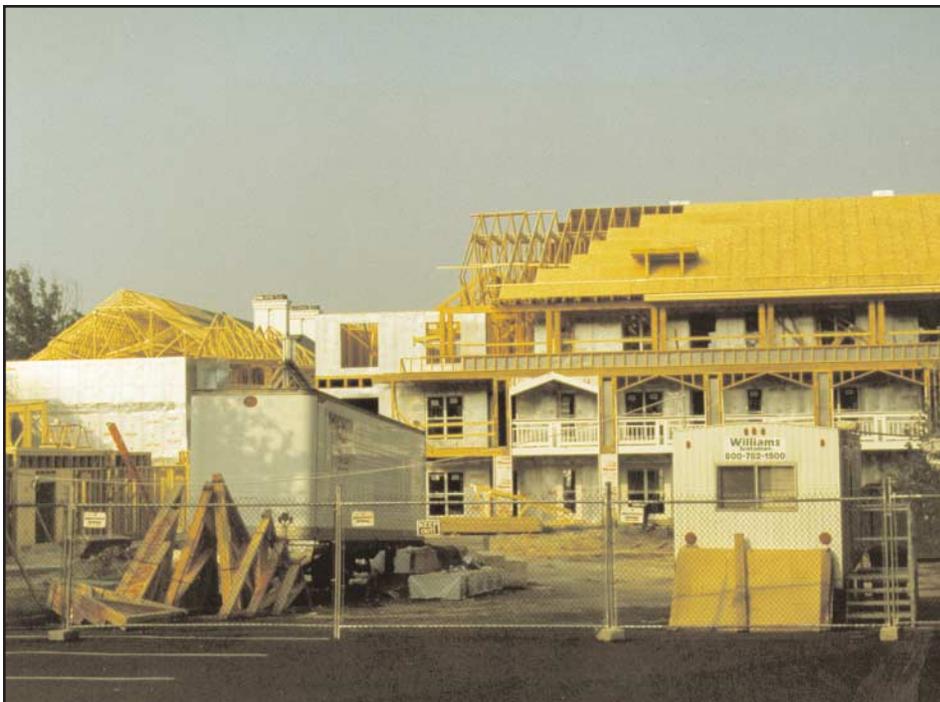
8. Reconstruction underway in Sector B, which is on the south side of the building. The exterior walkways were on this side of the wings.

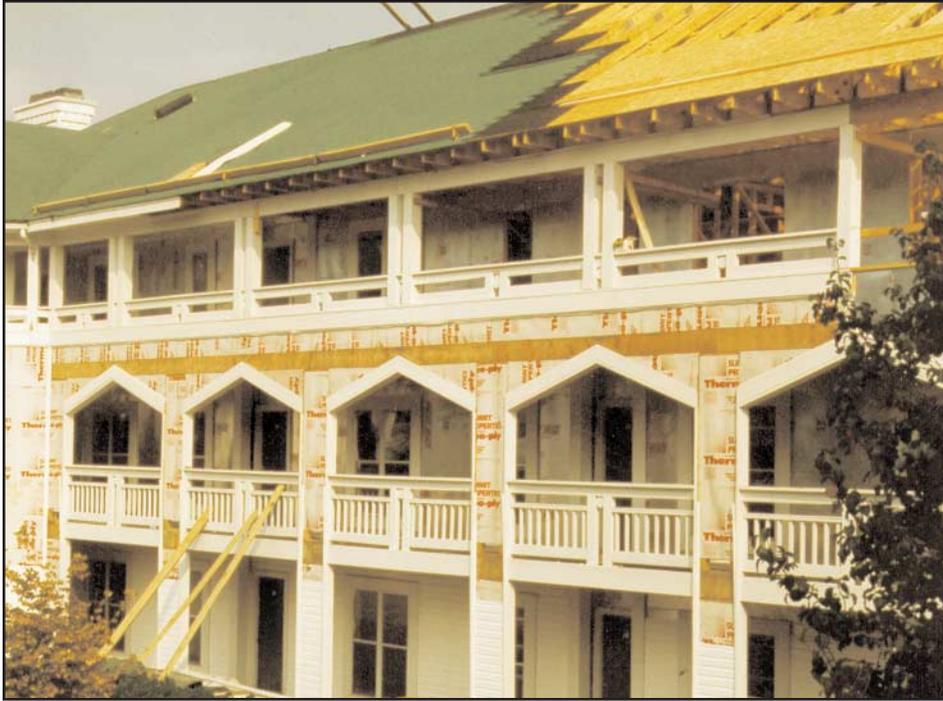
9. The exterior walkways in Sector D, with the stairway located at the left edge of the photograph. The core is out of the picture to the right.
