St. George Hotel Complex 16 Alarm Fire

Brooklyn, New York

Investigated by Scott M. Howell

August 26, 1995

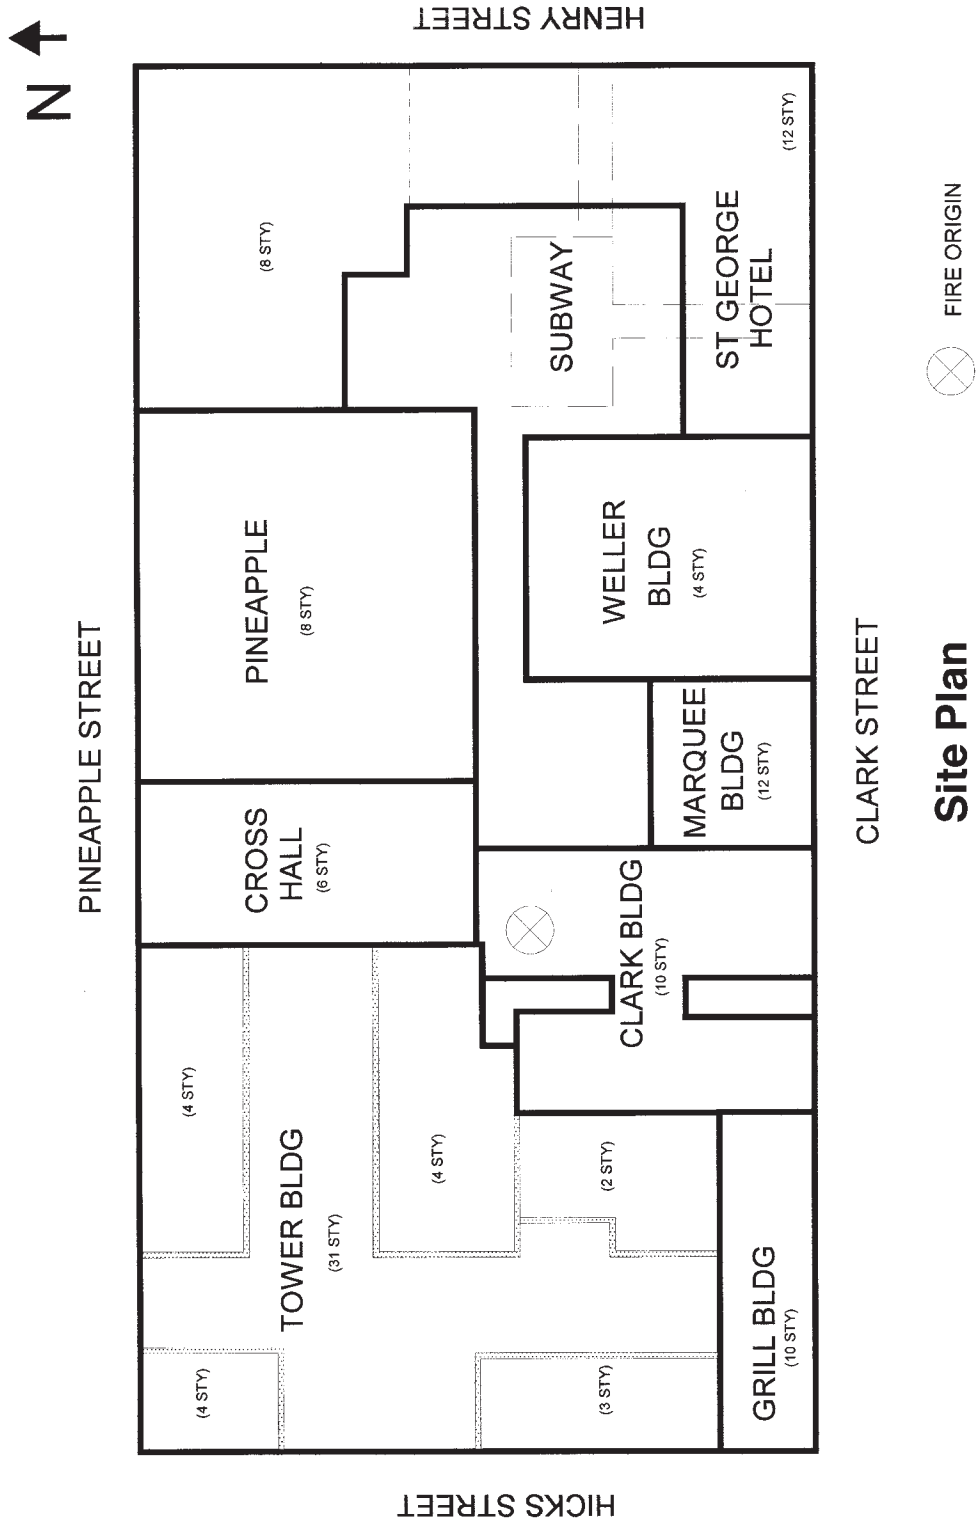
The St. George Hotel was the grandest of New York City's hotels when it opened in 1926. Located in the Brooklyn Heights area of the city, it had a total of 2,632 guestrooms in a complex of eight buildings that occupied an entire city block. (Figure 1). Some of the original buildings dated back to 1885. All the buildings were interconnected at the basement level, and there were numerous connections on various floor levels among the different buildings.

The complex was bordered by Pineapple Street to the north, Clark Street to the south, Hicks Street to the east and Henry Street on the west. Many streets in the Brooklyn Heights area are only 40 feet wide. Parking on the streets in front of the fire building further congested the area. Figure 1 shows the block and the relationships of the buildings to each other.

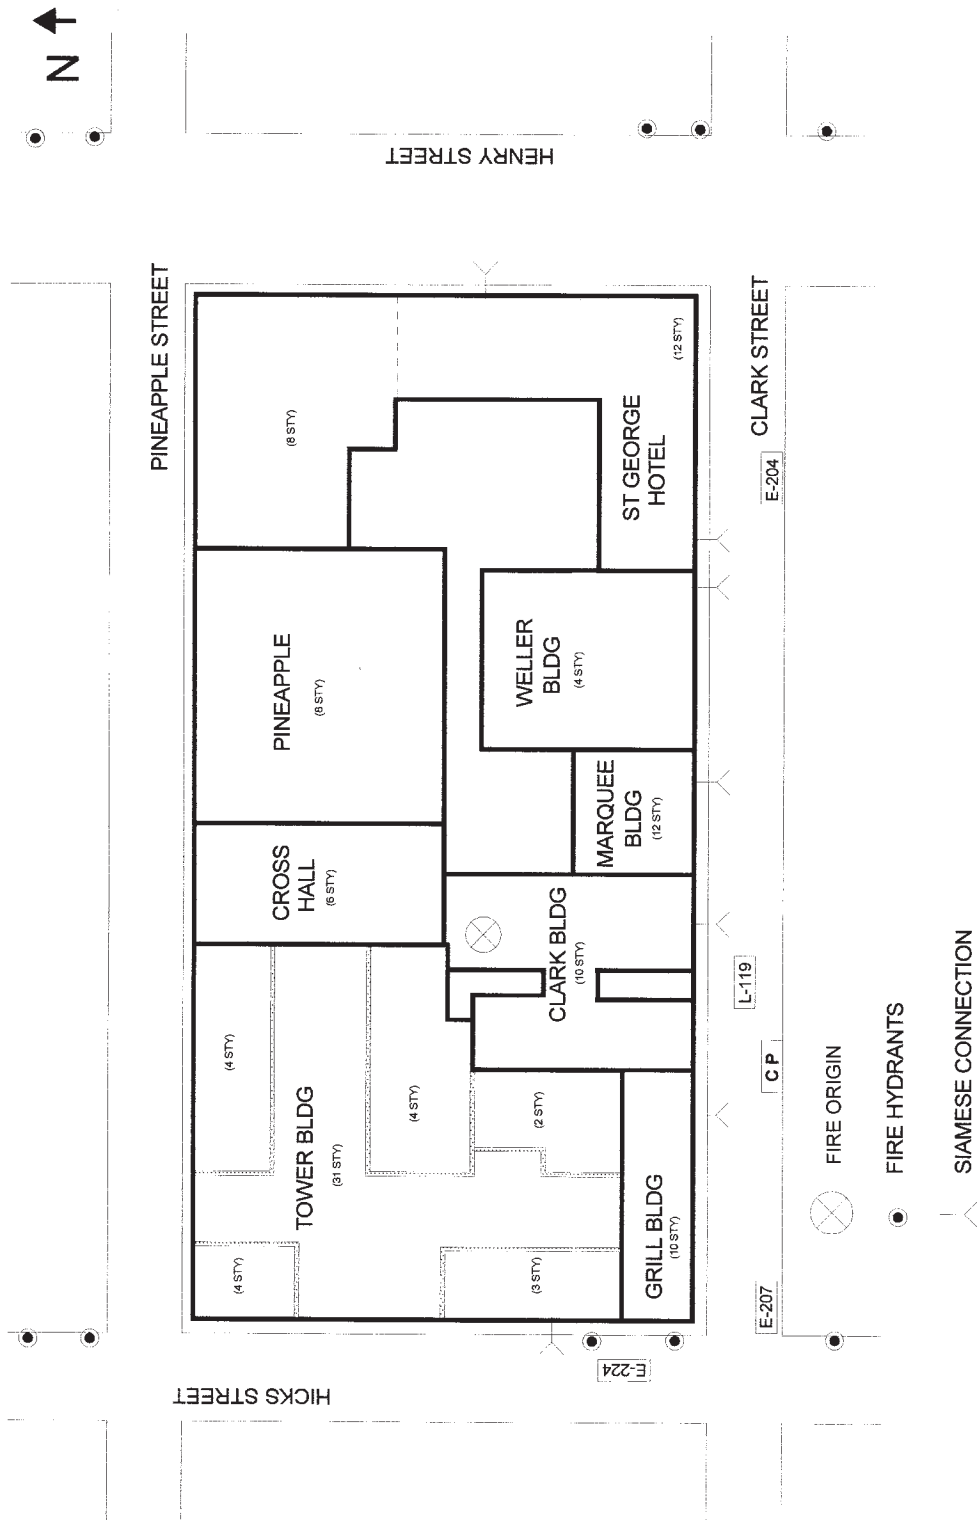
Figure 4

At 4:06 the first arriving Deputy Chief, DC-6, ordered a third alarm and assumed incident command. (Figures 3 and 4) As the fire was beginning to spread to exposure 4, the Marquee Building. The third alarm brought in four engines, 2 trucks, the Air Mask Maintenance Unit and a Medical Command Unit.

PLACEMENT OF "ALL HANDS" COMPANIES AT ABOUT 4:10 AM

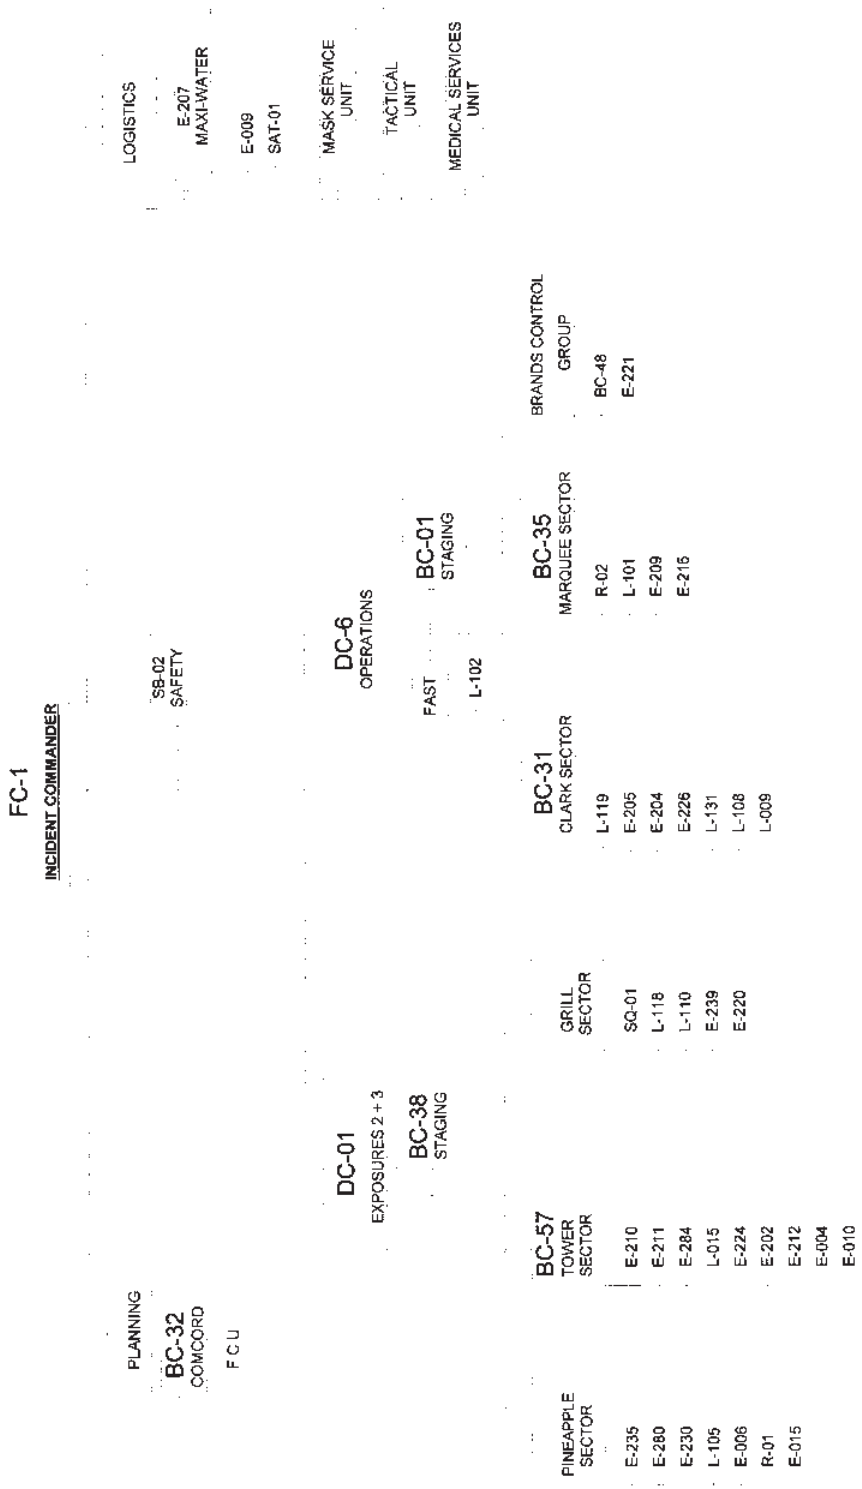
Figure 10

A secondary Command Post was established at the corner of Hicks and Pineapple and a second alarm assignment was requested by DC-1 to report to the Pineapple Sector, which included the Pineapple and Crosshall Buildings. The equivalent of a third alarm was requested to assist the companies that were already operating in the Tower Building. (Figure 10)

INCIDENT COMMAND STRUCTURE AT ABOUT 4:55 AM

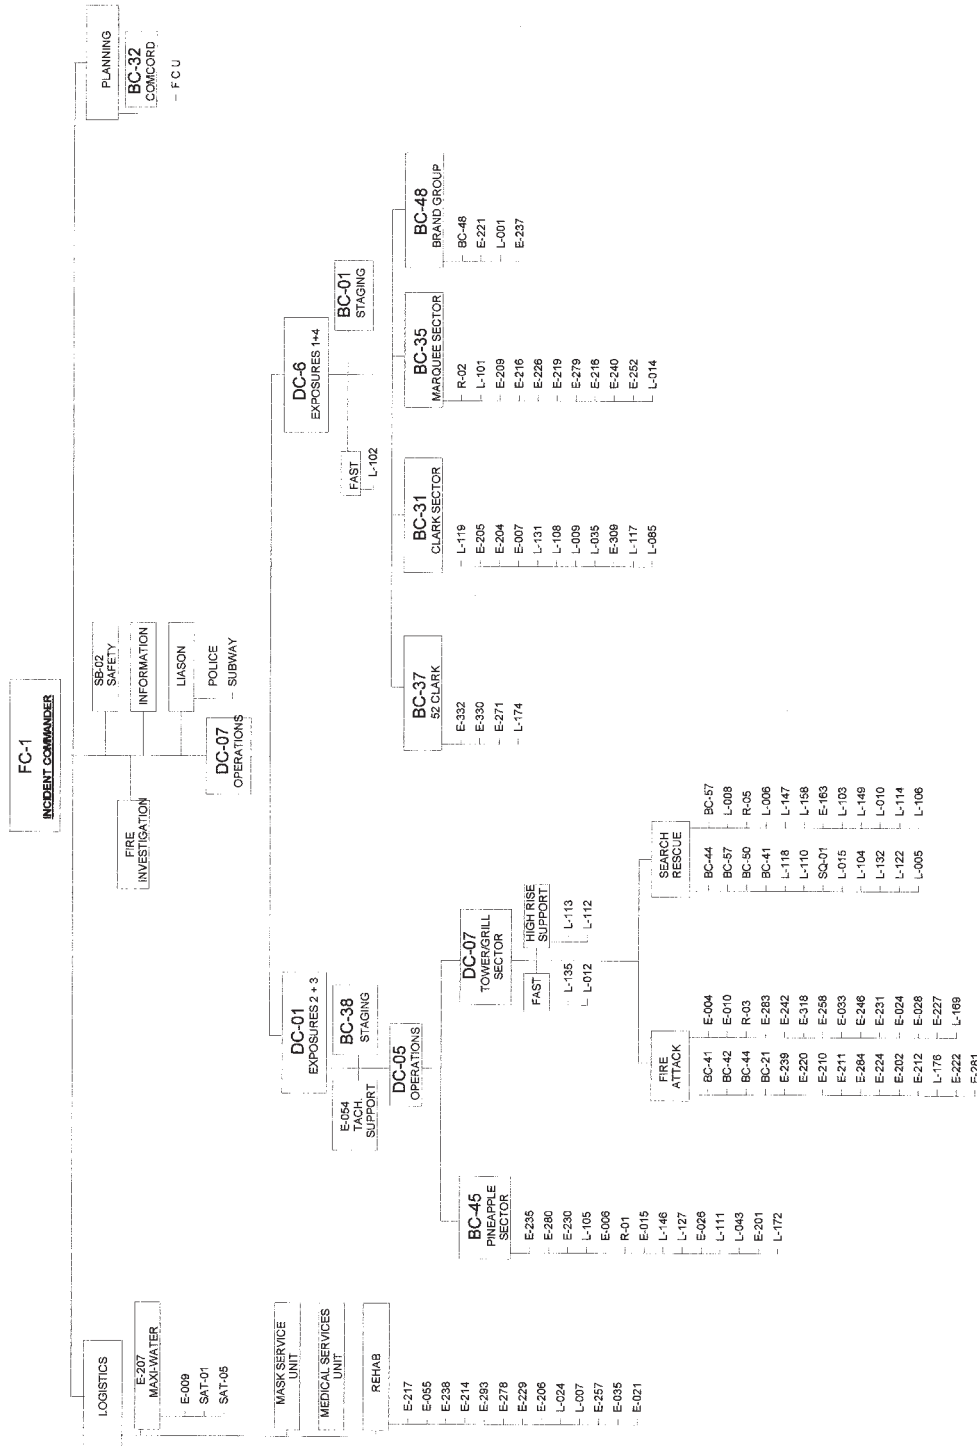
Figure 11

INCIDENT COMMAND STRUCTURE FOR THE HISTORY OF THE FIRE UNDER CONTROL AT 7:09 a.m.
