Floor Collapse Claims Two Firefighters Pittston, Pennsylvania

Floor Collapse Claims Two Firefighters Pittston, Pennsylvania (March 15,1993)

Investigated by: J. Gordon Routley

This is Report 073 of the Major Fires Investigation Project conducted by TriData Corporation under contract EMW-90-C-3338 to the United States Fire Administration, Federal Emergency Management Agency.

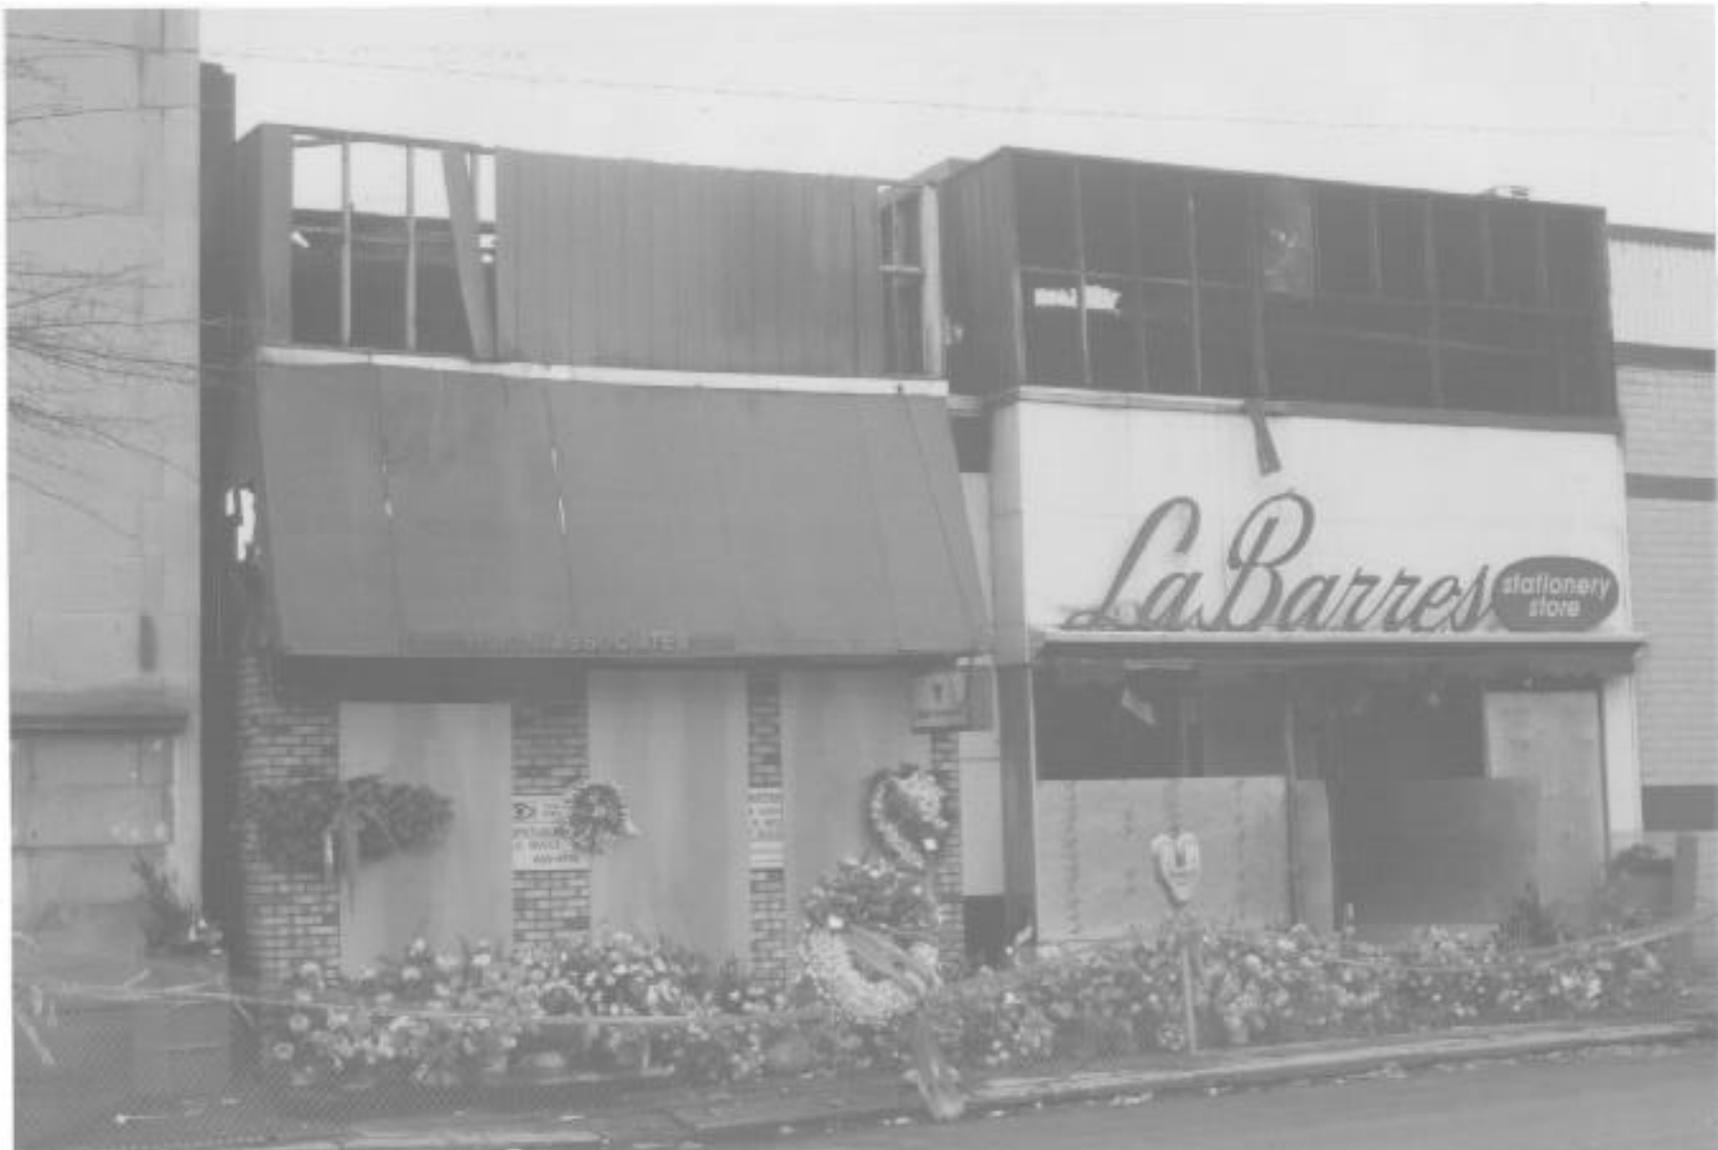
Collapsed roof section from the mid-section of the stationery store. The original walls of the front and rear buildings can be seen in this photo. The opening at the lower level is the original alley, which was filled in by construction joining the front and rear buildings. This opening provided an open path for fire extension between occupancies.
