Five Fatality Residential Motel Fire Thornton, Colorado

**Five Fatality Residential Motel Fire
Thornton, Colorado
January 27, 1997**

This is Report 104 of the Major Fires Investigation Project conducted by Varley-Campbell and Associates, Inc./TriData Corporation under contract EMW-94-4423 to the United States Fire Administration, Federal Emergency Management Agency.

**11 EAST 84TH AVENUE
THORNTON, COLORADO**

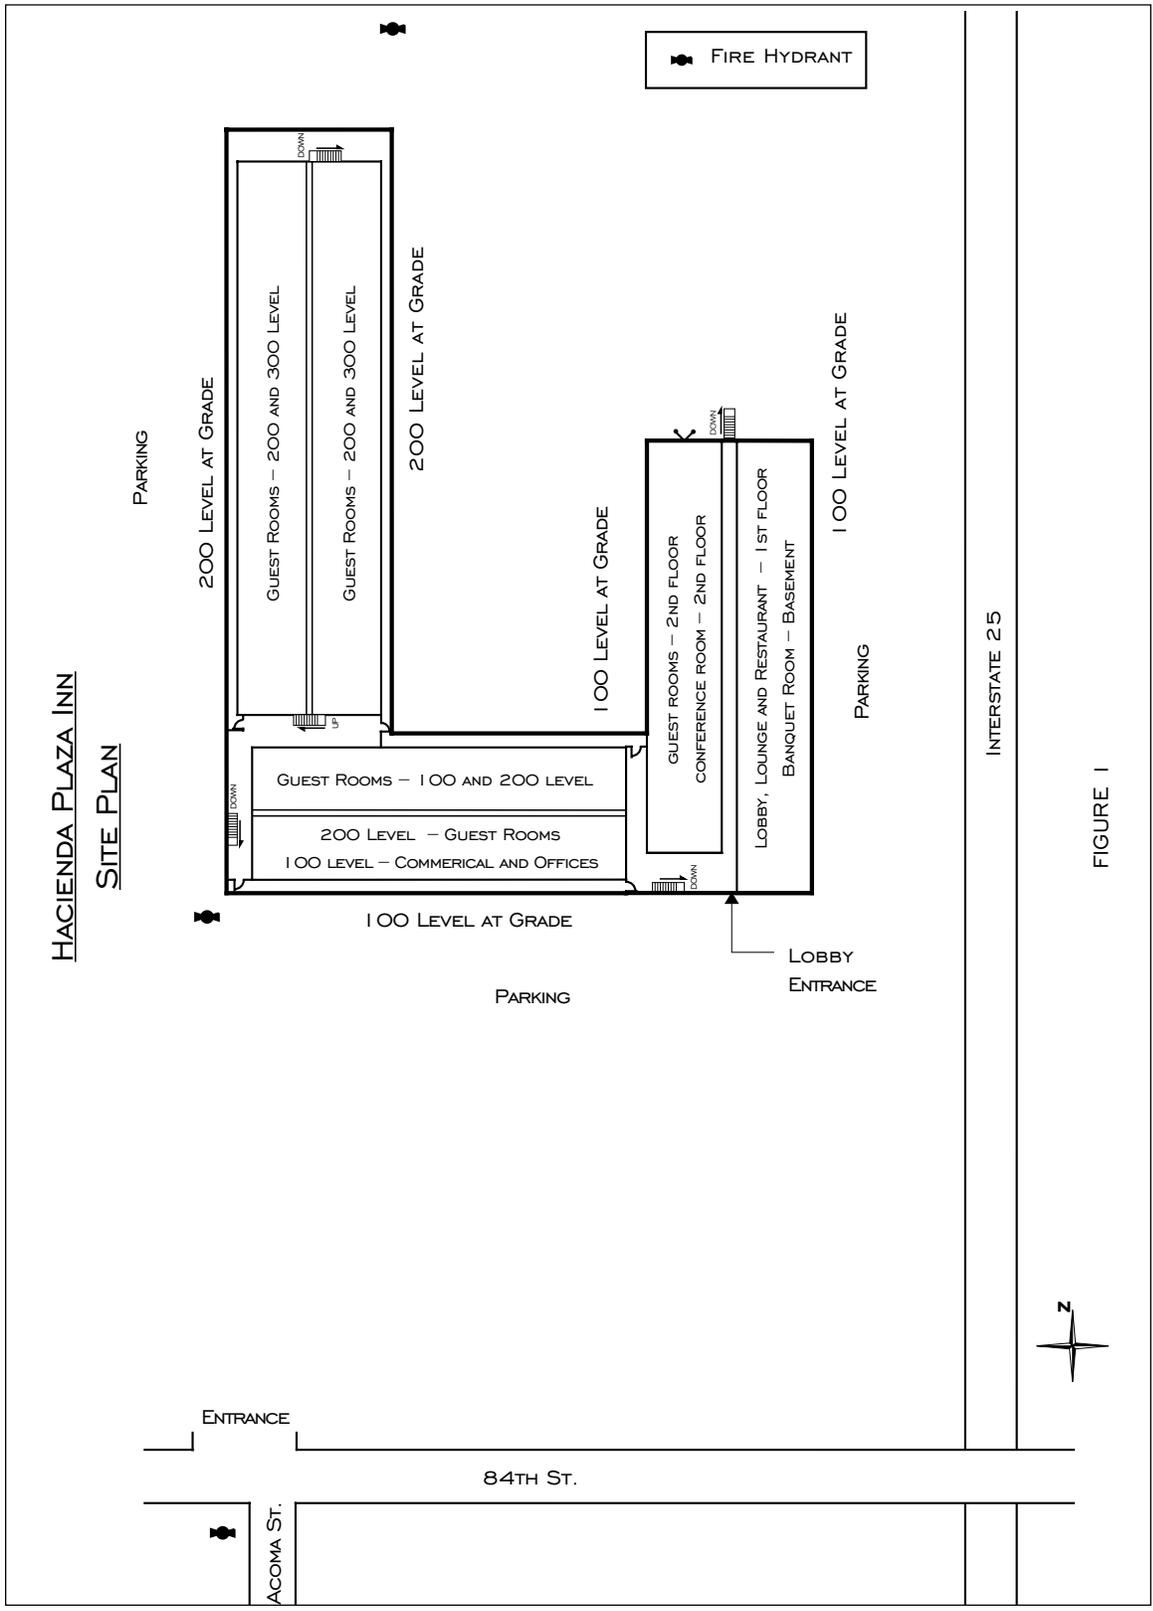
FIGURE 1

The Hacienda Plaza Inn was a partial “U” shaped structure consisting of three wings and was constructed in 1963. (See Figure 1 for diagram). The south or front wing and the west wing contained most of the guest rooms. The first floor of the front wing had several areas which were available for office and commercial use including one which was occupied by a quick print shop. The east wing contained the registration desk, offices, lounge, restaurant, banquet room, and on the second floor, efficiency style guest rooms with small kitchens.

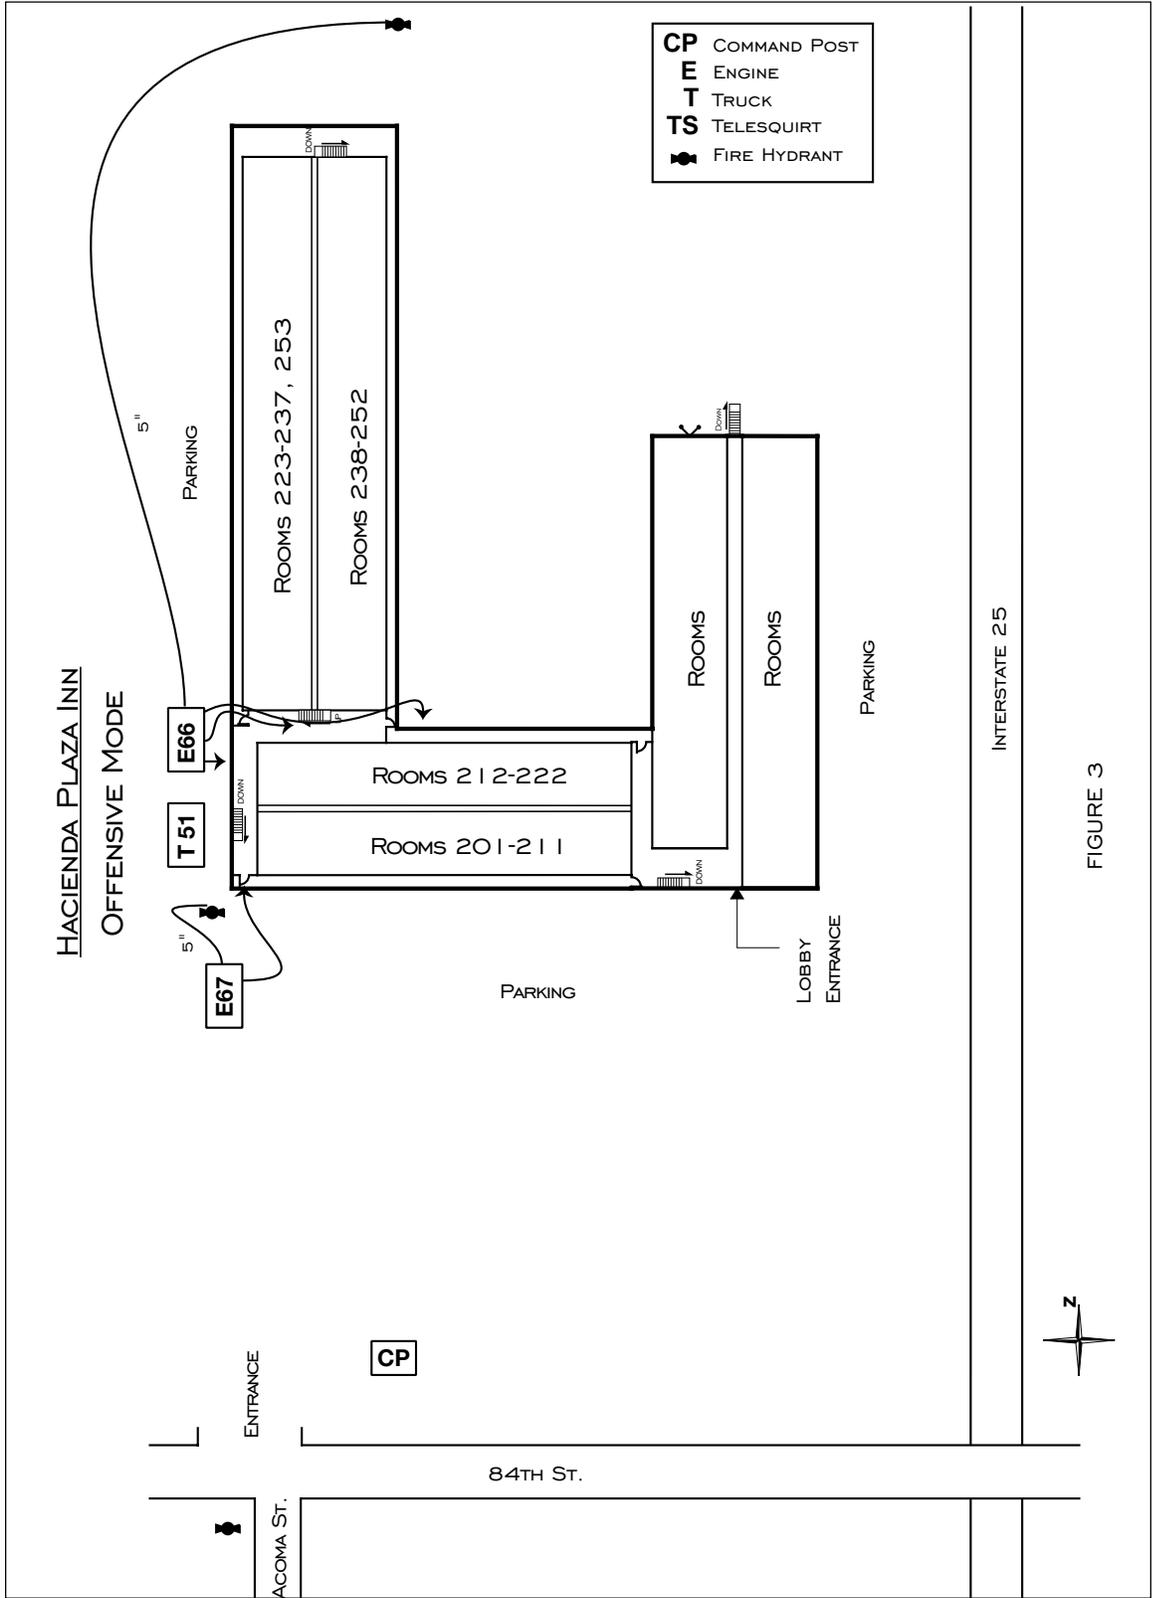
Figure 3. Offensive Mode

Engine 62 was the second engine on the scene just before 2:47 a.m. accompanied by Ambulance 62. The three member engine company assisted Engine 67 with rescue and advance of the hose line. The ambulance crew established a triage area in the front parking lot and requested additional resources from its headquarters. Eventually five AMR ambulances plus supervisory personnel responded to the fire scene. The search of Rooms 201 to 210 was completed by 2:52 a.m. and this area declared "all clear" by Engine 62. Attention now focused on extinguishing the fire at the base of the stairs at the west end of the front wing. (See Figure 3 for diagram)

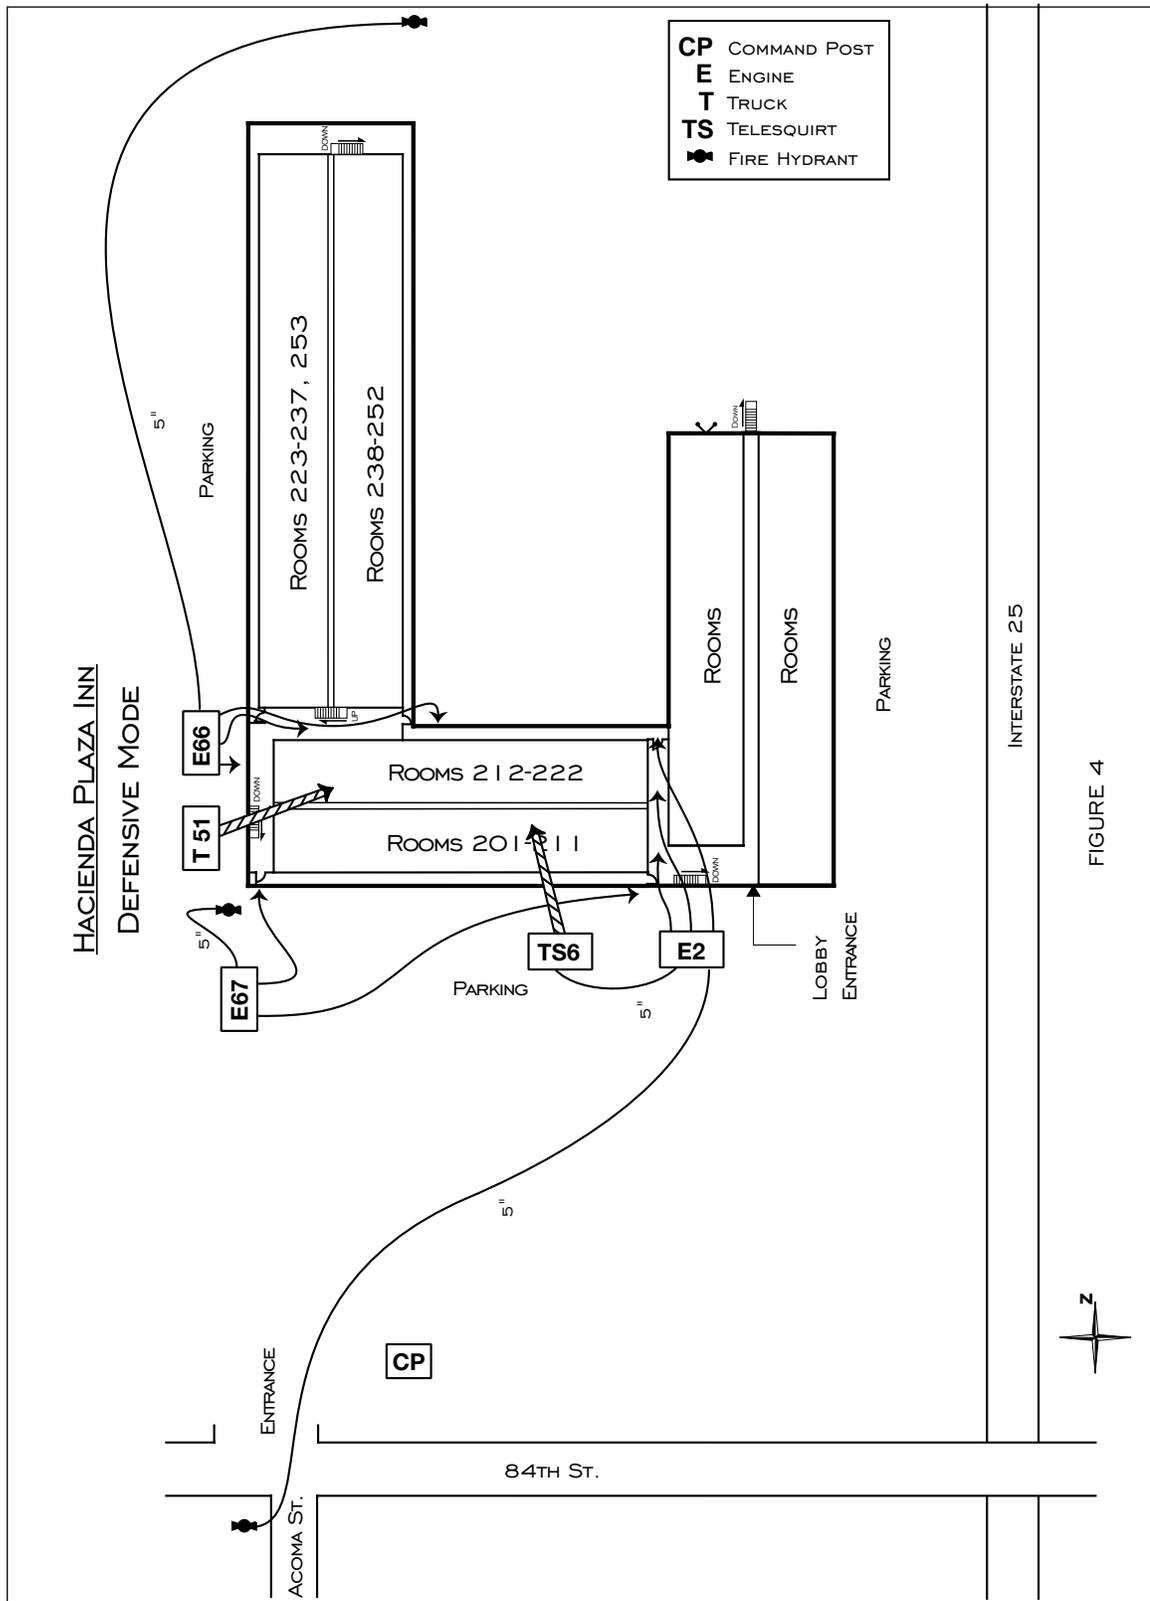
FIGURE 4

Tactical operations then changed from an offensive mode to a defensive one. About the same time the fire conditions were deteriorating, Incident Command was transferred to North Metro's deputy chief of operations. Command instructed Truck 51 to establish a ladder pipe operation at its position and two 2-1/2" lines were stretched from Engine 67. The "B" shift was recalled to their stations at 4:13 a.m. and two engines were requested from Southwest Adams County shortly after. (See Figure 4 for diagram)
